**UTAH POWER & LIGHT COMPANY
SUBSIDENCE MONITORING PROGRAM
ANNUAL REPORT FOR 1985**

February 1986

Submitted to: United States Department of the Interior
Office of Surface Mining
Minerals Management Service
Utah Division of Oil, Gas and Mining

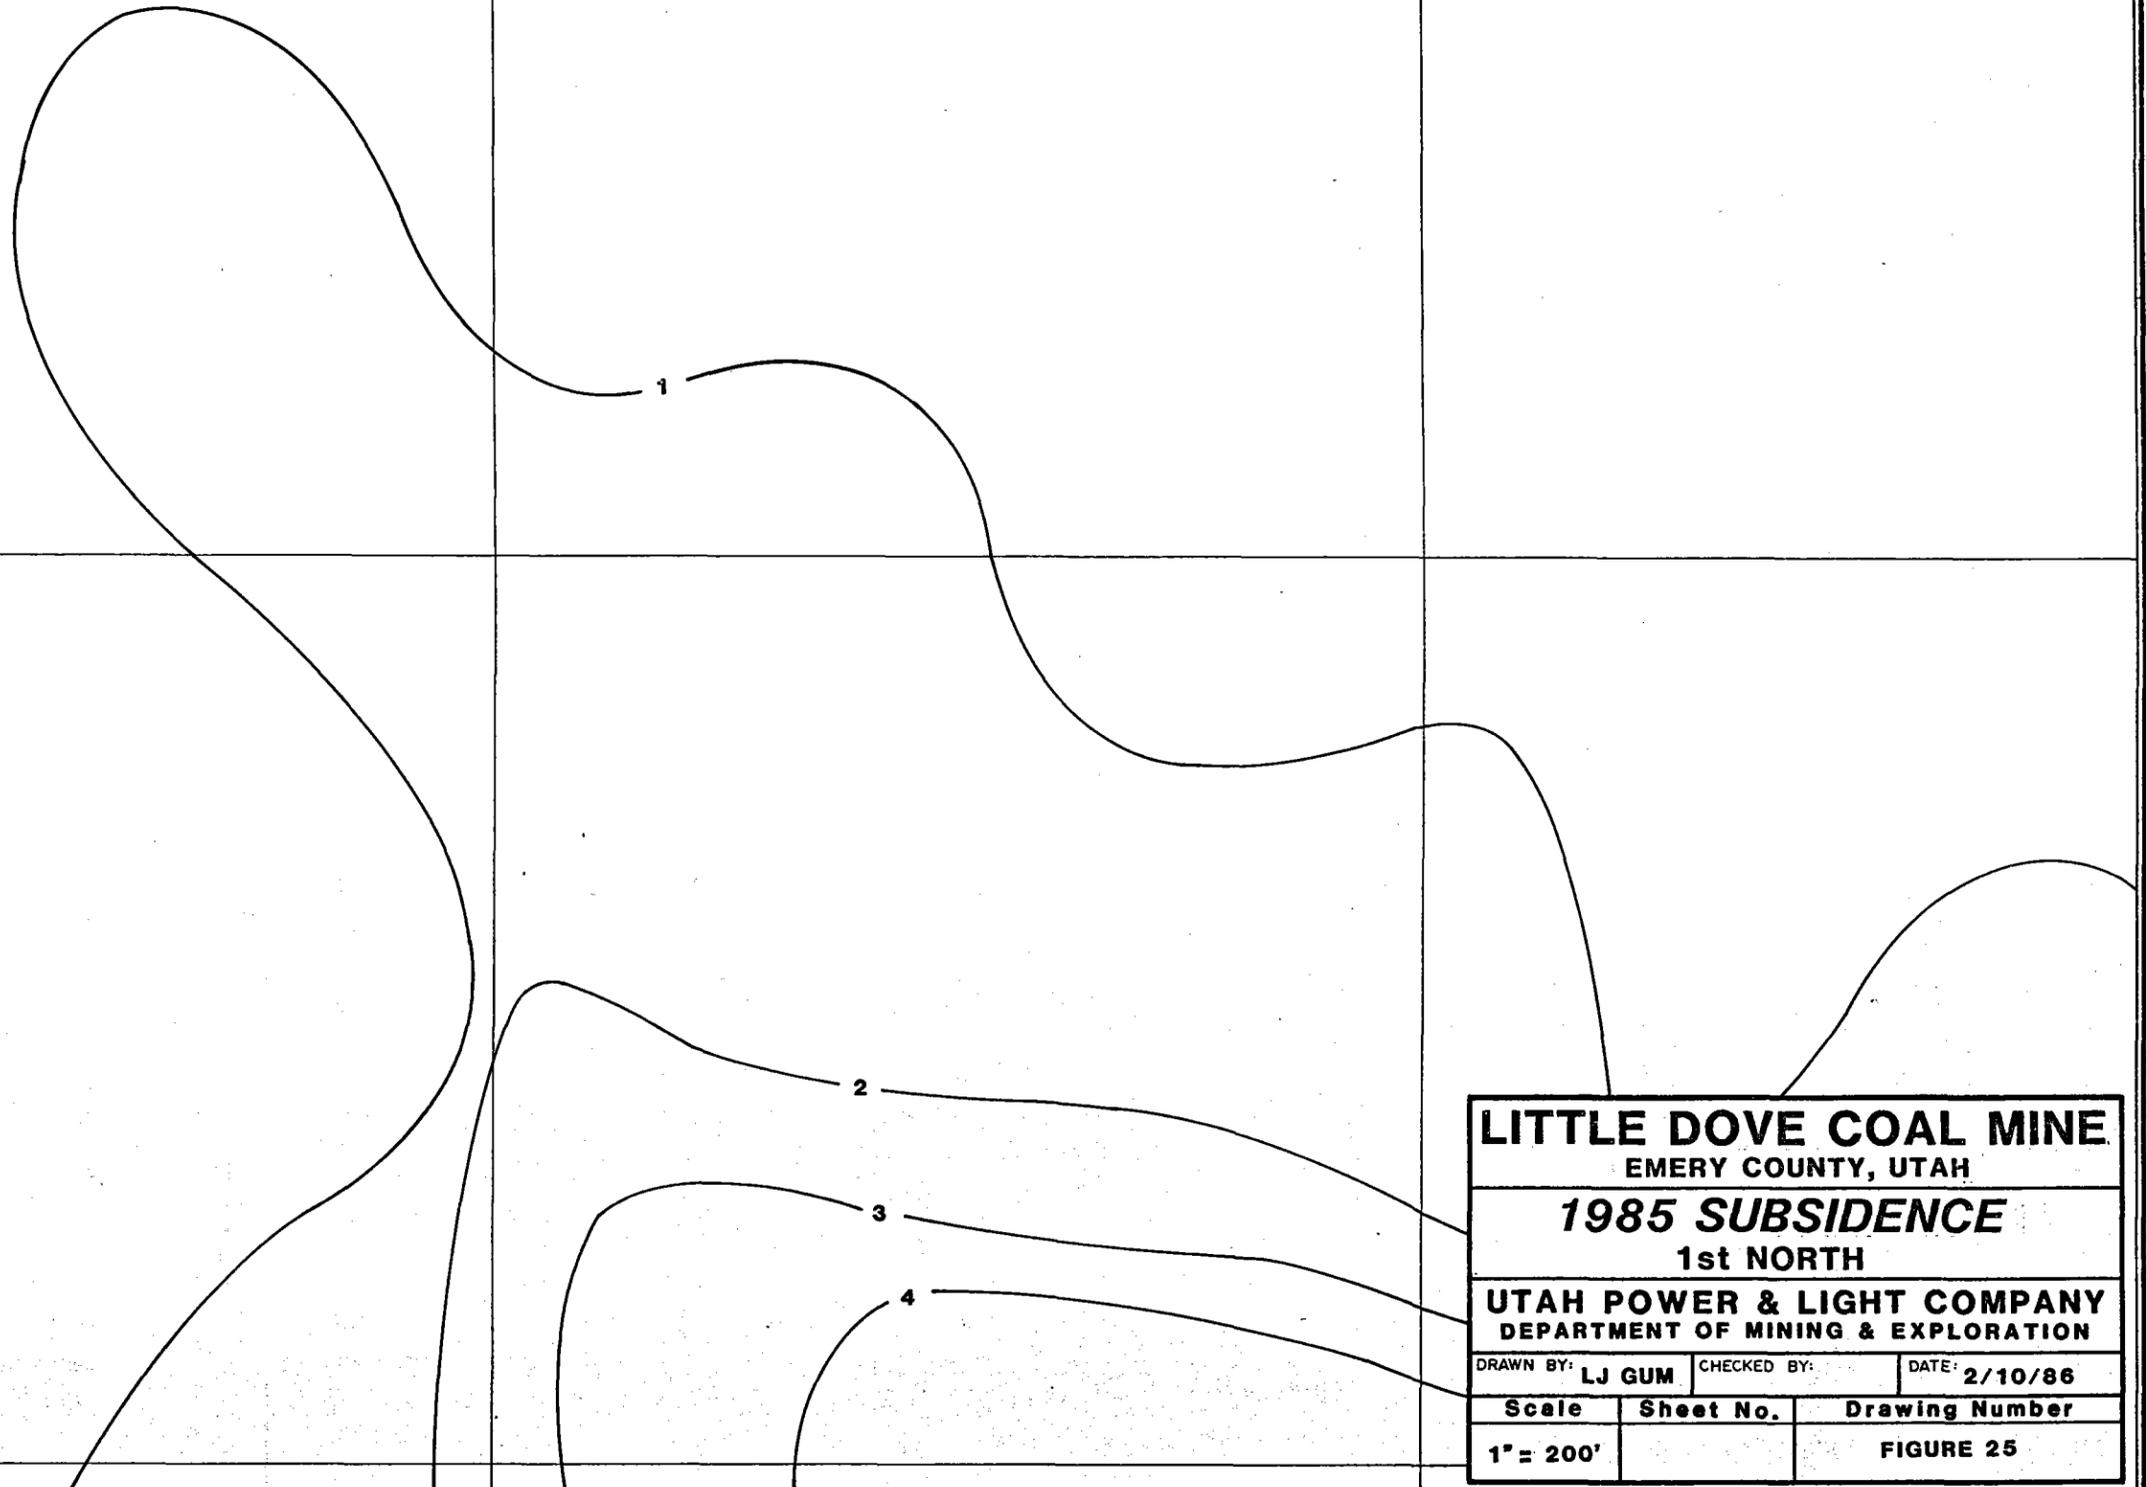
LITTLE DOVE COAL MINE		
EMERY COUNTY, UTAH		
1985 SUBSIDENCE		
1st NORTH		
UTAH POWER & LIGHT COMPANY		
DEPARTMENT OF MINING & EXPLORATION		
DRAWN BY: LJ GUM	CHECKED BY:	DATE: 2/10/86
Scale	Sheet No.	Drawing Number
1" = 200'		FIGURE 25

Maximum subsidence over the 1st North Little Dove workings remained at less than 2 feet in 1985 over an area of partial pillar extraction (compare Figures 24 and 25). The 4 feet of subsidence seen on Figure 25 actually occurs over the adjacent mined out workings of the Deer Creek and Wilberg Mines (Area 1).

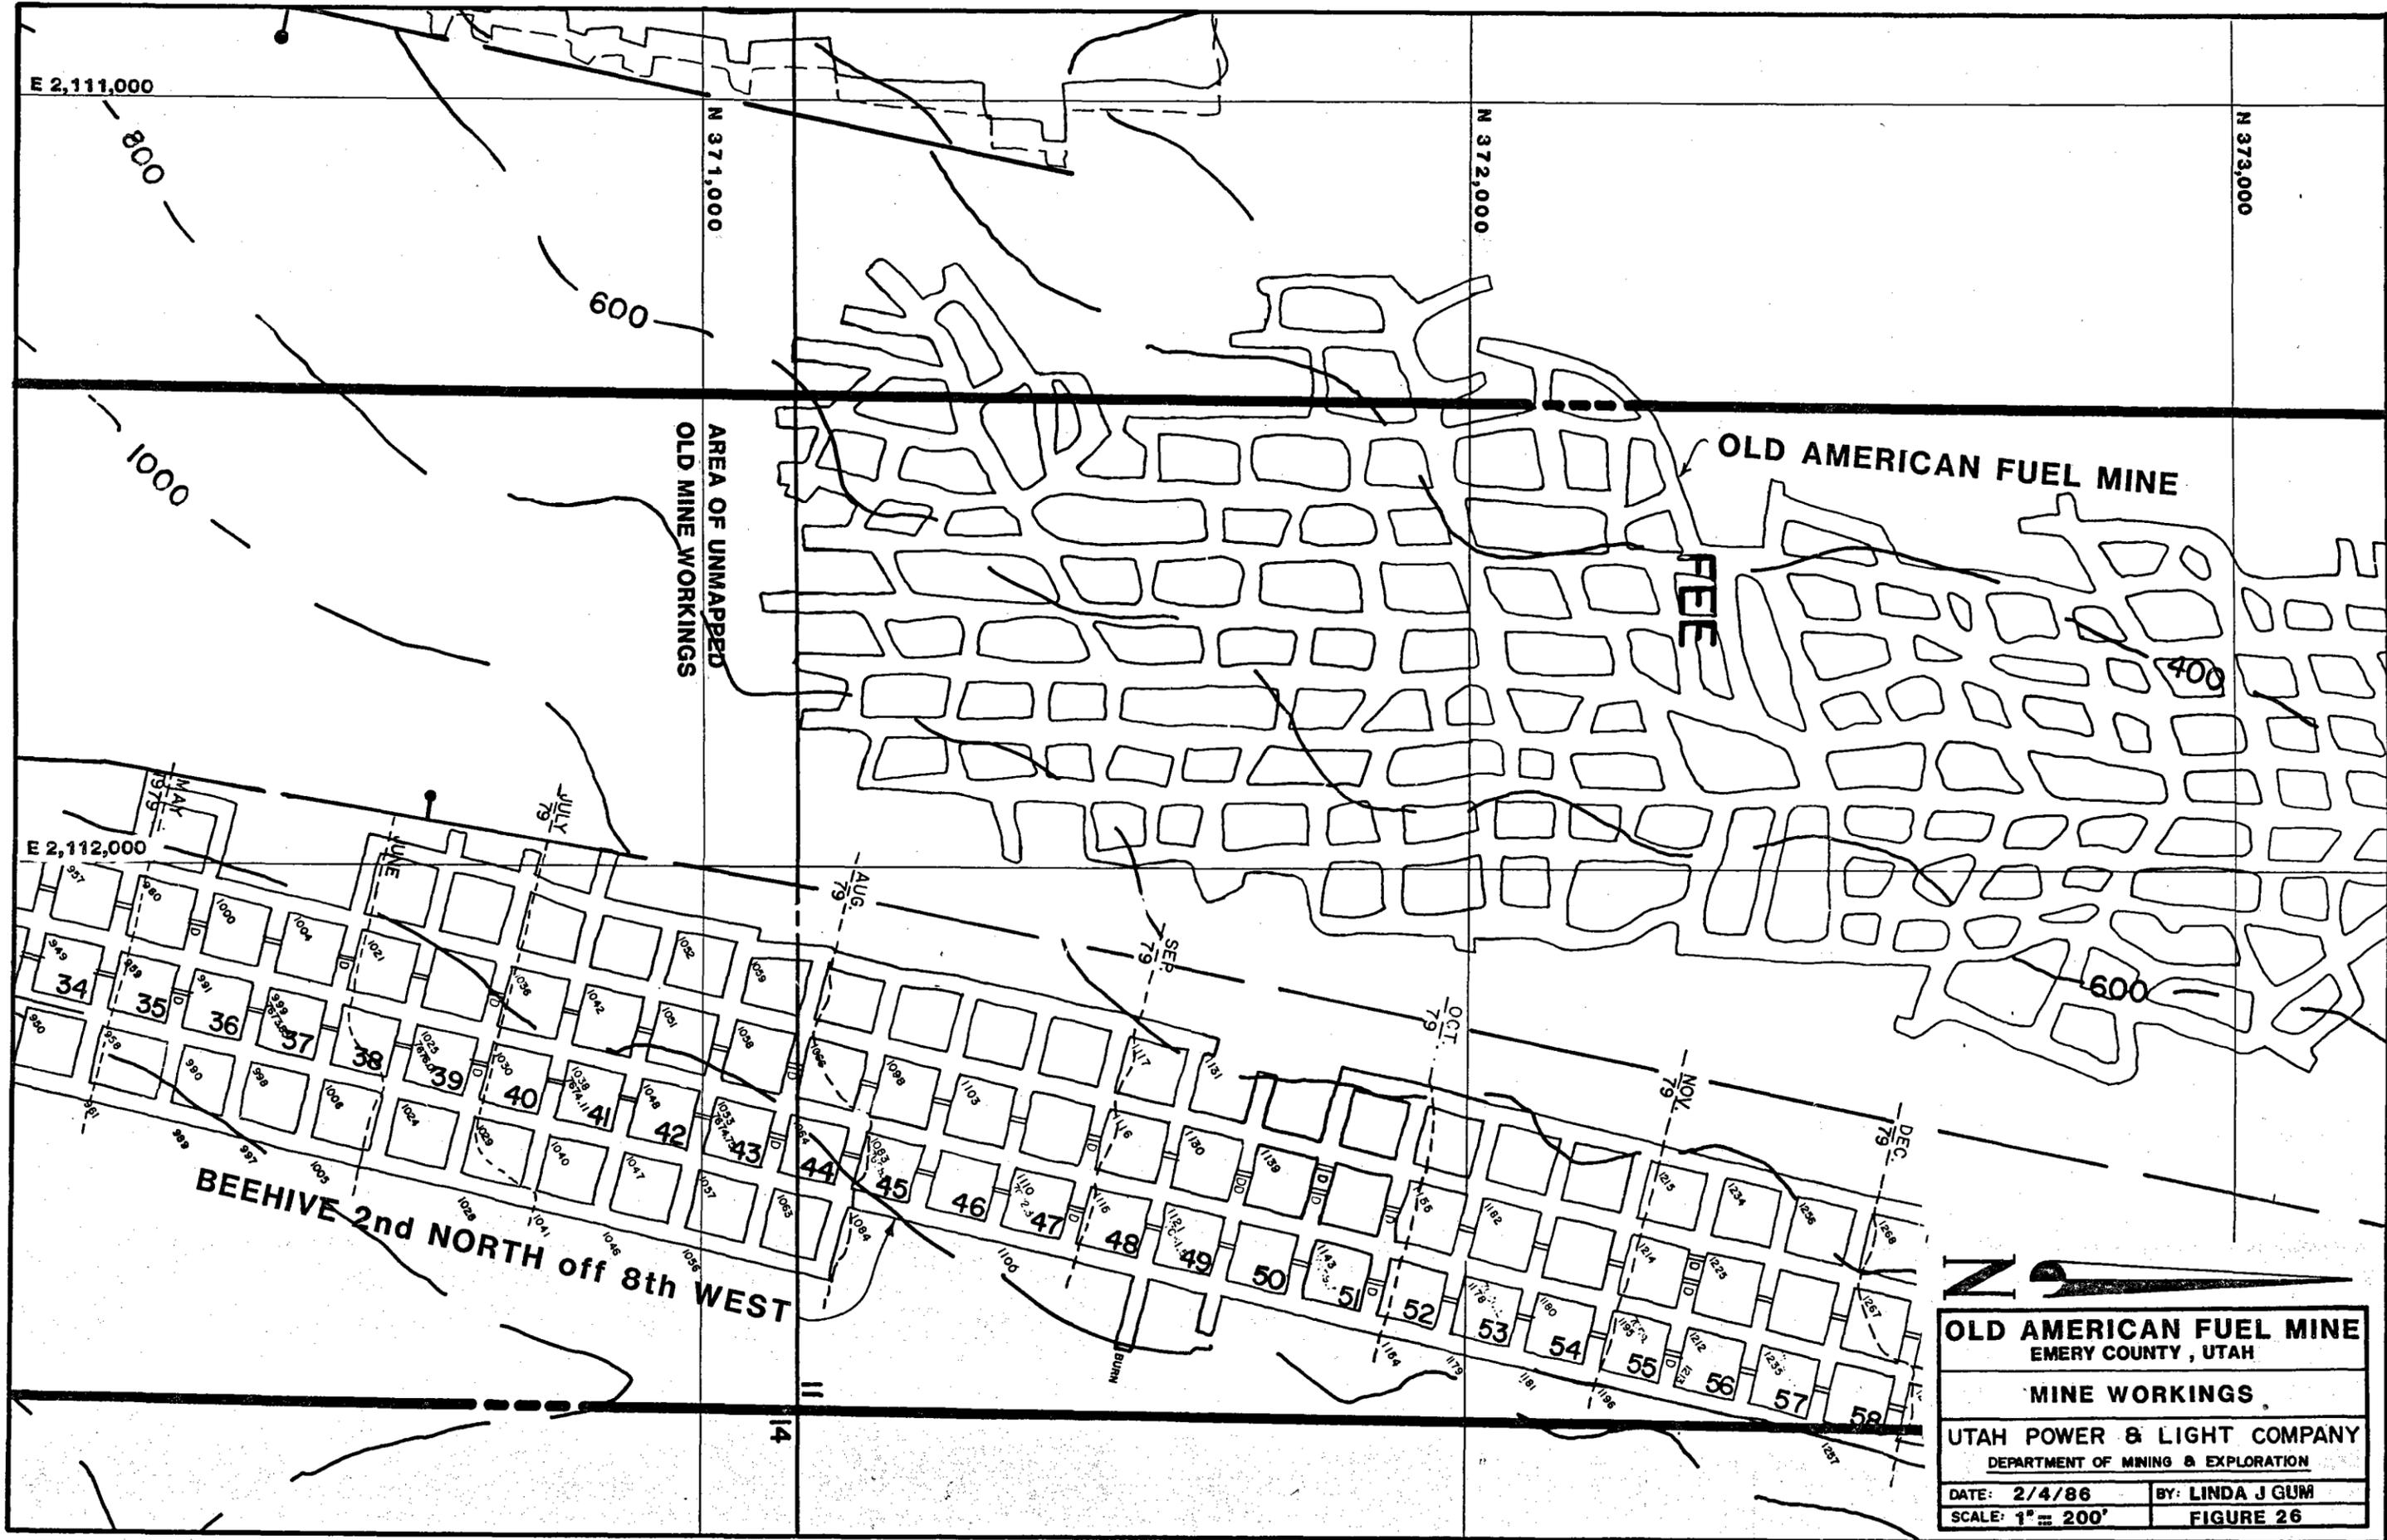
OLD AMERICAN FUEL MINE EMERY COUNTY, UTAH	
MINE WORKINGS	
UTAH POWER & LIGHT COMPANY DEPARTMENT OF MINING & EXPLORATION	
DATE: 2/4/86	BY: LINDA J GUM
SCALE: 1" = 200'	FIGURE 26

The latest mining in the old American Fuels Mine occurred in 1966. Since UP&L began observations, maximum subsidence has reached 4 feet over these old workings (Figures 26 and 27). Another small subsidence zone further south shows almost 4 feet of subsidence; no change since 1983. In that area several small surface fractures mark the reactivated trace of the Bear Creek Canyon Fault.

On the east side of the American Fuels Mine workings the angle of draw has been calculated at 8° to 9°. The subsidence has not affected the hydrology in any way.

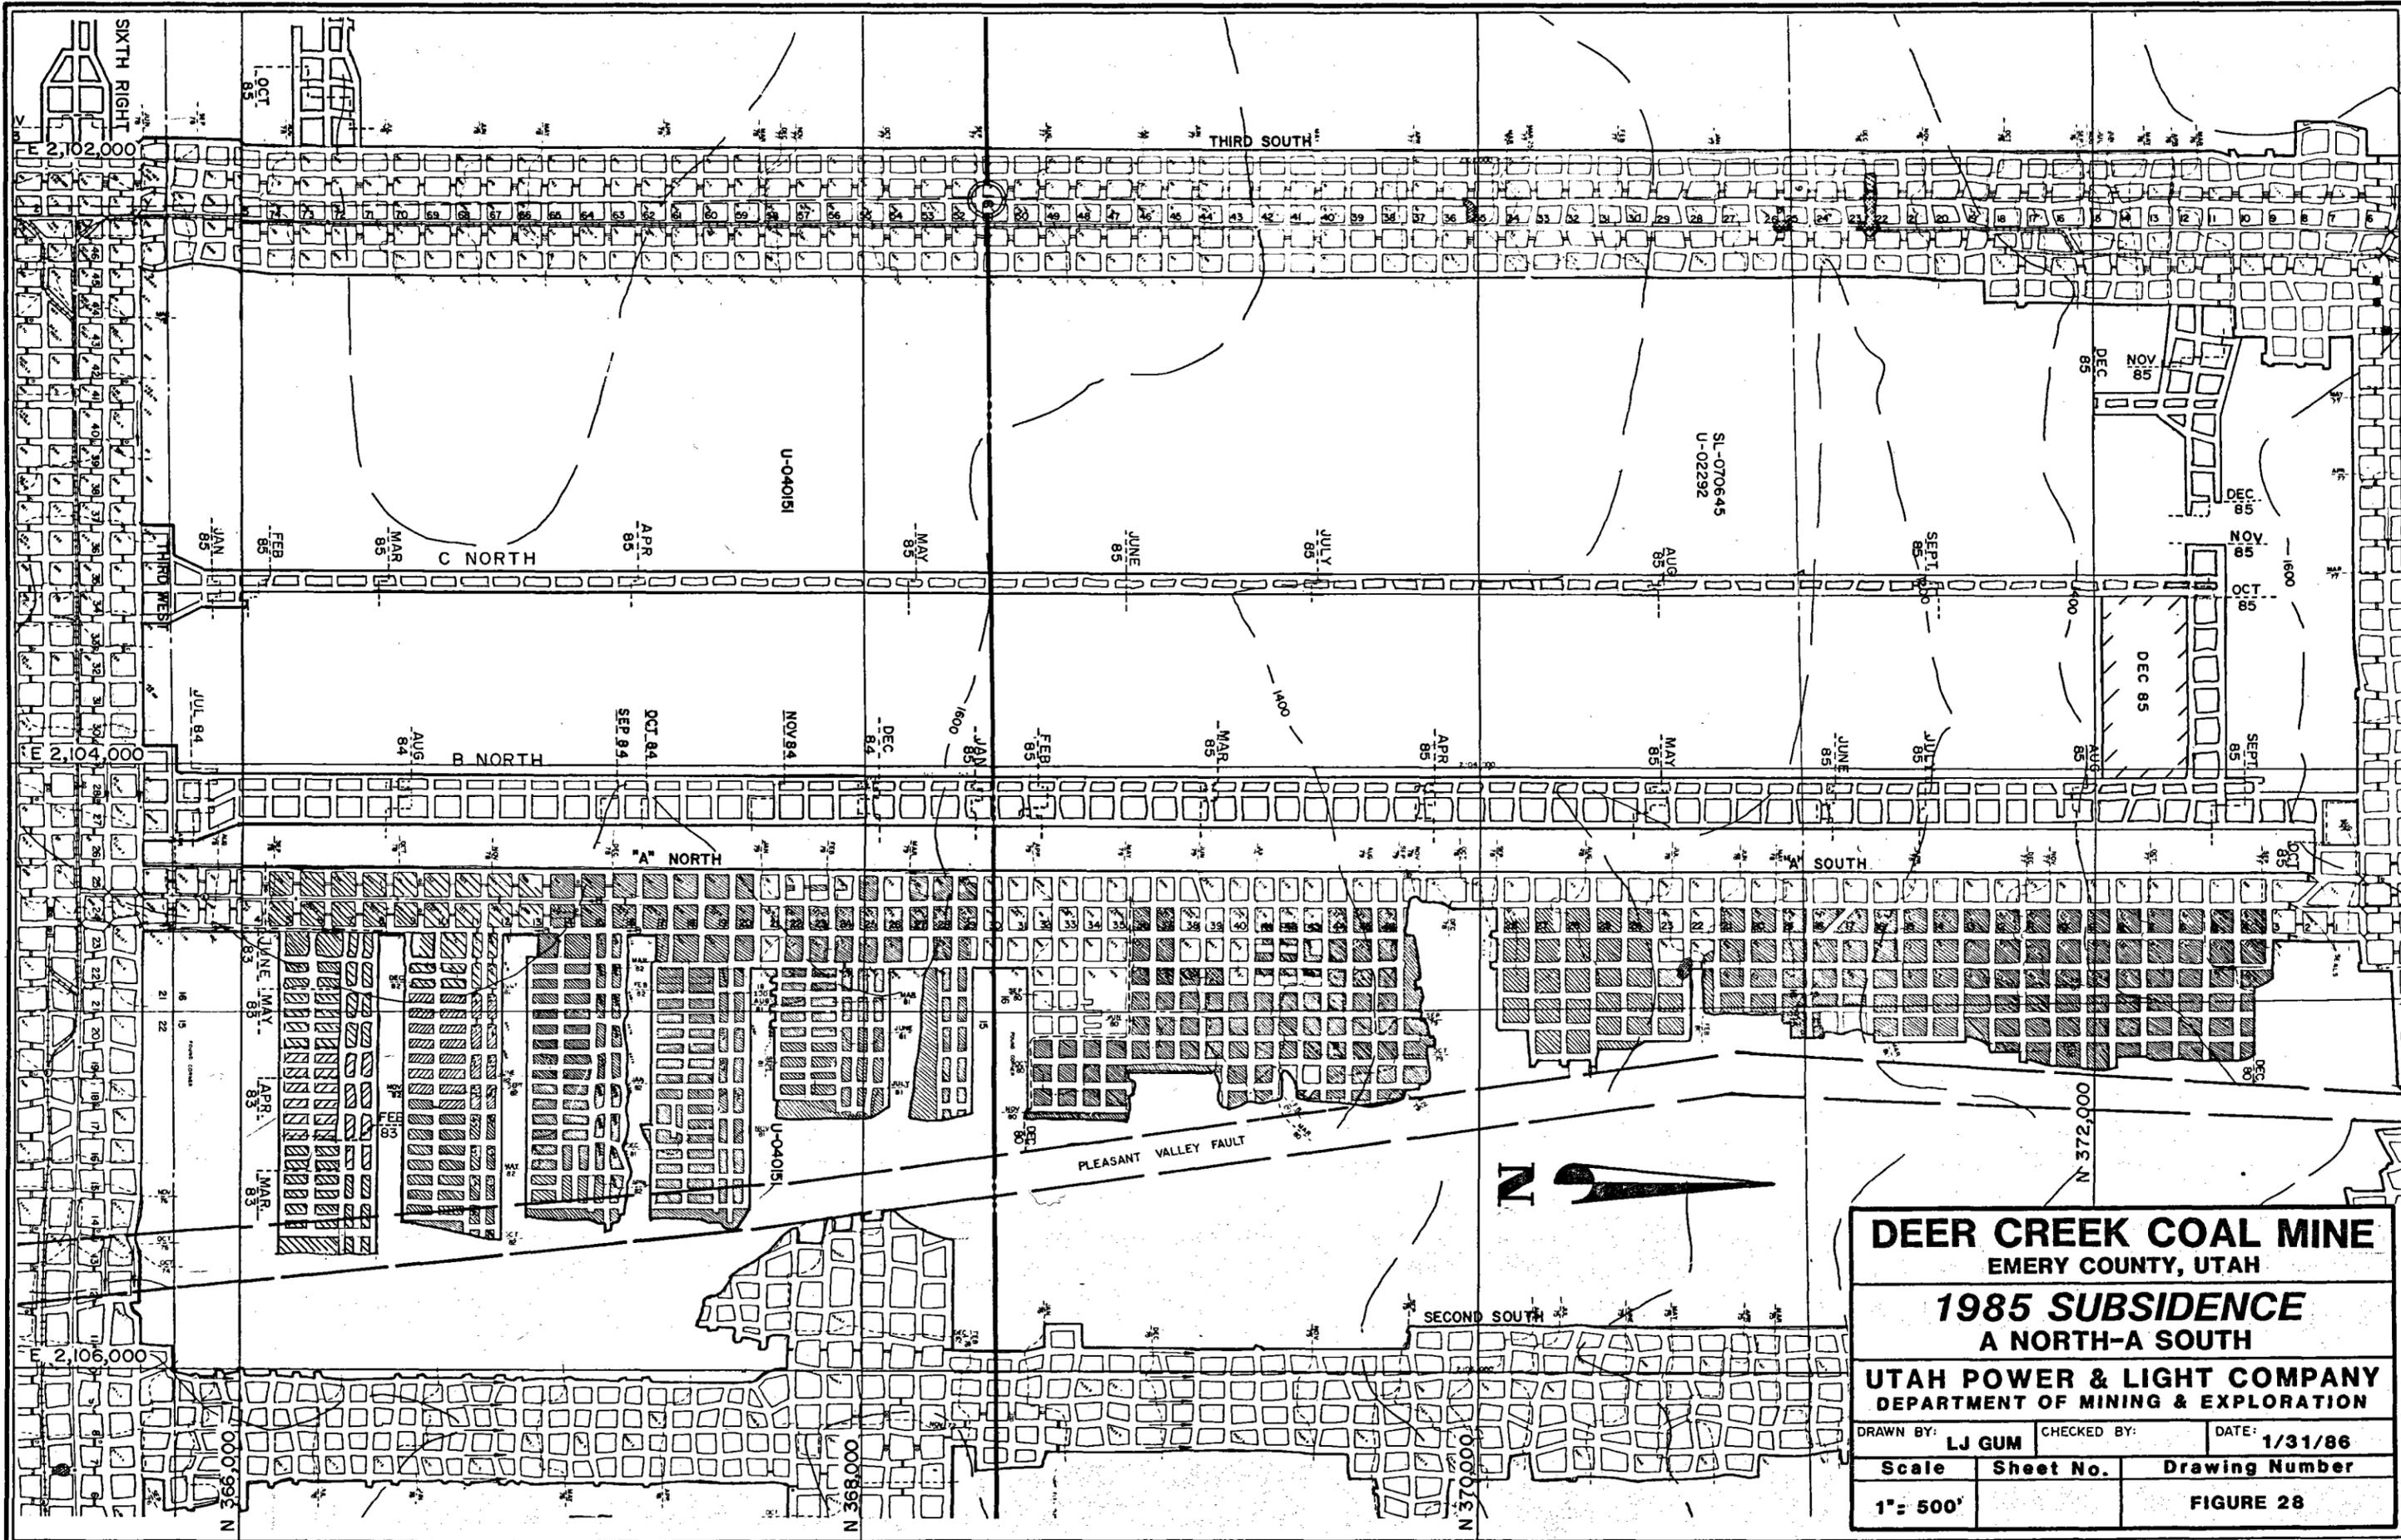
DEER CREEK COAL MINE		
EMERY COUNTY, UTAH		
1985 SUBSIDENCE		
A NORTH-A SOUTH		
UTAH POWER & LIGHT COMPANY		
DEPARTMENT OF MINING & EXPLORATION		
DRAWN BY:	CHECKED BY:	DATE:
LJ GUM		1/31/86
Scale	Sheet No.	Drawing Number
1" = 500'		FIGURE 28

Pillar extraction in A North and A South was completed in June 1983. These sections of Deer Creek extend from A North and A South eastward to the Pleasant Valley Fault (Figure 28). No measurable subsidence occurred during the 1984 monitoring period but, in 1985 just over one foot of subsidence was measured by photogrammetric methods (Figure 29).

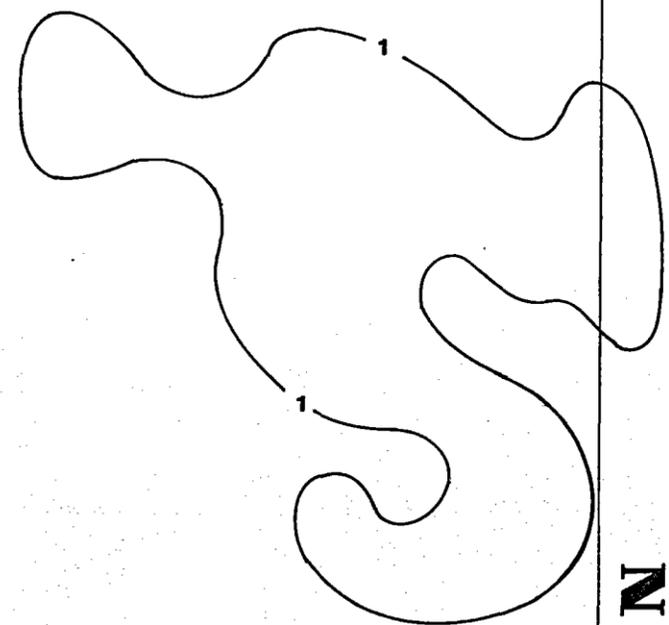
DEER CREEK COAL MINE		
EMERY COUNTY, UTAH		
1985 SUBSIDENCE		
A NORTH-A SOUTH		
UTAH POWER & LIGHT COMPANY		
DEPARTMENT OF MINING & EXPLORATION		
DRAWN BY: LJ GUM	CHECKED BY:	DATE: 1/31/86
Scale	Sheet No.	Drawing Number
1" = 500'		FIGURE 29

No fractures or other disturbance of the surface of the area has been observed. The maximum angle-of-draw calculated thus far is 34° but the average angle for the area is near vertical.
