**APPENDIX A**  
**COTTONWOOD MINE**  
**Cliff Subsidence & Eagle Monitoring**  
**REPORT**  
**1986**

**COTTONWOOD MINE**  
**CLIFF SUBSIDENCE & EAGLE MONITORING**  
**REPORT**  
**1986**

**PREPARED FOR**  
**UTAH POWER & LIGHT COMPANY**  
**MINING DIVISION**

**BY**  
**VAL PAYNE**

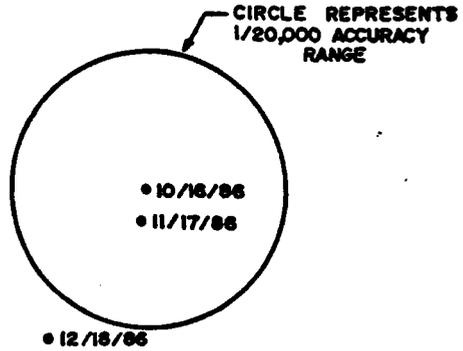
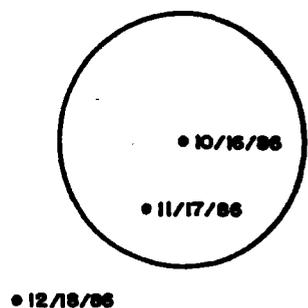
<b>COTTONWOOD COAL MINE</b> EMERY COUNTY, UTAH	
<b>NEWBERRY CANYON</b> <b>SUBSIDENCE MONITORING</b> <b>HORIZONTAL MOVEMENT</b>	
<b>UTAH POWER &amp; LIGHT COMPANY</b> MINING DIVISION - SALT LAKE CITY, UTAH 84110	
DATE: JANUARY 8, 1987	BY: LJ HANSEN
SCALE: 1" = 0.5'	FIGURE 1

Subsequent monitoring indicated both horizontal and vertical movement in the monitoring prisms. Data indicates that the maximum total horizontal and vertical movement occurred at prism 3 (see Fig. 1 and 2). Limits of accuracy in measuring both horizontal and vertical movement are affected by a number of factors including, instrument accuracy, atmospheric conditions and operator ability. The surveying accuracy achieved is approximately 1/20,000. Only data which indicates movement beyond the established accuracy is interpreted as indicating actual movement. Photo documentation revealed an area of cliff spalling which corresponds to the movement measured at prism 3 (see photo 8). However, no nests have been affected by spalling to date. Position of the longwall face at the time of subsidence monitoring is indicated on Map 3.

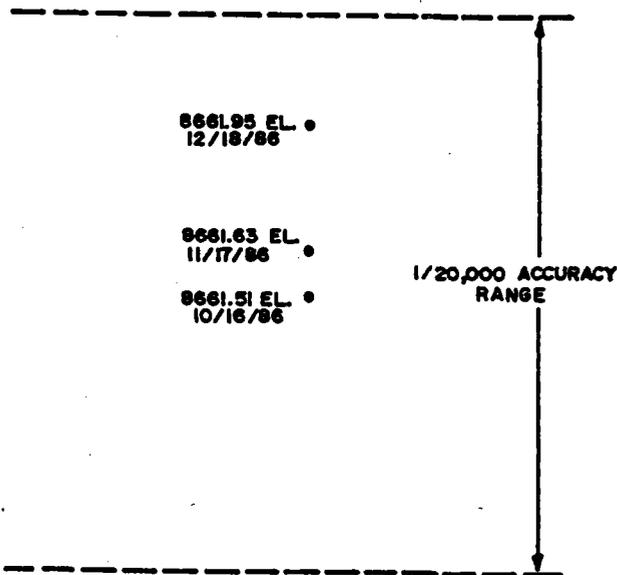
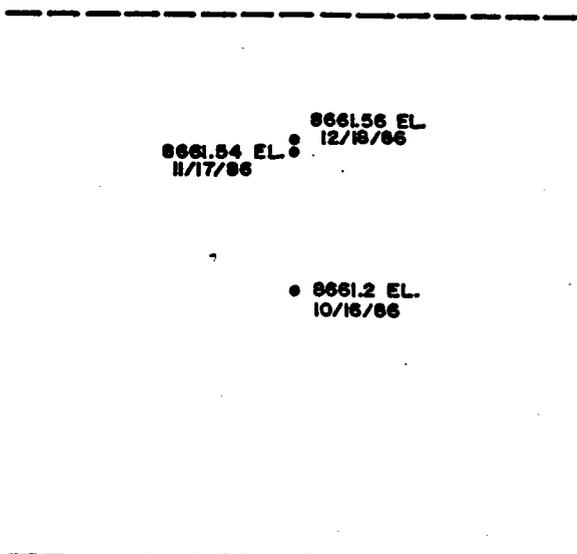
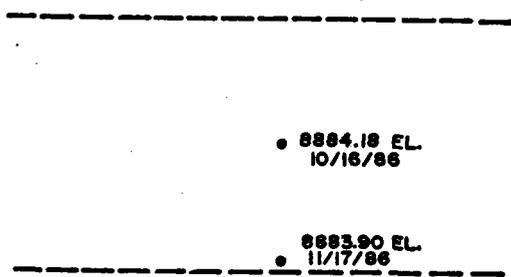
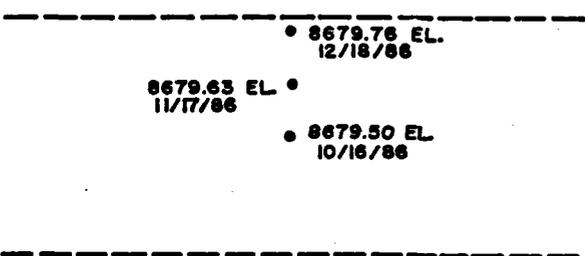
FIGURE 2

**NEWBERRY CANYON**  
**SUBSIDENCE MONITORING**  
**VERTICAL MOVEMENT**

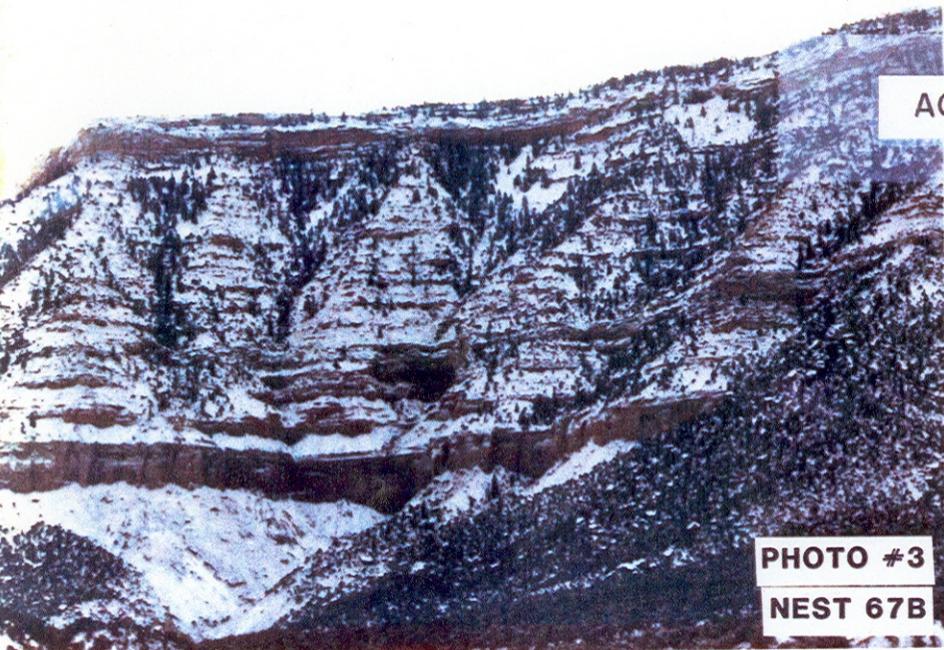
PHOTO #3  
NEST 67B

| 12. Comments - Fledging verified by ground survey. | 12. Comments - 1 downy young observed, fledging not verified. |

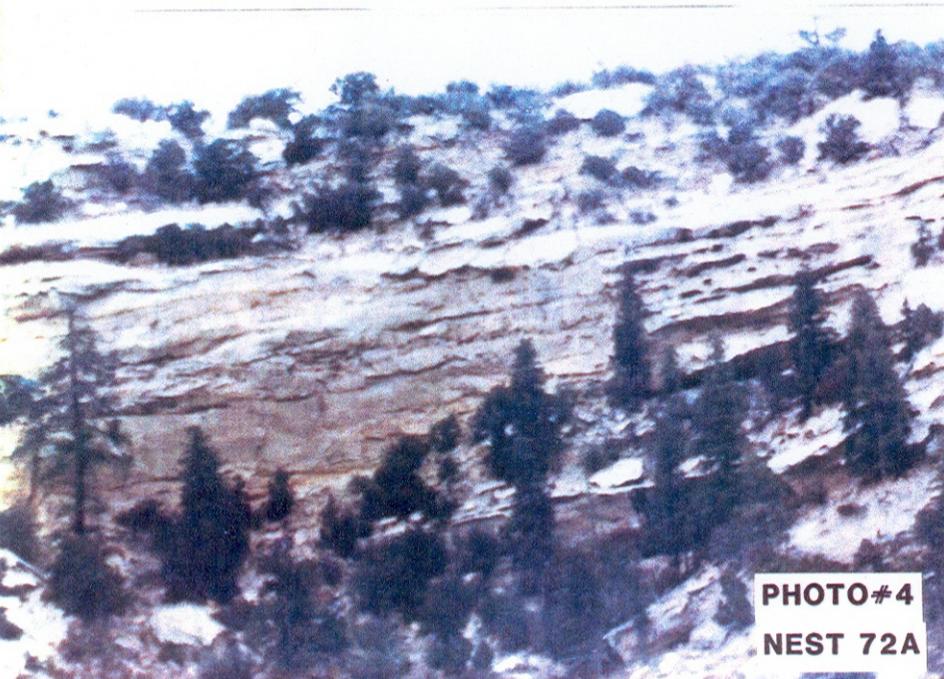
PHOTO #4  
NEST 72A

| 12. Comments - 1 downy young observed, fledging not verified. | 12. Comments - 1 downy young observed, fledging not verified. |

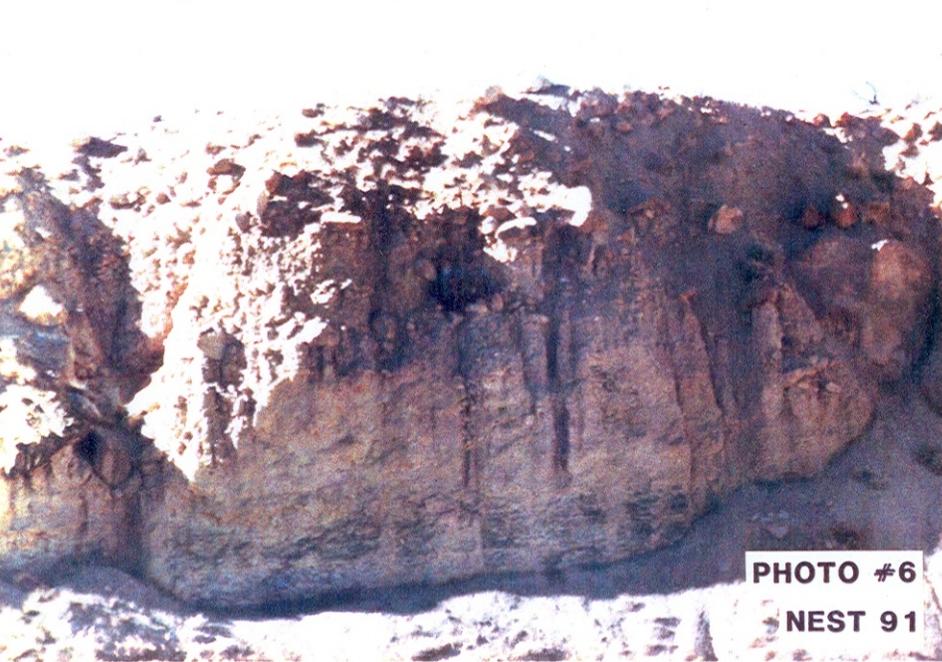
PHOTO #6  
NEST 91

1. Nest ID# - 91
2. Common Name - GOEA
3. Substrate - REP
4. Exposure - NE
5. Elevation - 6,400
6. Biome - 634
7. Habitat Assc. - 632
8. Status - ACTI
9. Productivity - 1
10. Disturbance Y (N)
11. Photo # - 6
12. Comments - Fledging verified by ground survey.

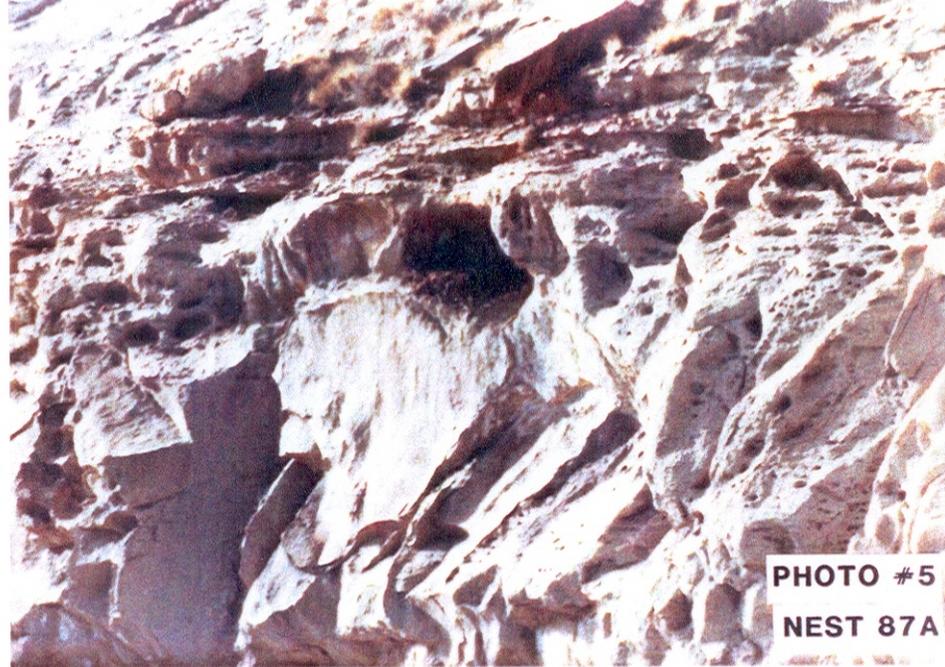
PHOTO #5  
NEST 87A

1. Nest ID# - 87A
2. Common Name - GOEA
3. Substrate - CLF
4. Exposure - SE
5. Elevation - 7,250
6. Biome - 320
7. Habitat Assc. - 320
8. Status - ACTI
9. Productivity - 1
10. Disturbance (Y) (N)
11. Photo # - 5
12. Comments - Fledging verified by ground survey. Potential disturbance due to proximity of road.

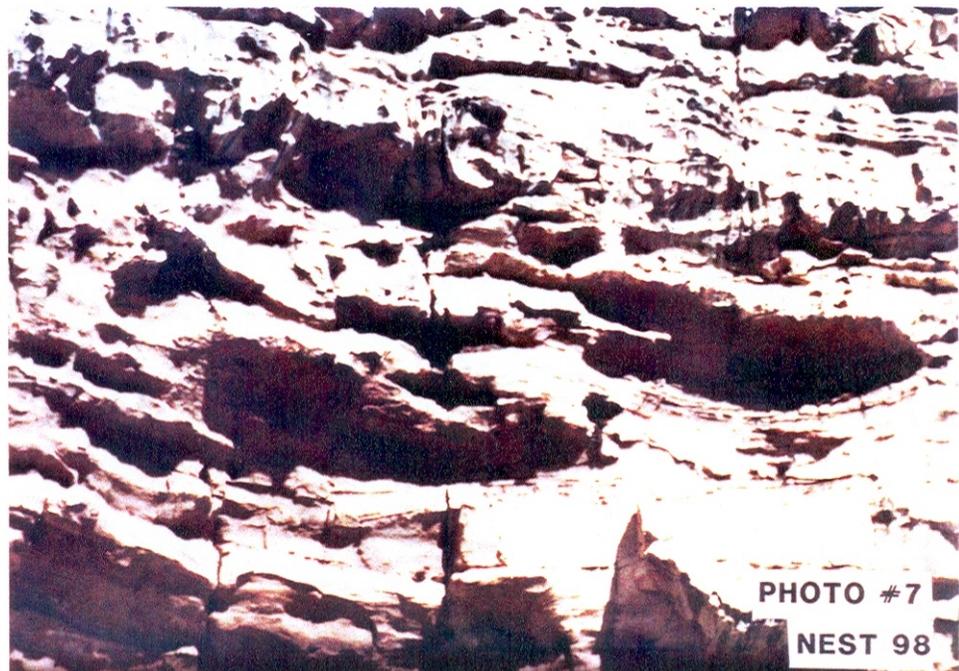
PHOTO #7  
NEST 98

1. Nest ID# - 98
2. Common Name - GOEA
3. Substrate - CLF
4. Exposure - SW
5. Elevation - 8,400
6. Biome - 823
7. Habitat Assc. - 823
8. Status - ACTI
9. Productivity -  $\emptyset$
10. Disturbance Y (N)
11. Photo # - 7
12. Comments - Incubating adults observed fledging not verified.
