PACIFICORP

*COTTONWOOD MINE
C/015/019*

*ANNUAL HYDROLOGIC REPORT
2002*

**VEGETATION MONITORING REPORTS FOR THE
COTTONWOOD MINE, DES-BEE-DOVE, DEER CREEK MINE,
TRAIL MOUNTAIN MINE, COTTONWOOD CANYON & RILDA CANYON**

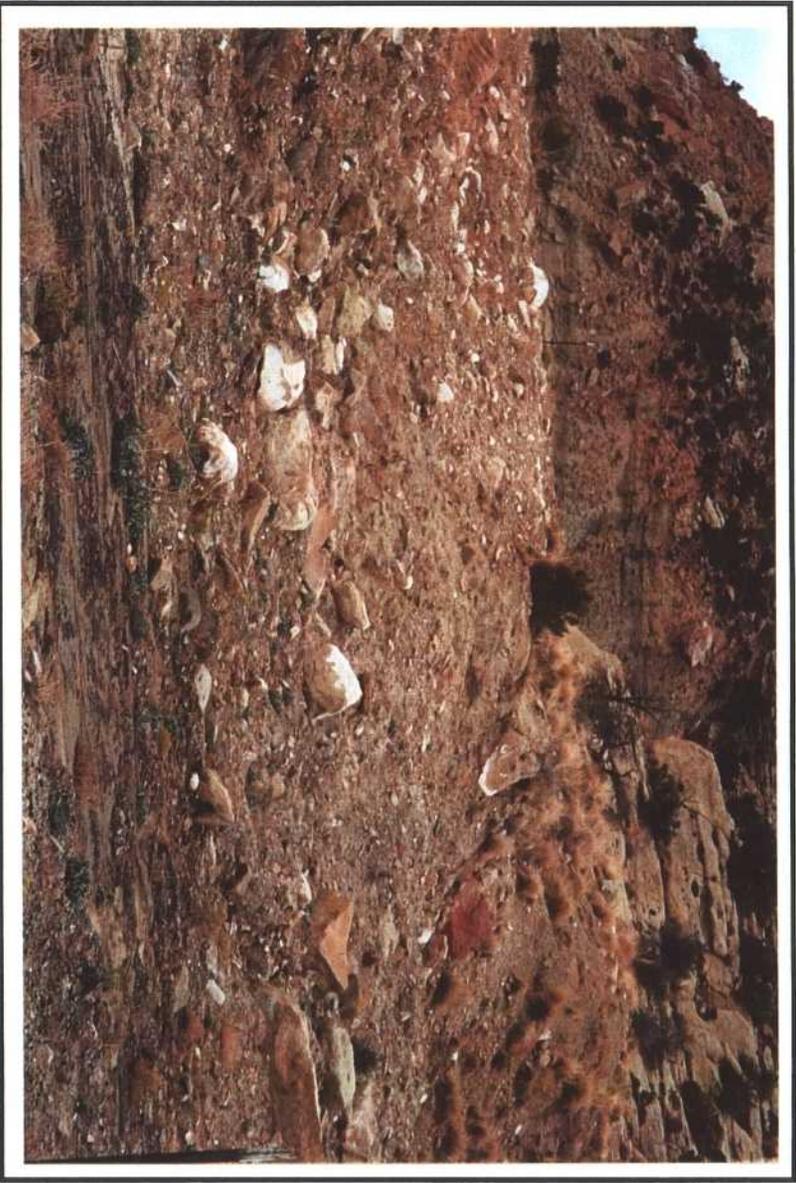
Des-Bee-Dove - Pumphouse (Final)

- NOTES:
- 1) Much fewer weedy species when compared to last year.
 - 2) Not much perennial cover, but there were lots of seedlings.
 - 3) The "slump area" had more desirable species when compared to last year, but the area had low diversity and cover.
 - 4) Site looked fair to good especially considering it was so recently seeded.
 - 5) The site had good "roughening" effect.
 - 6) The photos won't show much cover because the seedlings were so small.

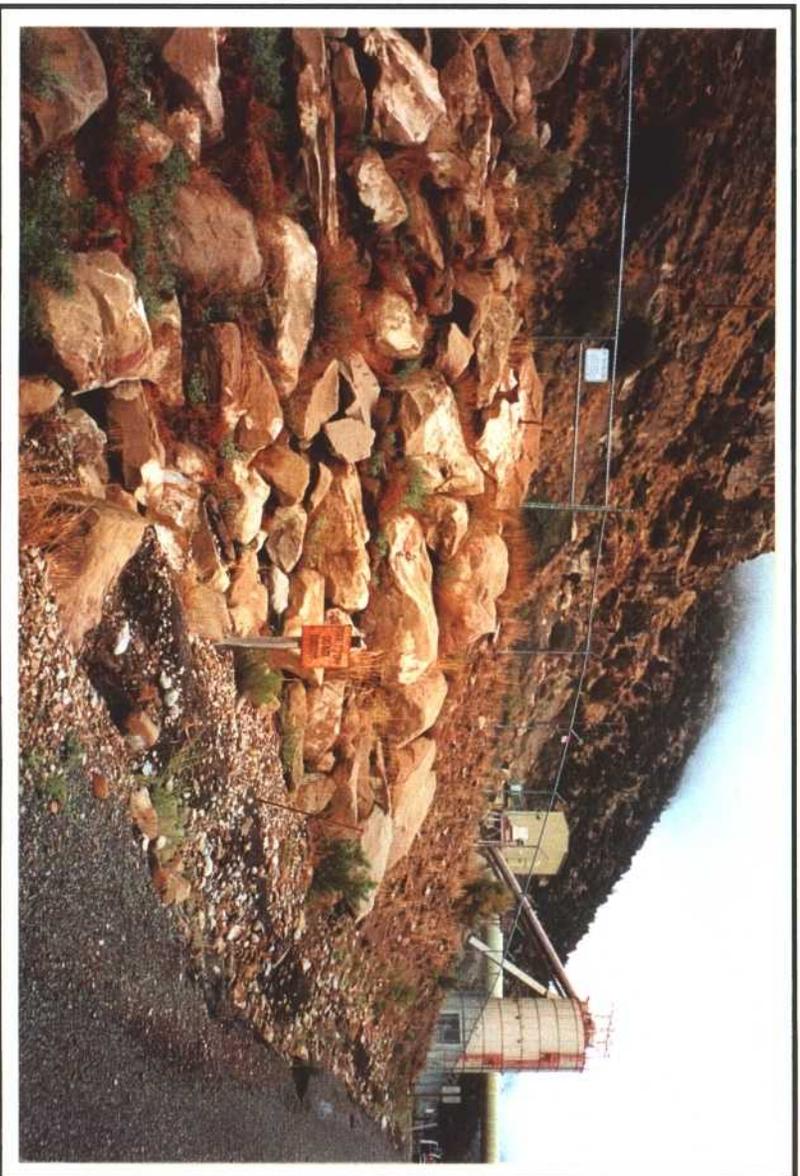
Trail Mountain Mine - Sediment Pond Outslope

- NOTES:
- 1) Qualitative sampling only was done this year.
 - 2) Site had good cover comprising mostly of grasses
 - 3) Diversity was fair..

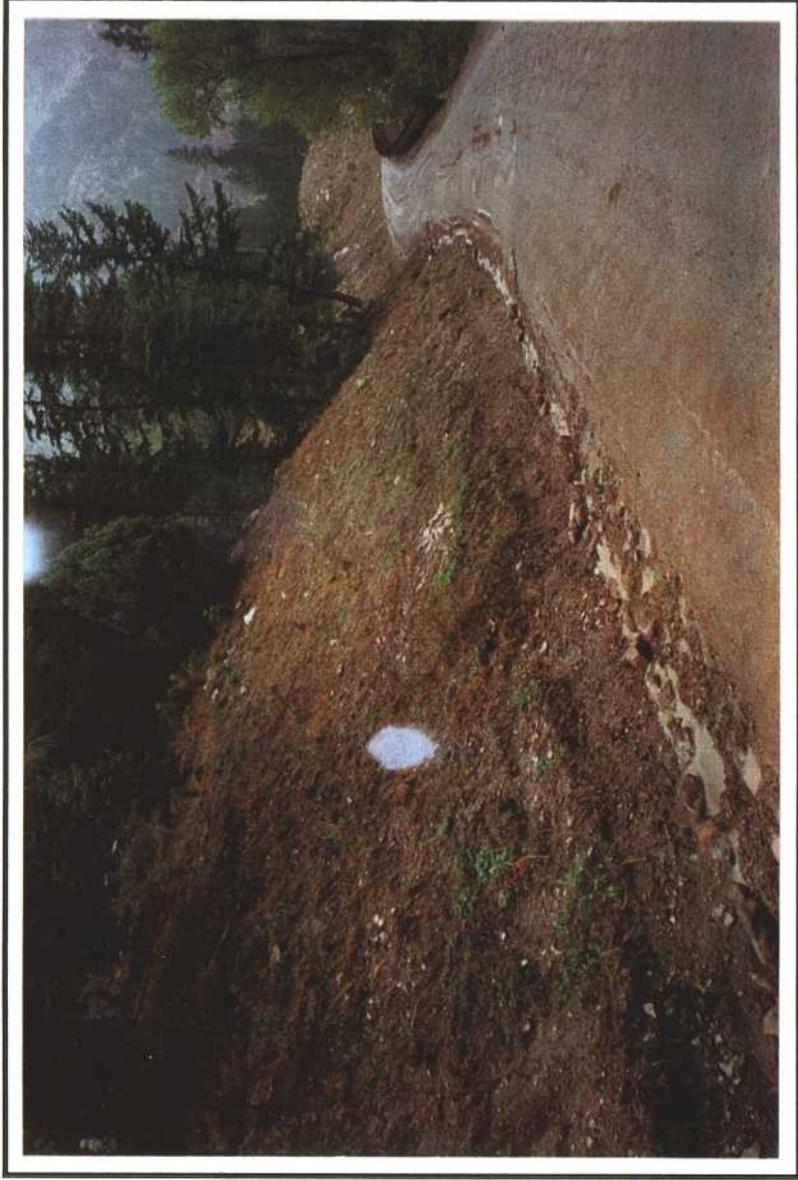
Rilda Canyon - Roadway Slopes

- NOTES:
- 1) Qualitative sampling only was done this year.
 - 2) The drought has had an effect on the cover and diversity seen.
 - 3) Mostly grasses were visible this year.
 - 4) Some areas were disturbed and reseeded in 2002. These area were located on the back side of the fence and around the pad area.
