Mine Site Inspection

Mine Name: Cottonwood Wilberg Mine

Inspection Date: August 4, 2016 8:00 – 2:15 (includes time spent at Des Bee Dove Mine)

Inspection Type: Partial Oversight Inspection

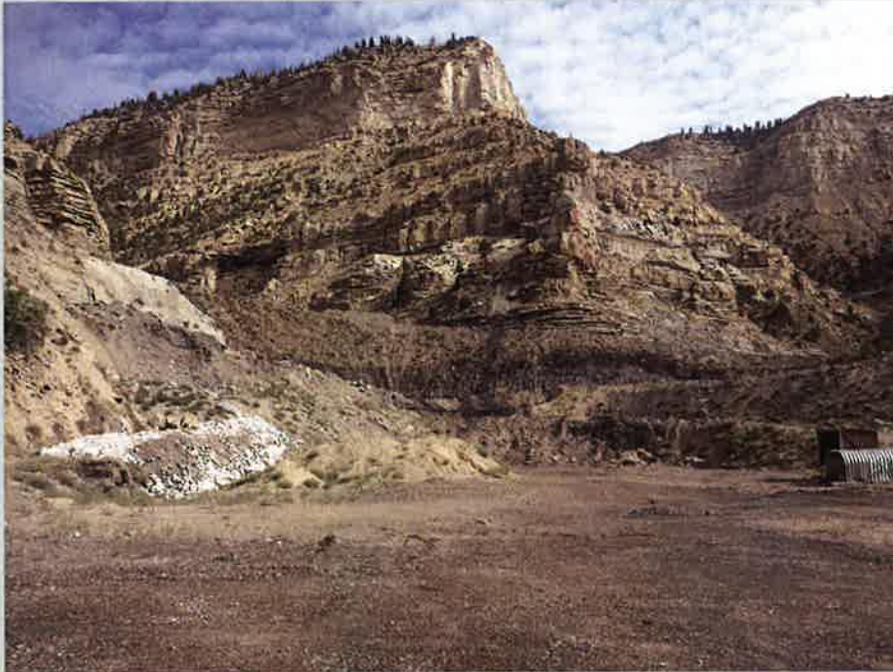
Photo ID: 28170

Most structures have already been demolished and removed from the facilities area, but final reclamation earthwork has not yet begun. This delay in reclamation is due to the fact that PacifiCorp is actively pursuing an alternative reclamation plan that staff believe would be more successful than the currently approved plan. A small building and two small shelter structures are still in place in the facilities area.

Most structures have been removed. Remaining shelters used for hay storage.

Subject: Facilities area

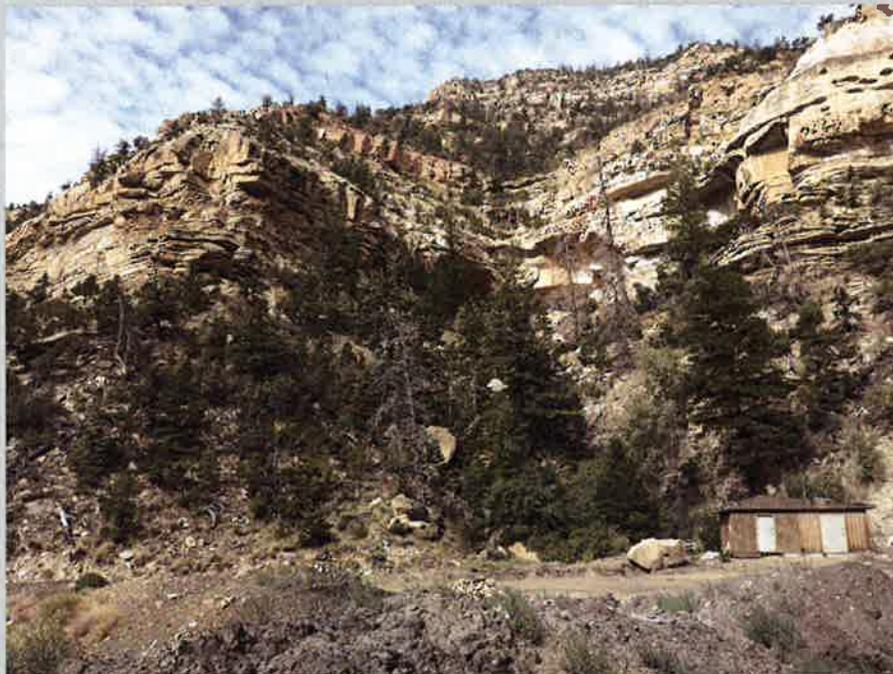
Photo ID: 28171

PacifiCorp apparently intends to use the building as an office during reclamation. The shelter structures are used to store hay which is used as mulch in reclamation. All portals along the upper road bench are backfilled to preclude access to abandoned workings. The road corridor and two large pad areas currently remain in place. Road surfacing materials have been removed. No erosion was noted during our inspection. All disturbed areas would be reclaimed using the deep pocking method under the potential permit revision.

PacifiCorp intends to use this building during reclamation activities.

Subject: Small building retained to support reclamation

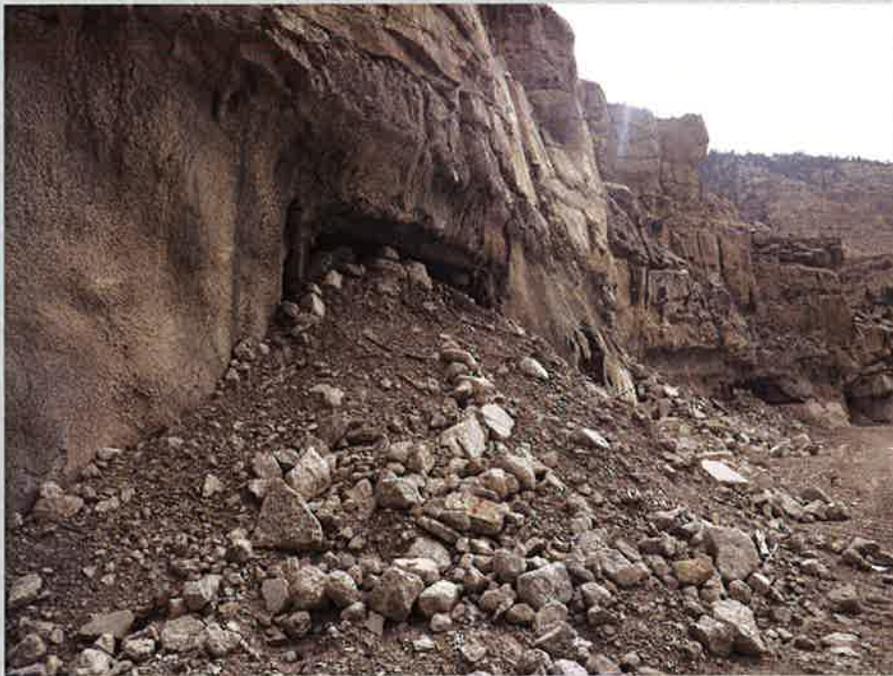
Photo ID: 28172

Backfill precludes access to underground workings, but does not fulfill final backfilling and grading / approximate original contour requirements for final reclamation.

Subject: Backfilled portals

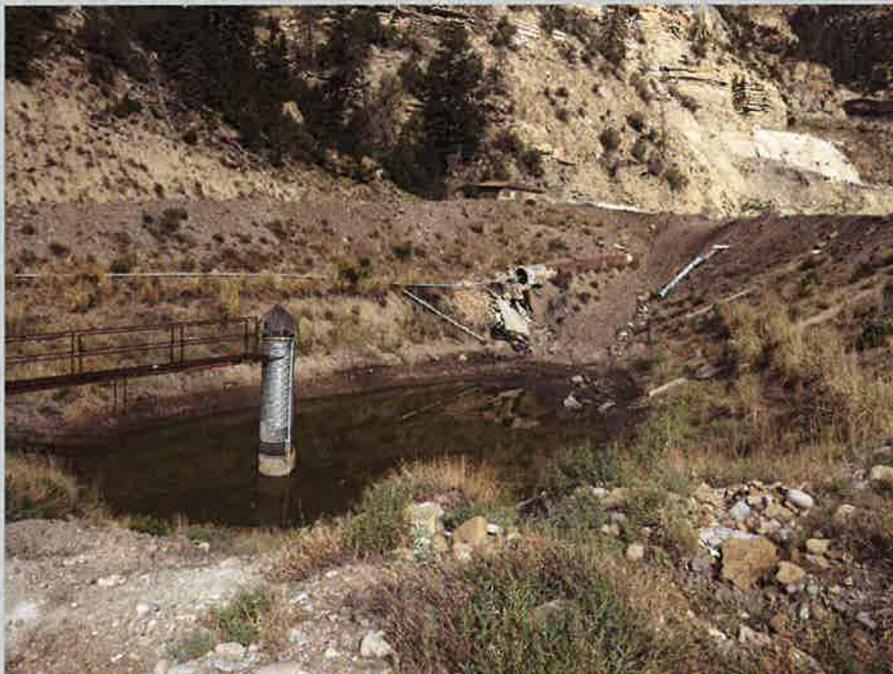
Photo ID: 28173

The north and south sedimentation ponds are in place, and disturbed area drainage reports to this two-cell system. Drop structures and culverts route disturbed area drainage to the ponds. The north pond contained a small amount of water but was not discharging; the south pond was dry during our inspection. Undisturbed area drainage is appropriately routed away from the disturbed area. Undisturbed drainage from the watershed above the disturbed area is routed under the disturbed area via culverts. Runoff from the east and west undisturbed areas is routed around the disturbance area via surface diversions. Surface topography, diversions, and culvert structures all indicate they are functioning as designed and routing runoff to appropriate locations.

Small amount of water present, pond not discharging.

Subject: North pond

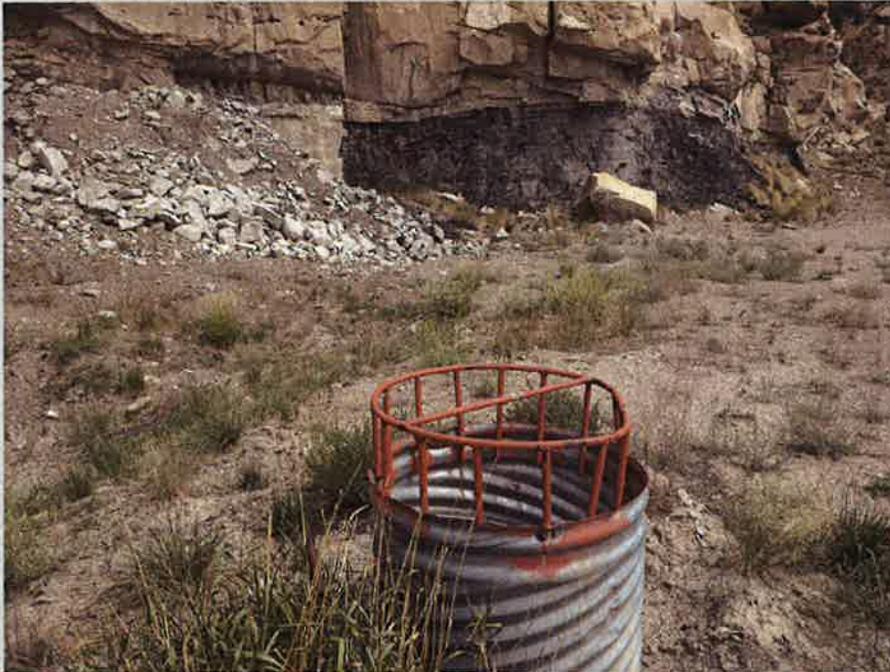
Photo ID: 28178

Culverts route disturbed area drainage to the sediment ponds.

Subject: Drop structure within disturbed area

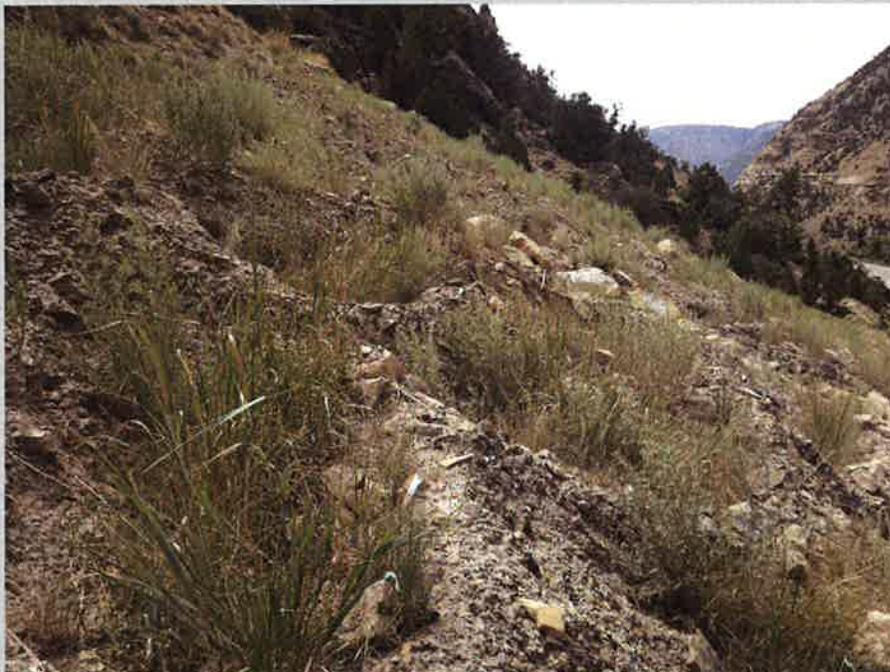
Photo ID: 28186

We inspected the reclaimed Cottonwood conveyor portal area which is adjacent to the Fossil Rock Mine on the southwestern edge of the Cottonwood Wilberg permit area. This slope was reclaimed using the deep-pocking method approximately two years ago. Vegetative growth was impressive for the second growing season in this region. The slope is steep, stable, and well vegetated.

Deep pocking method employed here. Vegetation is well-established and slopes are stable.

Subject: Cottonwood conveyor portal reclamation area
