Inspection Report

Permit Number:	C0150019
Inspection Type:	COMPLETE
Inspection Date:	Friday, January 29, 2016
Start Date/Time:	1/29/2016 10:20:00 AM
End Date/Time:	1/29/2016 12:30:00 PM
Last Inspection:	Thursday, December 17, 2015

Permitee: **PACIFICORP**
 Operator: **INTERWEST MINING CO**
 Site: **COTTONWOOD/ WILBERG**
 Address: **PO BOX 310, HUNTINGTON UT 84528**
 County: **EMERY**
 Permit Type: **PERMANENT COAL PROGRAM**
 Permit Status: **ACTIVE**

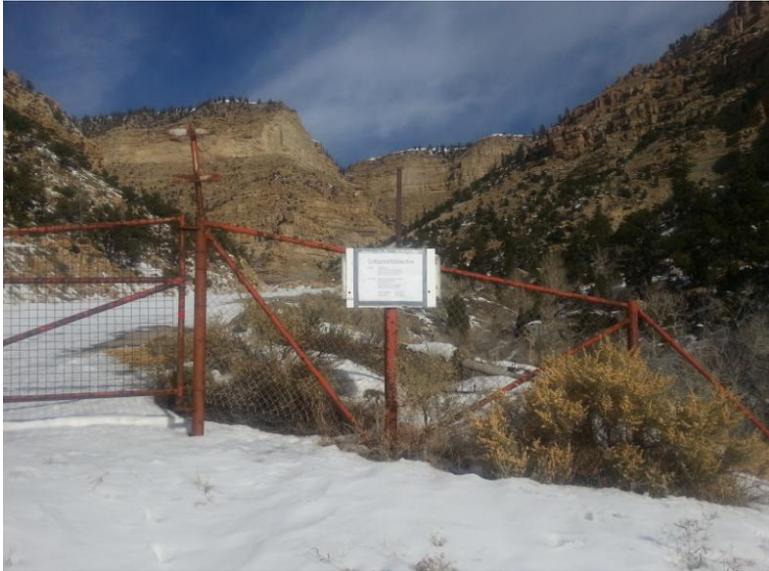
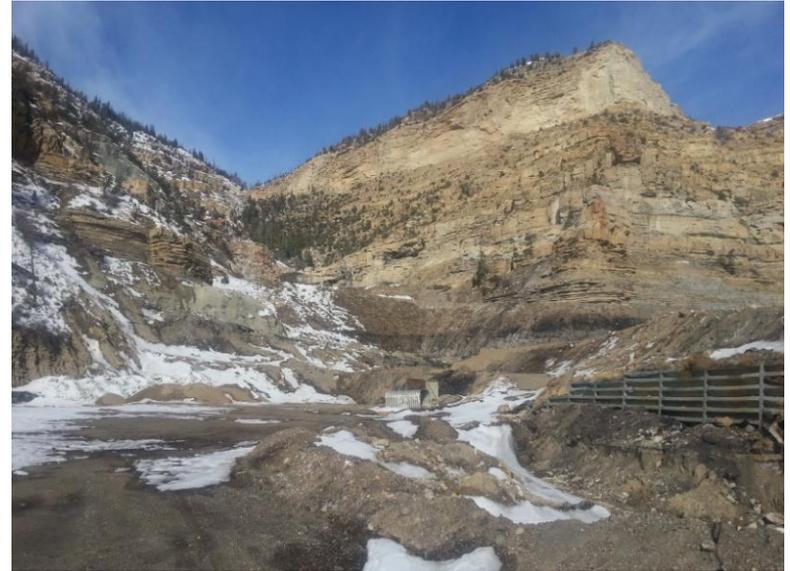
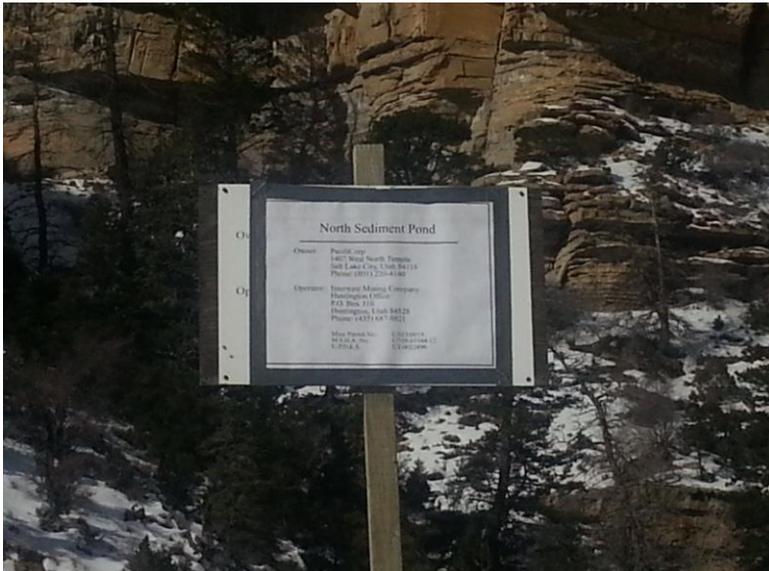
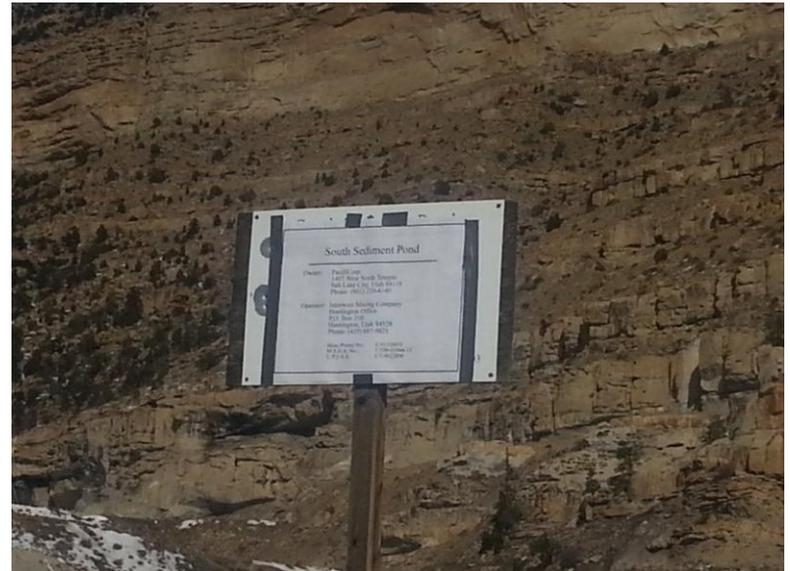
Cottonwood/Wilberg Mine Complete Inspection 01/29/2016 Overview and clearly marked signs

Storage areas, perimeter, and, reference areas are all posted and clearly identified. Signs are located at each point of access. Signs have been updated with new MSHA numbers.

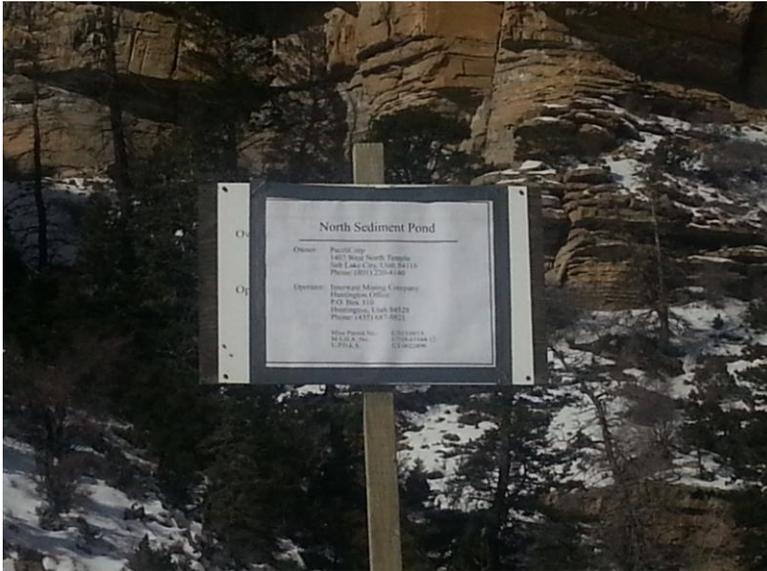
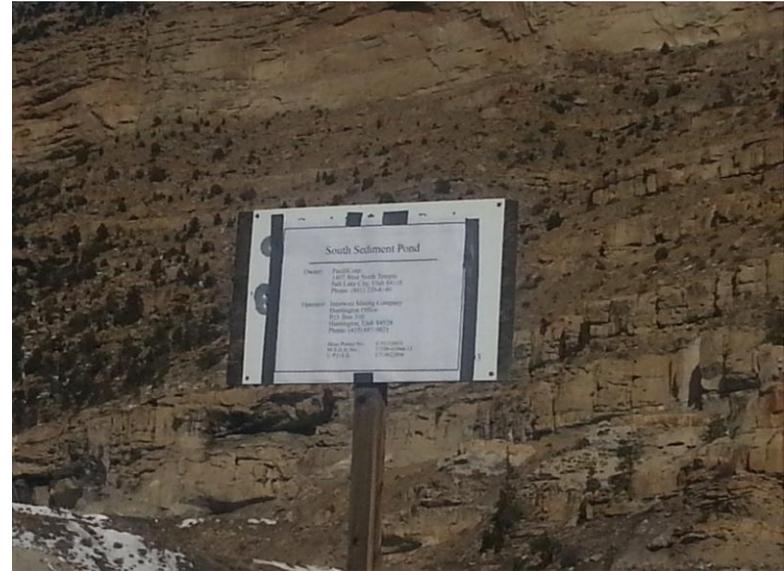
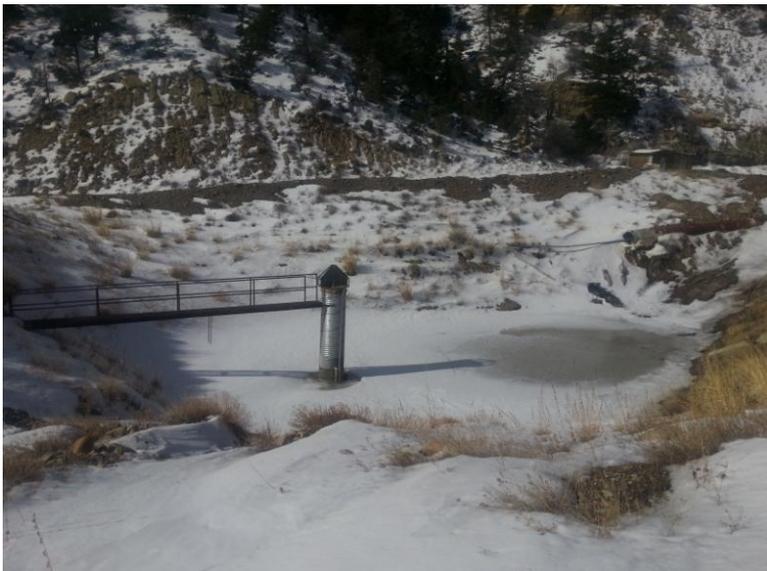
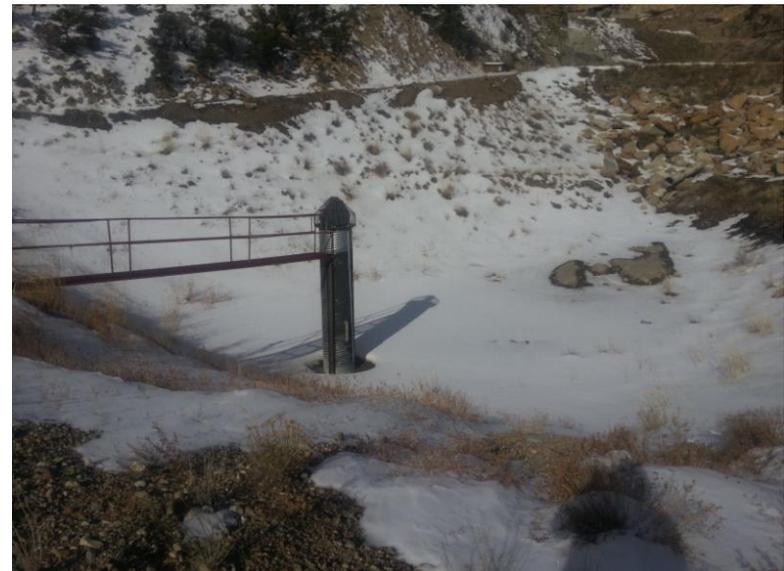
Cottonwood/Wilberg Mine Complete Inspection 01/29/2016 : Sed Ponds

The mine was idled in 2001 so the only water that reports to the ponds are run-off during a storm event.

North sediment pond: Standing water was measured at elevation 7351.55. According to the inspection report, remaining sediment capacity is 0.24 AF. 60% Sediment storage capacity is at 7351.0 ft. Current sediment volume is 7348.0 ft. Water impounded is 0.18 AF.

South sediment pond: The southern sediment pond was dry. 60% sediment storage capacity is .19 AF at 7322.3 ft. Current sediment volume is 0.00 with remaining storage capacity at 0.19 AF. Water impounded is 0.00 AF.

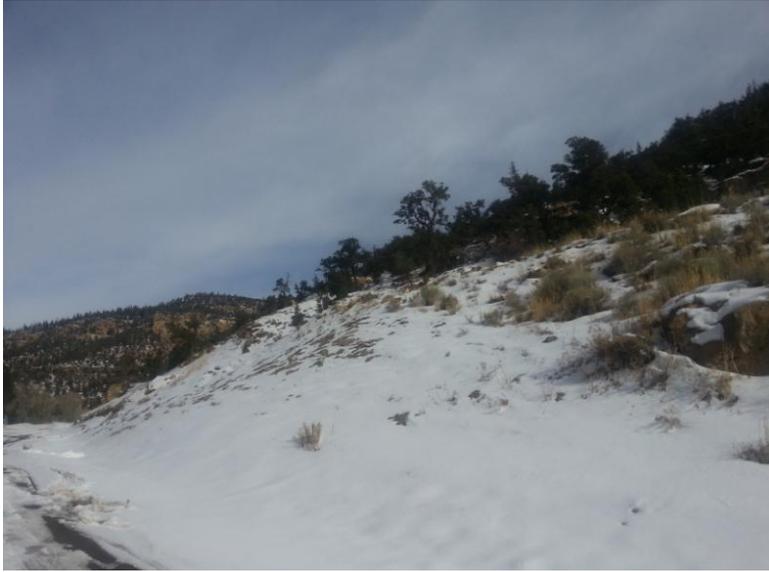
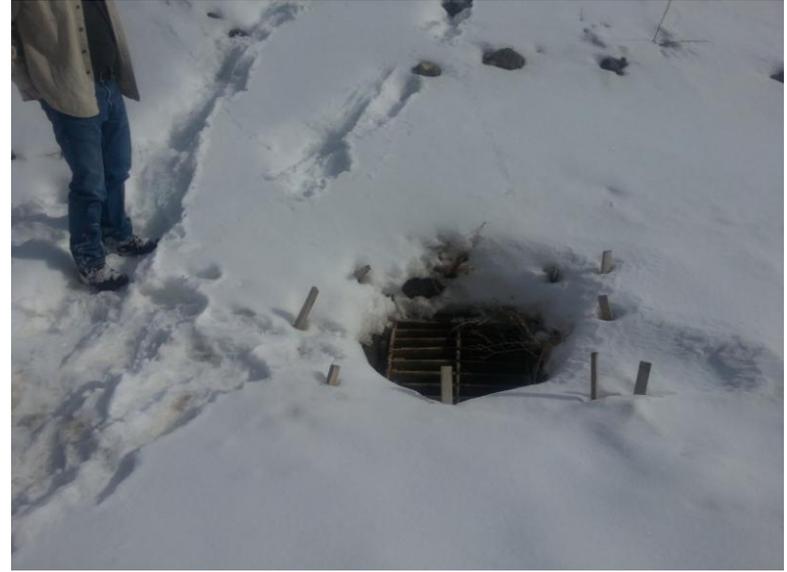
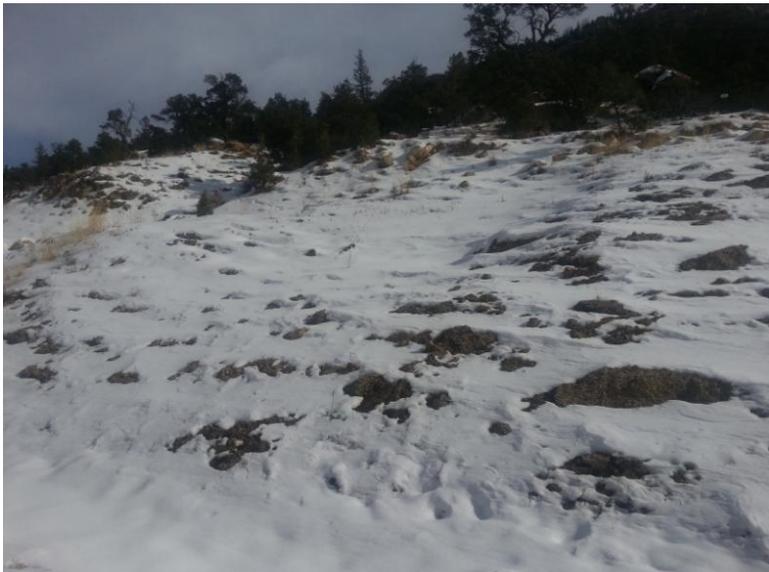
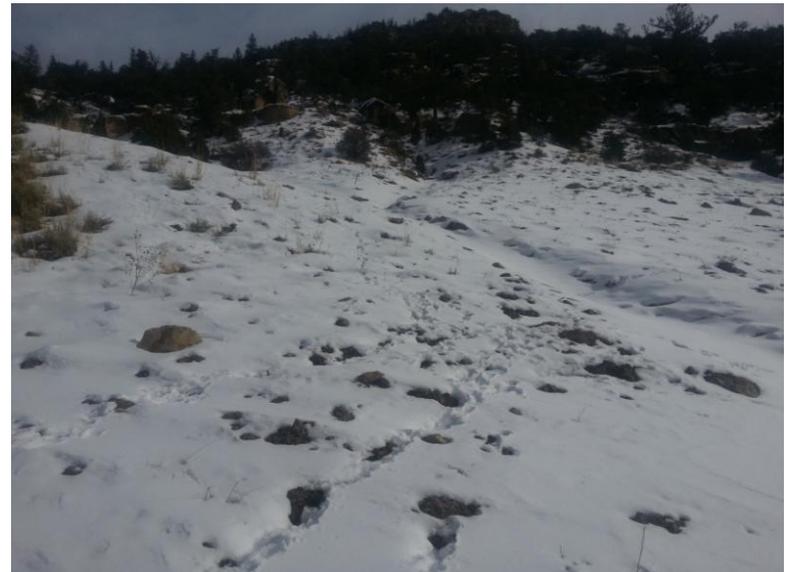
Cottonwood/Wilberg Mine
Complete Inspection 01/29/2016: Cottonwood Fan Portal, UPDES 001-A

The UPDES UT0022896 discharge reports for October, November and December were submitted 11/18/15, 12/10/15 and 1/15/16 respectively. All parameters of OO1-A are within permit limits and there has been no discharge from 003-A or 005-A.

The Cottonwood Canyon portal was backfilled, regraded and reseeded Spring 2015. The backfill is settling and a noticeable depression is evident at the portal face. This location needs continued observation and will be addressed if the settling is severe enough to warrant additional earthwork. At this time, the appropriate action is observation as it was recently backfilled and reseeded.
