Inspection Report

Permit Number:	C0150019
Inspection Type:	PARTIAL
Inspection Date:	Friday, April 28, 2017
Start Date/Time:	4/28/2017 9:30:00 AM
End Date/Time:	4/28/2017 10:00:00 AM
Last Inspection:

Permitee: **PACIFICORP**
 Operator: **INTERWEST MINING CO**
 Site: **COTTONWOOD/ WILBERG**
 Address: **PO BOX 310, HUNTINGTON UT 84528**
 County: **EMERY**
 Permit Type: **PERMANENT COAL PROGRAM**
 Permit Status: **ACTIVE**

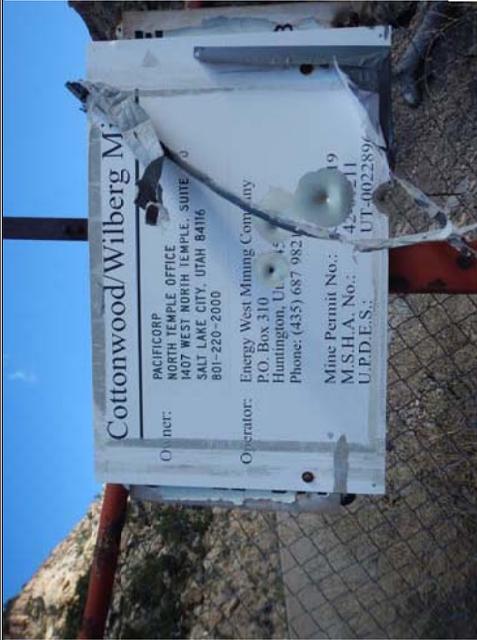
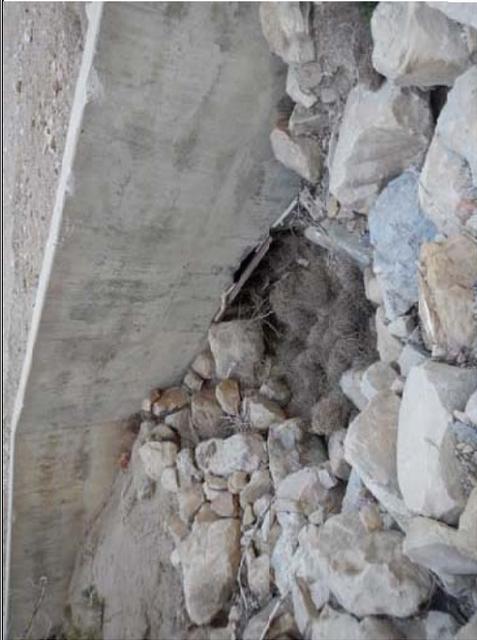
<p>PHOTO 1 The sign to the mine site is in need of maintenance. April 28, 2017</p>

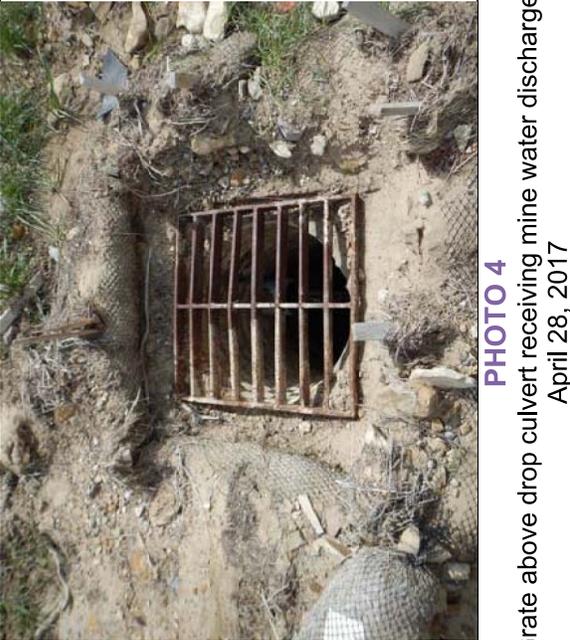
The pipe conveying mine water discharge to the drop culvert appeared to be working well (Photos 3-4).

<p>PHOTO 3 Mine water discharge in Cottonwood Canyon. April 28, 2017</p>	<p>PHOTO 4 Grate above drop culvert receiving mine water discharge. April 28, 2017</p>

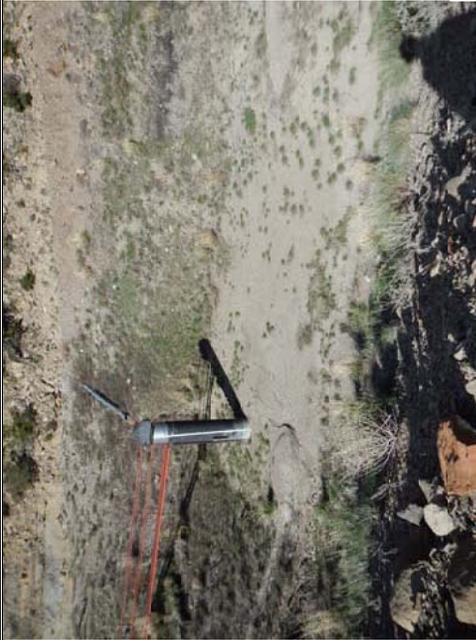
The South Pond was dry the North Pond had a couple feet of water (Photos 5-6).

PHOTO 5
South Pond was dry.
April 28, 2017

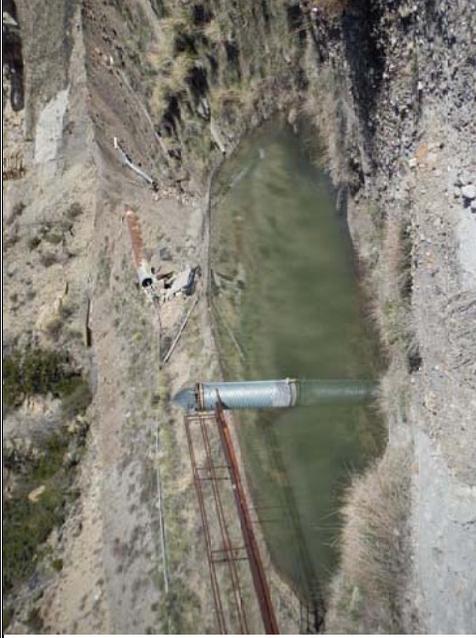
PHOTO 6
North Pond contained a couple feet of water.
April 28, 2017

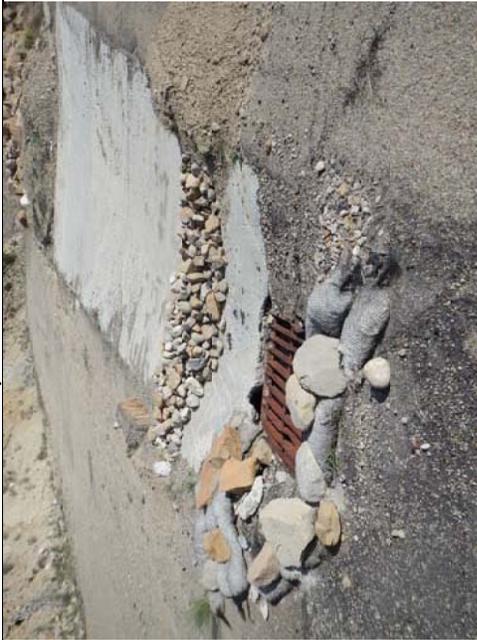
The BTCA directly below the sediment ponds and to the east of the mine gate are in good working order. These two locations treat runoff prior to exiting the permit area (Photos 7-8).

PHOTO 7
BTCA below sediment ponds.
April 28, 2017

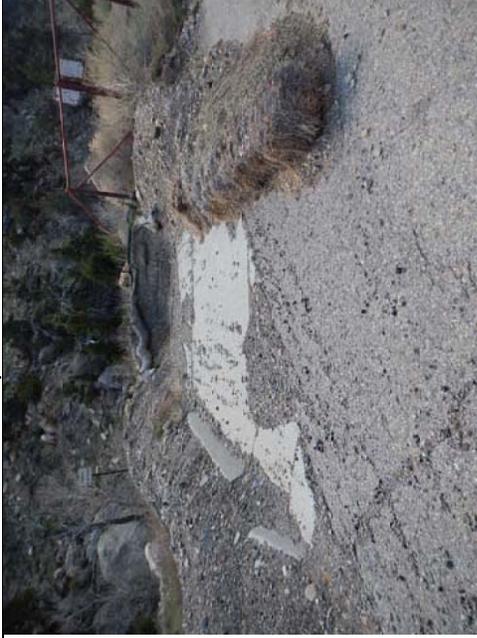
PHOTO 8
BTCA adjacent to gated entrance.
April 28, 2017

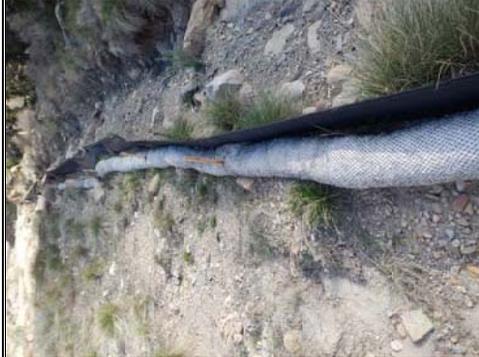
The sediment fence with a straw wattle installed on the eastern boundary of the permit area are functioning properly (Photo 9).

<p>PHOTO 9 Silt fence and straw wattle on eastern boundary of disturbed area. April 28, 2017</p>

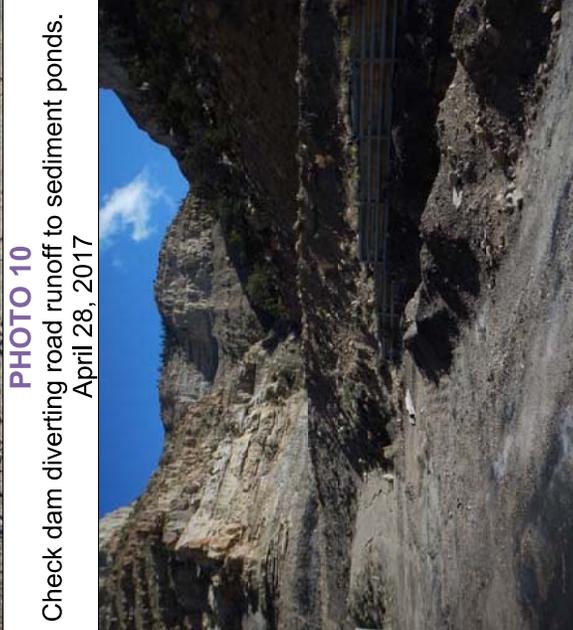
Check dam diversions along the road are working as designed. Straw bales have been placed to direct road runoff into drop culverts that eventually drain to the ponds for treatment (Photo 10).

<p>PHOTO 10 Check dam diverting road runoff to sediment ponds. April 28, 2017</p>

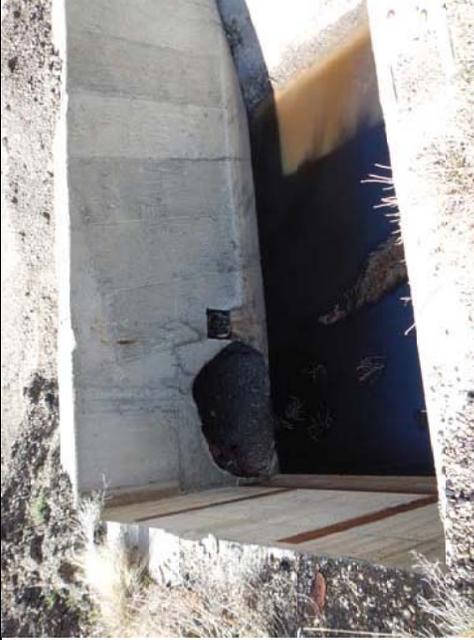
PHOTO 13

Water conveyance system properly functioning.
April 28, 2017
