Inspection Report

Permit Number:	C0150019
Inspection Type:	PARTIAL
Inspection Date:	Wednesday, July 26, 2017
Start Date/Time:	7/26/2017 10:00:00 AM
End Date/Time:	7/26/2017 11:30:00 AM
Last Inspection:

Permitee: **PACIFICORP**
 Operator: **INTERWEST MINING CO**
 Site: **COTTONWOOD/ WILBERG**
 Address: **PO BOX 310, HUNTINGTON UT 84528**
 County: **EMERY**
 Permit Type: **PERMANENT COAL PROGRAM**
 Permit Status: **ACTIVE**

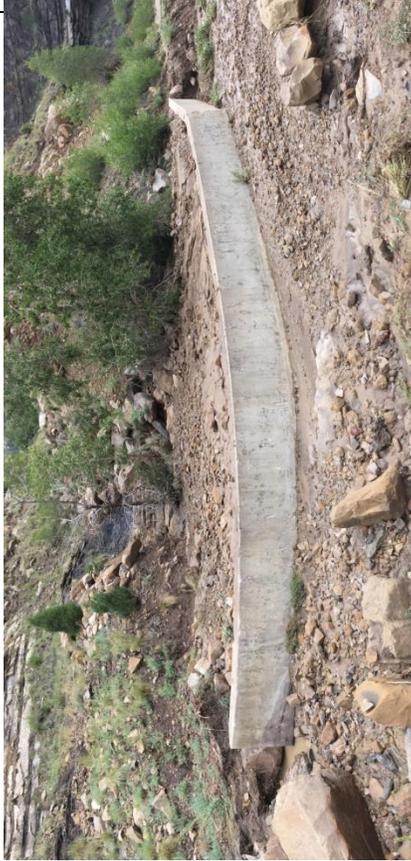
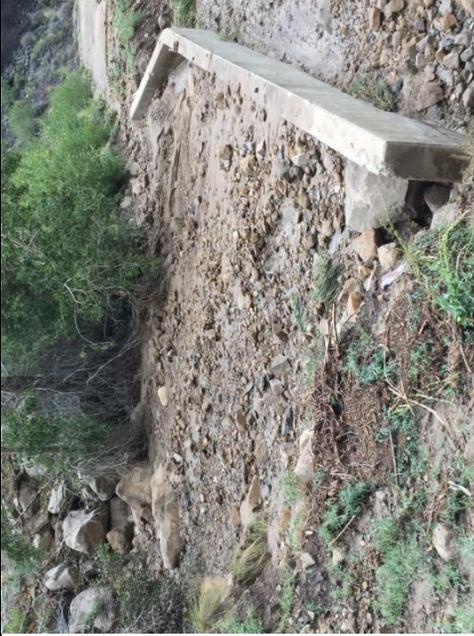
<p>PHOTO 1 Right fork of Grimes Wash bypass culvert blocked by runoff event. July 26, 2017</p>	<p>PHOTO 2 Right fork of Grimes Wash bypass culvert blocked by runoff event. July 26, 2017</p>

In mid- to late-July a high intensity short duration rain event (Graph 1) passed over the Right Fork of Grimes wash causing extensive erosion and flooding within the drainage. The rain event and subsequent peak runoff exceeded the design storm for the sediment control structures in the right fork. This caused the bypass culvert inlet to be blocked by rocks, sediment, and large woody debris (Photos 1 and 2). The excess runoff from the watershed was then routed down the main access road and into the undisturbed ditch on the eastern edge of the mine site (Photos 4, 5, 8). Runoff conveyed along this path was able to bypass the site safely while only causing minimal damage to the road bed. The majority of the mine site was unaffected or functioned as designed during the large rain event.

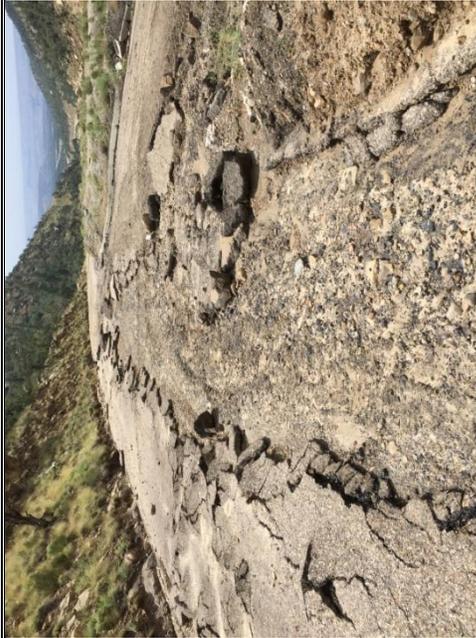
PHOTO 5
Damage to road from excess runoff during a large rain event.
July 26, 2017

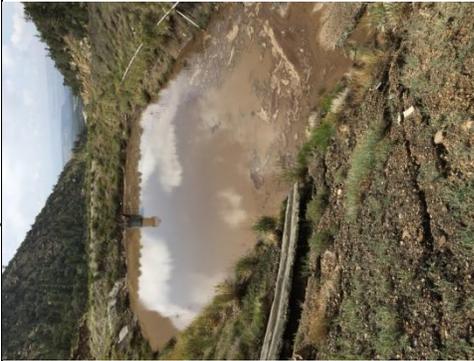
PHOTO 7
North pond full and discharging to south pond.
July 26, 2017

The North and South sediment ponds were full of water and discharging. During a follow up conversation with Dennis Oakley, I was informed the sediment pond discharge was sampled the following day (July 27, 2017). The ponds were functioning properly by treating and discharging excess runoff as designed.

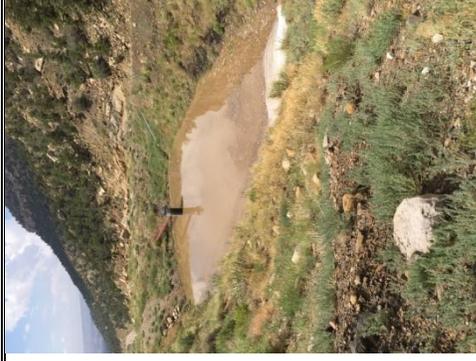
PHOTO 6
South pond full and discharging.
July 26, 2017

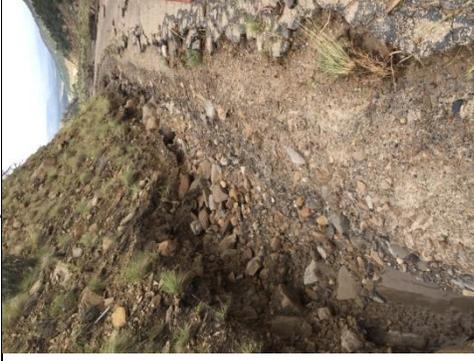
PHOTO 8
Undisturbed ditch carried a significant volume of runoff past the site.
July 26, 2017

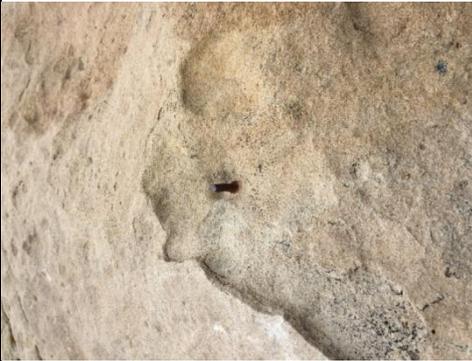
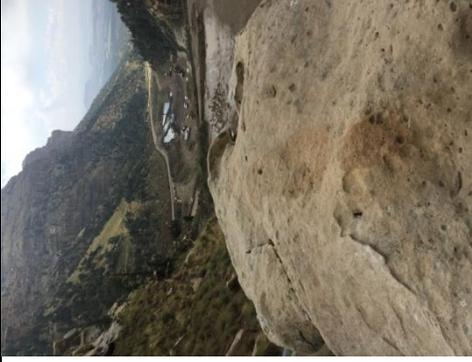
<p>PHOTO 9 Survey Pin #40 with known NEZ. July 26, 2017</p>	<p>PHOTO 10 Survey Pin #40 with known NEZ. July 26, 2017</p>

Survey pin #40 with a known NEZ was located during the inspection. The pin was installed and used regularly when the mine was active. The pin is located on top of a rock sitting just off of the upper portal access road (Photos 9, 10, 11). On Surface Facilities Map 3-16, its position is shown as sitting across the access road from the westernmost office, adjacent to the 'Trash Chute'. This pin may be used for repeat surveys at the site.

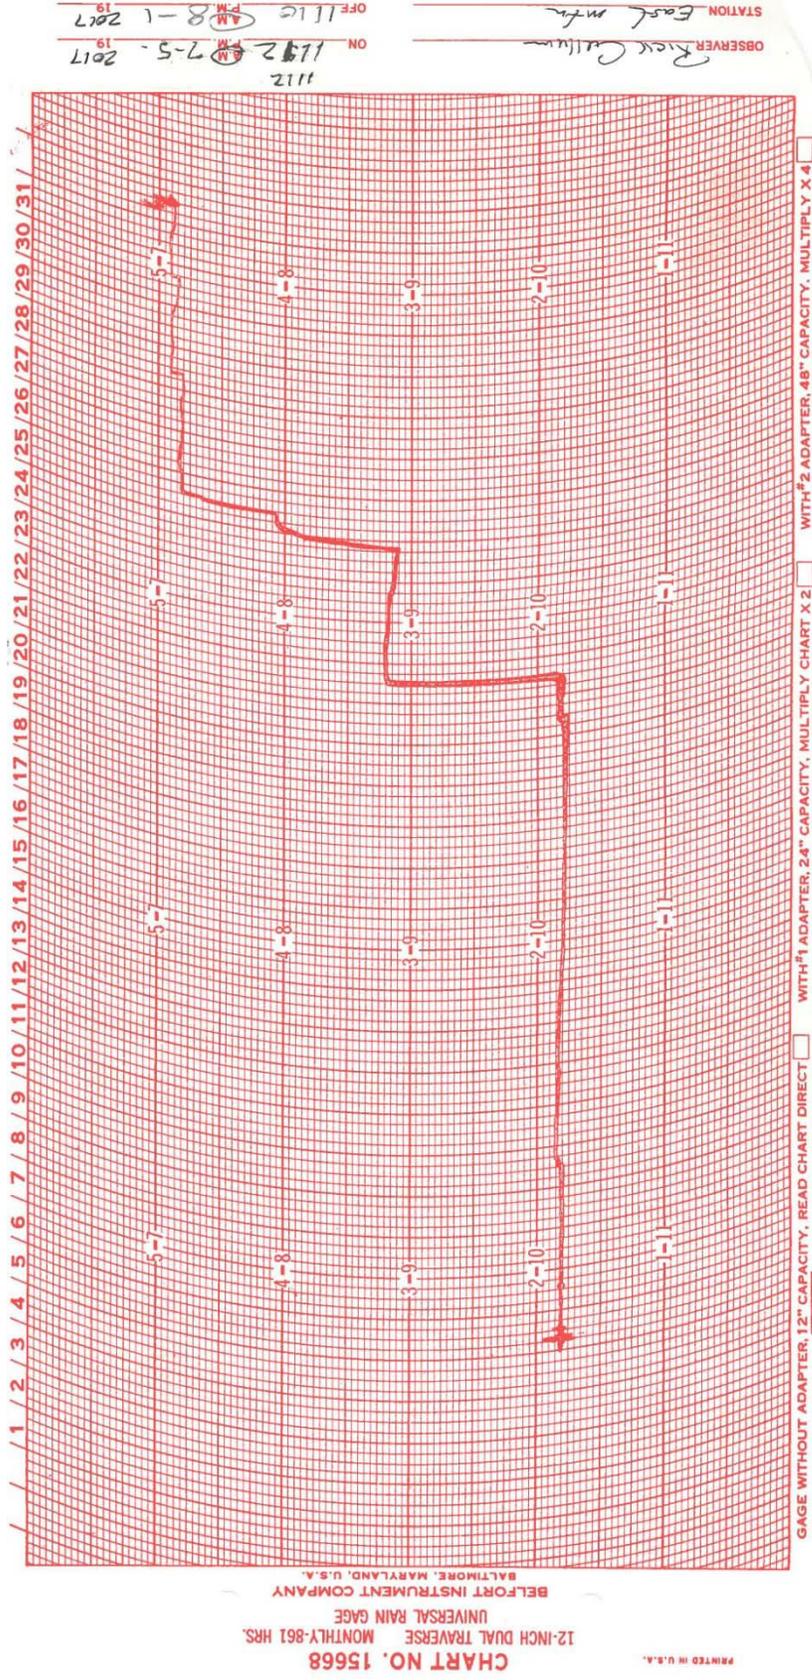
GRAPH 1

High intensity rain events that triggered massive runoff events at the Cottonwood Mine site in late July 2017.
