Inspection Report

Permit Number:	C0150019
Inspection Type:	BOND RELEASE
Inspection Date:	Wednesday, April 17, 2019
Start Date/Time:	4/17/2019 8:00:00 AM
End Date/Time:	4/17/2019 1:00:00 PM
Last Inspection:	Wednesday, March 27, 2019

Permitee: **PACIFICORP**
 Operator: **INTERWEST MINING CO**
 Site: **COTTONWOOD/ WILBERG**
 Address: **PO BOX 310, HUNTINGTON UT 84528**
 County: **EMERY**
 Permit Type: **PERMANENT COAL PROGRAM**
 Permit Status: **ACTIVE**

ATTACHMENT A – Cottonwood Phase I Bond Release Inspection April 29, 2019

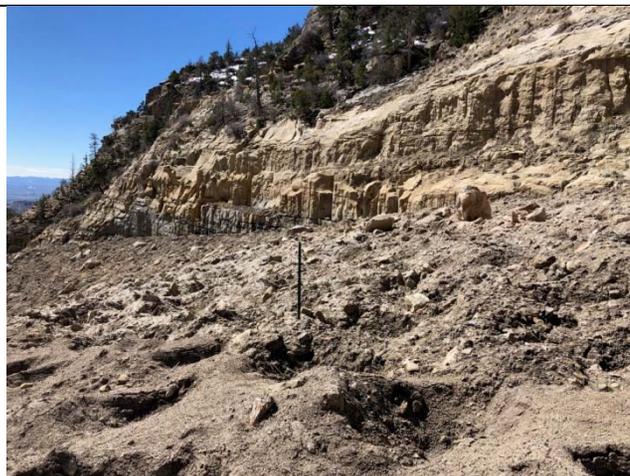
Lower Grimes Wash Soil locations CTW0718 on left and CTW0918 on right

The locations noted on Plate Appendix A-2 with high SAR values at the Cottonwood reclaimed site (CTW 1417, CTW 1517, CTW 0118, CTW0218 and CTW0718) were observed and photographed.

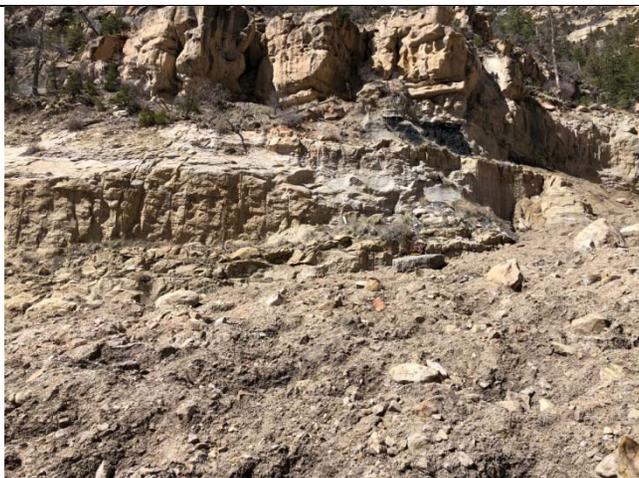
East facing slope Left Fork Grimes Wash Soil locations CTW0118 and CTW 1517

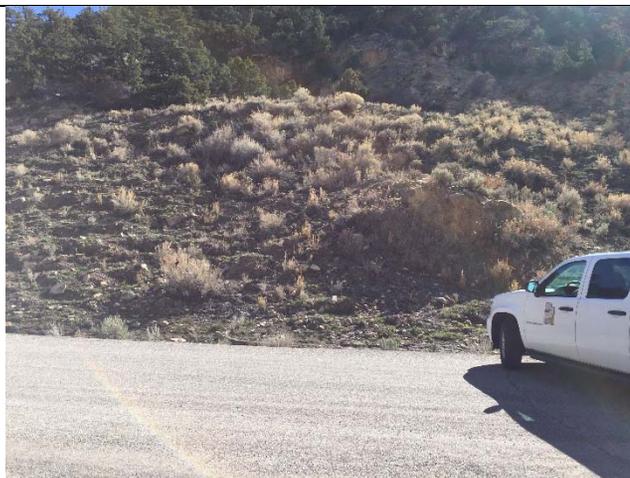
East facing slope Left Fork Grimes Wash soil location CTW1417

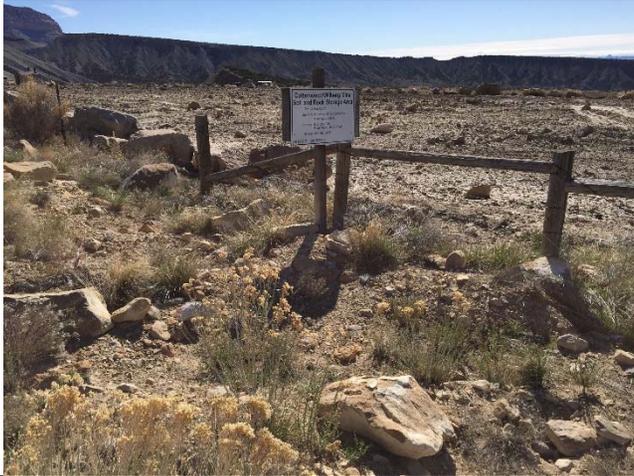
PHOTO 4

The previously disturbed areas at the Trail Mountain Access (TMA) and Belt Portal Area in Cottonwood Canyon were reclaimed in late 2014. Slopes have been regraded to AOC and pocked to arrest erosion and encourage revegetation.

Reclaimed TMA and Belt Portal Area in Cottonwood Canyon

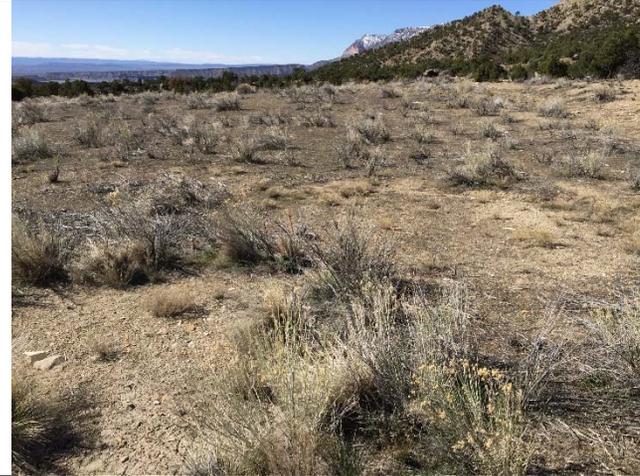
PHOTO 5

Many of the boulders and oversize rocks at the Rock and Soil Storage Area were removed and used as rip rap and/or landscaping at the main Cottonwood/Wilberg site. The remaining surfaces have been regraded to AOC, pocked, and hydroseeded.

Reclaimed Rock and Soil Storage Area

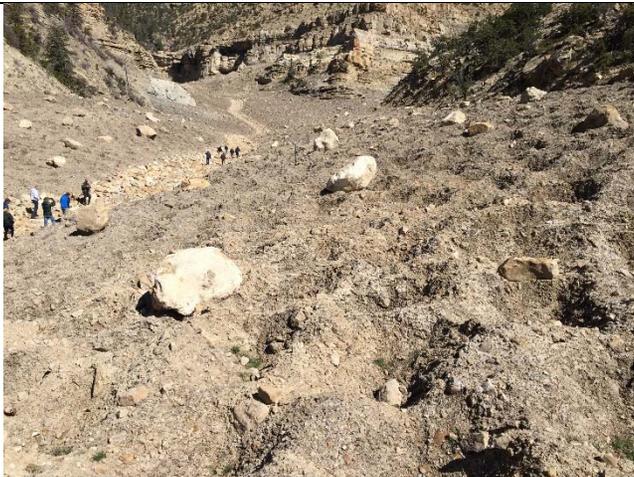
PHOTO 6

Reclaimed Leach Field

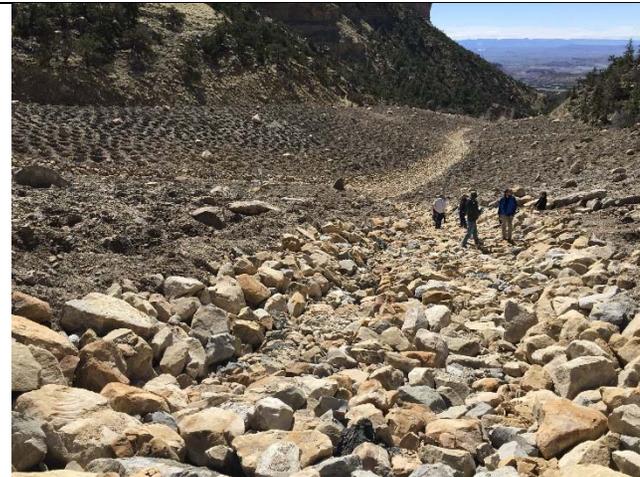
PHOTO 7

The entirety of the Main Cottonwood/Wilberg mine site currently appears stable. The slopes between the undisturbed areas down to the newly established main drainage have been regraded to AOC and pocked. Straw was mixed into the topsoil upon final placement and hydroseed applied.

Reclaimed Cottonwood/Wilberg mine site
