# Inspection Report

Permit Number:	<b>C0150019</b>
Inspection Type:	COMPLETE
Inspection Date:	Friday, May 3, 2019
Start Date/Time:	5/3/2019 10:00:00 AM
End Date/Time:	5/3/2019 2:00:00 PM
Last Inspection:	Wednesday, April 17, 2019

Permitee: **PACIFICORP**  
 Operator: **INTERWEST MINING CO**  
 Site: **COTTONWOOD/ WILBERG**  
 Address: **PO BOX 310, HUNTINGTON UT 84528**  
 County: **EMERY**  
 Permit Type: **PERMANENT COAL PROGRAM**  
 Permit Status: **ACTIVE**

The Cottonwood-Wilberg site inspection for permit compliance and reclamation stability took place on May 3, 2019.

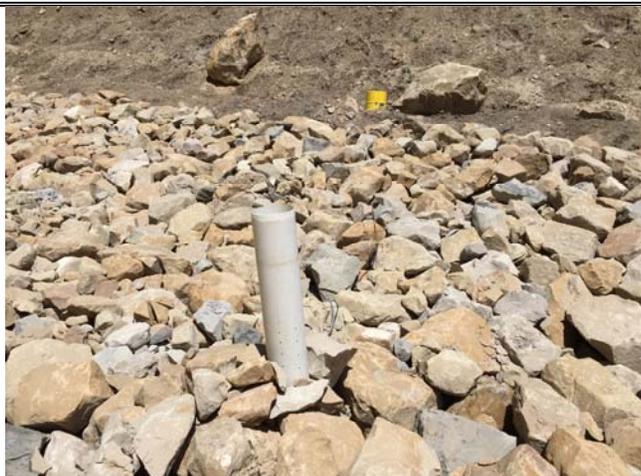
**PHOTO 1**  
ISCO stilling well sampling device installed  
May 3, 2019

The ISCO samplers have been installed above and below the main mine site. A stilling well for the ISCO sampler has been installed in the Left fork of Grimes wash.

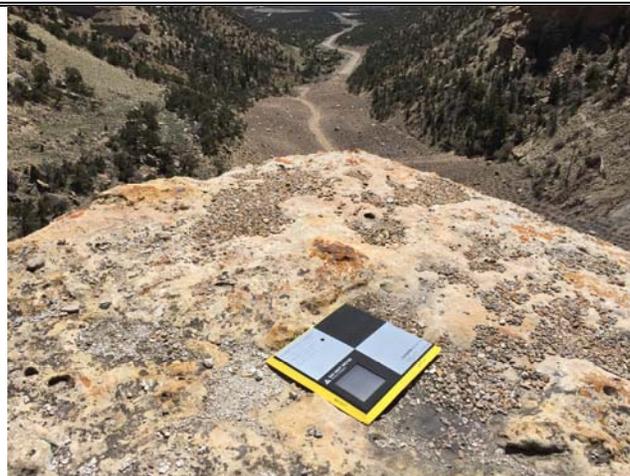
**PHOTO 2**  
Ground control point with reclaimed site in background  
May 3, 2019

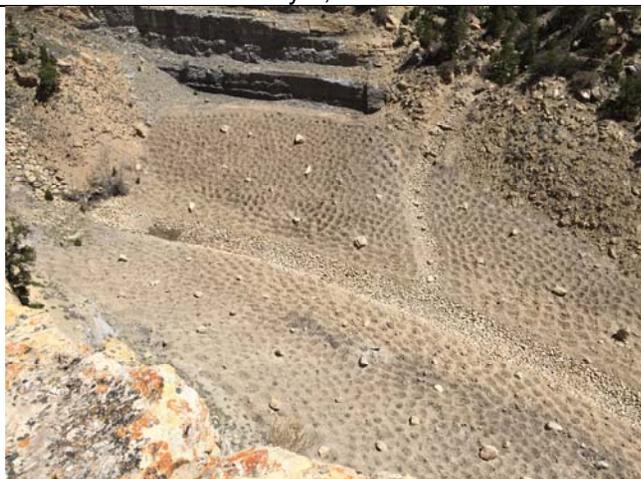
**PHOTO 3**  
Right fork of Grimes wash is stable  
May 3, 2019

Diversions are functioning as designed. There are no instabilities along the length of the reclaimed channels.

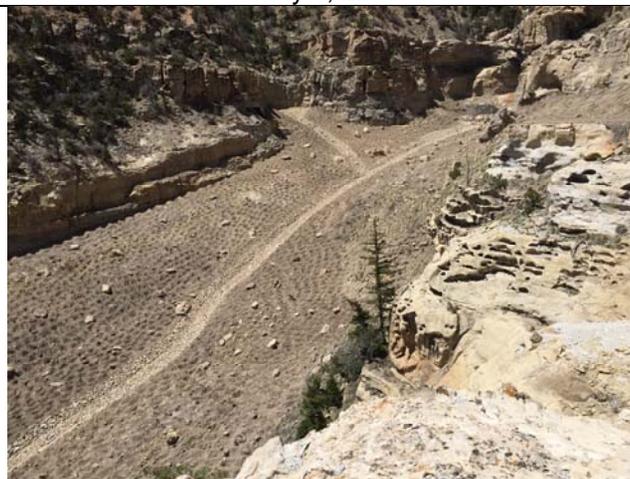
**PHOTO 4**  
Left fork of Grimes wash is stable  
May 3, 2019
