# Inspection Report

Permit Number:	<b>C0150019</b>
Inspection Type:	COMPLETE
Inspection Date:	Tuesday, May 12, 2020
Start Date/Time:	5/12/2020 10:00:00 AM
End Date/Time:	5/12/2020 1:00:00 PM
Last Inspection:	Tuesday, March 24, 2020

Permitee: **PACIFICORP**  
 Operator: **INTERWEST MINING CO**  
 Site: **COTTONWOOD/ WILBERG**  
 Address: **PO BOX 310, HUNTINGTON UT 84528**  
 County: **EMERY**  
 Permit Type: **PERMANENT COAL PROGRAM**  
 Permit Status: **ACTIVE**

### ATTACHMENT A – Cottonwood

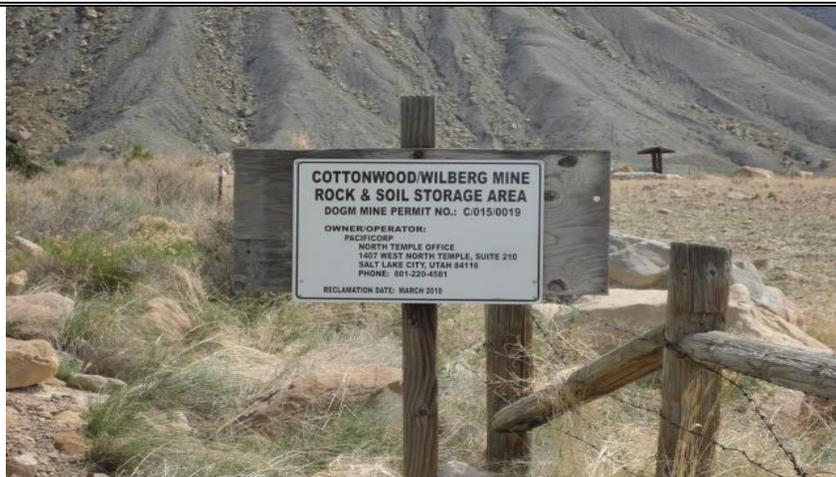
**PHOTO 1**  
Identification Sign

The identification sign was inspected and it meets the requirements of the R645 Coal Rules. See Photo

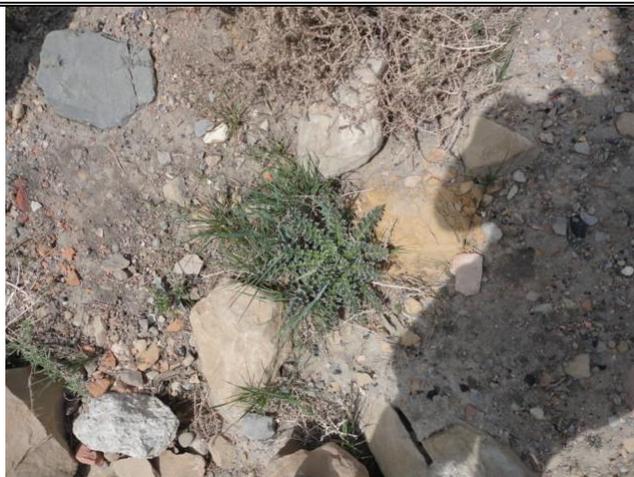
**PHOTO 2**  
THISLE ON RECLAIM SITE

Green Grasses are coming up in the pocks.

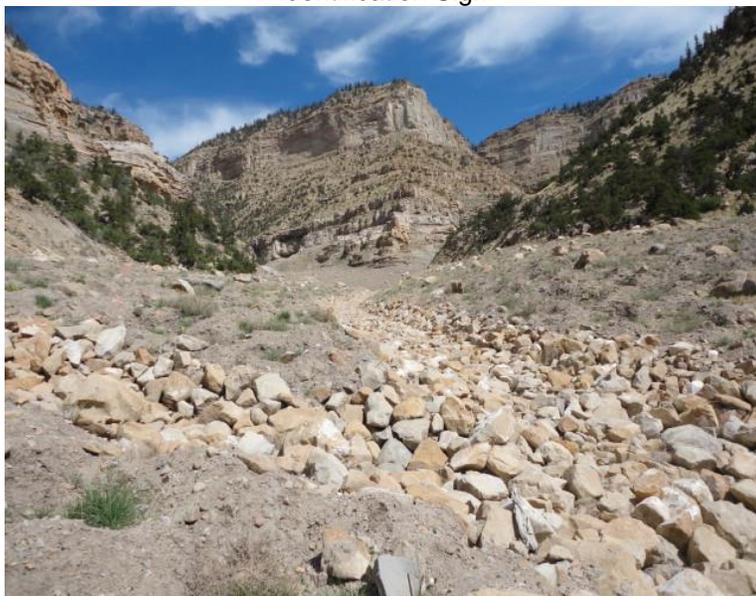
**PHOTO 3**  
Rock Channel

The Cottonwood site is completely reclaimed. The site is dry but vegetation is spring up within the pocks. See Photo No water was flow on top of the rocks in the stream channel. There could be water below /under the rip rap. The reclamation is complete. An inspection was made on the Trail Mountain side, Rock Storage site and the Cottonwood Mine facilities.

Diversions are functioning as designed. There are no instabilities along the length of the reclaimed channels. No flow flow was noticed.
