Inspection Report

Permit Number:	C0150025
Inspection Type:	TECHNICAL
Inspection Date:	Wednesday, March 04, 2009
Start Date/Time:	3/4/2009 1:00:00 PM
End Date/Time:	3/4/2009 3:30:00 PM
Last Inspection:

Permitee: **HIAWATHA COAL CO INC**
 Operator: **HIAWATHA COAL CO INC**
 Site: **BEAR CANYON MINE**
 Address: **PO BOX 1240, HUNTINGTON UT 84528**
 County: **EMERY**
 Permit Type: **PERMANENT COAL PROGRAM**
 Permit Status: **ACTIVE**

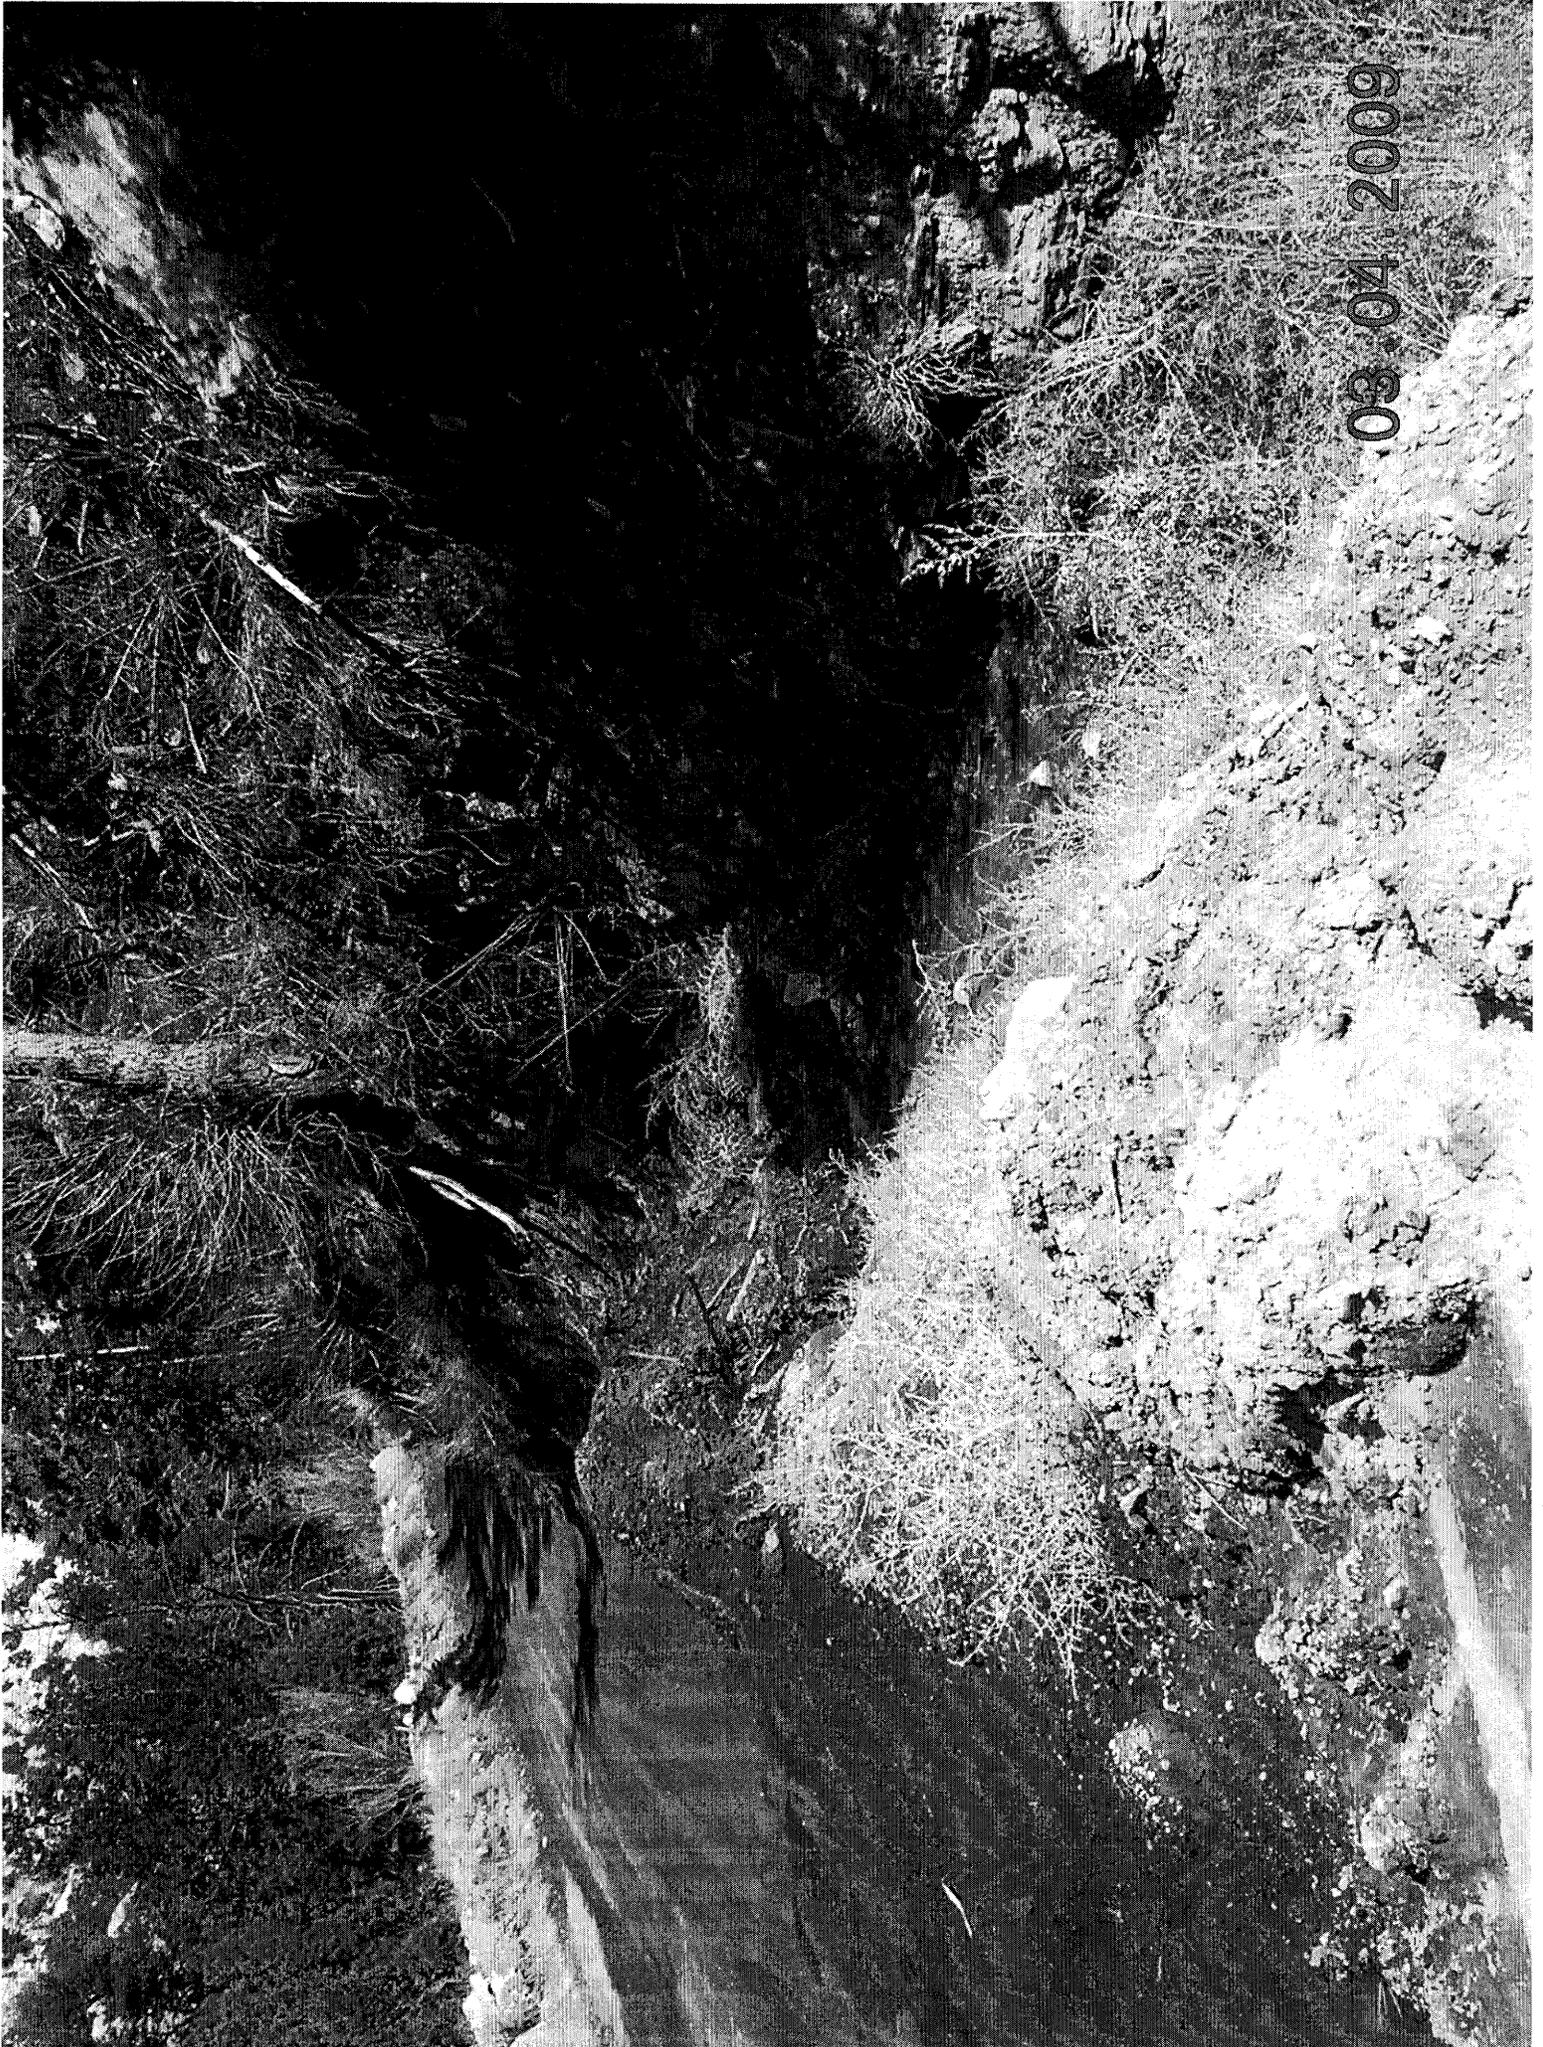
Here is my inspection report from last week's site visit. Thanks for taking the time to meet with me. As I noted to you while out there, the berm area from the intersection of the primary haul road to the road leading up to the active portal needs some maintenance. This was the location where the snow pile was alongside the road. There were two spots along the berm in need of some shoring up (see photo). If you would like to discuss this further, tomorrow is the best day, as I will be out of the office from Mon-Wed of next week.

Observed Bear Creek and stream sampling locations along the creek. Observed berm failure where the primary haul road intersects the road leading to the active portal. Runoff and erosion from the road is making its way into the undisturbed drainage channel. Operator was made aware of the concern. Karl will reevaluate next week to determine if any further actions are appropriate.
