**Storage Pad Stability Analysis**

STORAGE PAD SLOPE STABILITY ANALYSIS  
AT THE CRANDALL CANYON MINE,  
EMERY COUNTY, UTAH

GENWAL COAL COMPANY  
Crandall Canyon Mine  
Huntington, Utah

EARTHFAX ENGINEERING, INC.  
Midvale, Utah

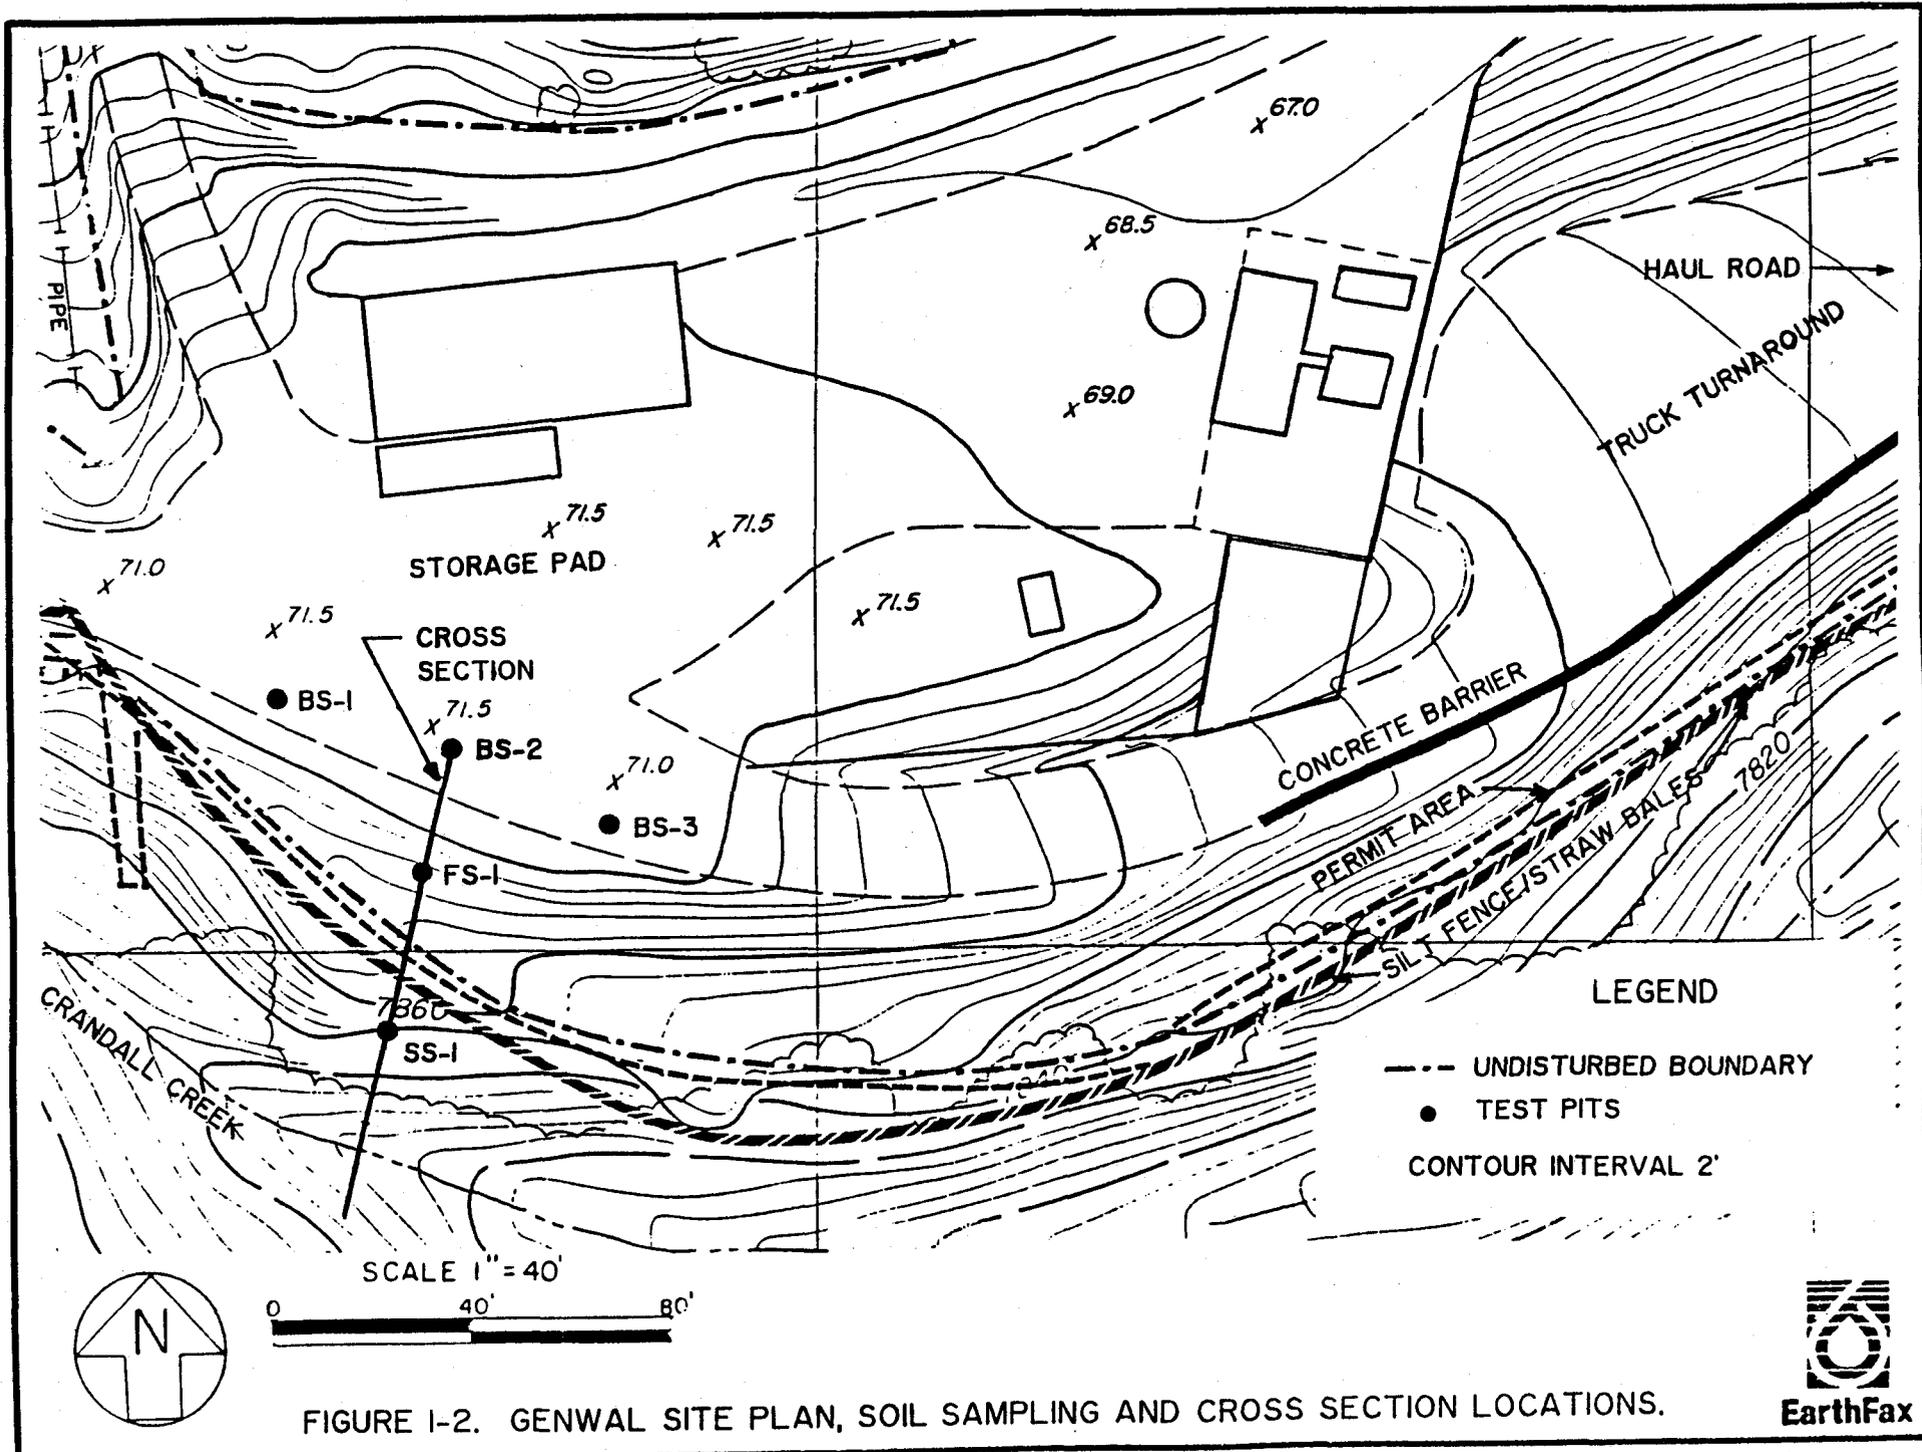
FIGURE I-2. GENWAL SITE PLAN, SOIL SAMPLING AND CROSS SECTION LOCATIONS.

The Crandall Coal Mine, owned by Genwal Coal Company near Huntington, Utah (Figure 1-1), currently trucks approximately 1,000,000 tons of coal annually down Crandall Canyon. This stream-incised canyon provides only limited area for structures, storing equipment, and maneuvering vehicles (Figure 1-2).

To provide additional surface area for equipment storage and vehicle maneuvering, Genwal has proposed extending their existing storage pad toward Crandall Creek. In addition, Genwal has proposed paving their haul road from the mouth of Crandall Canyon to the truck turnaround area, a distance of approximately 1.3 miles. The truck turnaround area is shown on Figure 1-2.

The site of the proposed storage pad extension was investigated by hand excavating five shallow test pits on September 20, 1990 at locations identified as BS-1 through BS-3, FS-1, and SS-1 in Figure 1-2. Bulk grab samples were collected from each location and submitted for physical analyses.

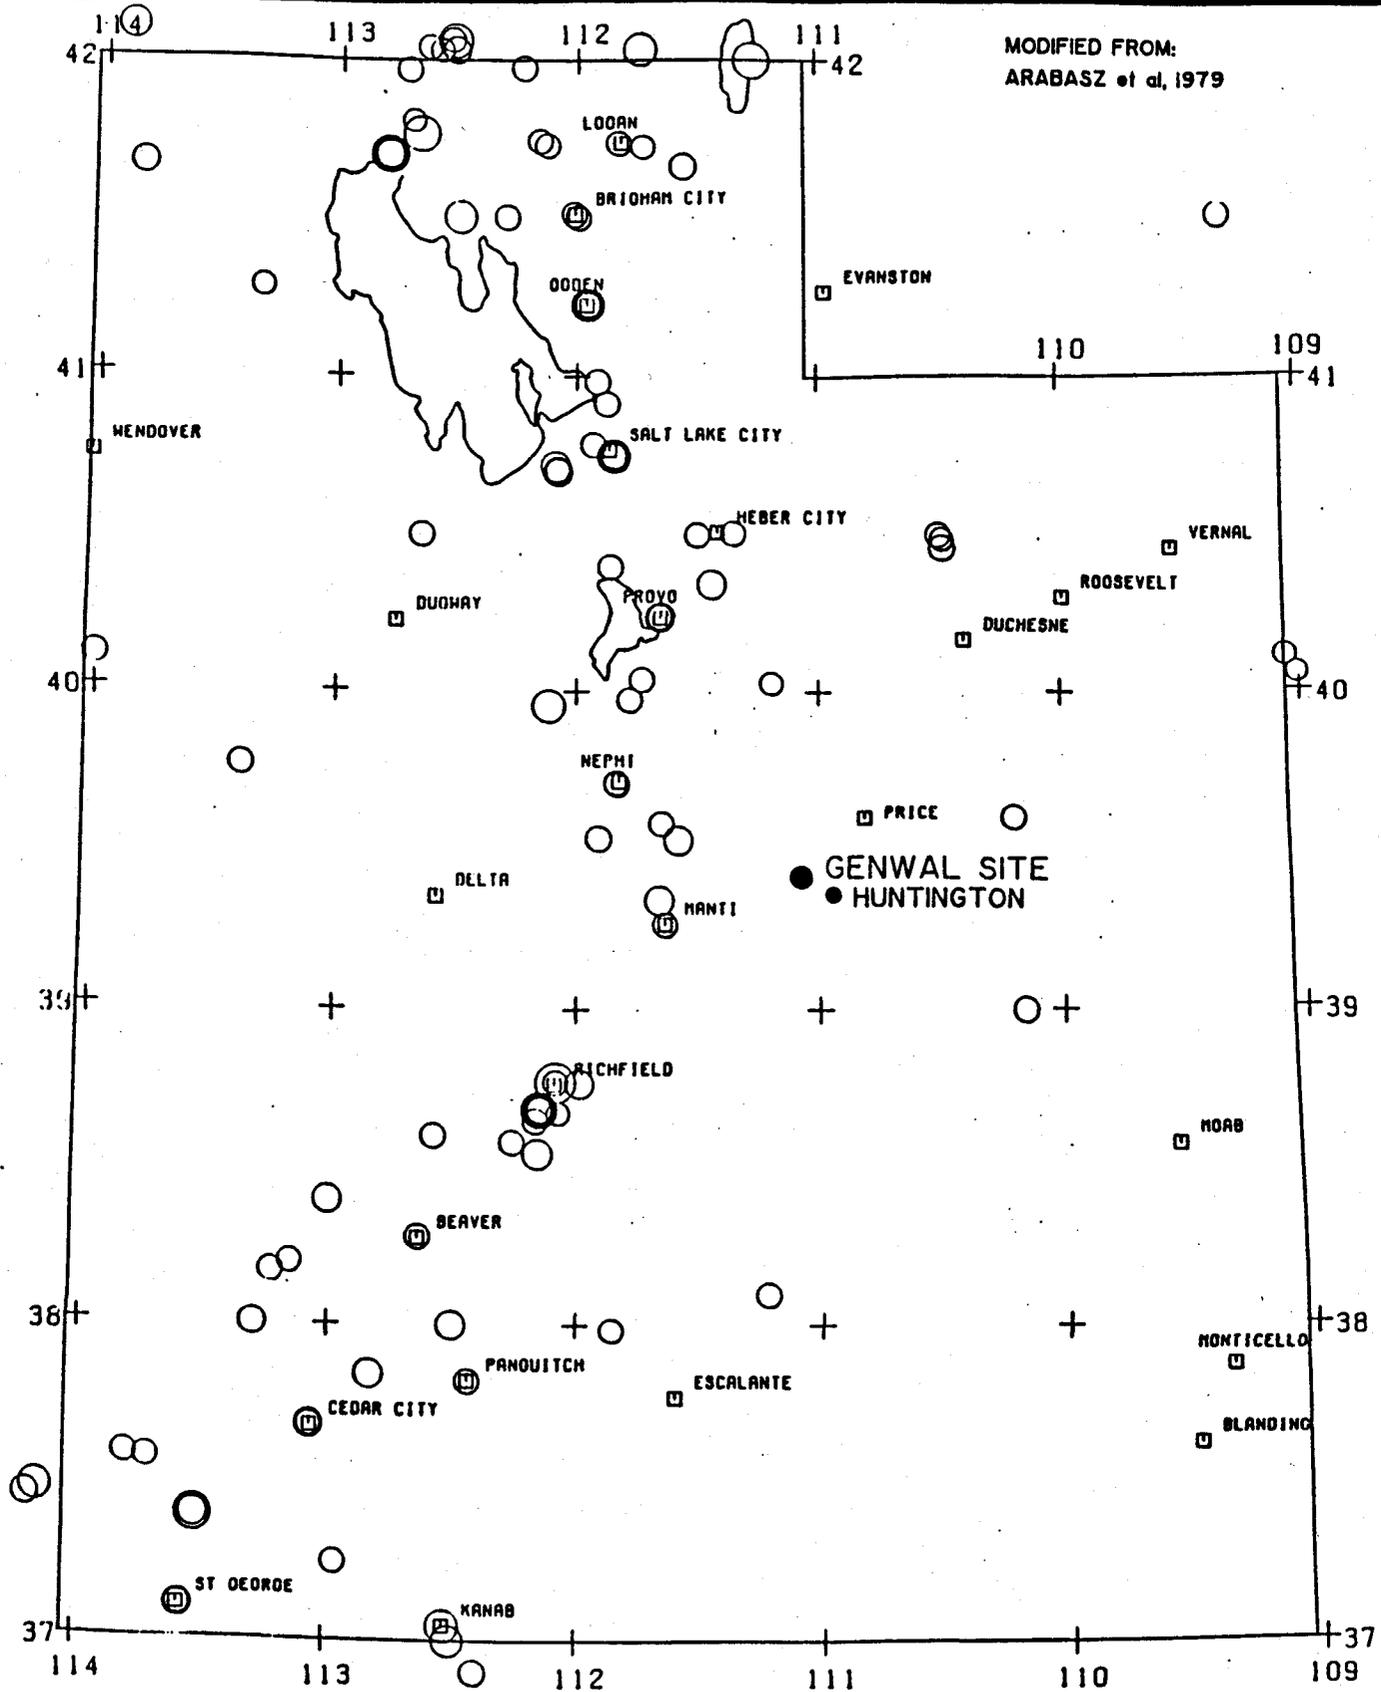
FIGURE 2-1. UTAH EARTHQUAKES OF MAGNITUDE 4.0 (RICHTER) OR GREATER - 1850 TO 1978.

Seismic activity in the vicinity of the Crandall Creek Mine has been historically low. Between 1850 and 1978, the largest seismic event to occur near the site was Magnitude 5.8 (Richter scale) at a hypocentral distance of approximately 26 miles west (Figure 2-1; Arabasz et al, 1979). According to worldwide earthquake data compiled by Seed (1982), this event corresponds to a peak horizontal acceleration in rock of about 0.07g, where g is gravitational acceleration. This peak horizontal acceleration will be used for the slope stability analyses.

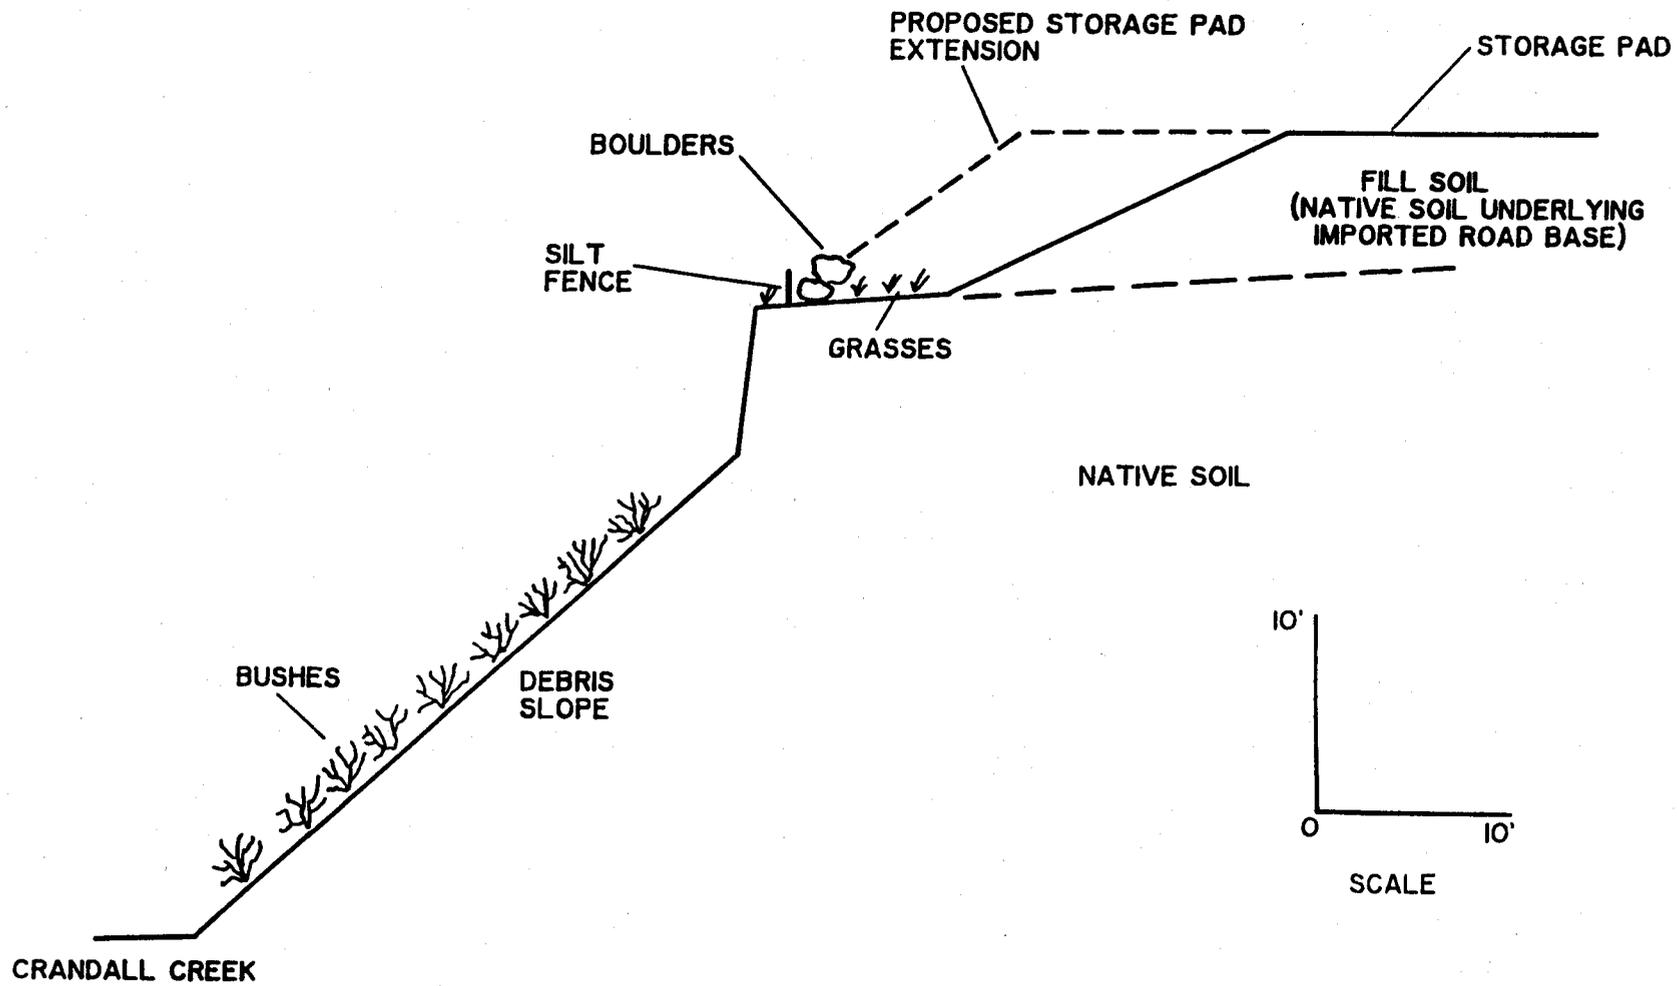
FIGURE 4-1. STORAGE PAD CROSS-SECTION.

A cross-section of the Crandall Canyon and storage pad slope is presented in Figure 4-1. This cross-section was developed by surveying the slope using a hand-held eye level and a measuring tape. The proposed storage pad extension is also shown in Figure 4-1. Boulders will be placed at the toe of the extension slope to act as a makeshift retaining wall, thereby enabling additional fill soil to be placed.

The proposed slope in Figure 4-1 is stable with a critical safety factor of 1.58 under static conditions and 1.45 under dynamic conditions using a horizontal acceleration of 0.07g. Results of the stability analyses are presented in Appendix C. As a worst-case condition, the debris slope at the base of the near-vertical stream cut was not included in the analyses since Crandall Creek may wash this debris away during a period of peak flow.

Slope stability analyses were conducted using an angle of internal friction of 46 degrees and an internal cohesion of 700 psf. In the interest of conservatism, shear strengths imparted through root/soil interaction, calcium carbonate cementation, and inter-particle capillarity were neglected. In addition, as a worst-case condition, the debris slope at the base of the near-vertical stream cut was not included in the analyses since Crandall Creek may wash this debris away during a period of peak flow. The proposed slope in Figure 4-1 is stable with a critical safety factor of 1.58 under static conditions and 1.45 under dynamic conditions using a horizontal acceleration of 0.07g.

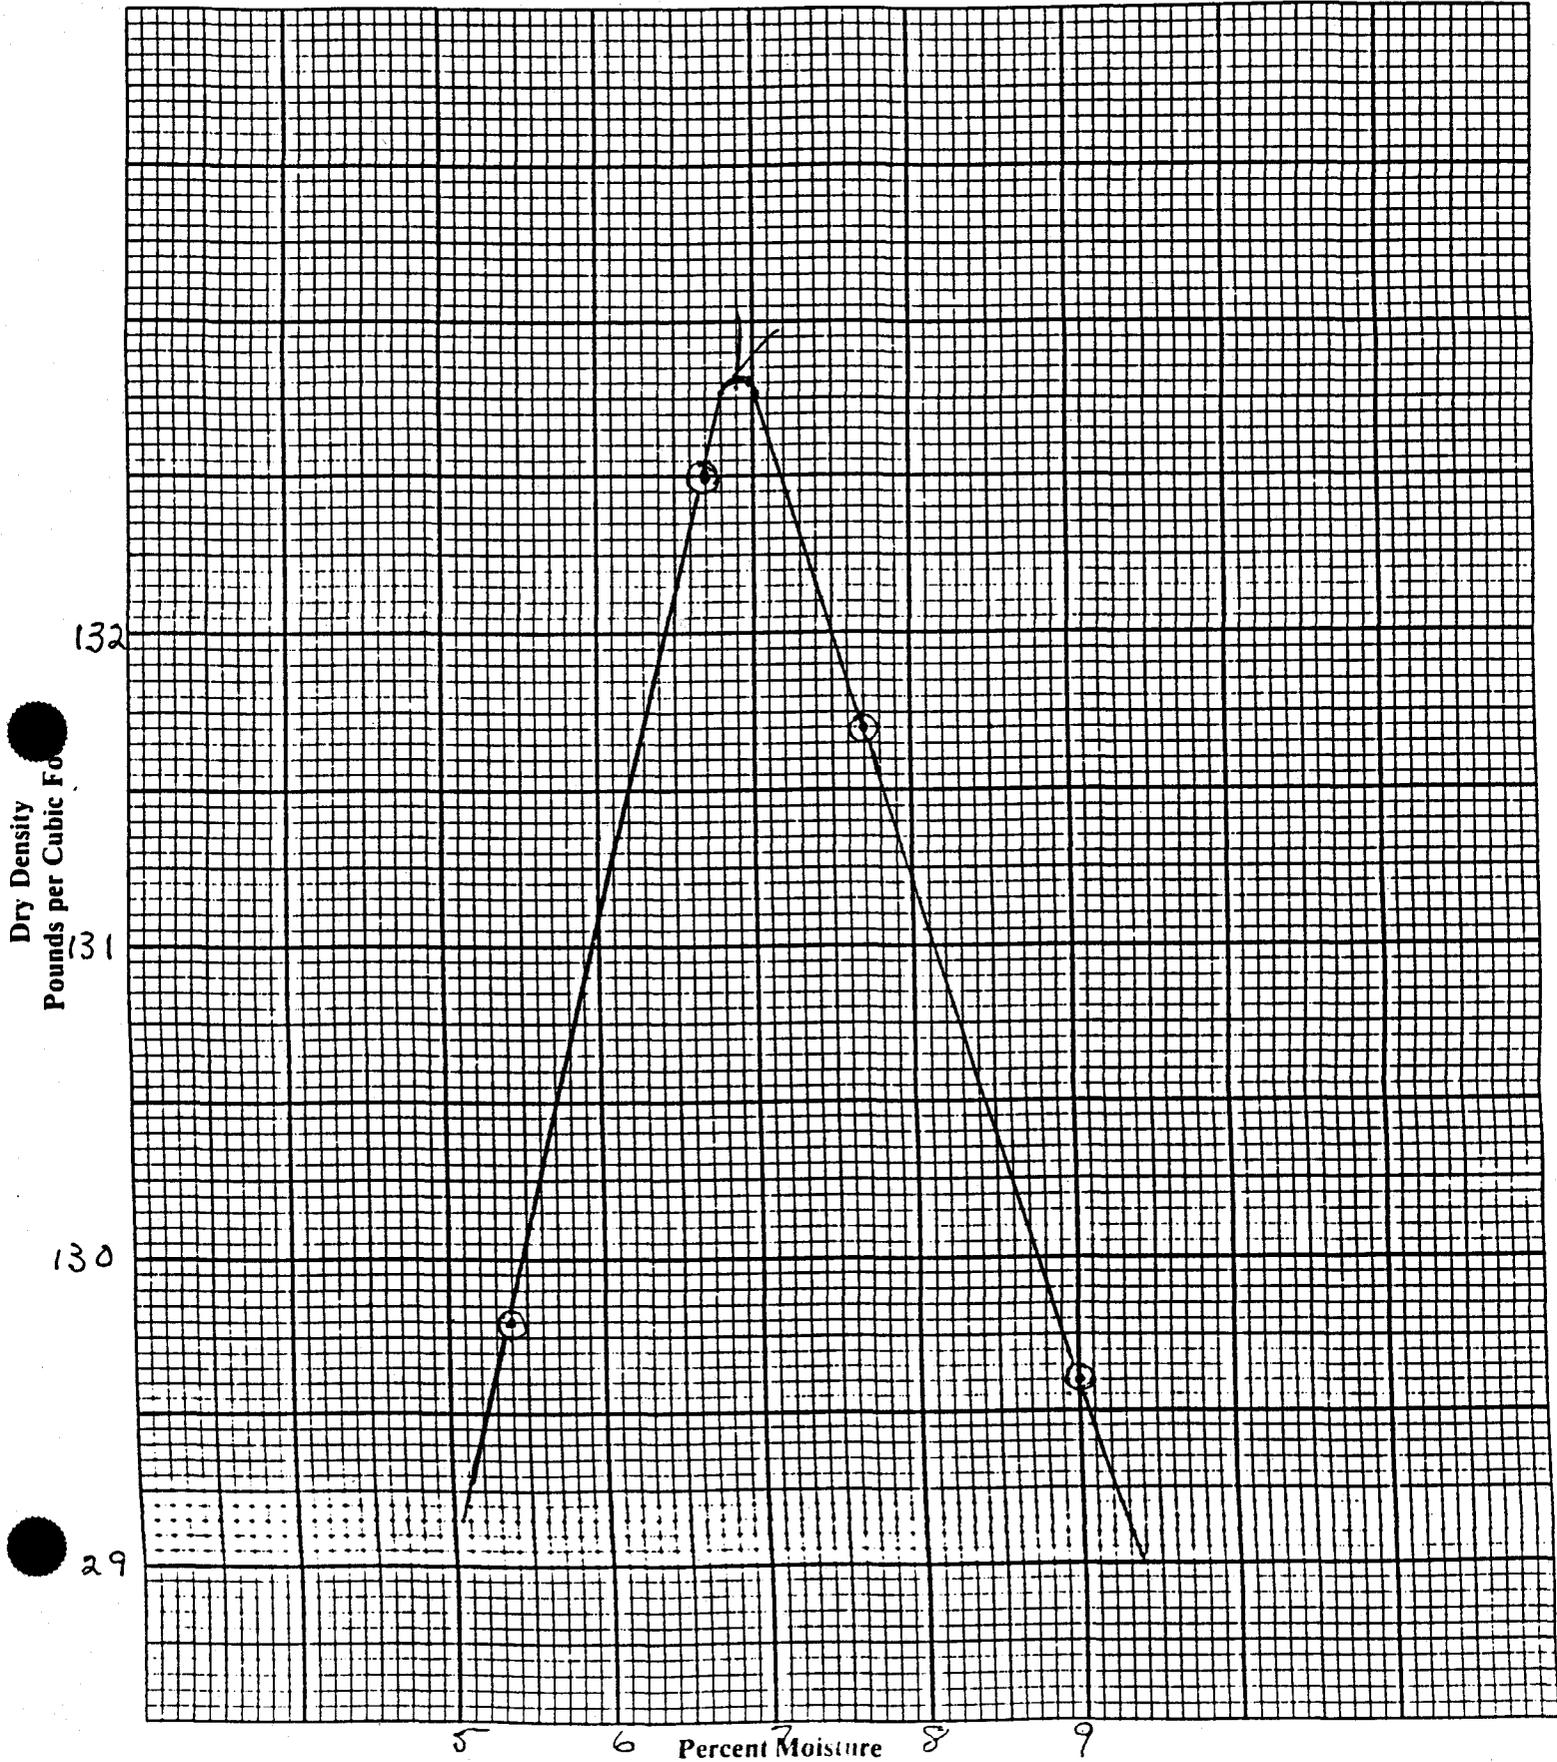
## MOISTURE DENSITY CURVE ASTM C-698, D-1557

Job # 33095 Material \_\_\_\_\_ Source comb. BS-1, BS-2, BS-3  
Owner Earth Fax Project Gen wal Date 9-26-90  
Test Method T-180-D Max. Compaction 132.8 Opt. Moist. 6.9

sandy gravels. Typically, 19.8% of the soil is fine-grained (passing a #200 sieve). Since the samples are nonplastic, the fine-grained fraction is probably silt rather than clay. The modified Proctor density of the base course material is 132.8 pounds per cubic foot (pcf) at an optimum moisture content of 6.9%.

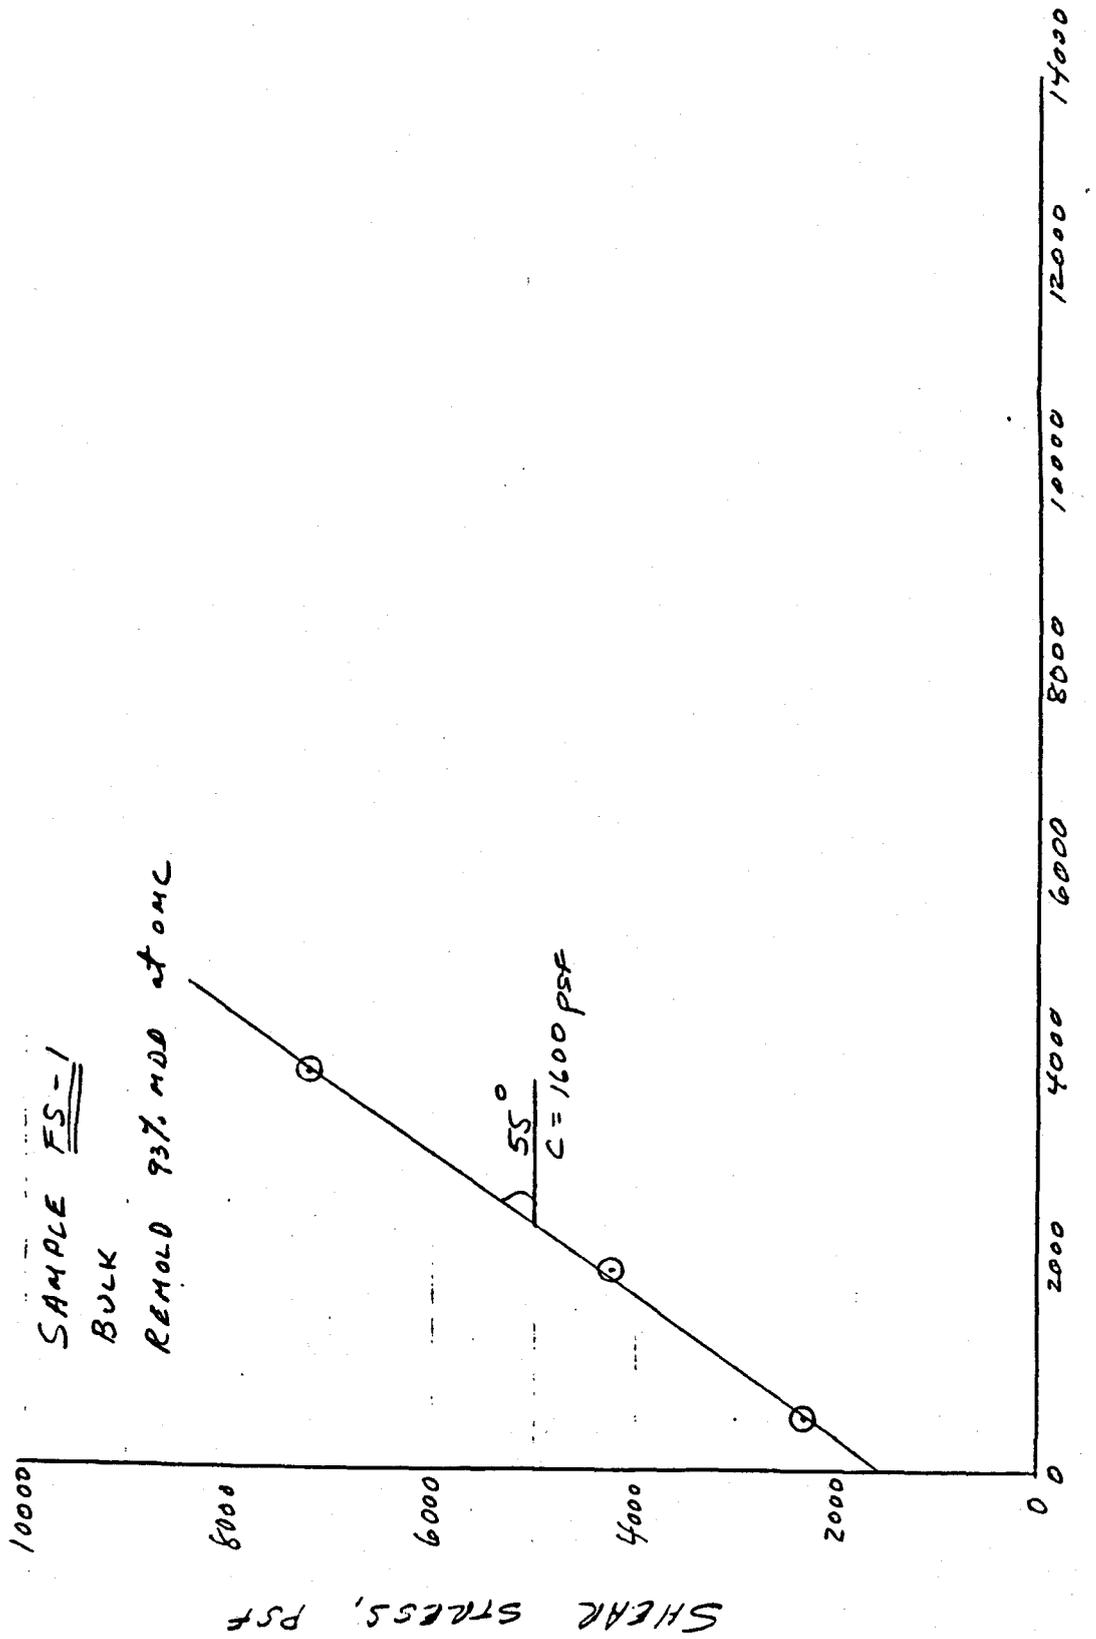
DIRECT SHEAR  
 UNCONSOLIDATED - UNDRAINED

SAMPLE FS-1  
 BULK  
 REMOLD 93% MOD at omc

$P_N$  NORMAL STRESS, PSF

The angle of internal friction as determined by the direct shear test is 46 degrees for sample SS-1 and 55 degrees for sample FS-1. The internal cohesion is 700 pounds per square foot (psf) for sample SS-1 and 1600 psf for sample FS-1. These values are unusually high and, in the case of sample FS-1, may indicate that gravel-sized particles had a significant effect on the limited testing surface of the direct shear device. The high strength values for sample SS-1 may explain the prolonged stability of the near-vertical stream cut downslope of the storage pad on the north bank of Crandall Creek. The strength parameters from sample SS-1 will be used to conduct the slope stability analyses.
