MINING AND RECLAMATION PLAN

ADDENDUM TO THE RECLAMATION PLAN

for the
**EAST MOUNTAIN
EMERGENCY DRILLPADS AND ACCESS
ROADS**

Submitted: December 21, 2007

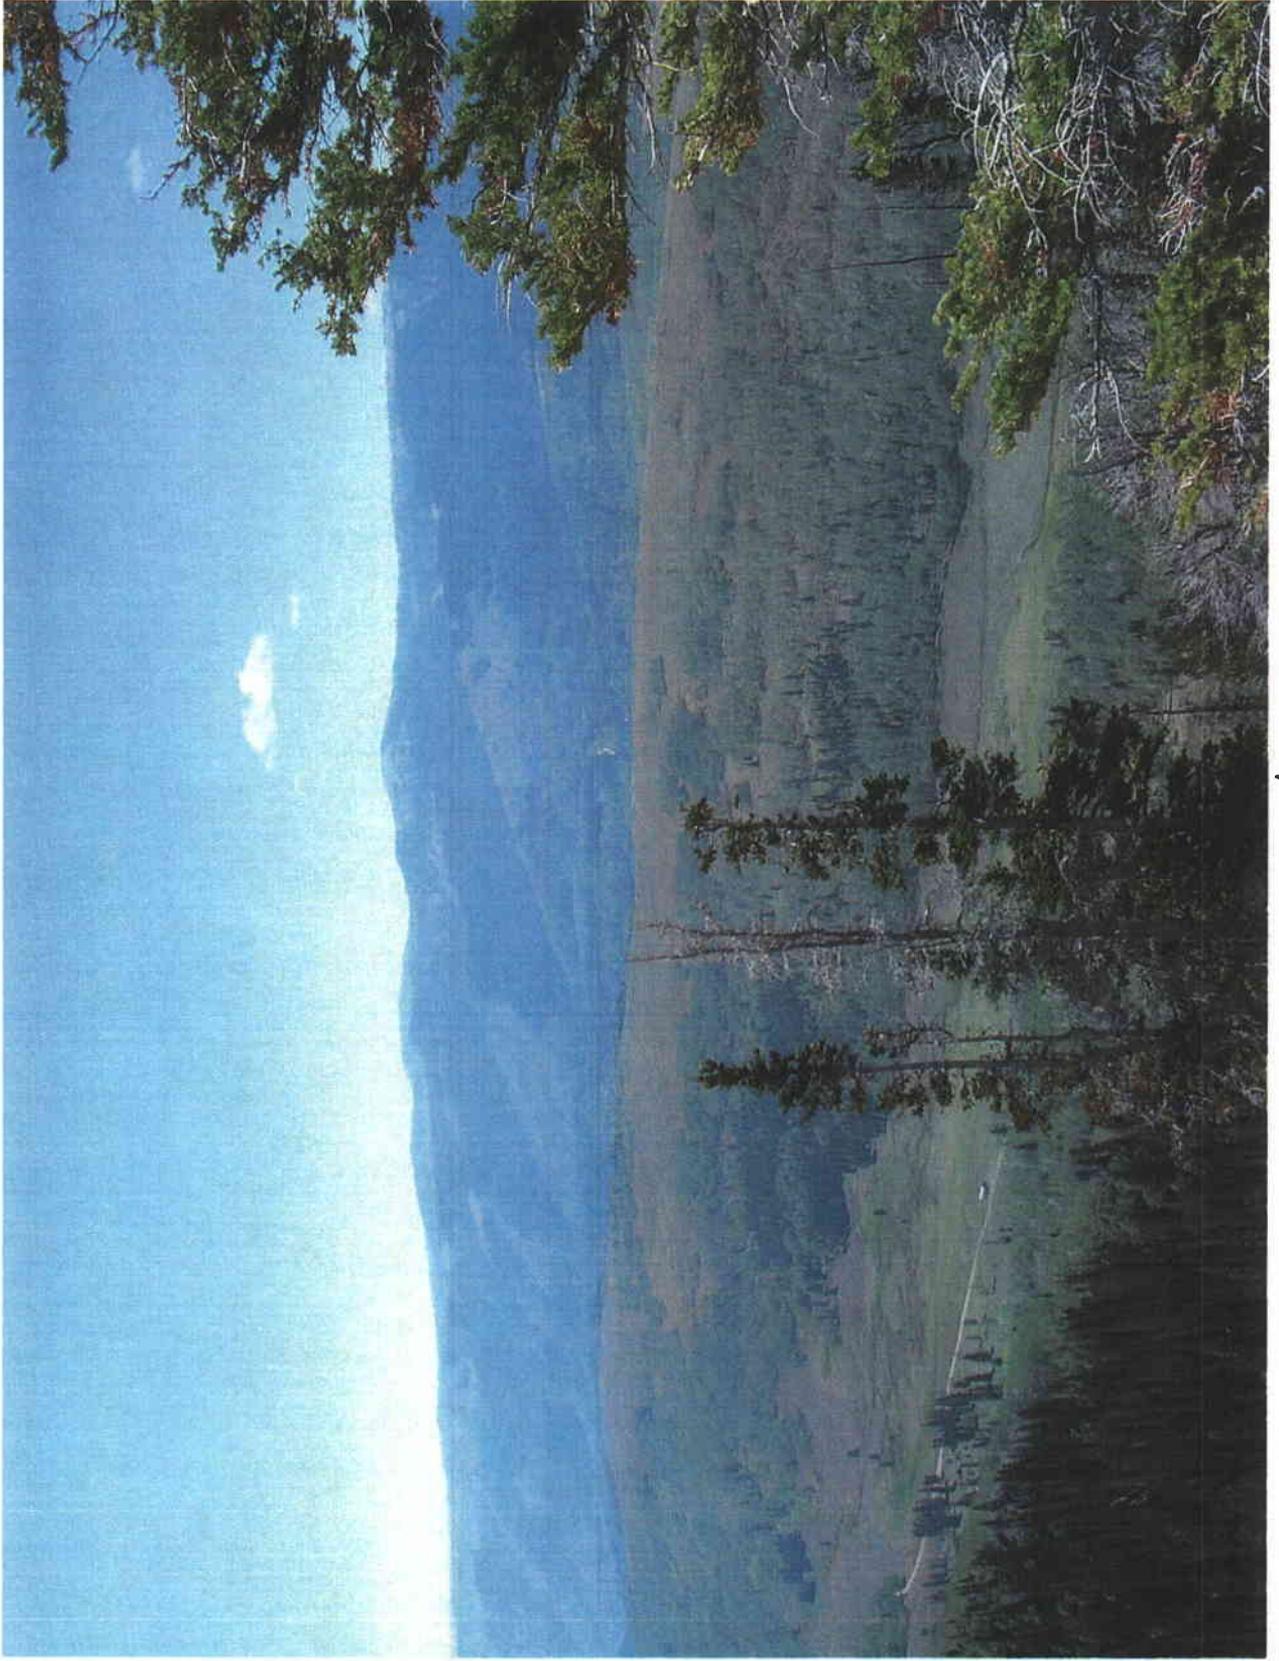
View from drillsites

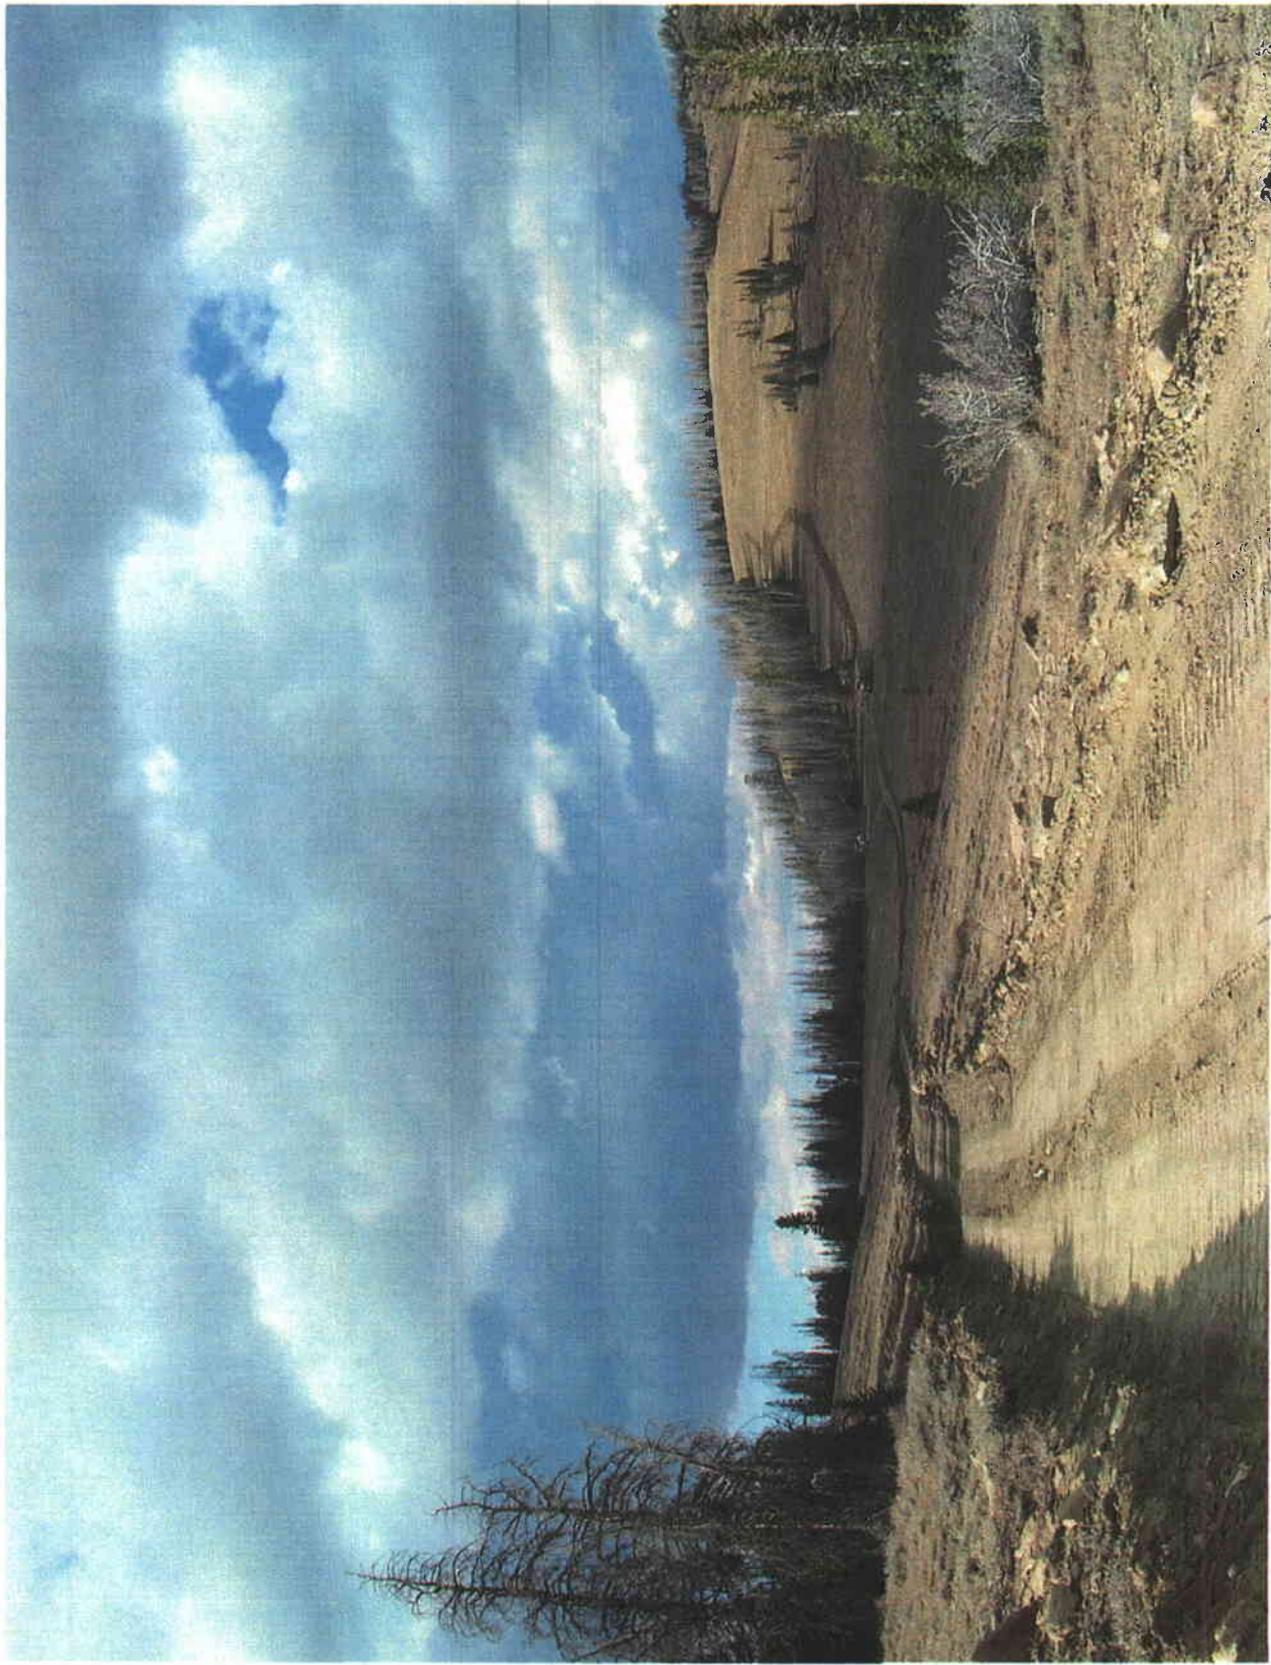
SITUA road (foreground), reclaimed water truck road (background)

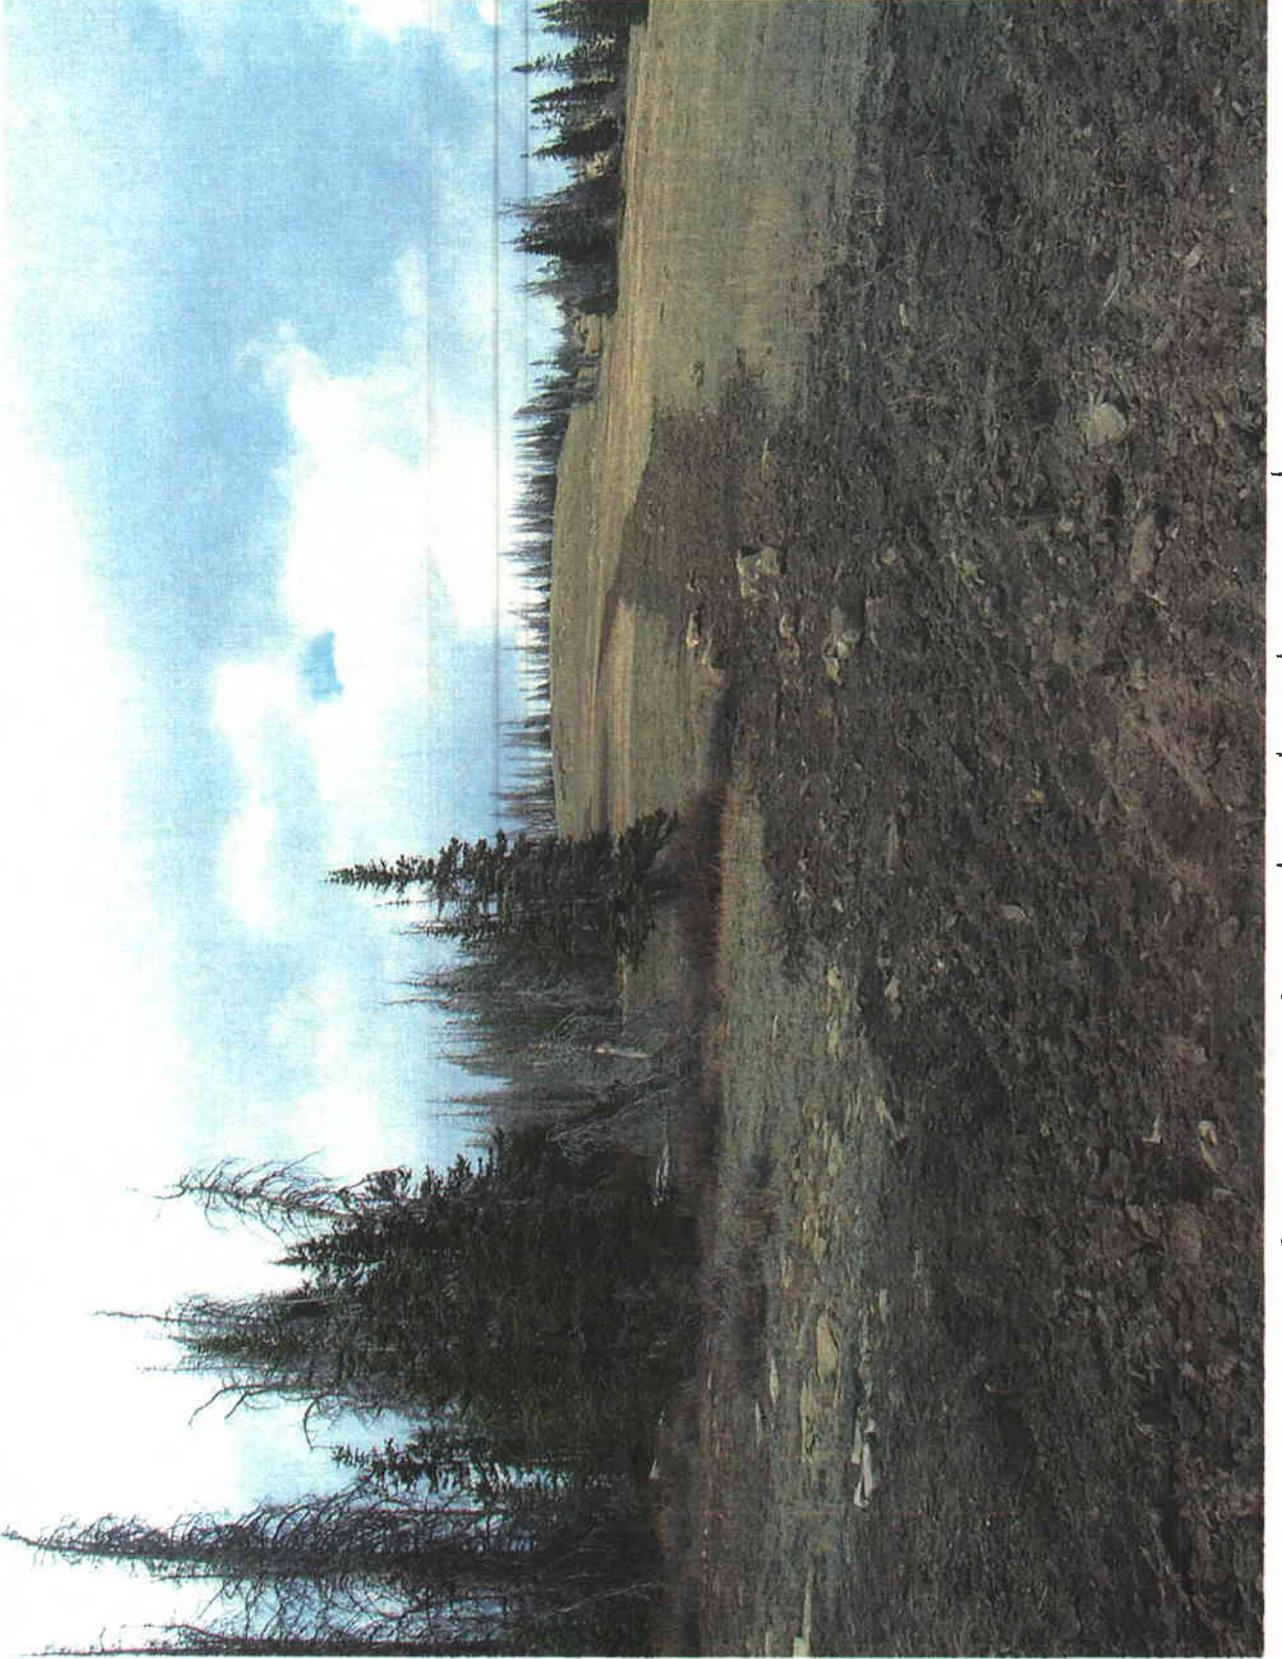
Reclaimed water truck road

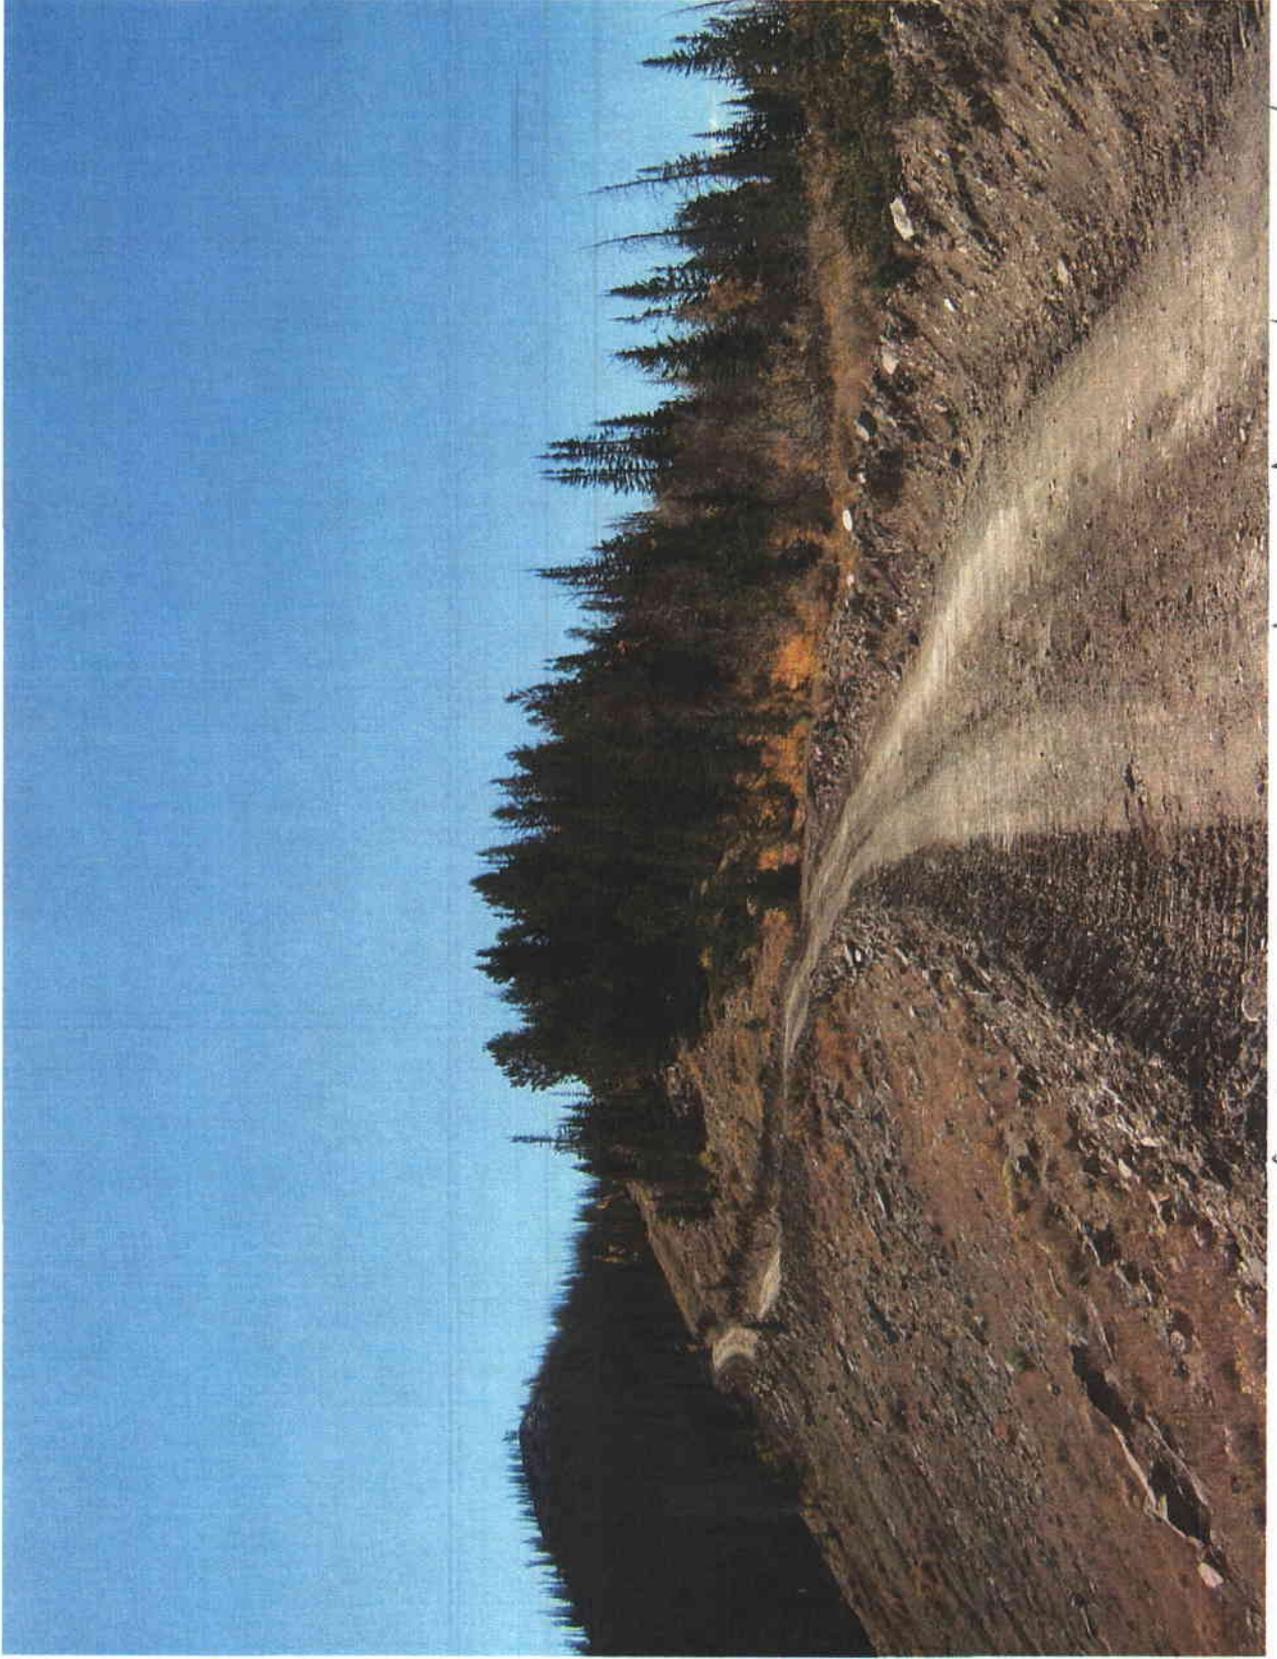
SITLA road before reclamation and realignment

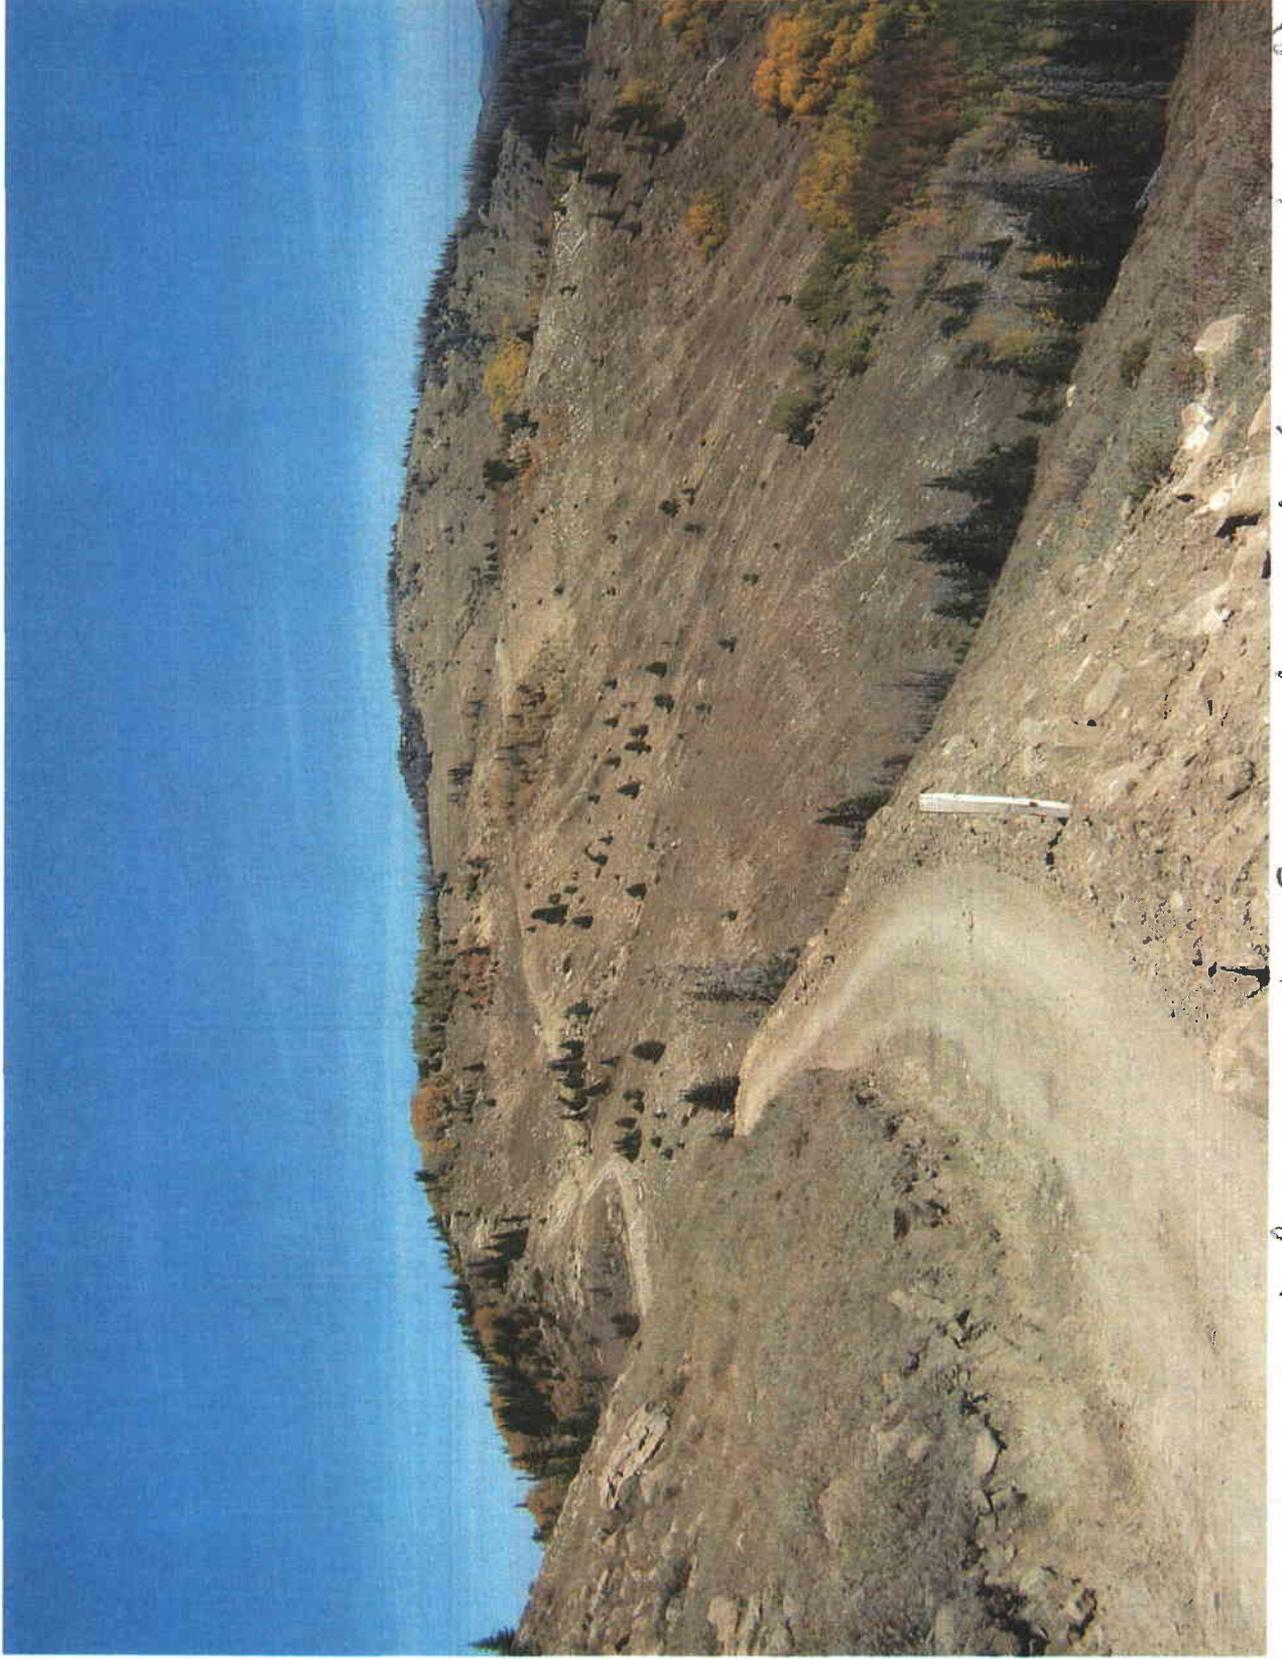
Unreclaimed segment of SITEA road (now reclaimed)

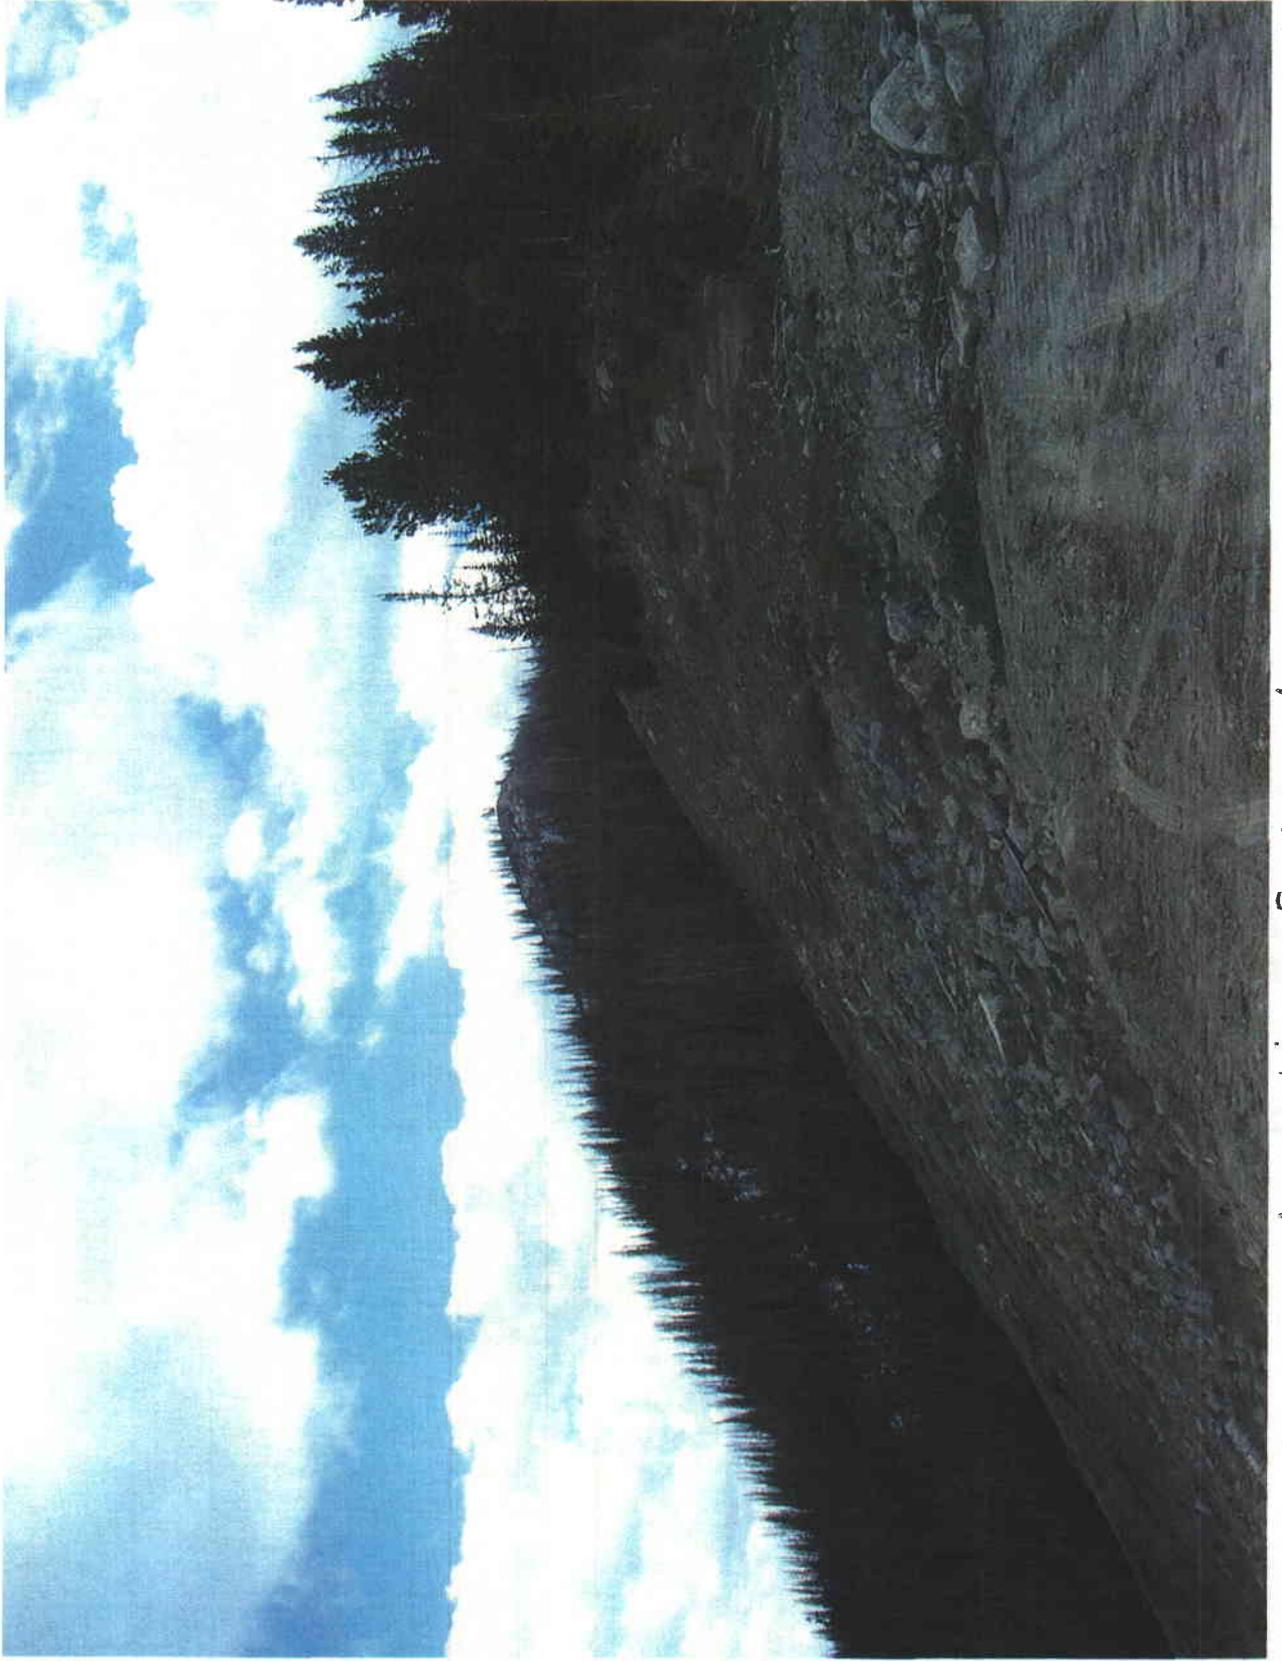
Reclaimed section of SITLA road

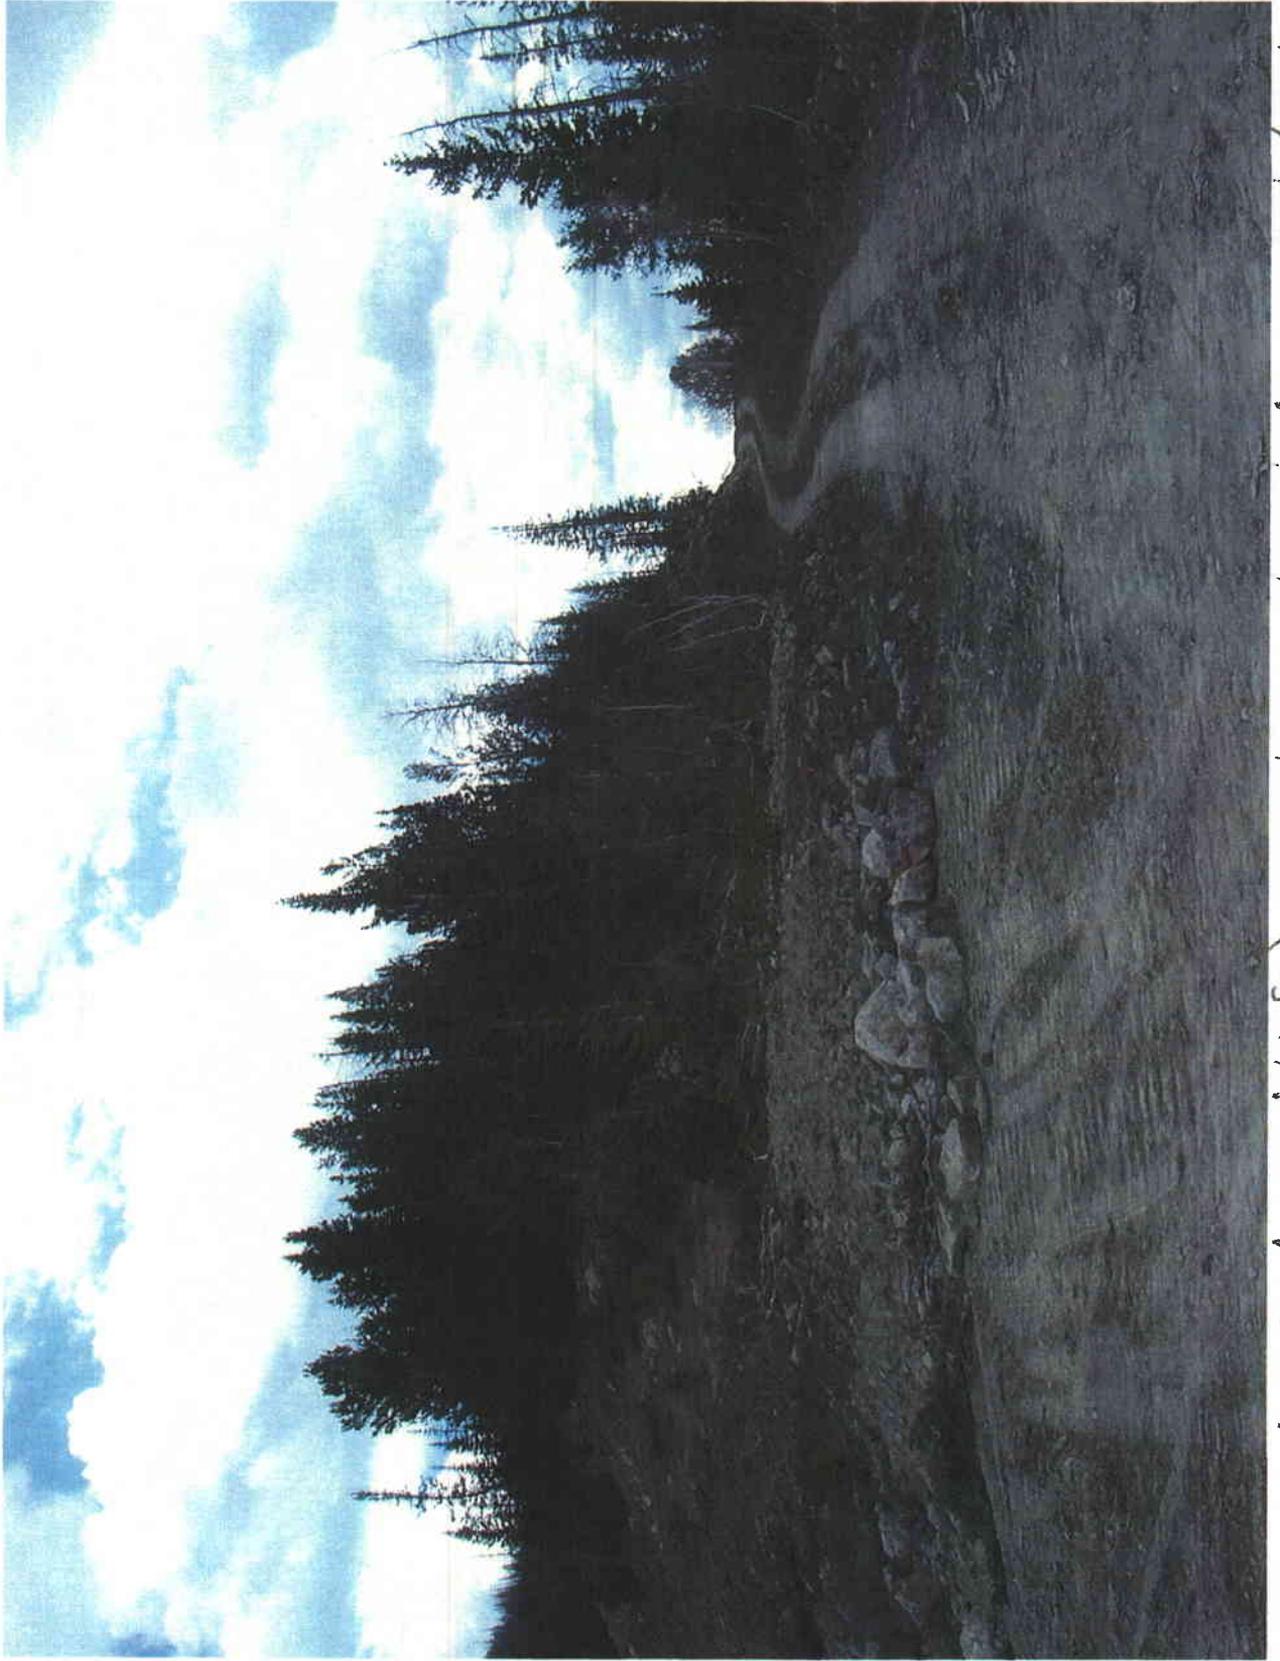
Reclaimed SITLA road (left), newly constructed segment (right)

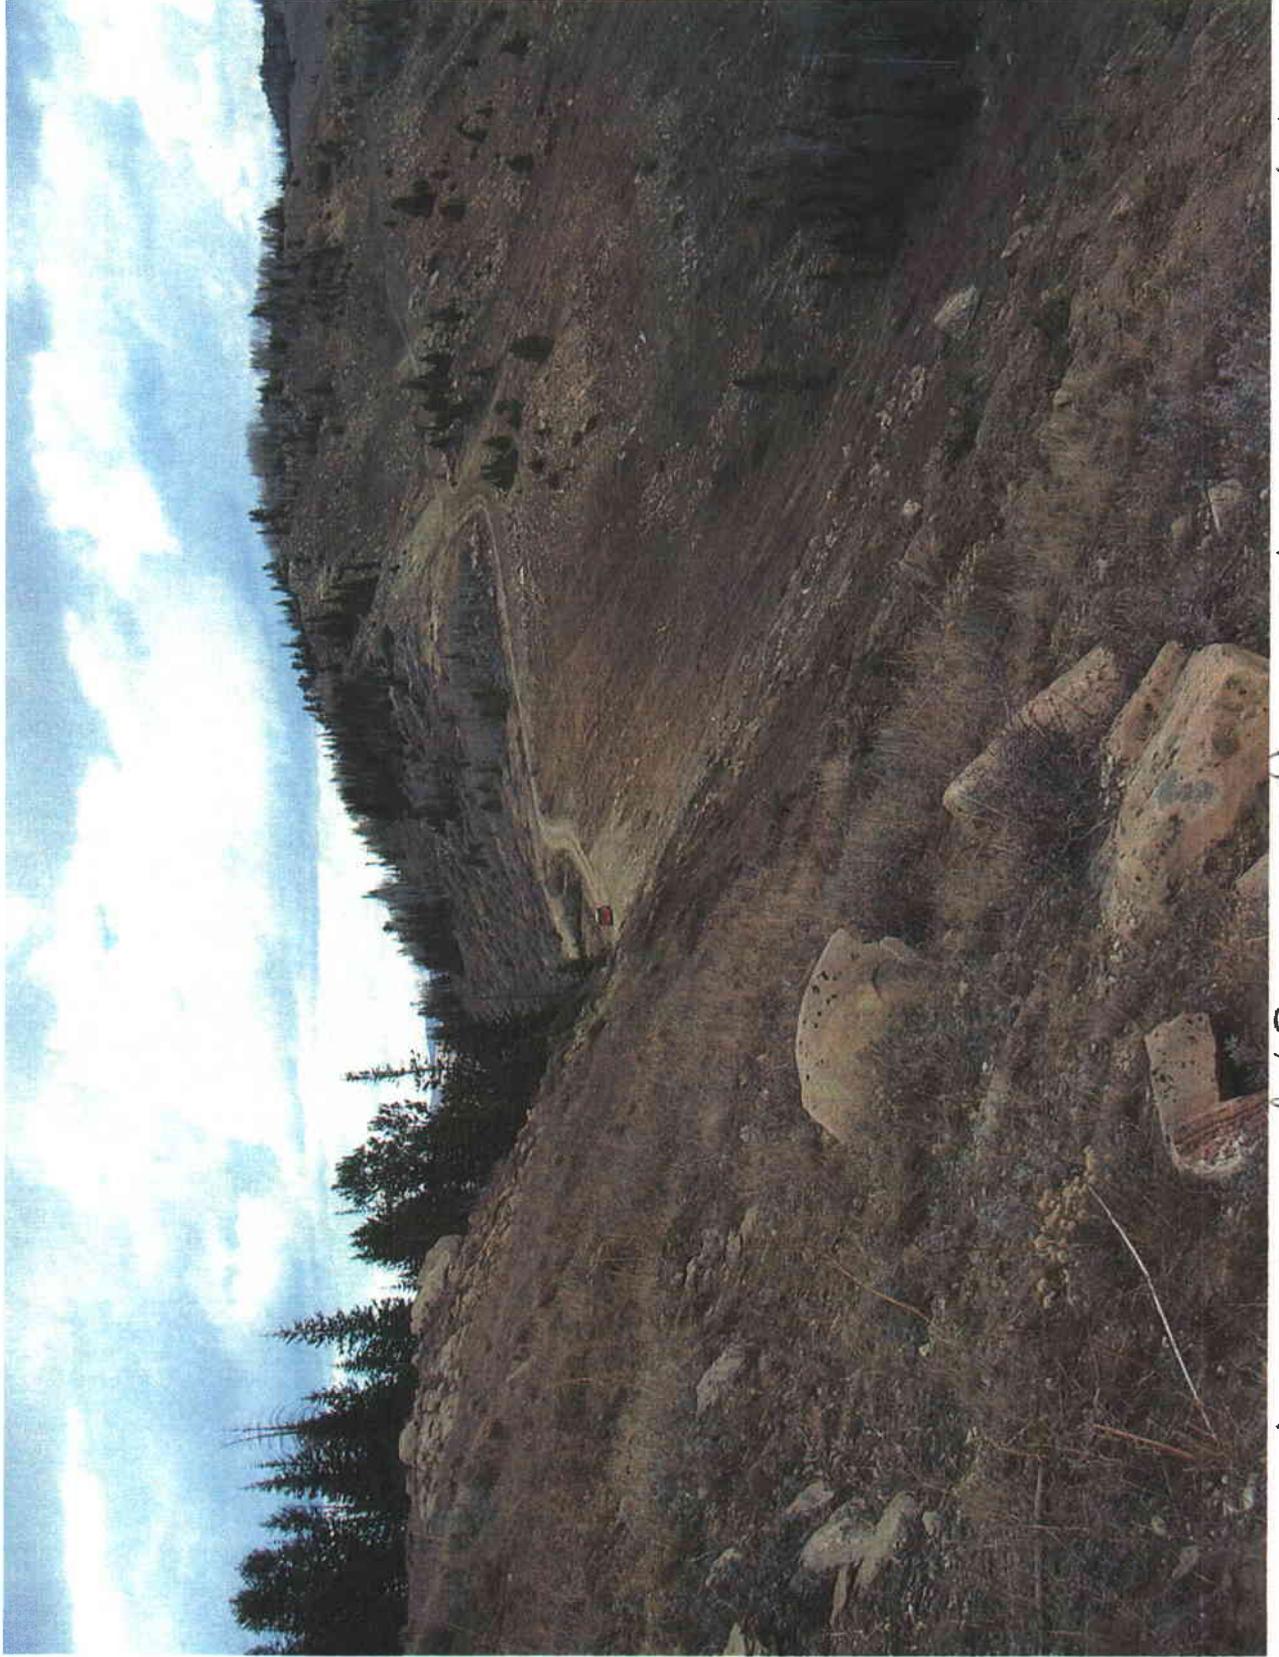
Reclaimed SITLA road (foreground), existing SITLA road (background)

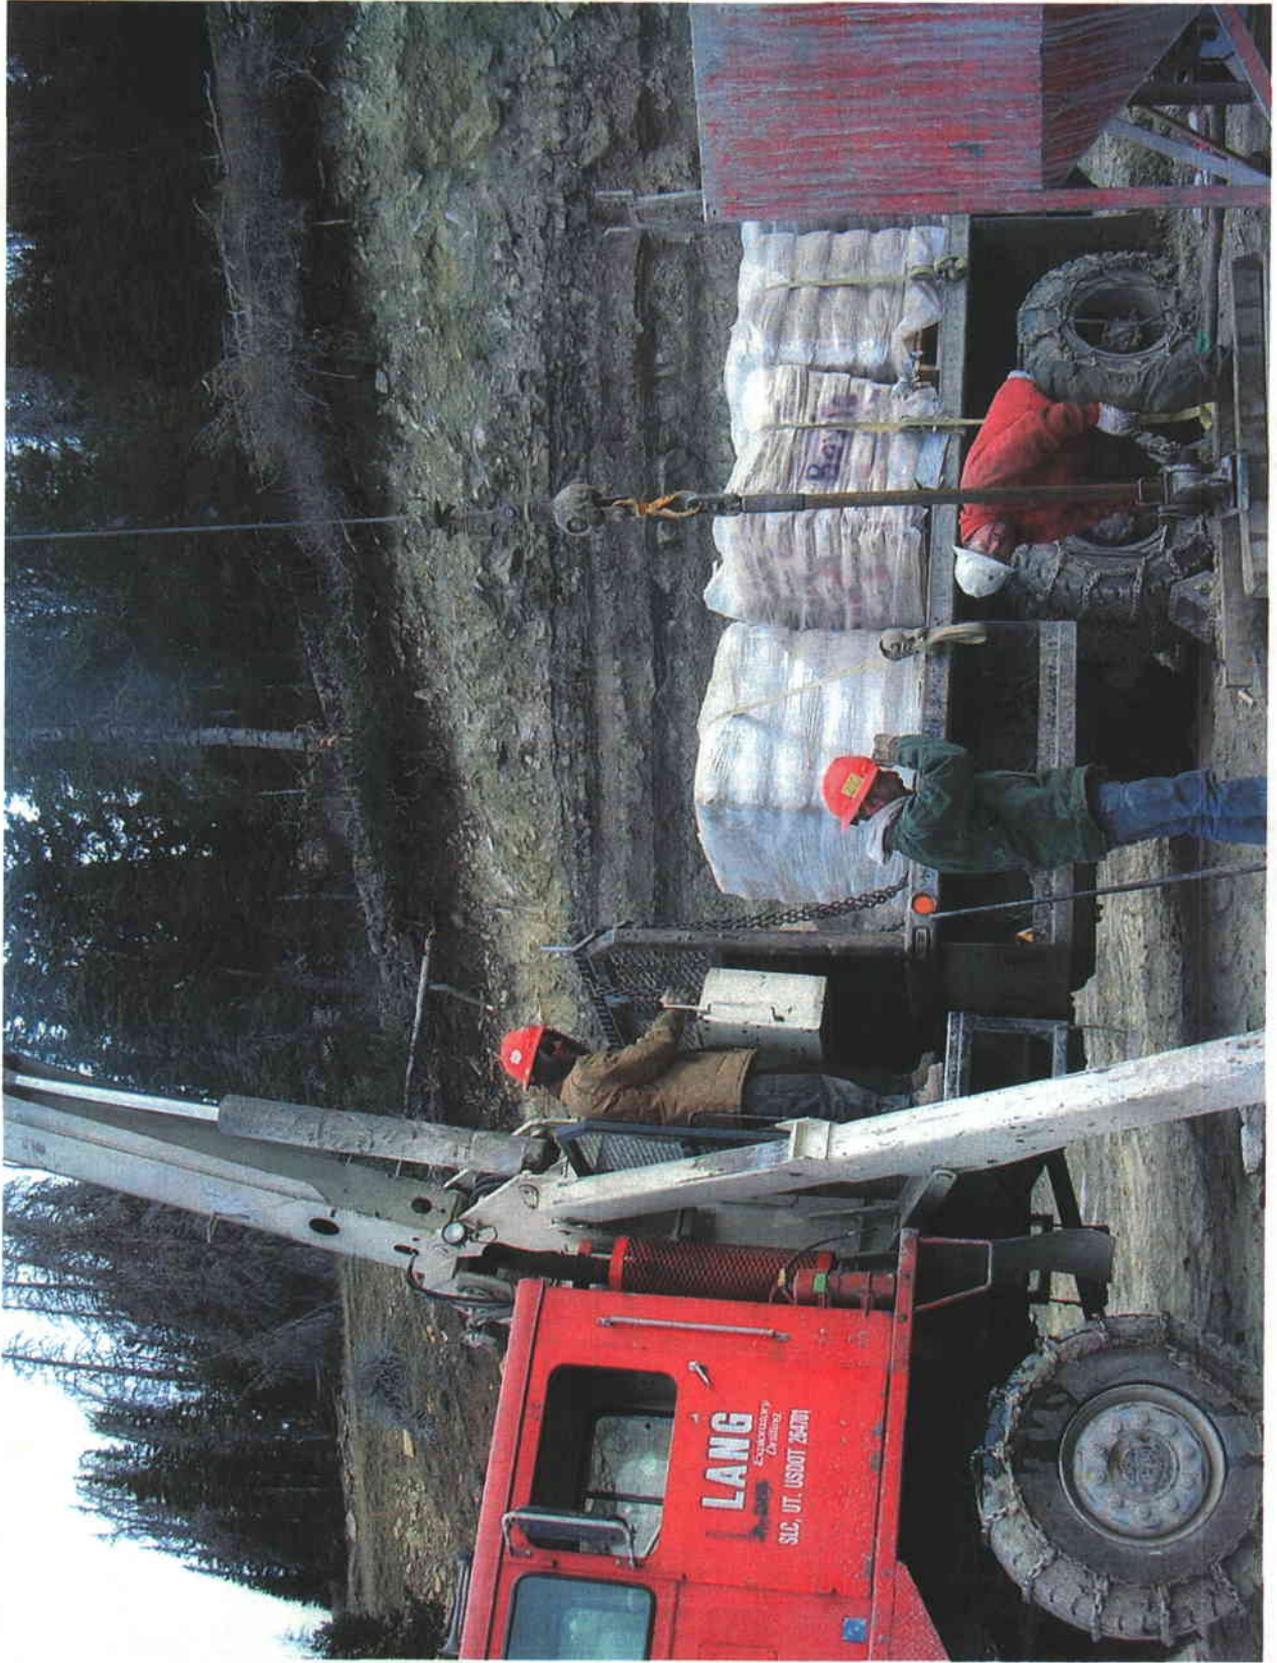
Drill hole 5 being plugged

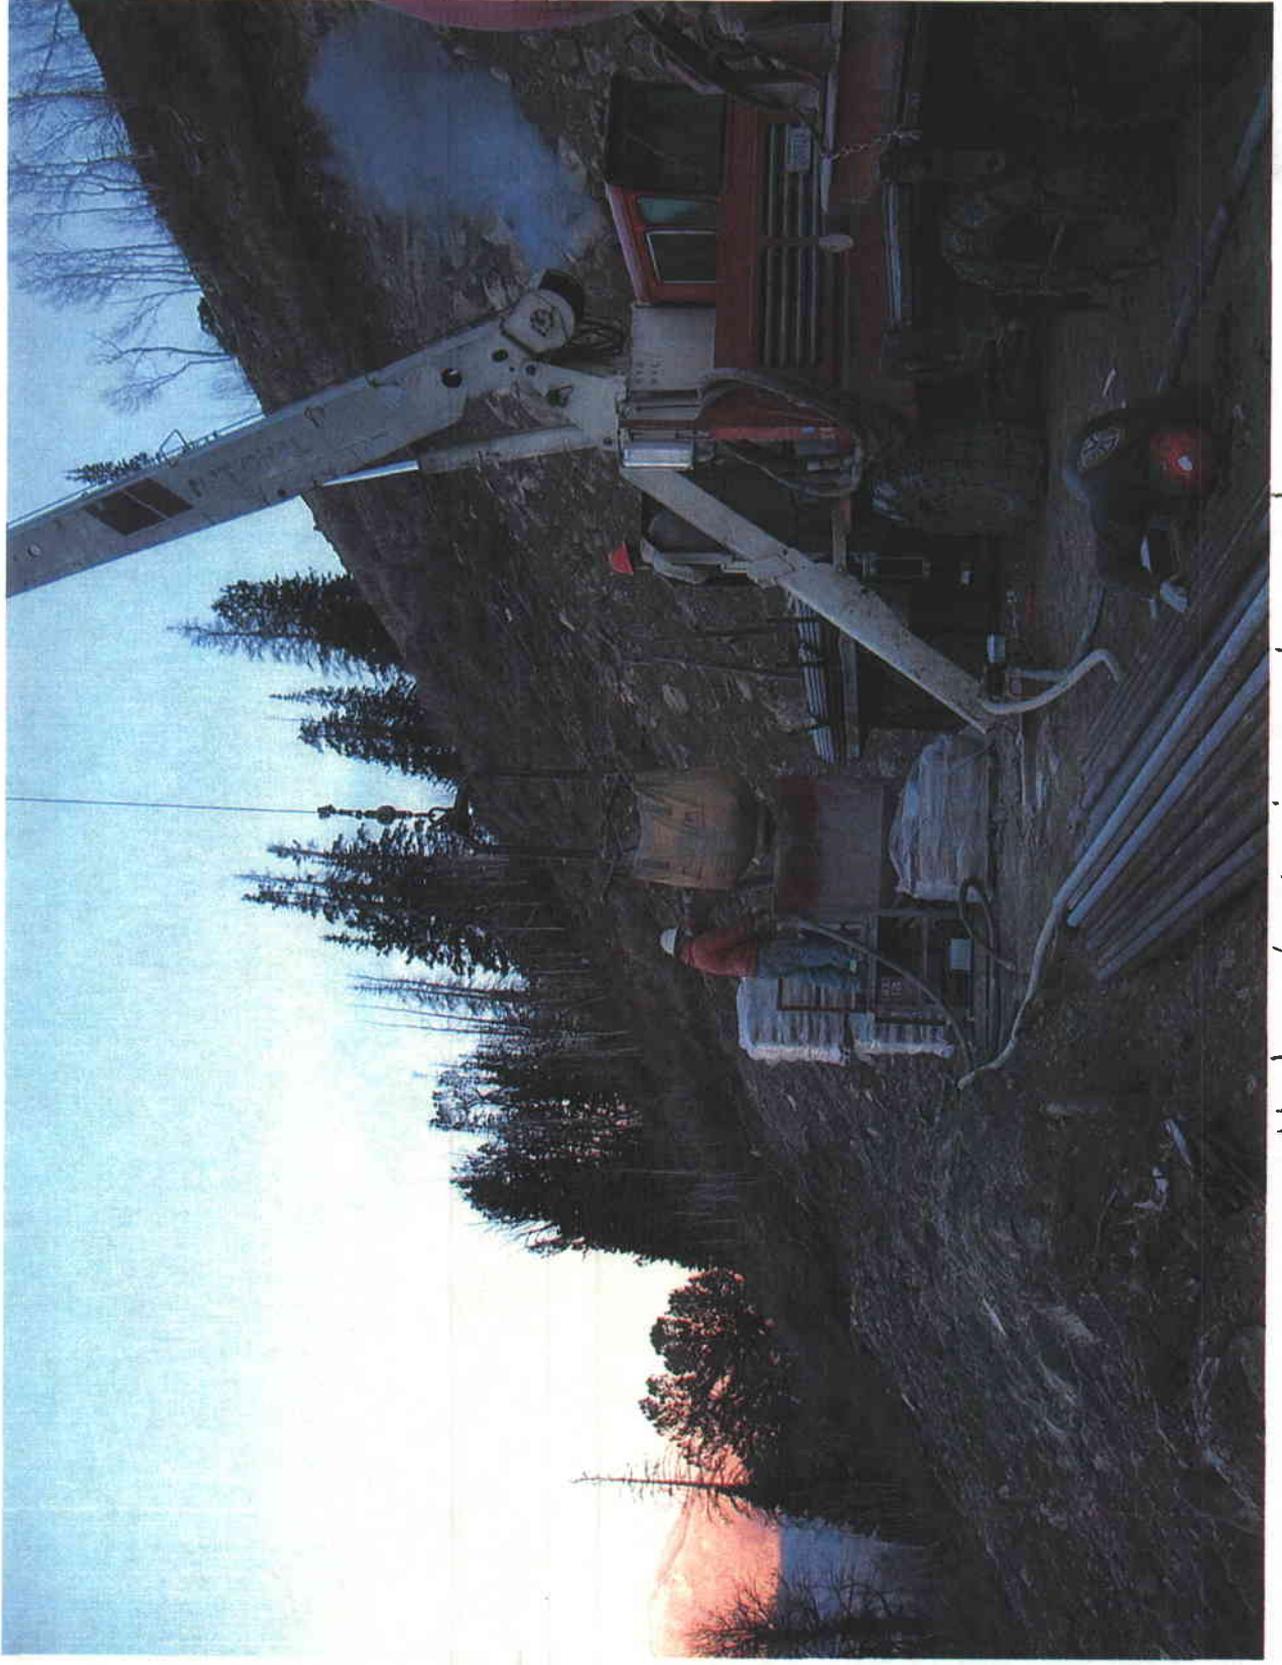
Drillhole 6 being plugged
