MINING AND RECLAMATION PLAN

ADDENDUM TO THE RECLAMATION PLAN

for the
**EAST MOUNTAIN
EMERGENCY DRILLPADS AND ACCESS
ROADS**

Submitted: December 21, 2007

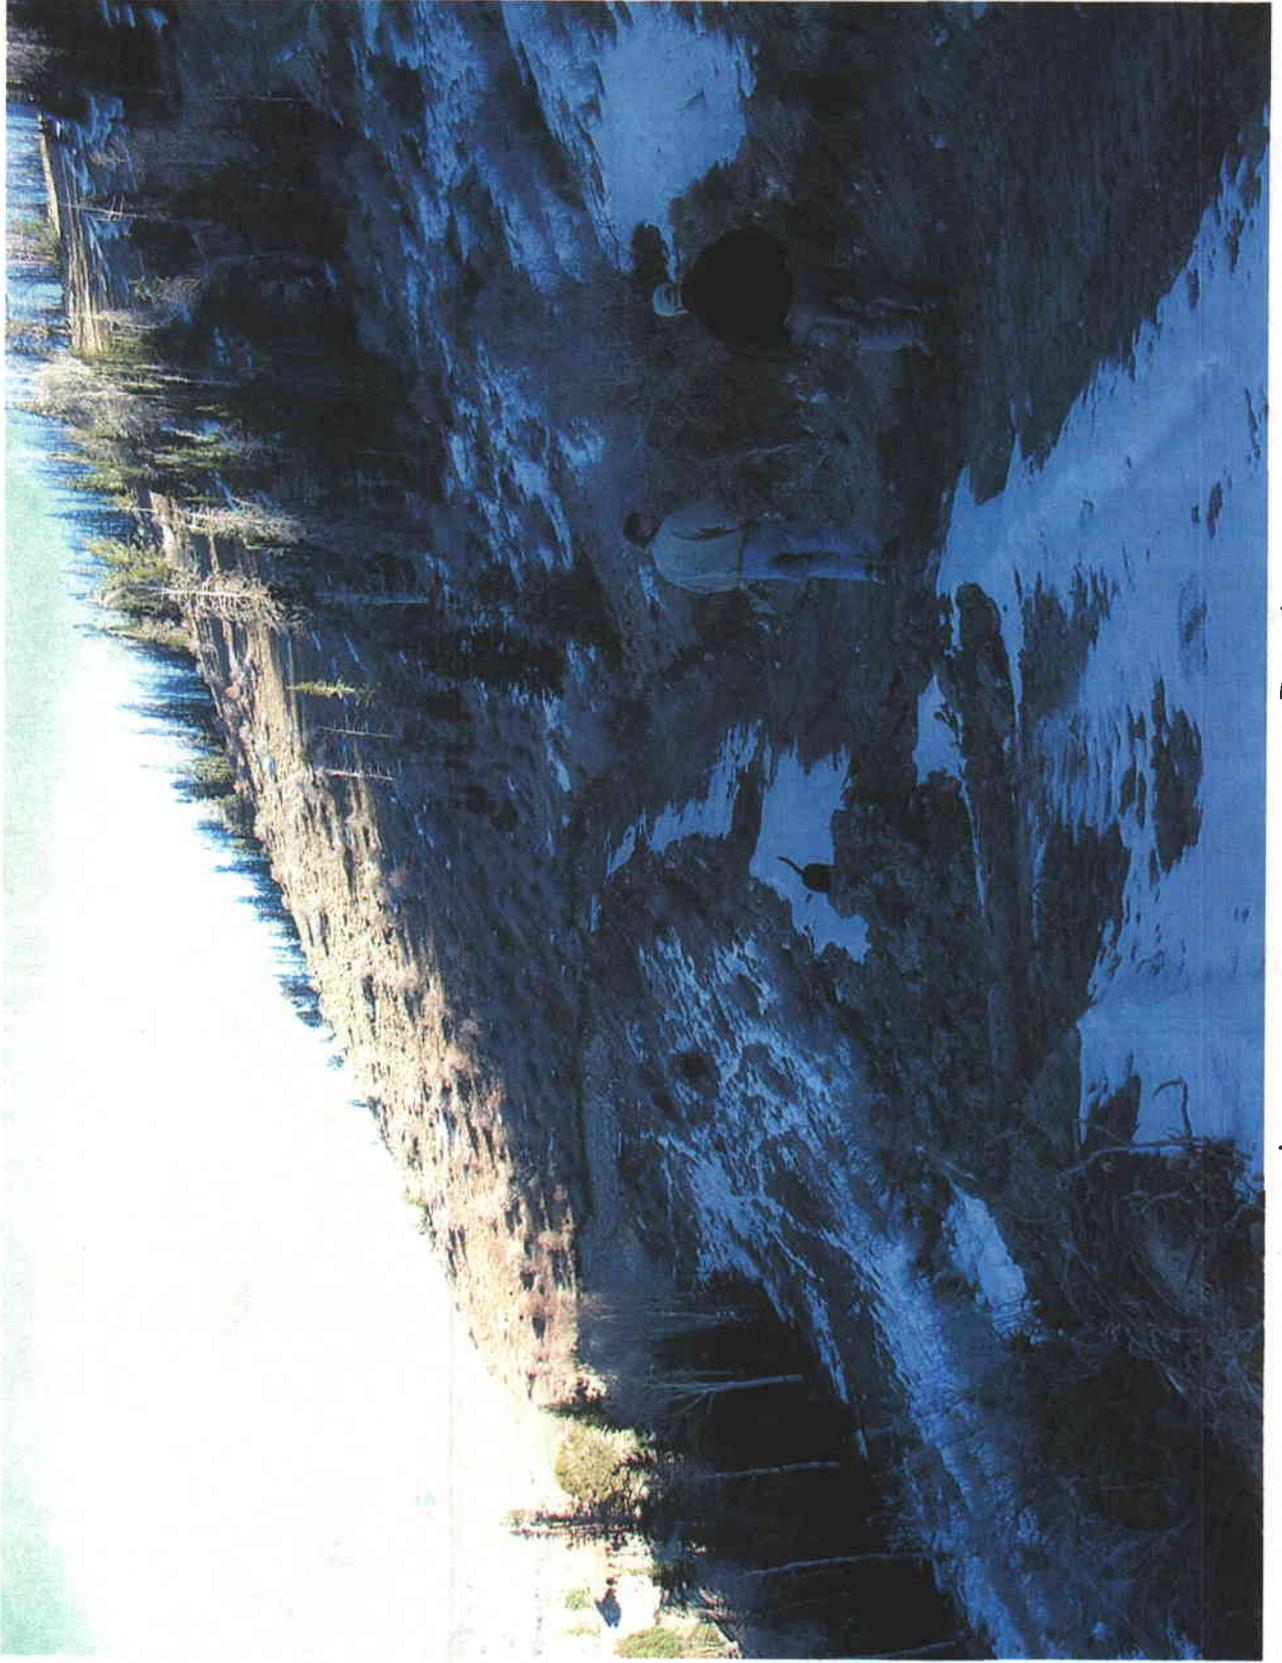
Unreclaimed road into Pad 2

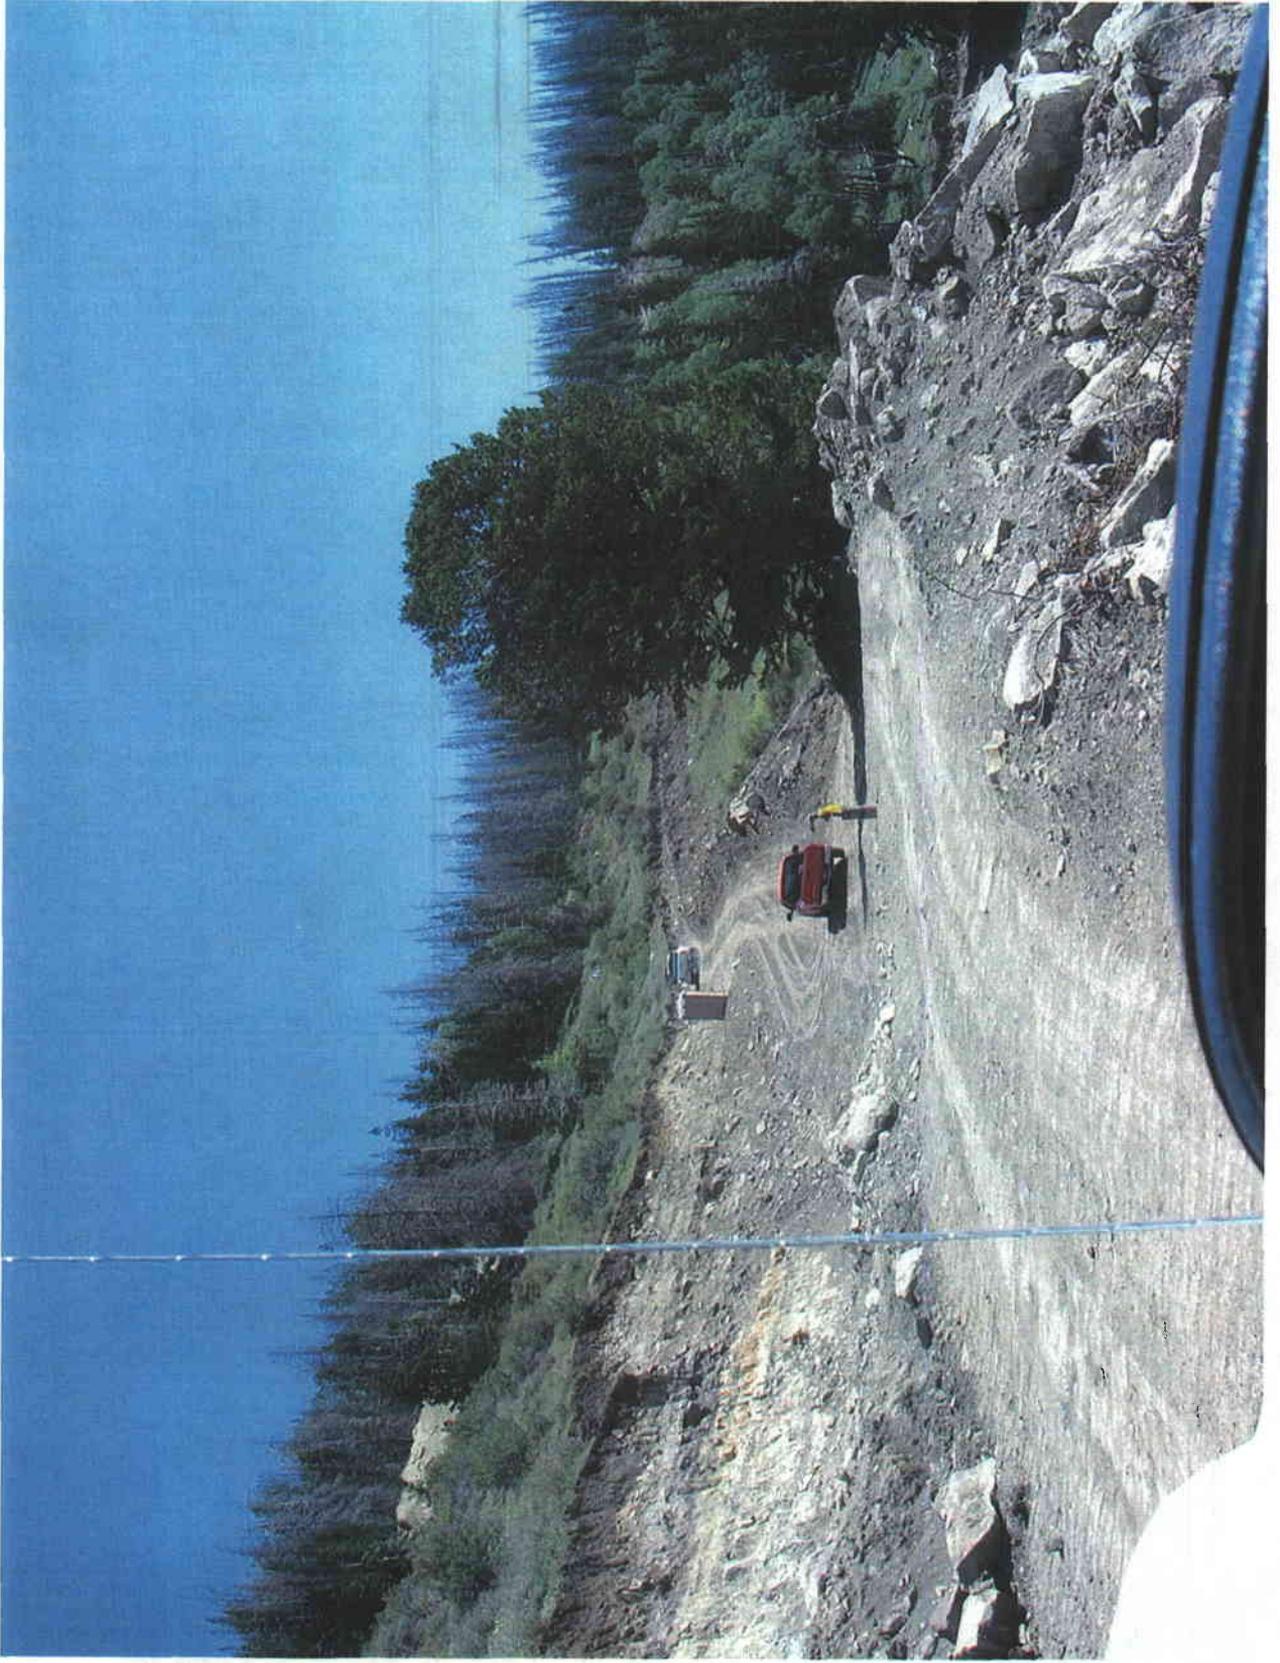
Pad 2 pre-reclamation

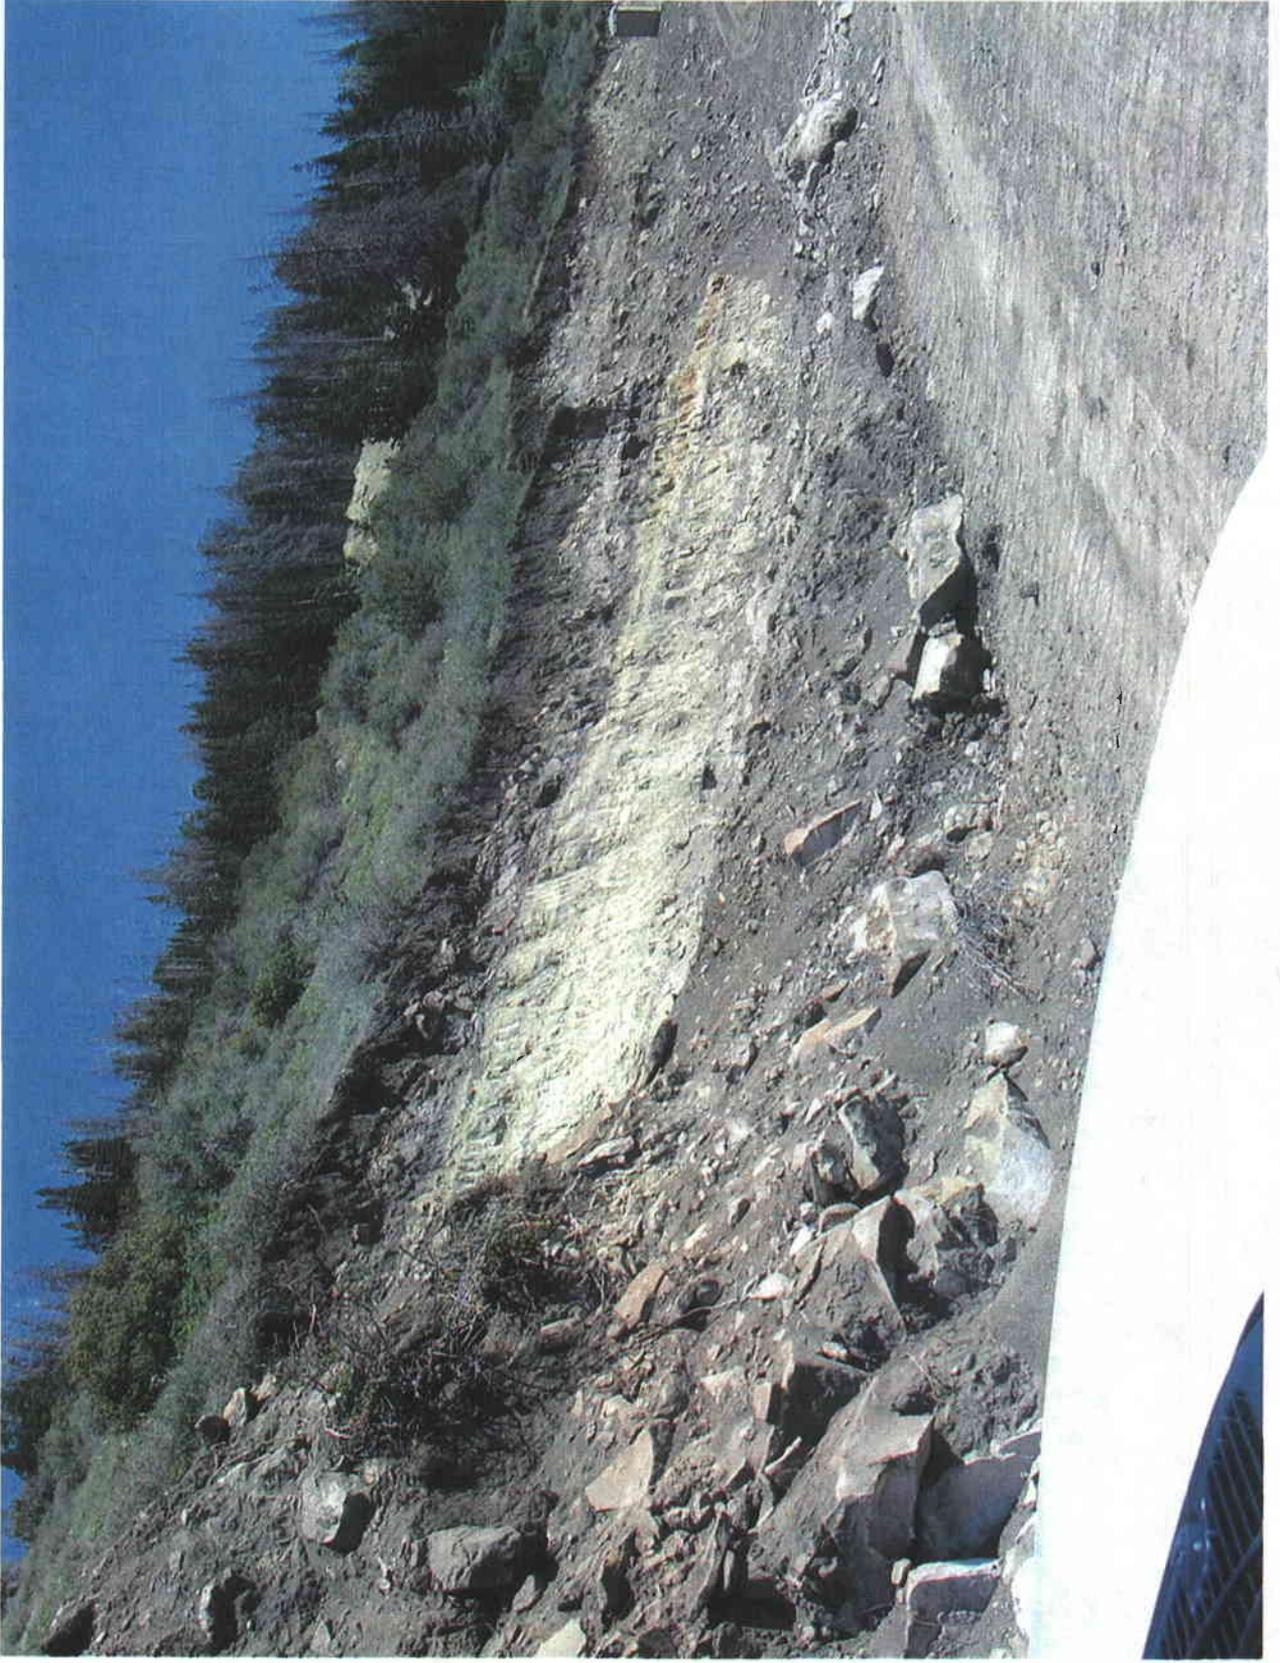
Pad 2, pre-reclamation

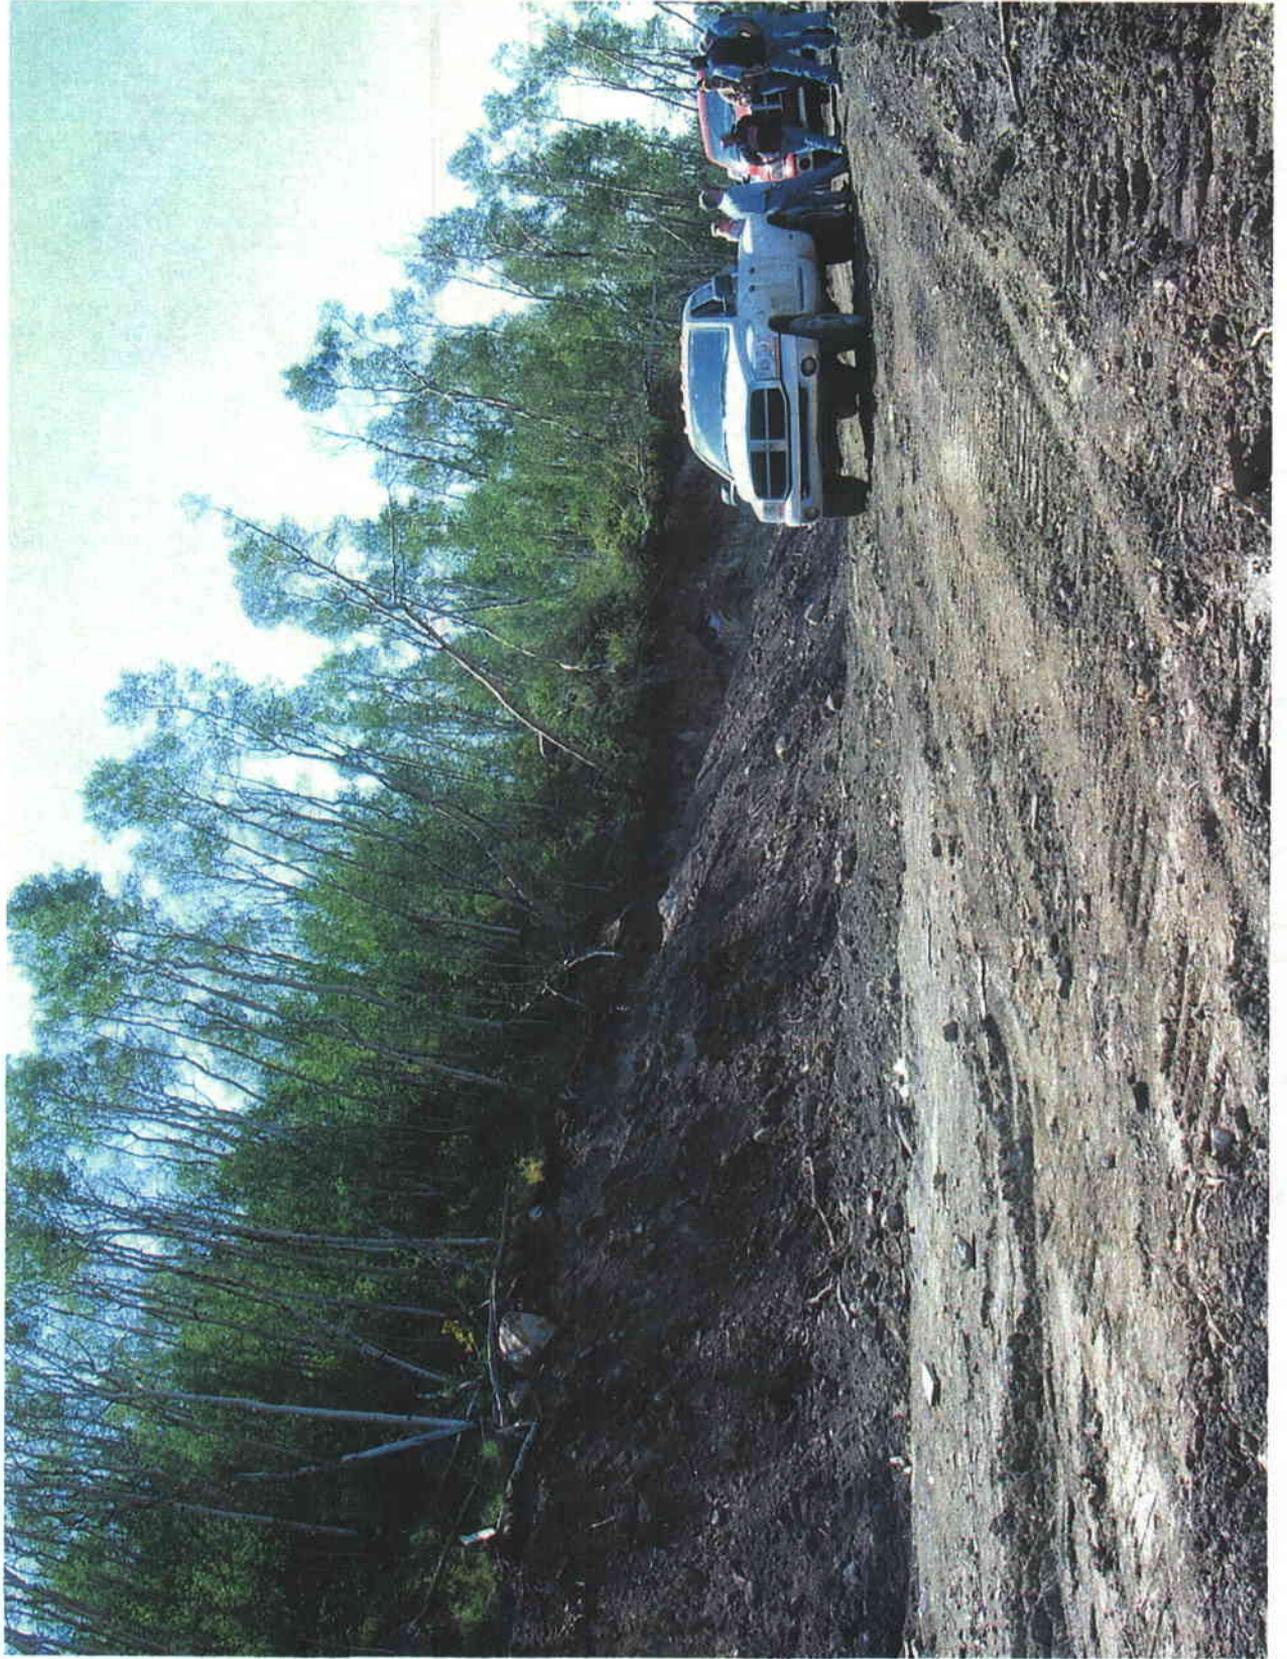
Pad 3 pre-reclamation

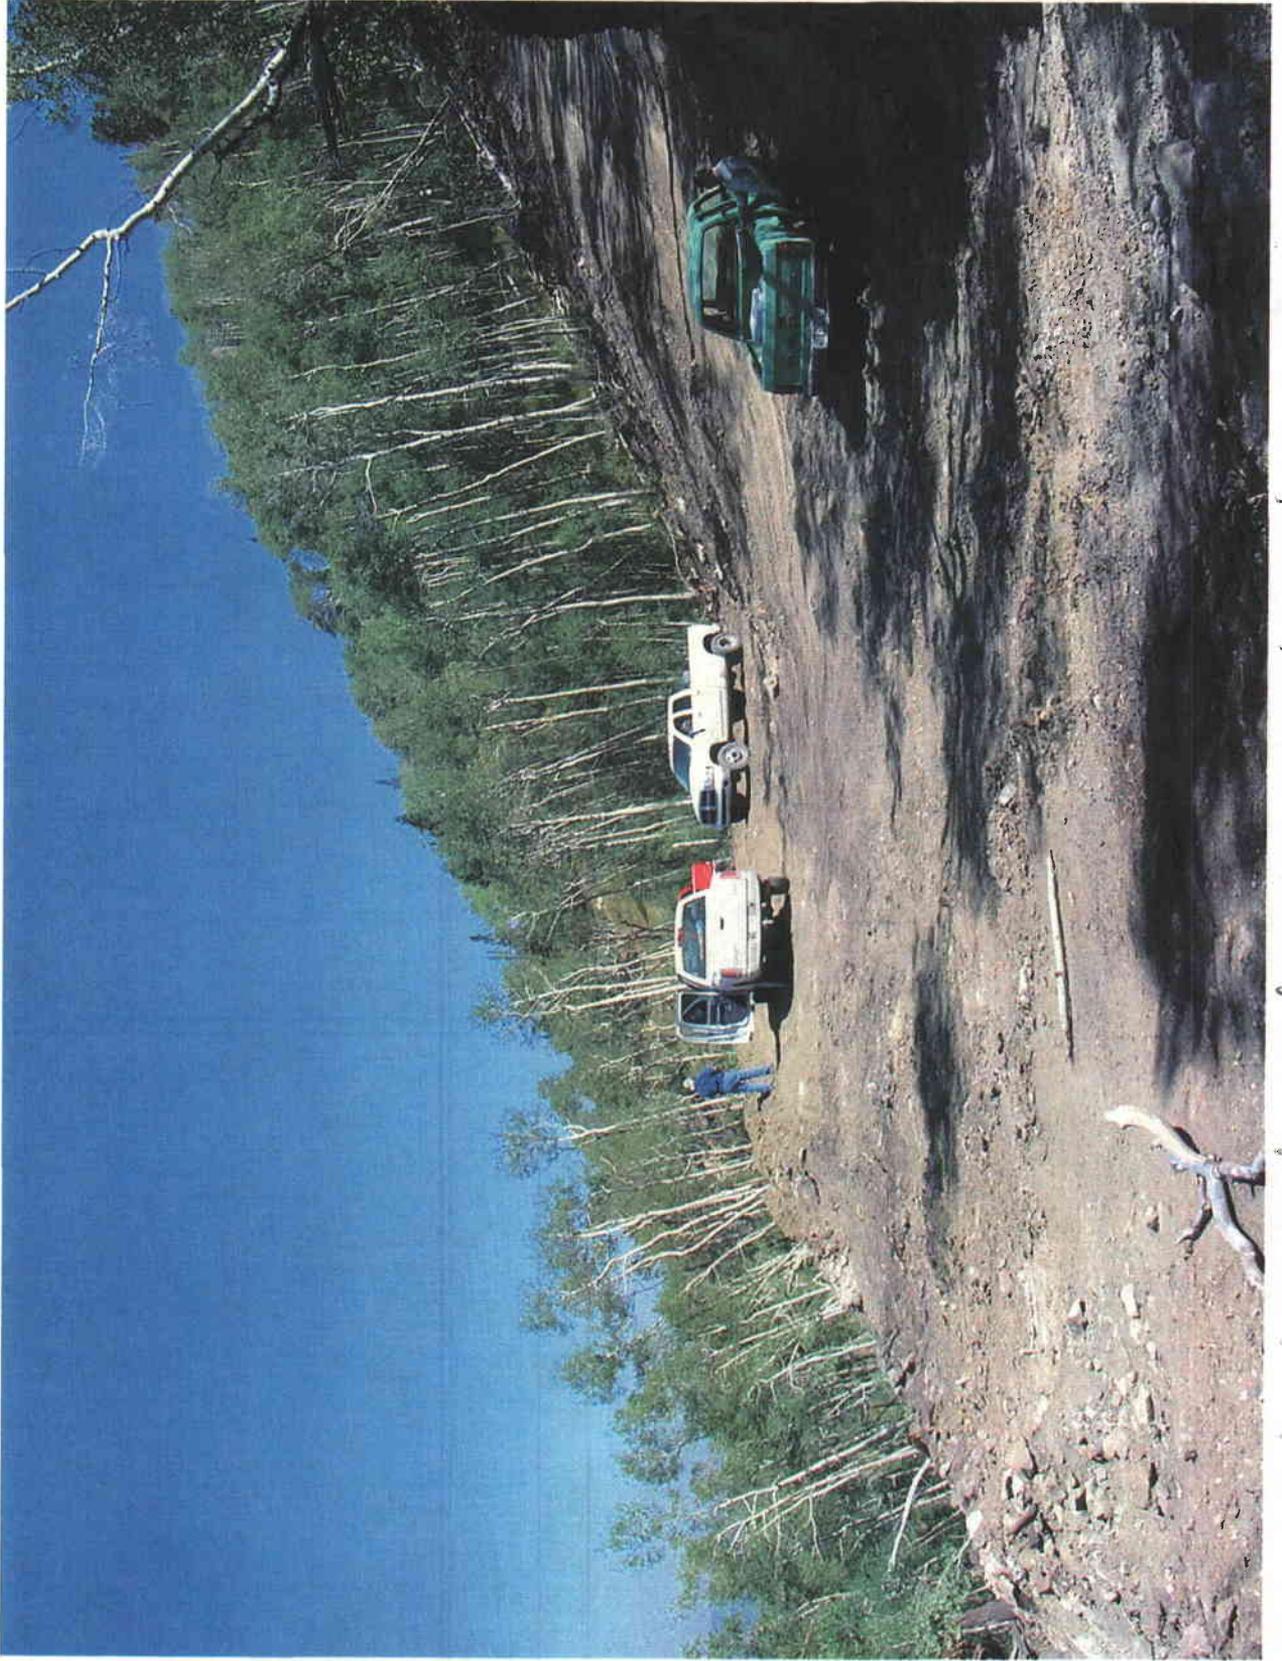
Rad 3 and road, Pre-reclamation

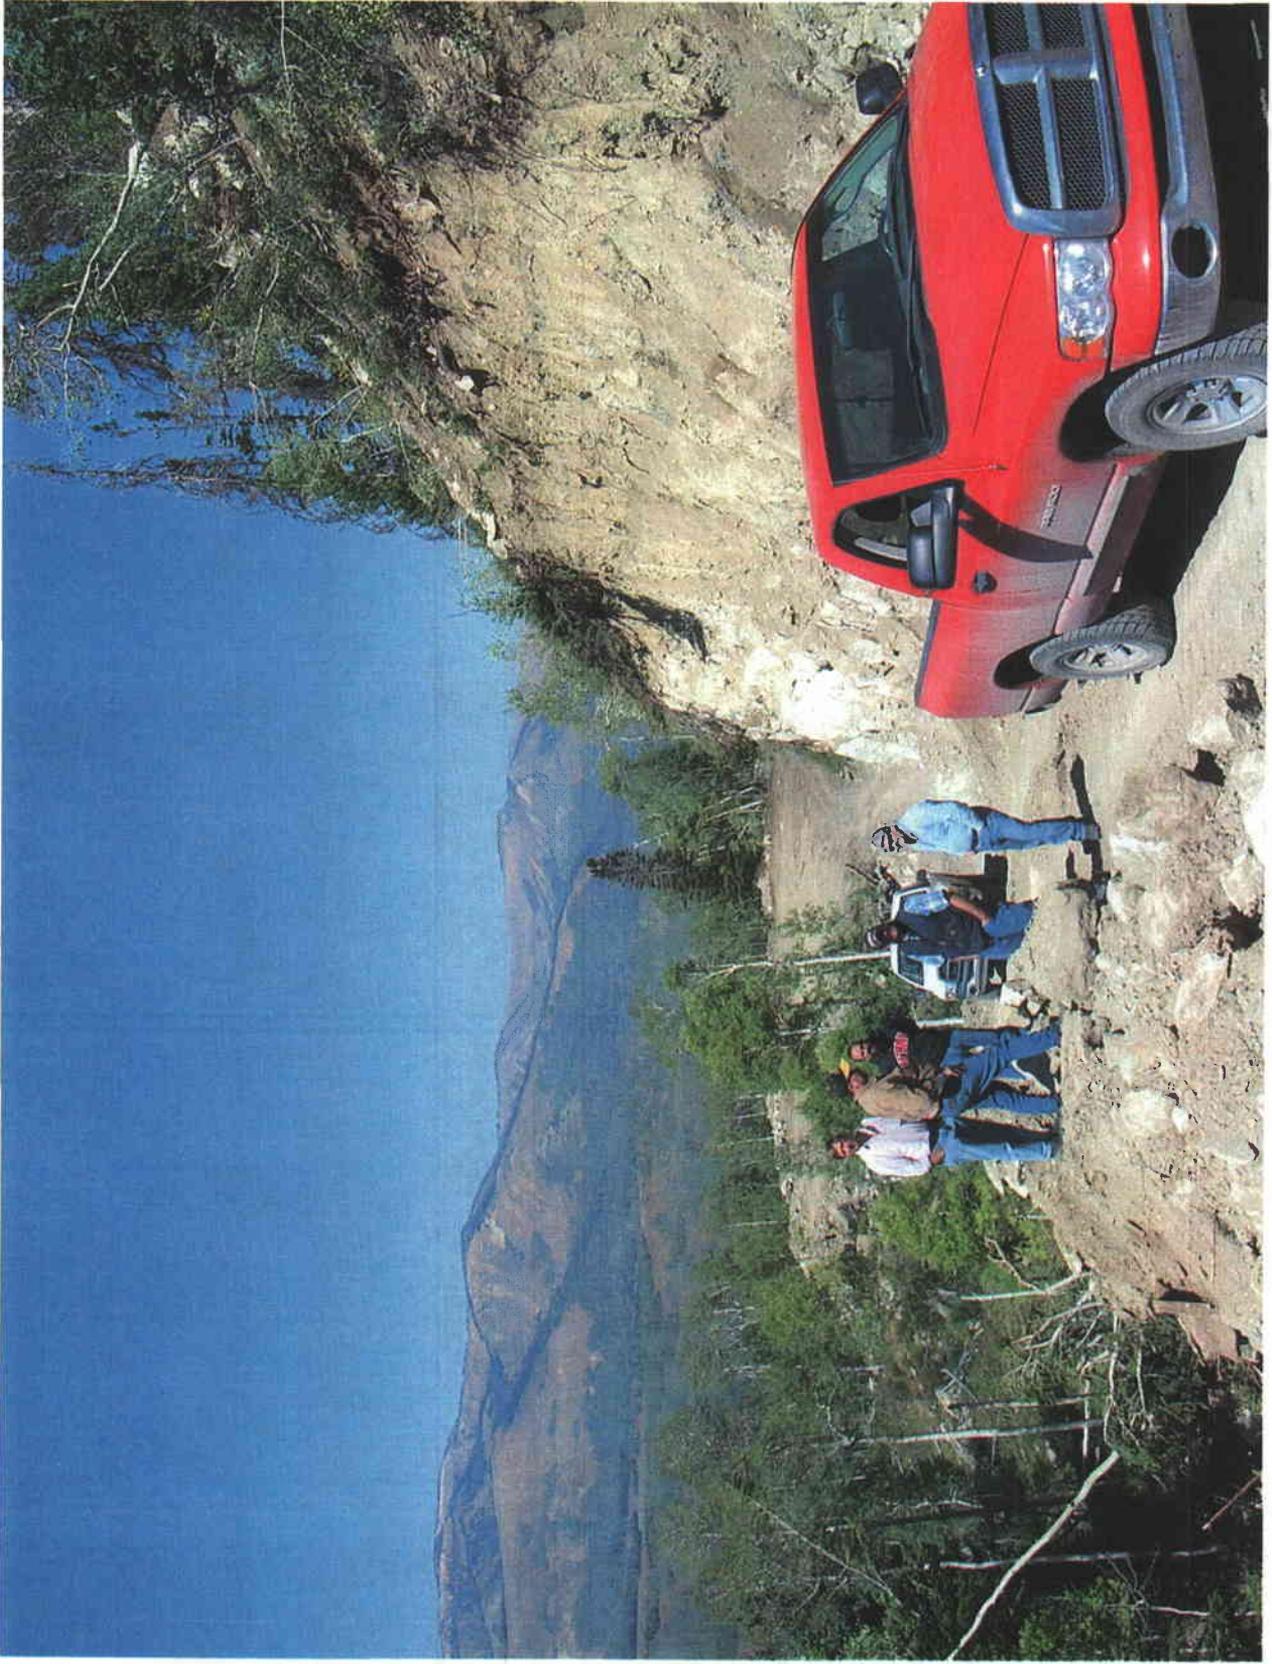
Unreclaimed road from ledge down to Pad 4

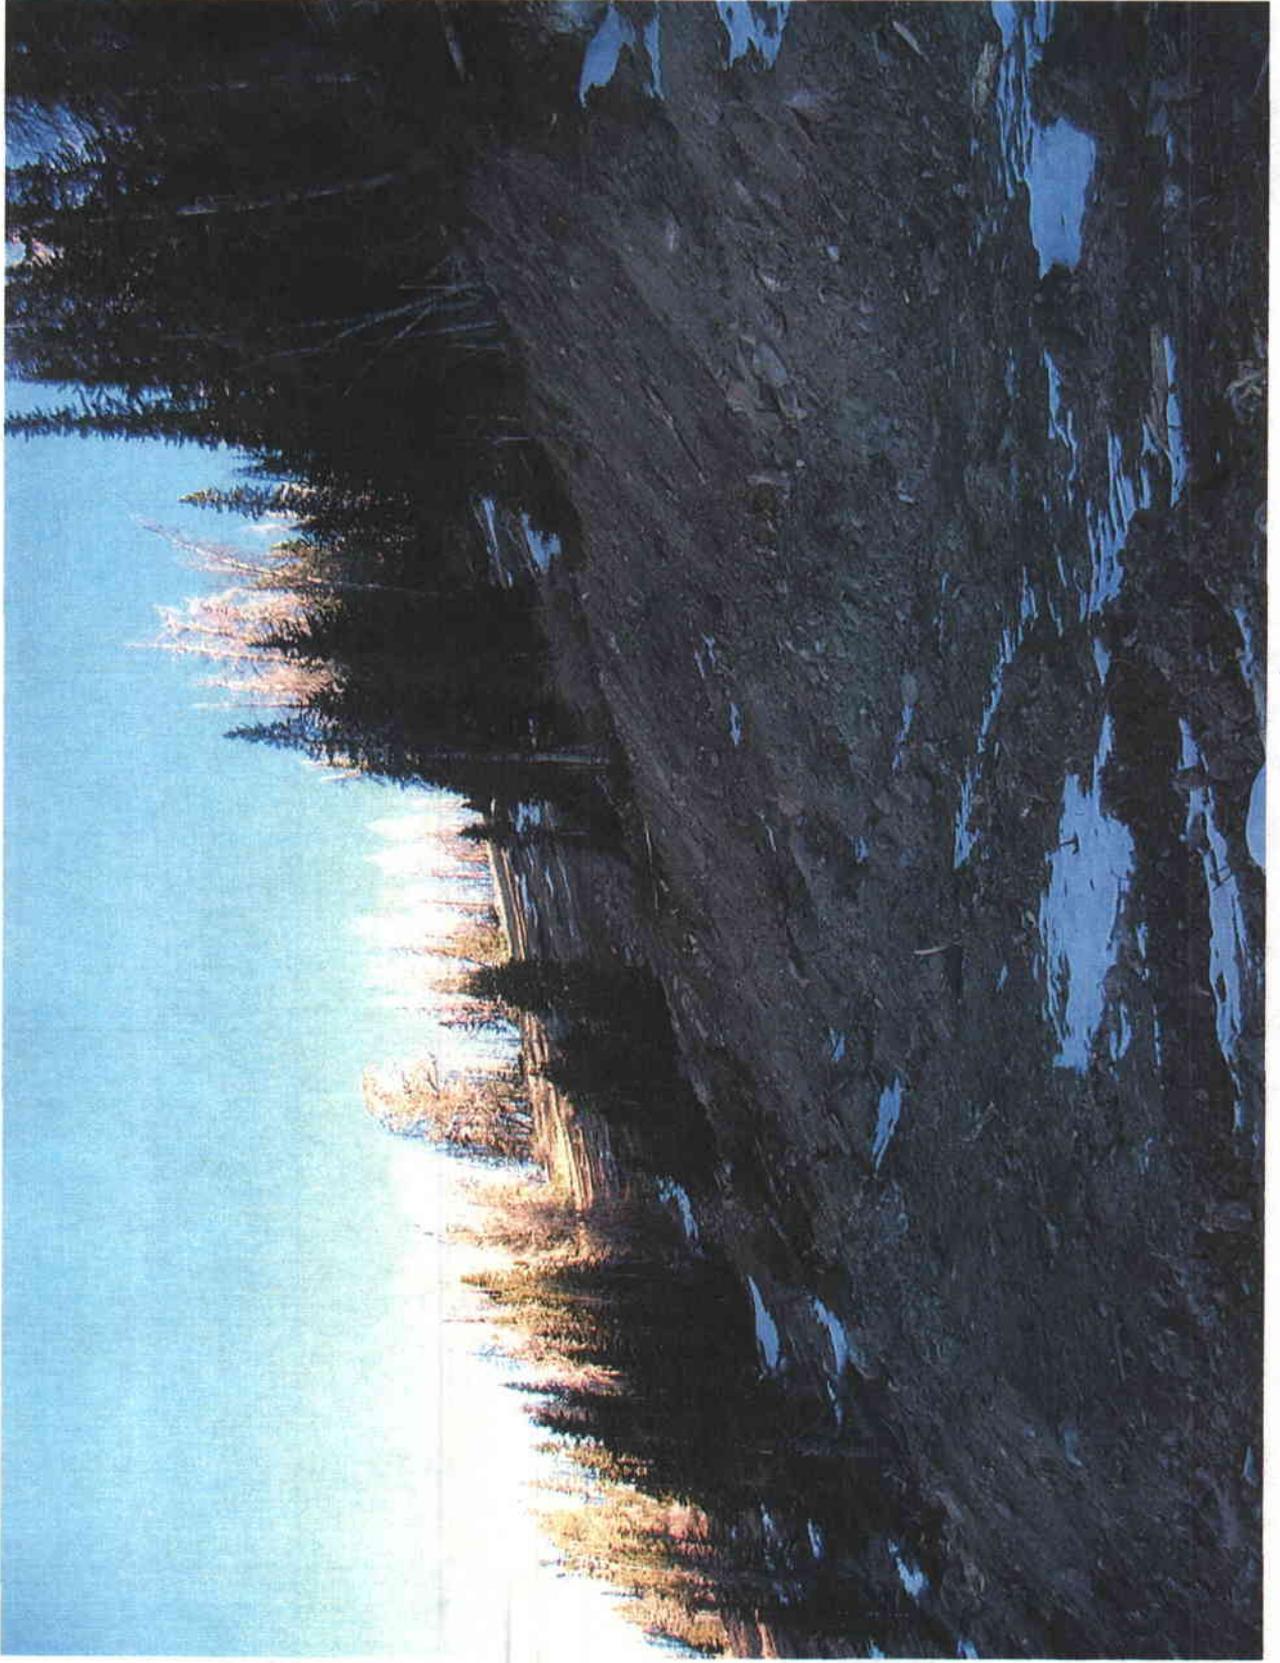
Partially reclaimed Pad 5

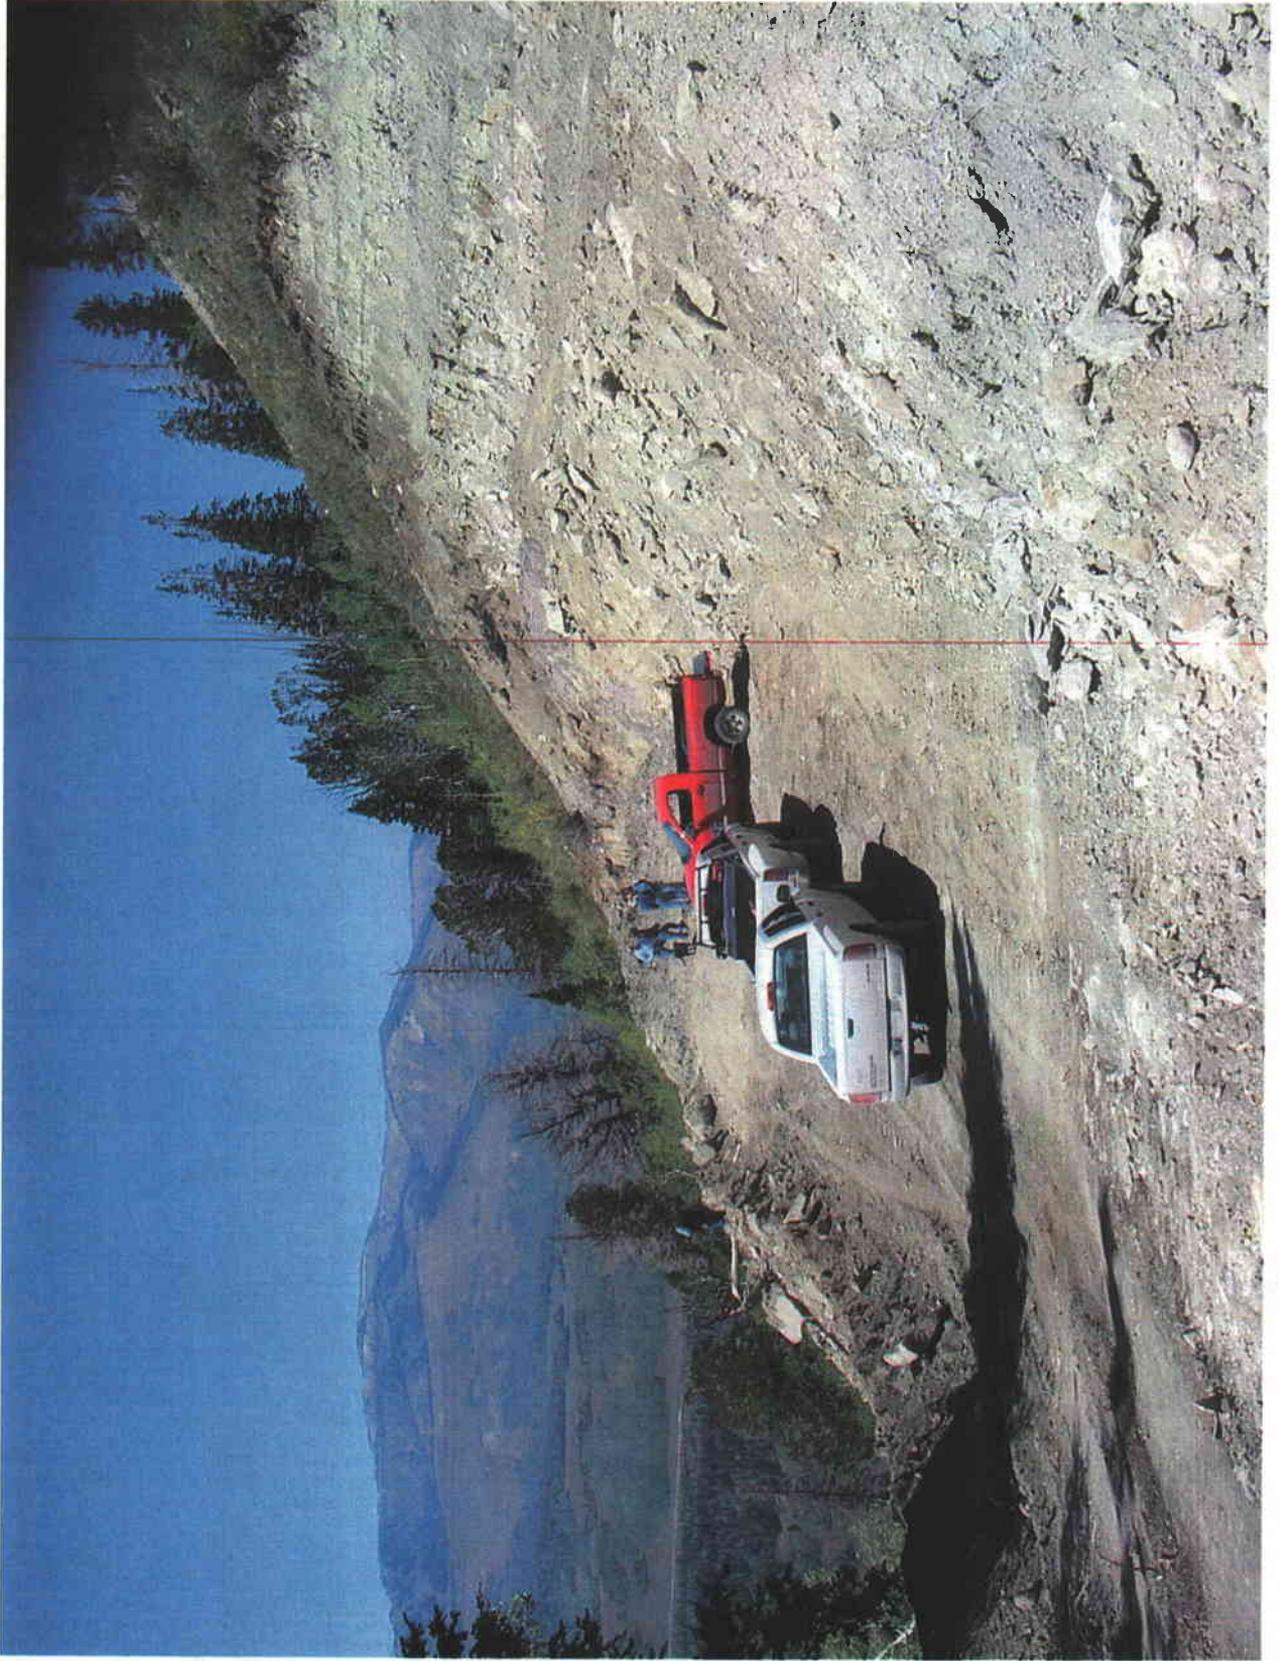
Pad 6 pre reclamation

Because of the magnitude of the effort required to reclaim combined pad #2/6 this work was always planned for the summer of 2008 when the threat of snowstorms would no longer be a factor. The plan to reclaim this site consists of using three trackhoes, two rock trucks, and several dozers. Much of the outslope from pad #2 will be pulled down and be used as backfill

for pad #6. Some of the outslope material below pad #6 can be pulled back up to the pad, but most of this outslope material will be loaded by backhoes into rock trucks and hauled back up the hill to be used as backfill for both pads #2 and #6. By carrying the material back up to the top of the padsites the trackhoes can do much of their work with gravity rather than against it. The oops road will be cleaned off and will serve as the bottom-side access for the rock trucks to get loaded. The existing access road (located below the oops road) has been reclaimed up to the ledge. The remaining extent of this road will act as a catchment for any material which may roll down from the final reclamation of the pad #2/6/oops combined area. This will help ensure that no extraneous material rolls down onto undisturbed areas. Indeed, the reason that reclamation of this road stopped at the ledge was to allow it to serve as a catchpoint for subsequent reclamation above. Reclamation of the pad #2/6/oops area will be done to re-establish approximate original contour as much as possible. Prior reclamation of pads #3, 4, 5 and 7 are good indicators of the ability to achieve approximate original contour at this site, even in these very steep conditions.

After the backfilling and grading operations are complete the site will be roughened with pocks similar in size and spacing as those placed in the previously reclaimed pad areas. A permanent seed mix will then be applied, followed by putting down a layer of a wood straw. Density of seed application and wood straw application will be similar to that of the previously reclaimed pads, which in all cases exceeded pre-determined recommended application rates.

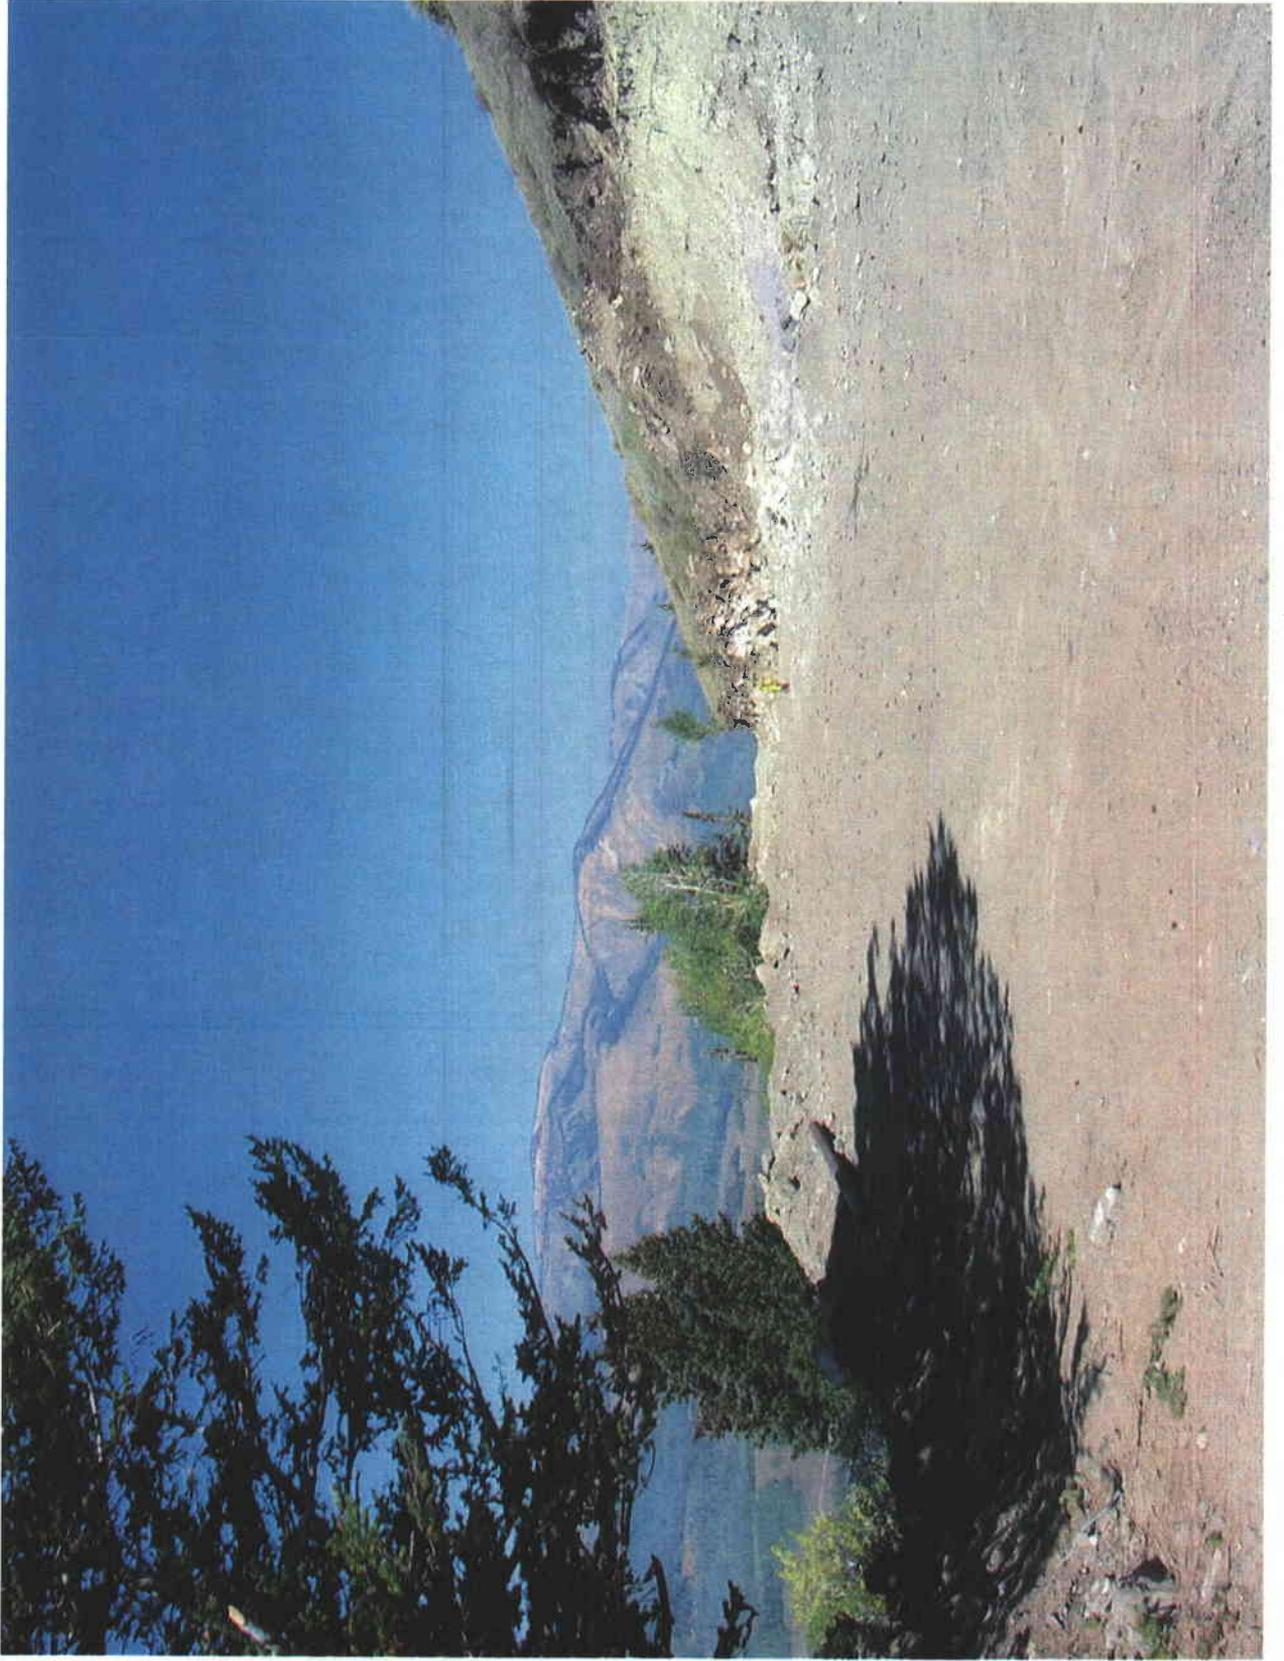
Pad 7 pre reclamation

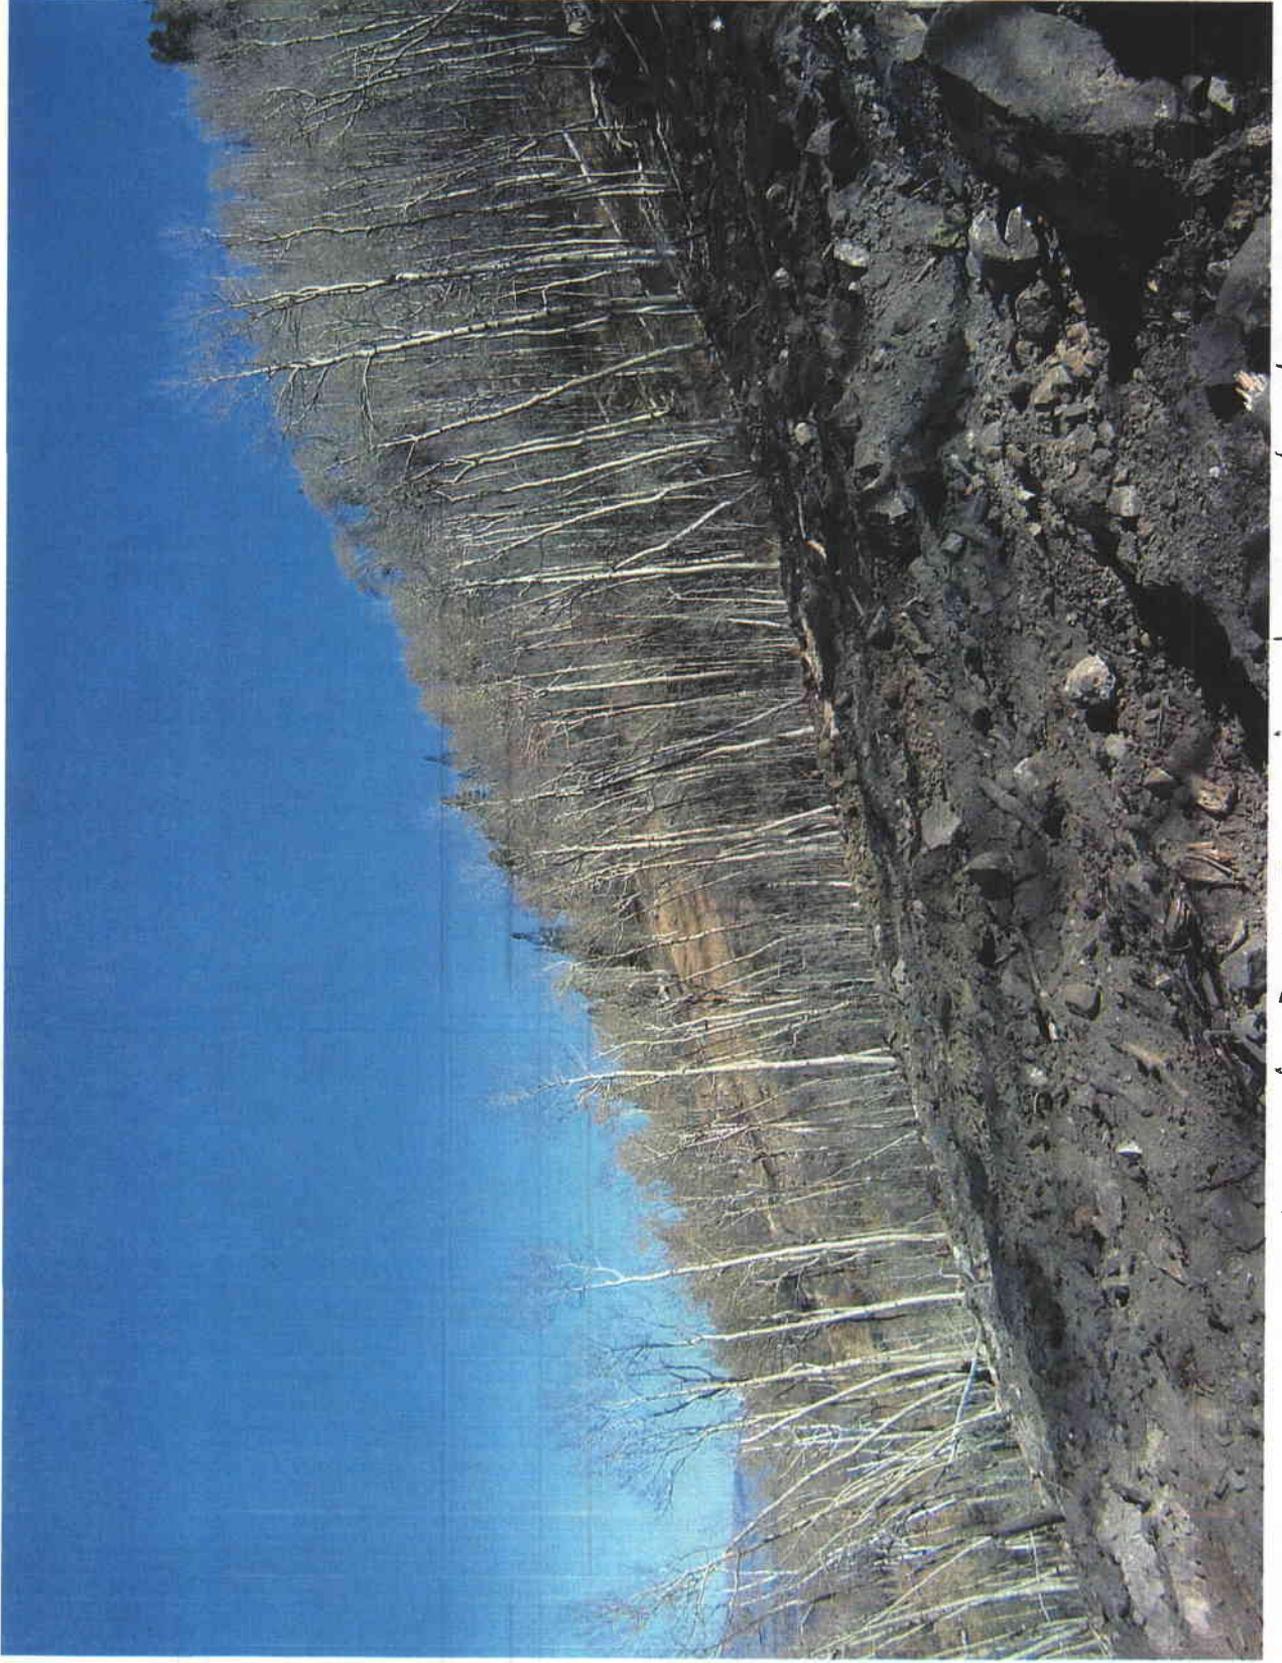
Reclaimed Pad 3 prior to wood straw
