MINING AND RECLAMATION PLAN

ADDENDUM TO THE RECLAMATION PLAN

for the
**EAST MOUNTAIN
EMERGENCY DRILLPADS AND ACCESS
ROADS**

Submitted: December 21, 2007

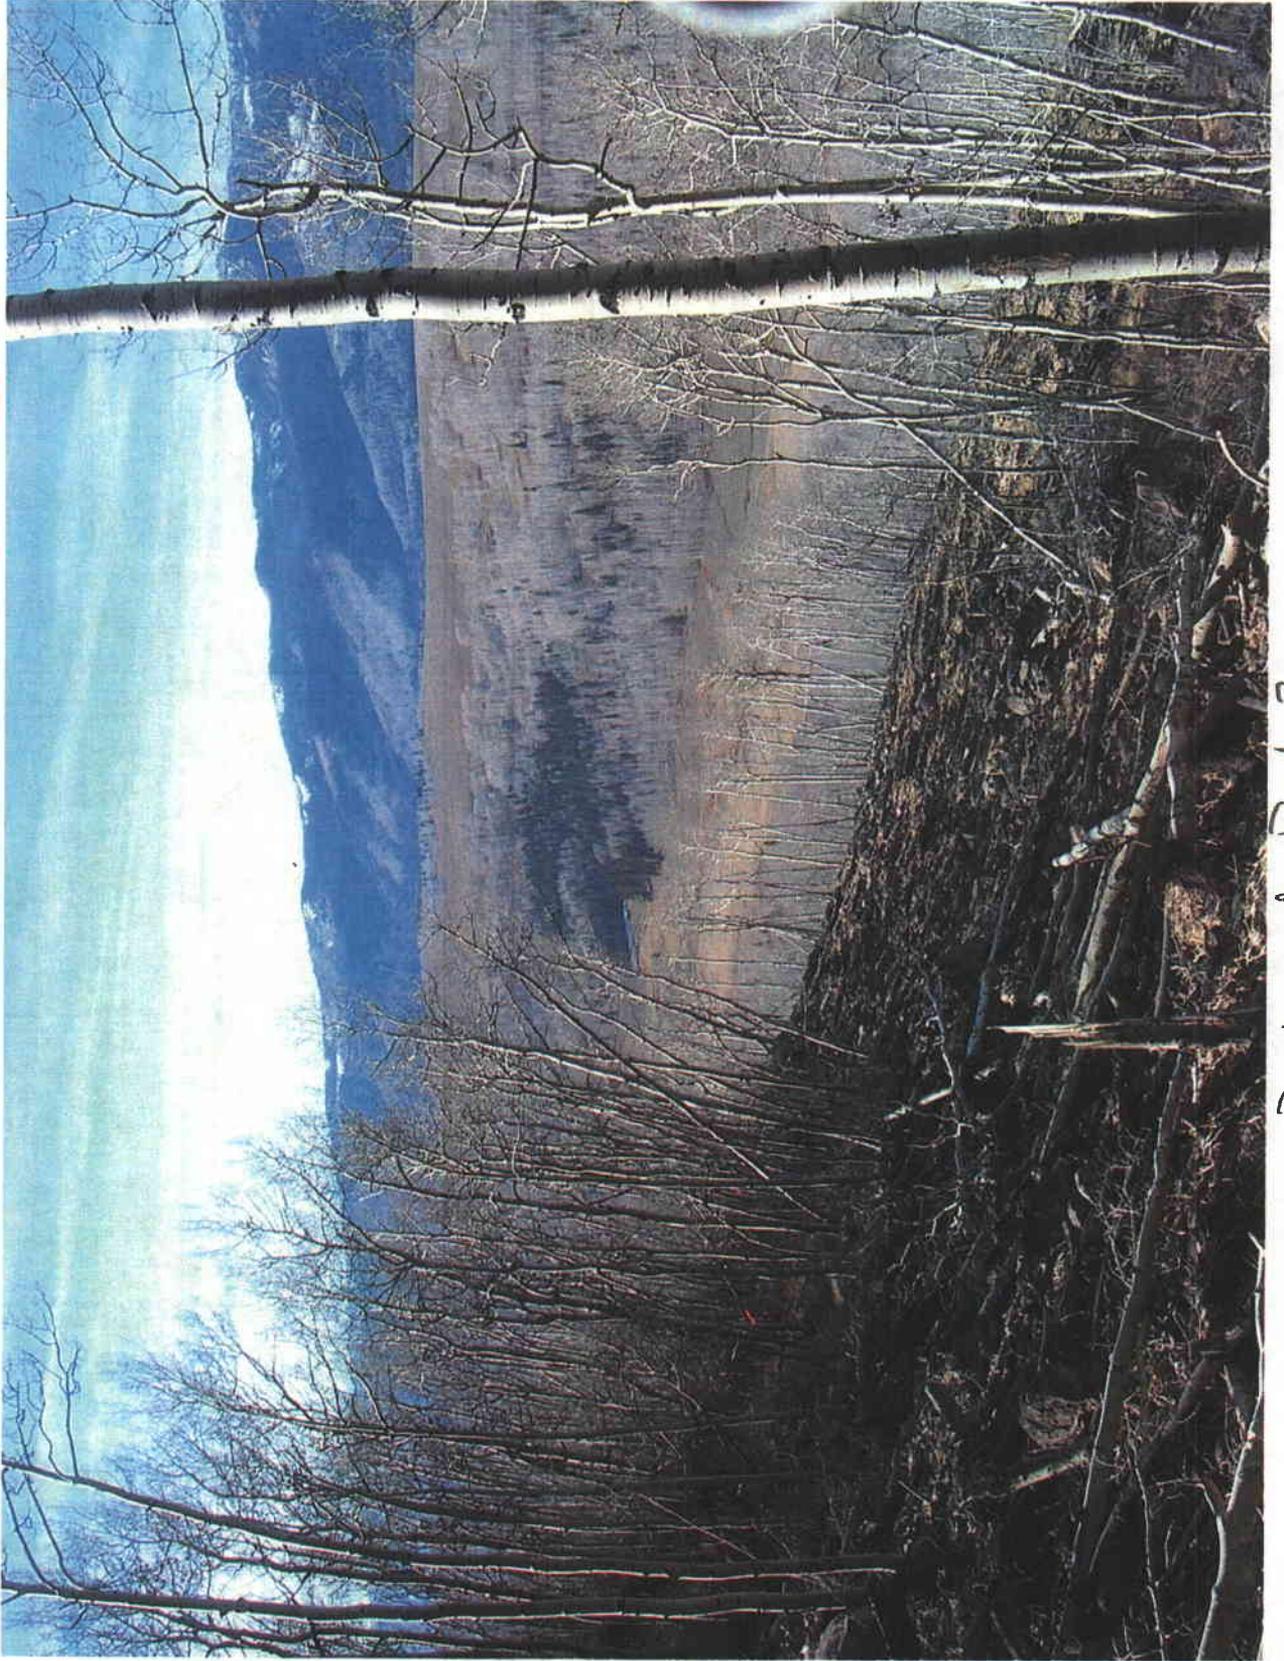
Reclaimed Pad 3

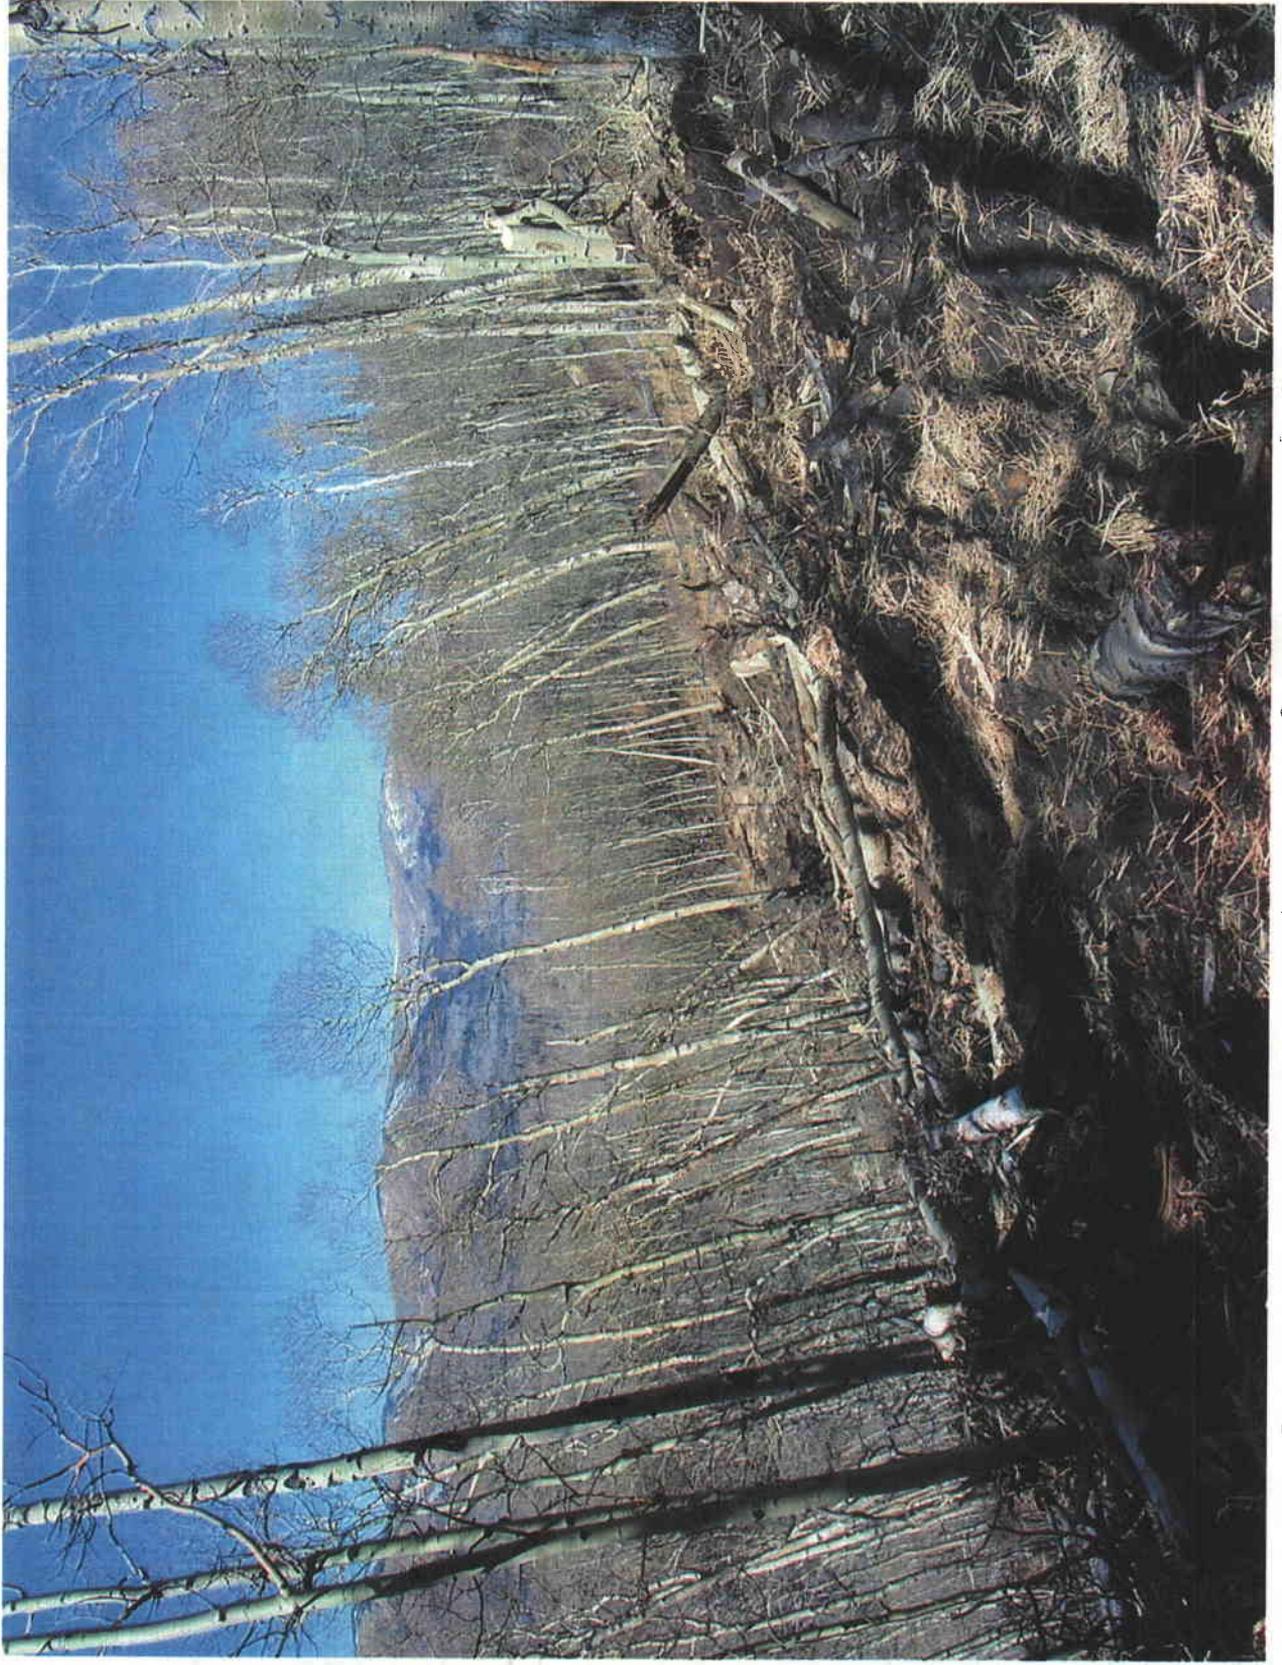
Reclaimed road between Pad 4 and Pad 3

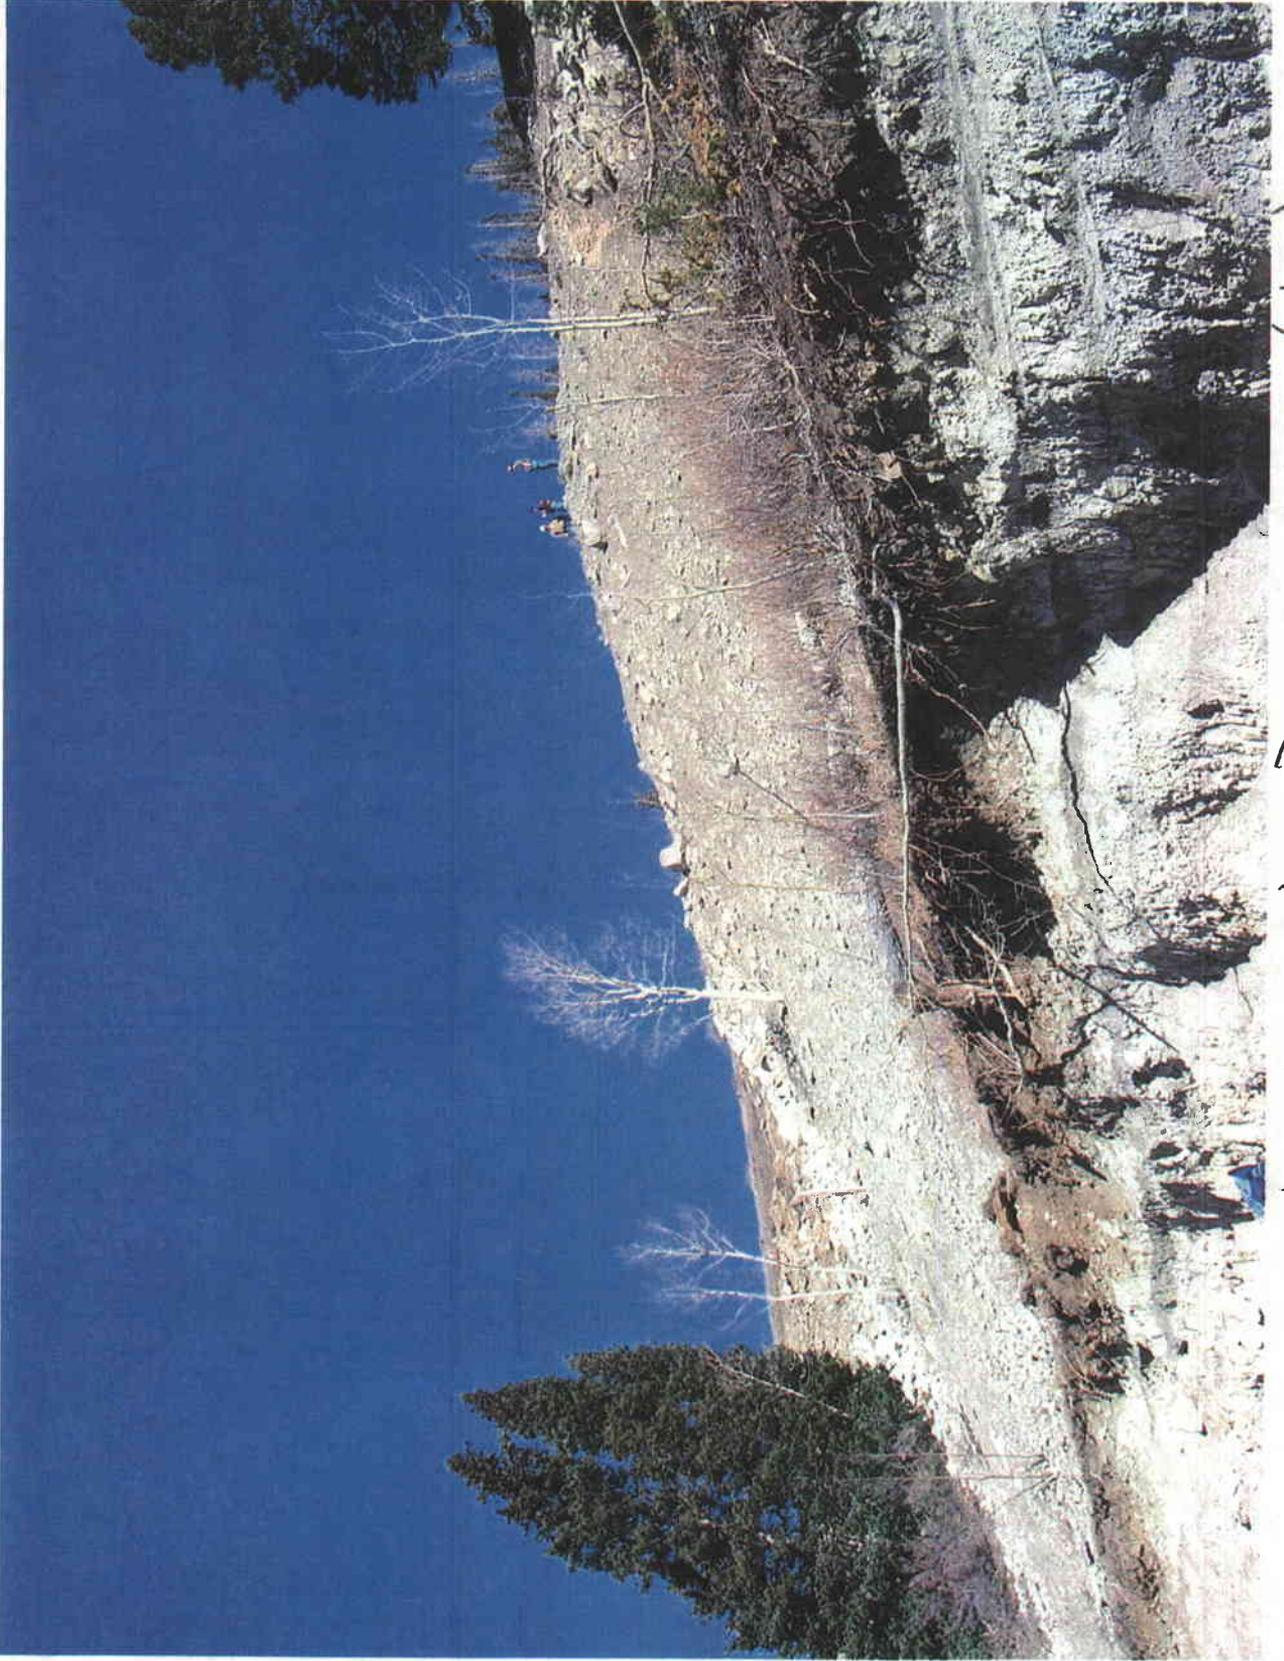
Pad 6 (bottom), Pad 2 outslope (top)

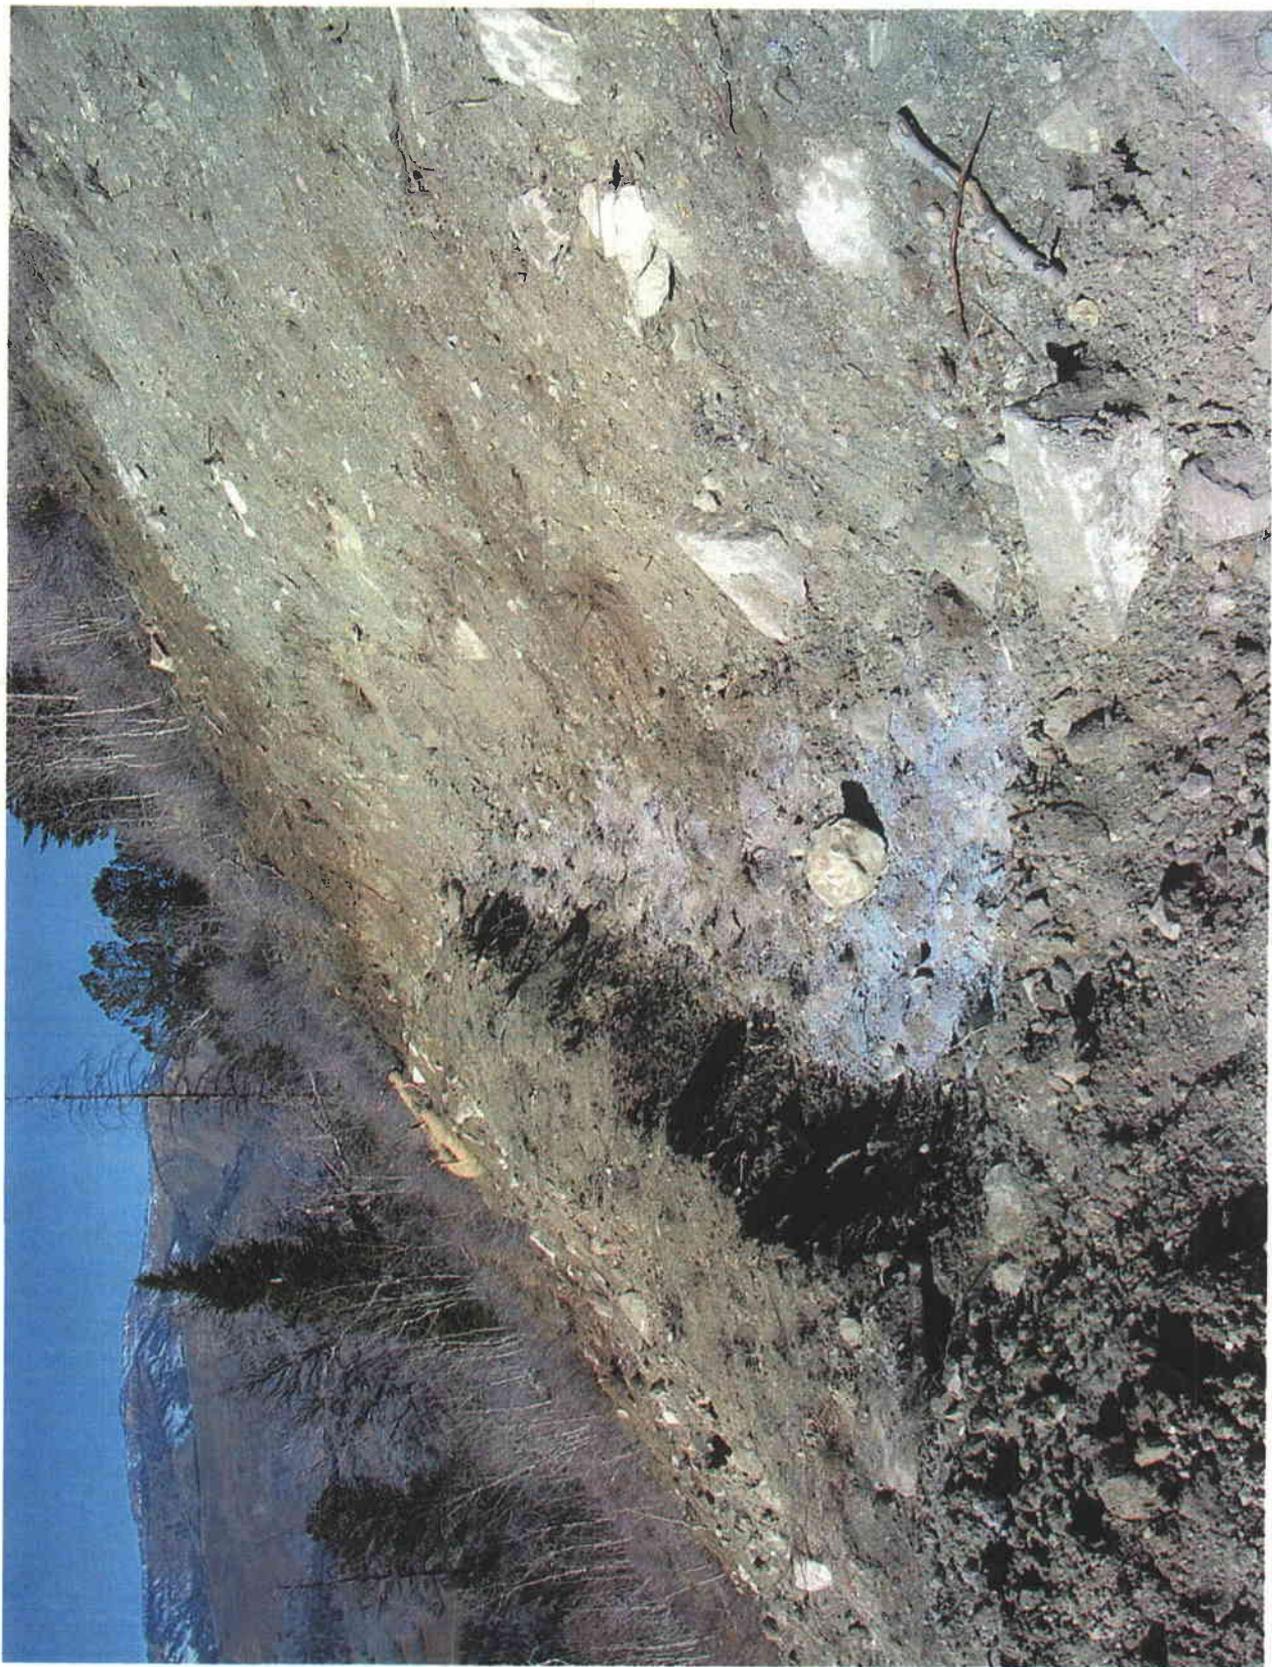
Interior drain ditch, Pod 6

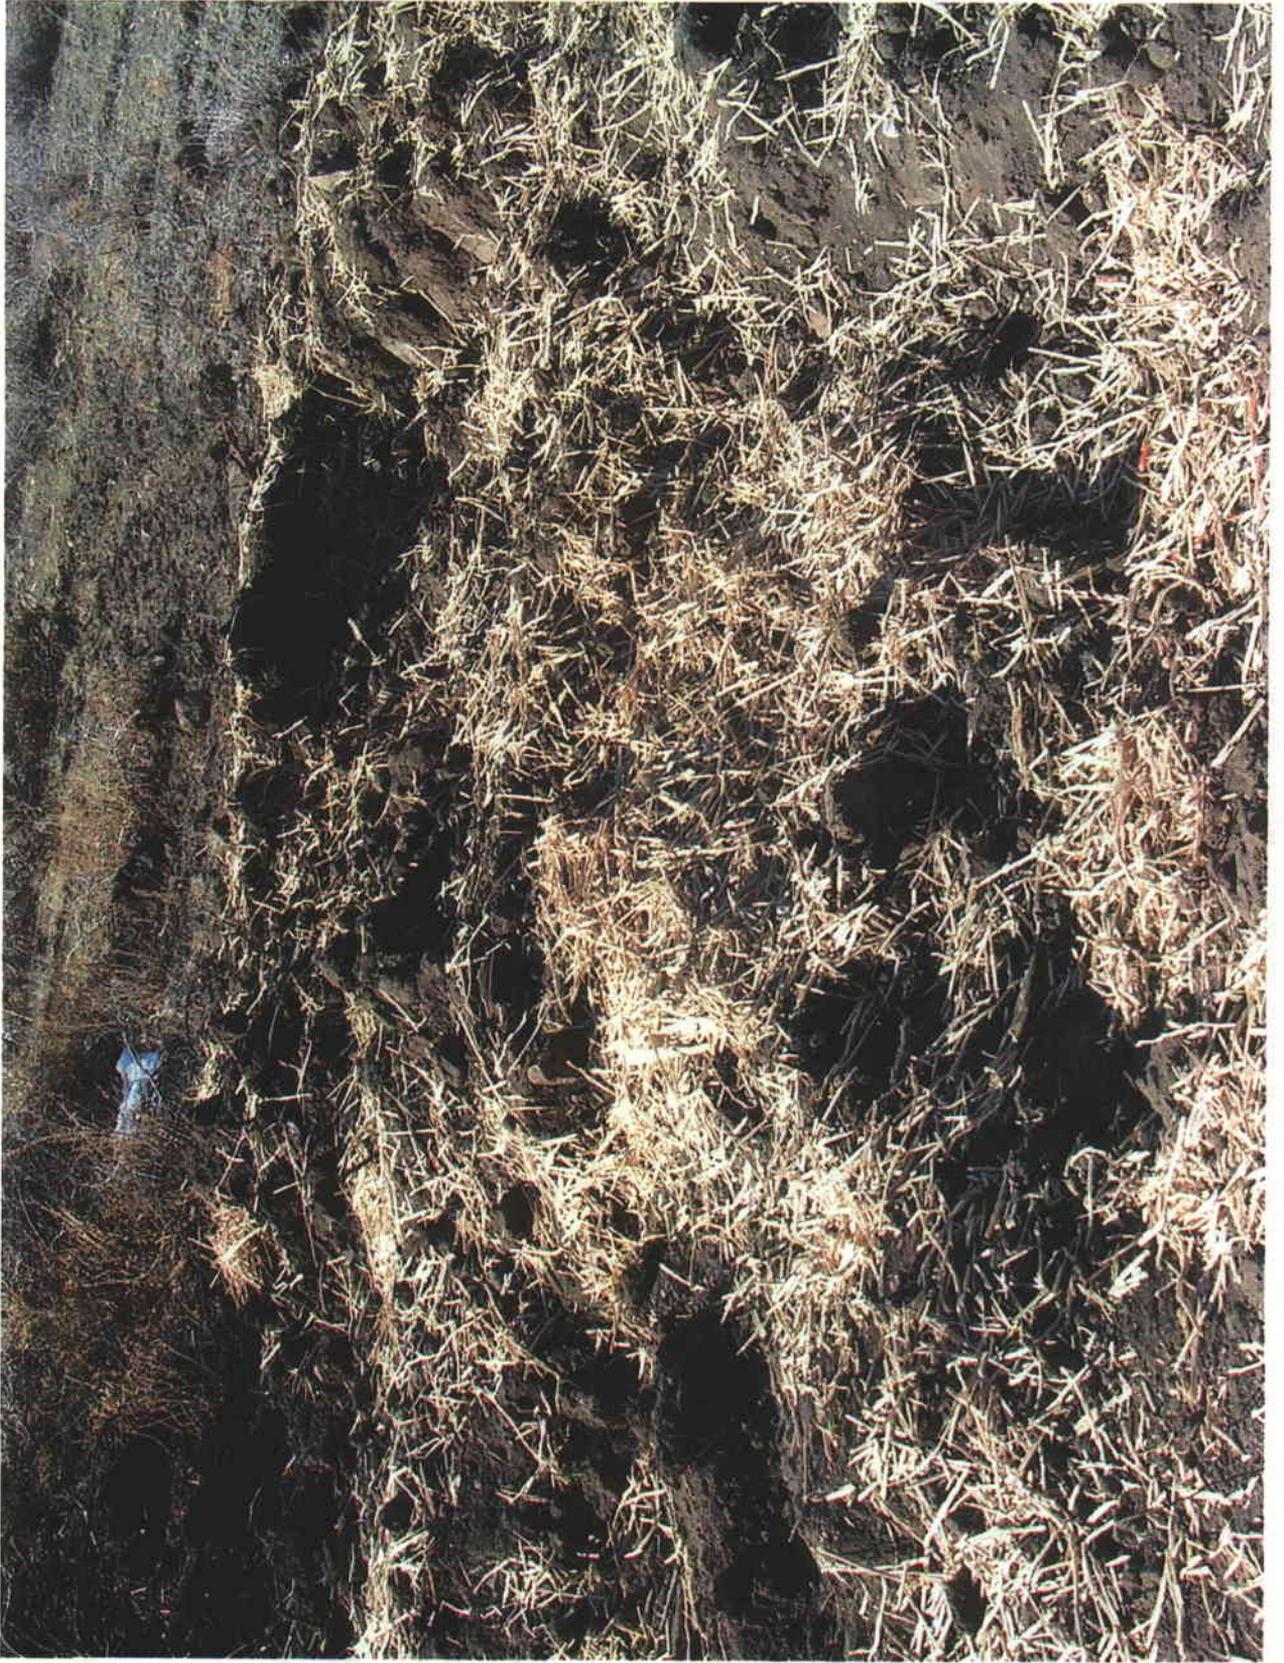
Typical wood straw application

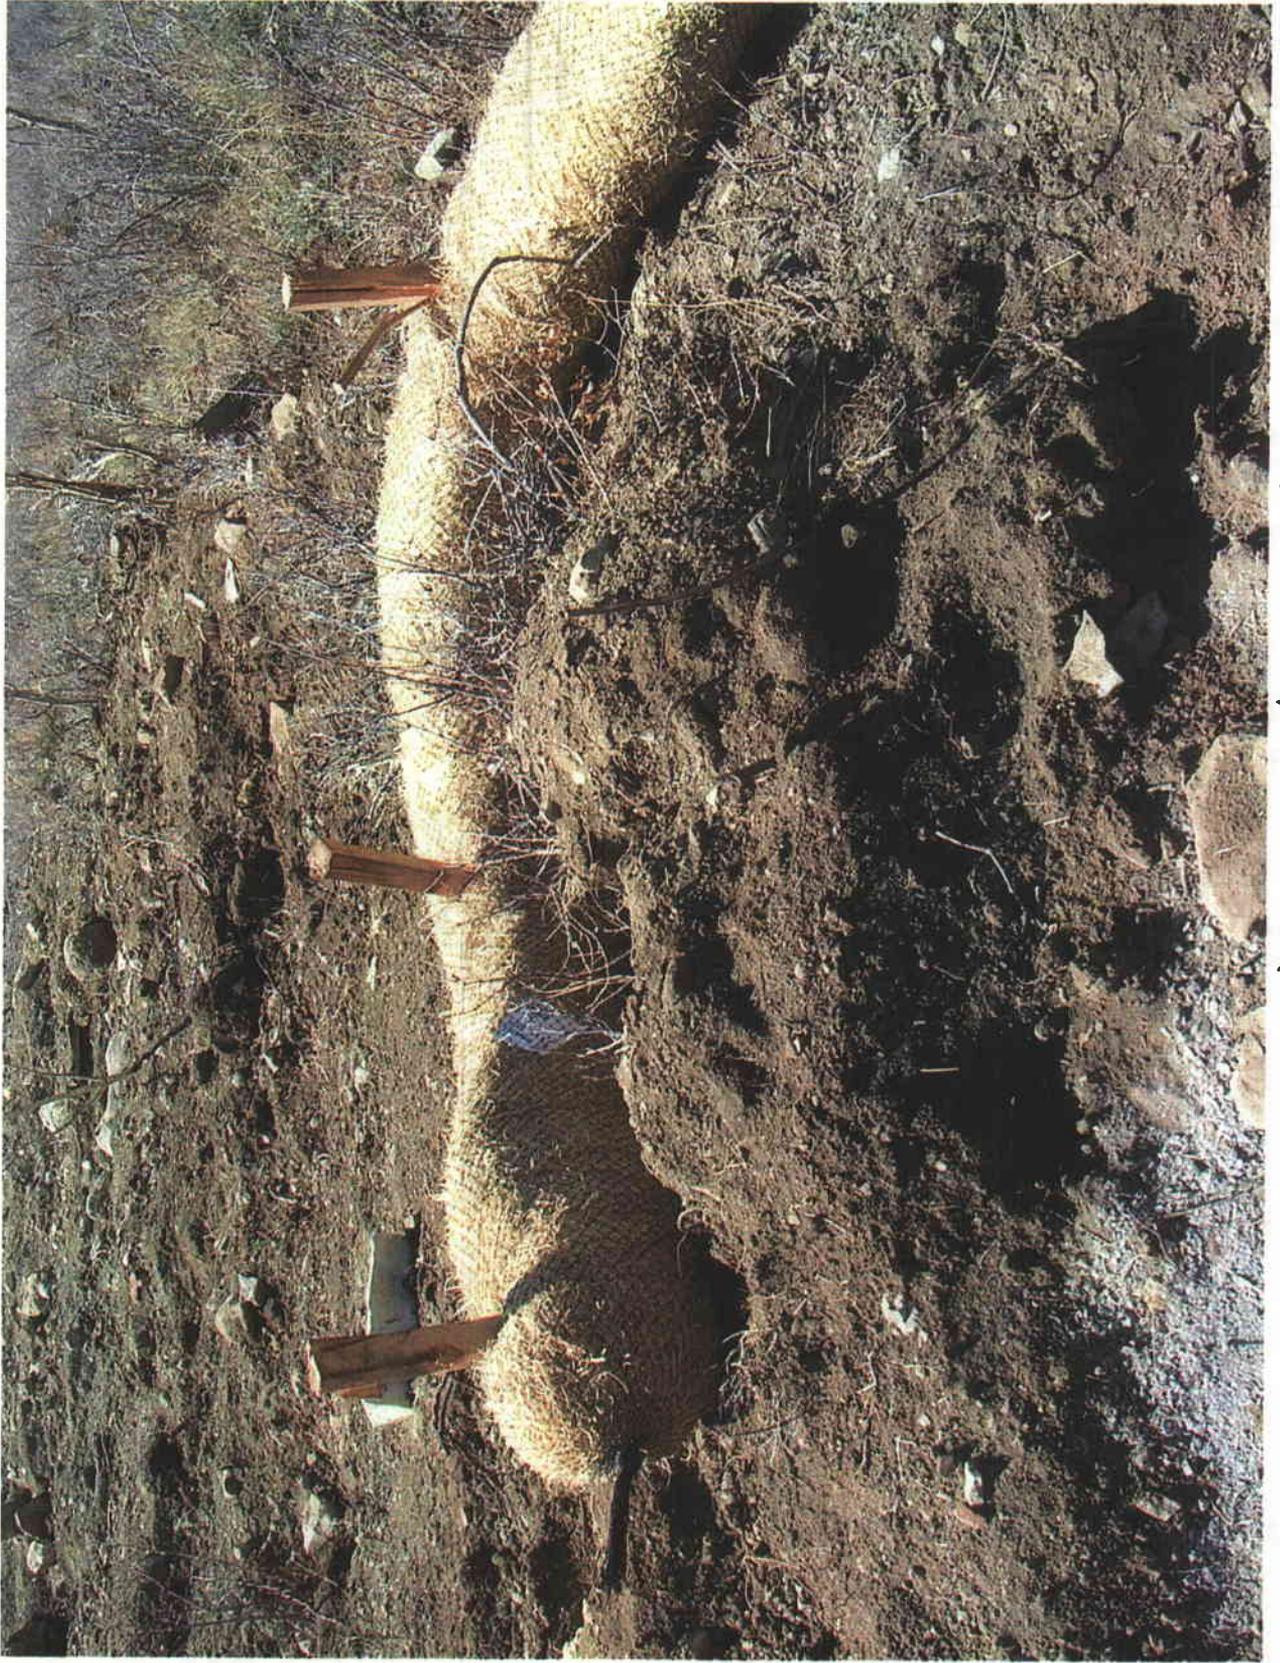
Typical excelsior erosion log
