Re: Crandall Canyon Mines, C/015/032
Change to Appendix 7-65
Mine Water Iron Treatment Facility
To Allow Temporary Iron Sludge Storage in Crandall Sediment Pond

**CHANGE TO
APPENDIX 7-65
MINE DISCHARGE WATER
IRON TREATMENT FACILITY**

**TO ALLOW TEMPORARY STORAGE OF
IRON TREATMENT SLUDGE IN
CRANDALL CYN MINE SEDIMENT POND**

CRANDALL CANYON MINE MINE DISCHARGE WATER IRON TREATMENT FACILITY

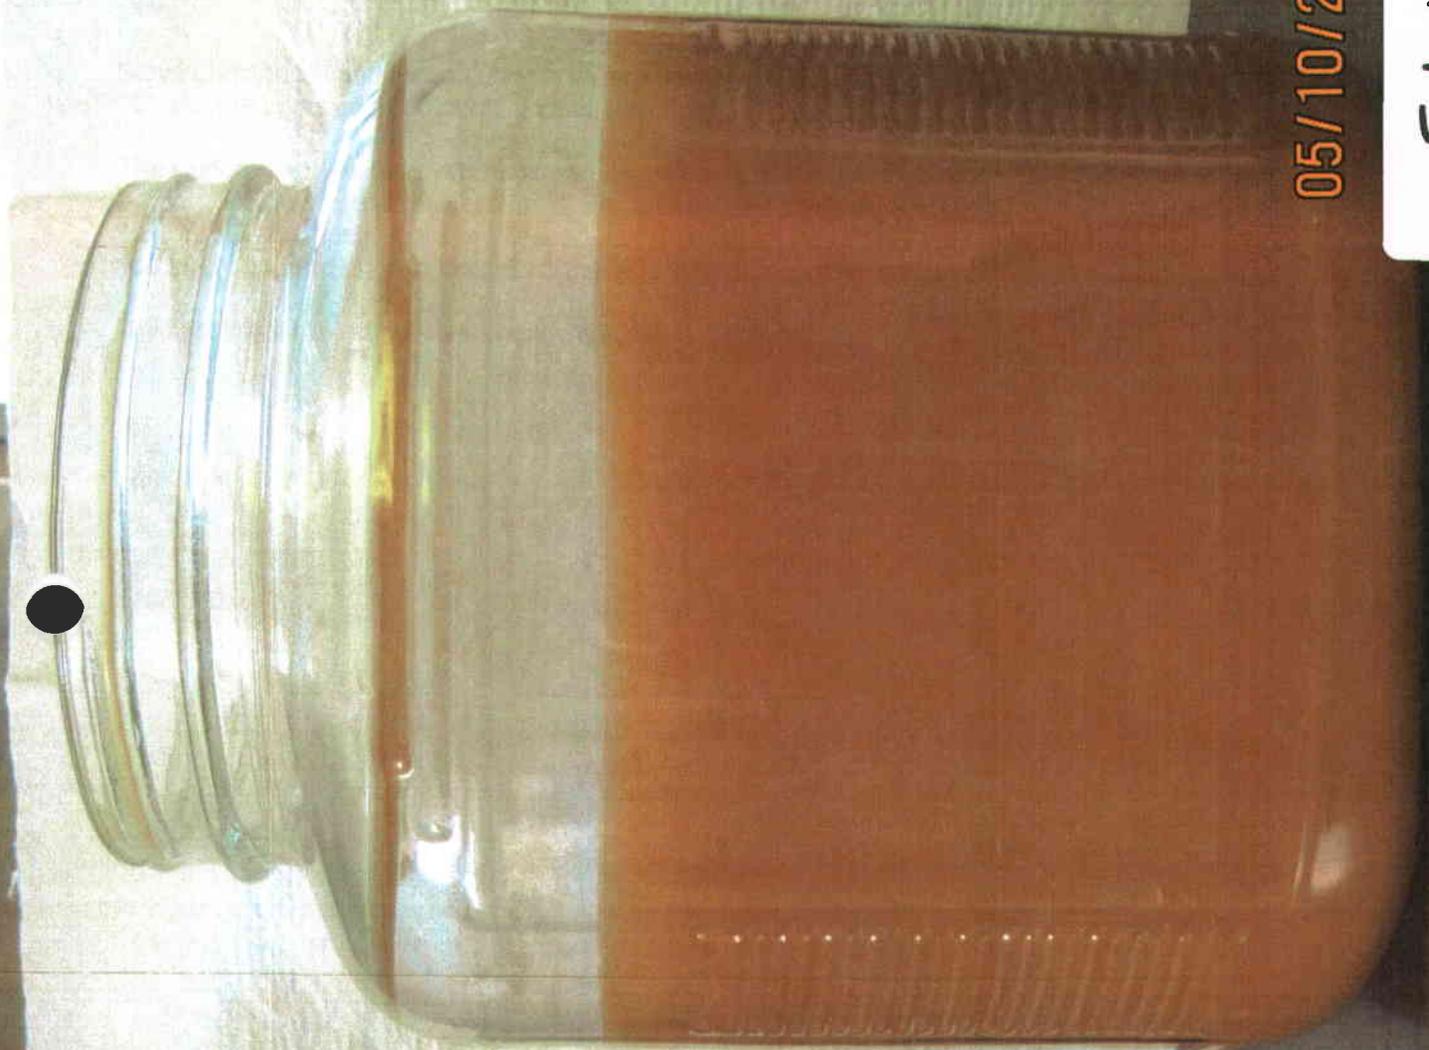
Exhibit 1

Exhibit 1....Photos of cleanout sludge material. Note separation of supernate after several hours retention time.

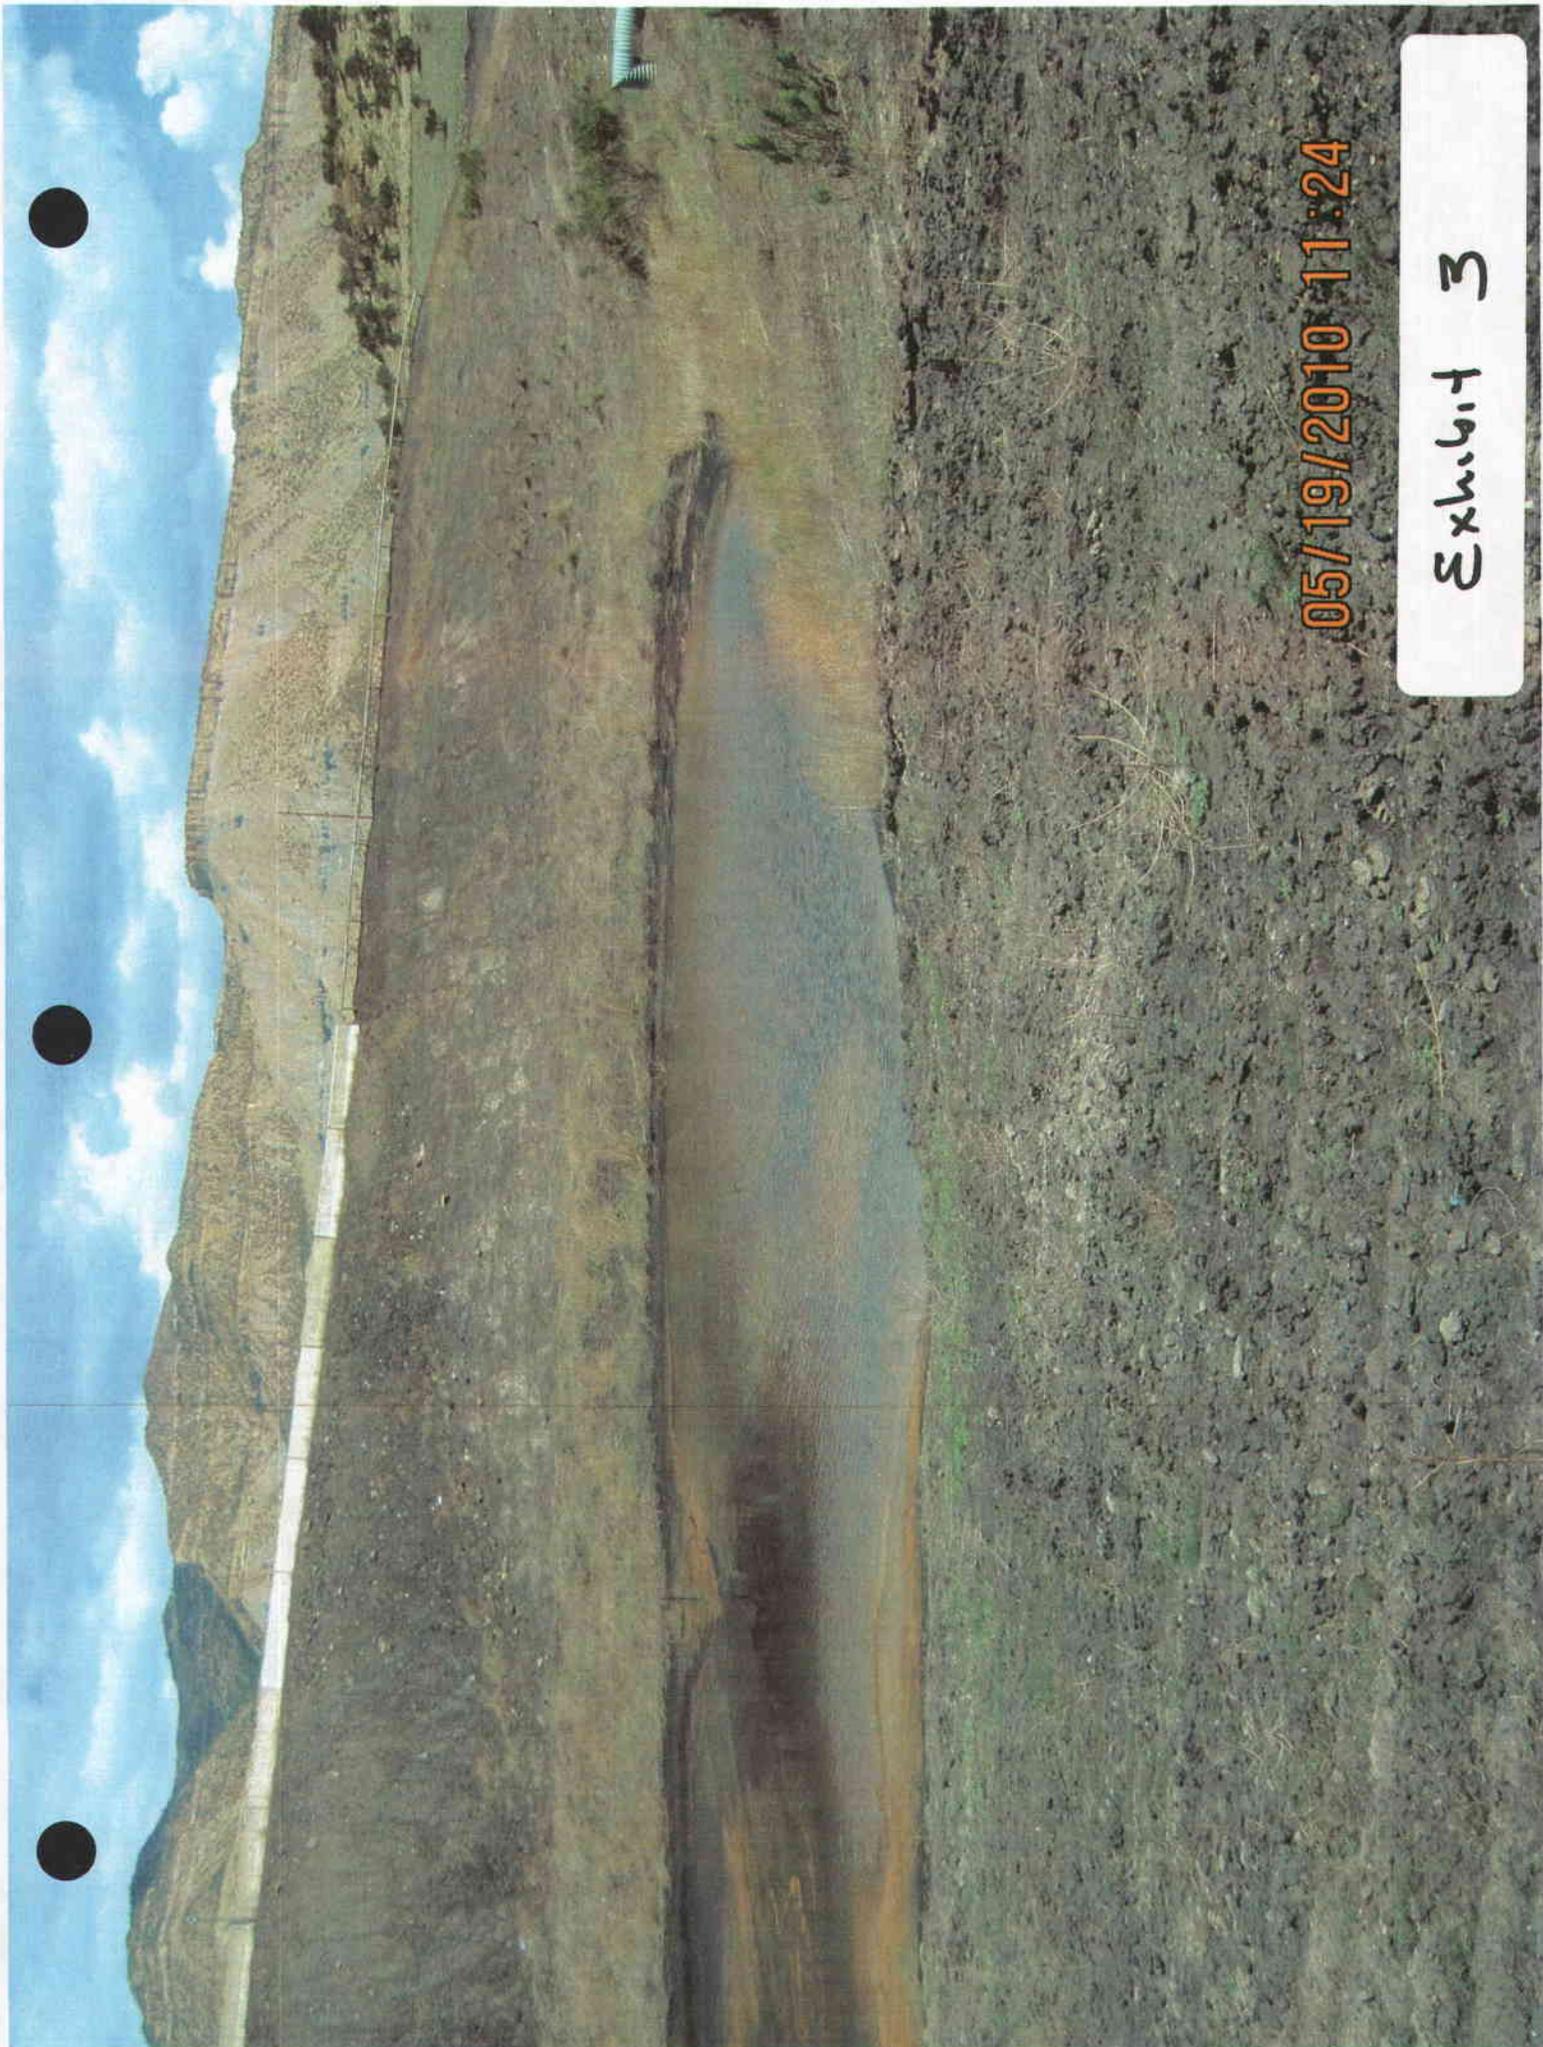
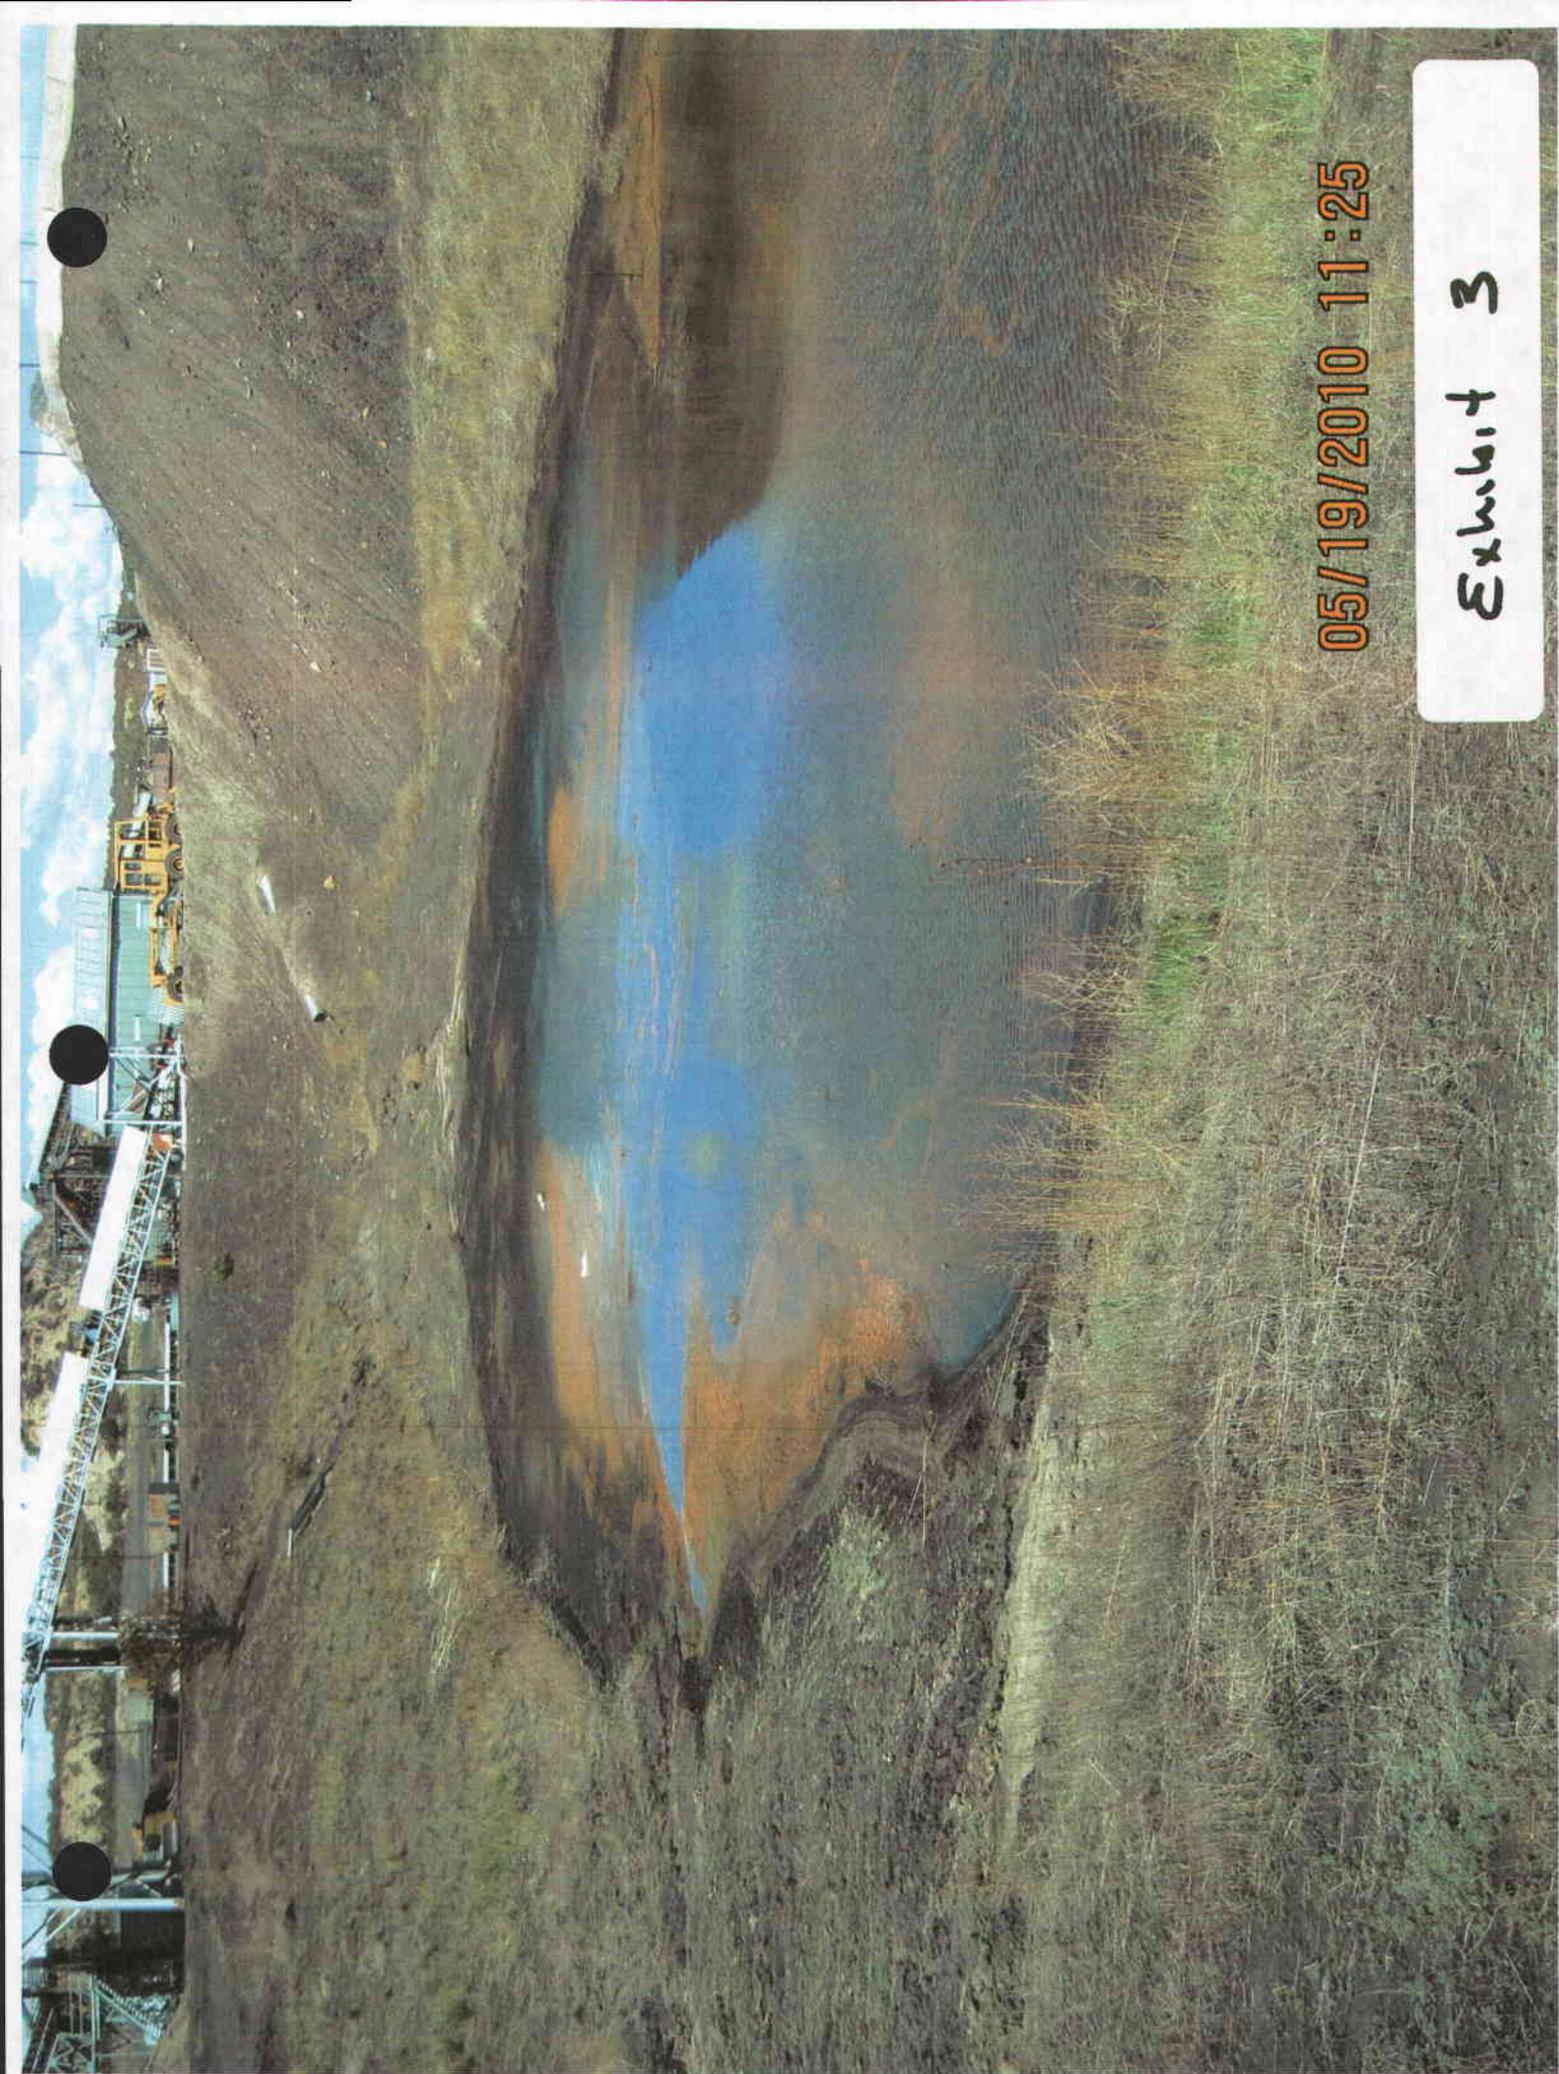
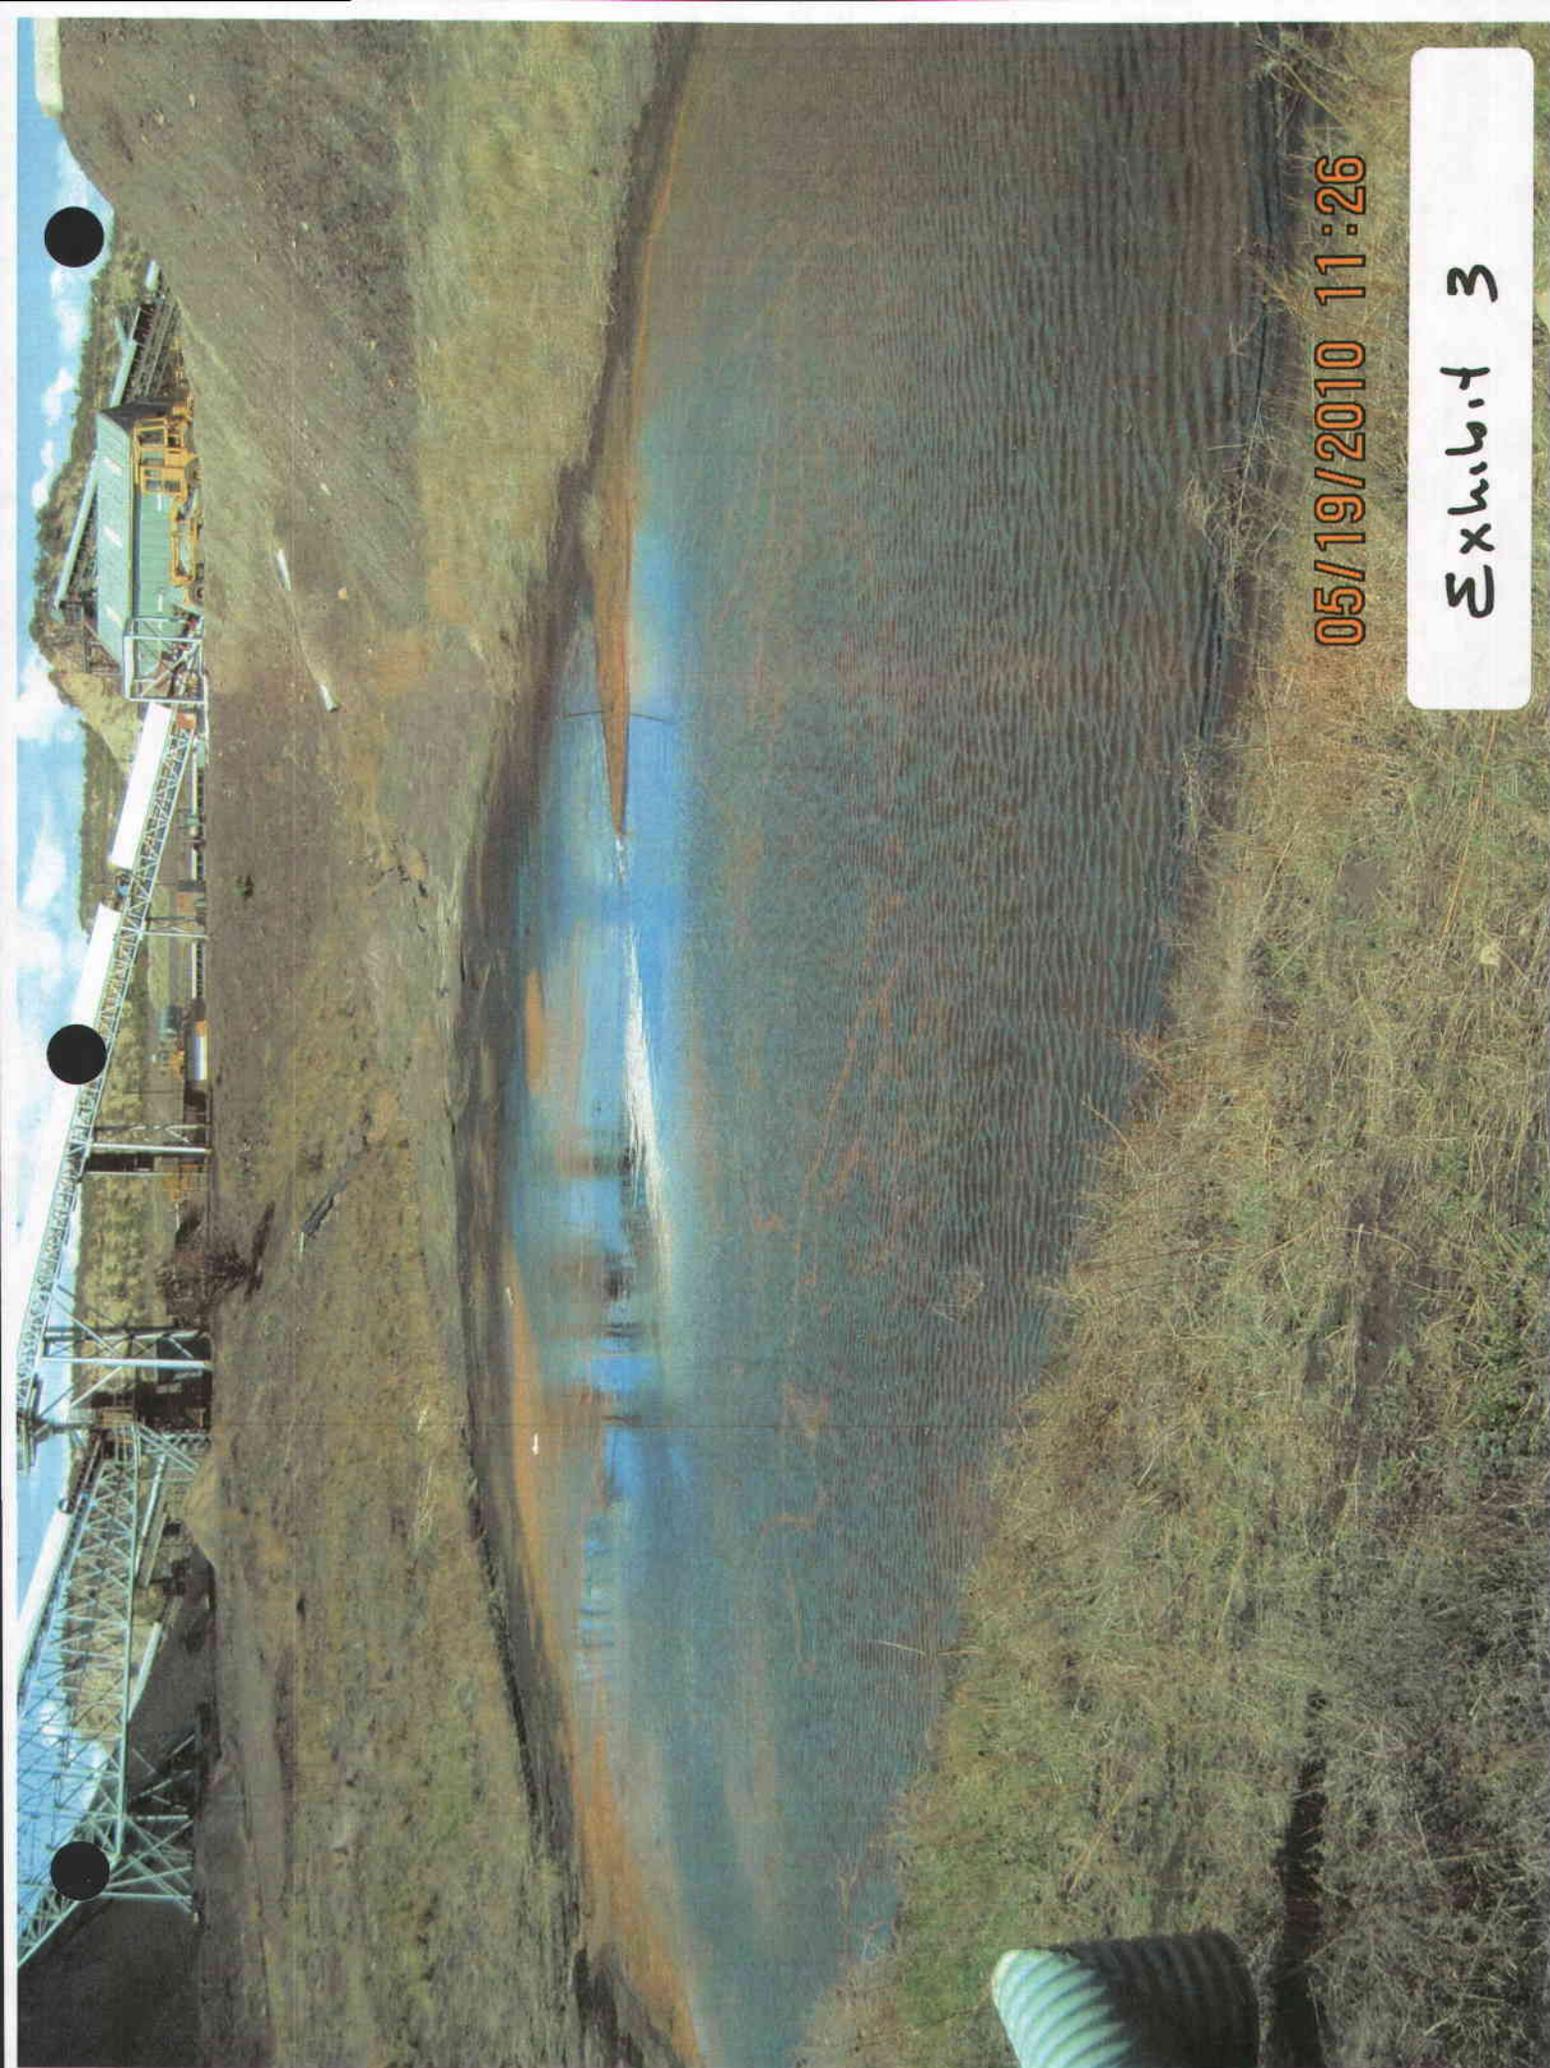
Exhibit 3

Exhibit 3....Photos of sludge disposal, Wildcat Pond C.

Laboratory analysis of the cleanout sludge shows that it is in compliance with all standards for RCRA metals (see Exhibit 4, Attachment 9). Lab analysis also shows that the sludge material is mostly water, being 94.12% water, 5.88% solids (see Exhibits 1 and 5, Attachment 9). Shortly after the cleanout, representatives of the Division inspected the material in Pond C at Wildcat. By this time much of the solids had settled out, leaving a clear supernate on top. This supernate material was sampled and analyzed (see Exhibits 2 and 6, Attachment 9). Exhibit 3, Appendix 9 shows additional photos of the Wildcat Pond C as the sludge continued to settle and dry out. Within the next several weeks the sludge material dried up entirely, leaving only a thin residue caked in the bottom of Pond C.

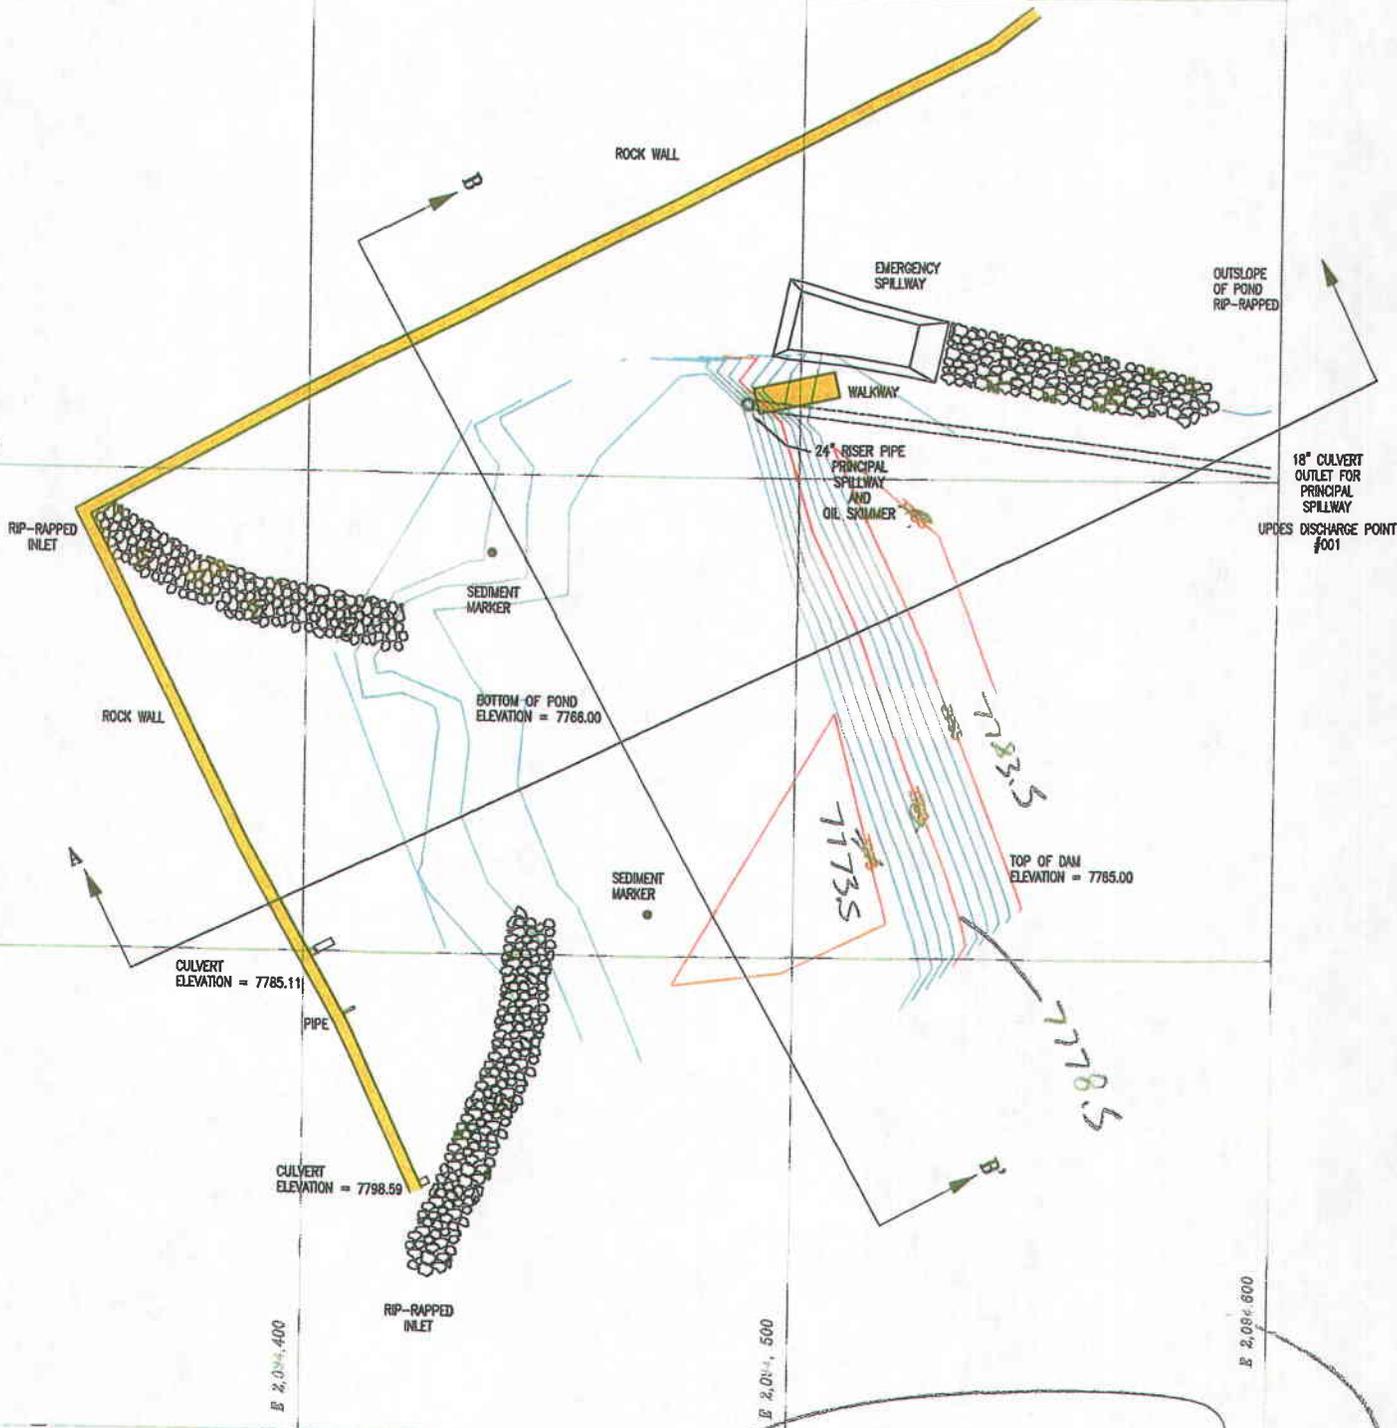
AS-BUILT SEDIMENT POND:

LOCATION:	ELEVATION:	VOLUME:
BOTTOM OF POND:	7766.00	0.000 AC. FT.
SEDIMENT CLEANOUT LEVEL:	7769.00	0.290 AC. FT.
MAXIMUM SEDIMENT LEVEL:	7770.00	0.437 AC. FT.
PRINCIPAL SPILLWAY:	7780.81	3.613 AC. FT.
EMERGENCY SPILLWAY:	7781.81	3.936 AC. FT.

CONTOUR INTERVAL = 1'
SCALE: 1" = 40'

The Crandall sediment pond was recently cleaned and certified in December, 2009 (see Exhibit 7, Appendix 7). New sediment markers were then installed. Based on the post-cleaning survey, the available sediment volume in the pond is now 21,826 cubic feet. The volume of the solids measured from the initial iron sludge cleanout was $216,000 \text{ gal} \times \text{ft}^3/7.48 \text{ gal} \times 5.88\% = 1698$ cubic feet. Therefore, the Crandall sediment pond presently has sufficient capacity to allow for at least 13 additional iron sludge cleanout runs. This is obviously far more capacity than would be needed for sludge cleanout prior to the October 30, 2010, deadline when the pond will no longer be utilized for testing storage.

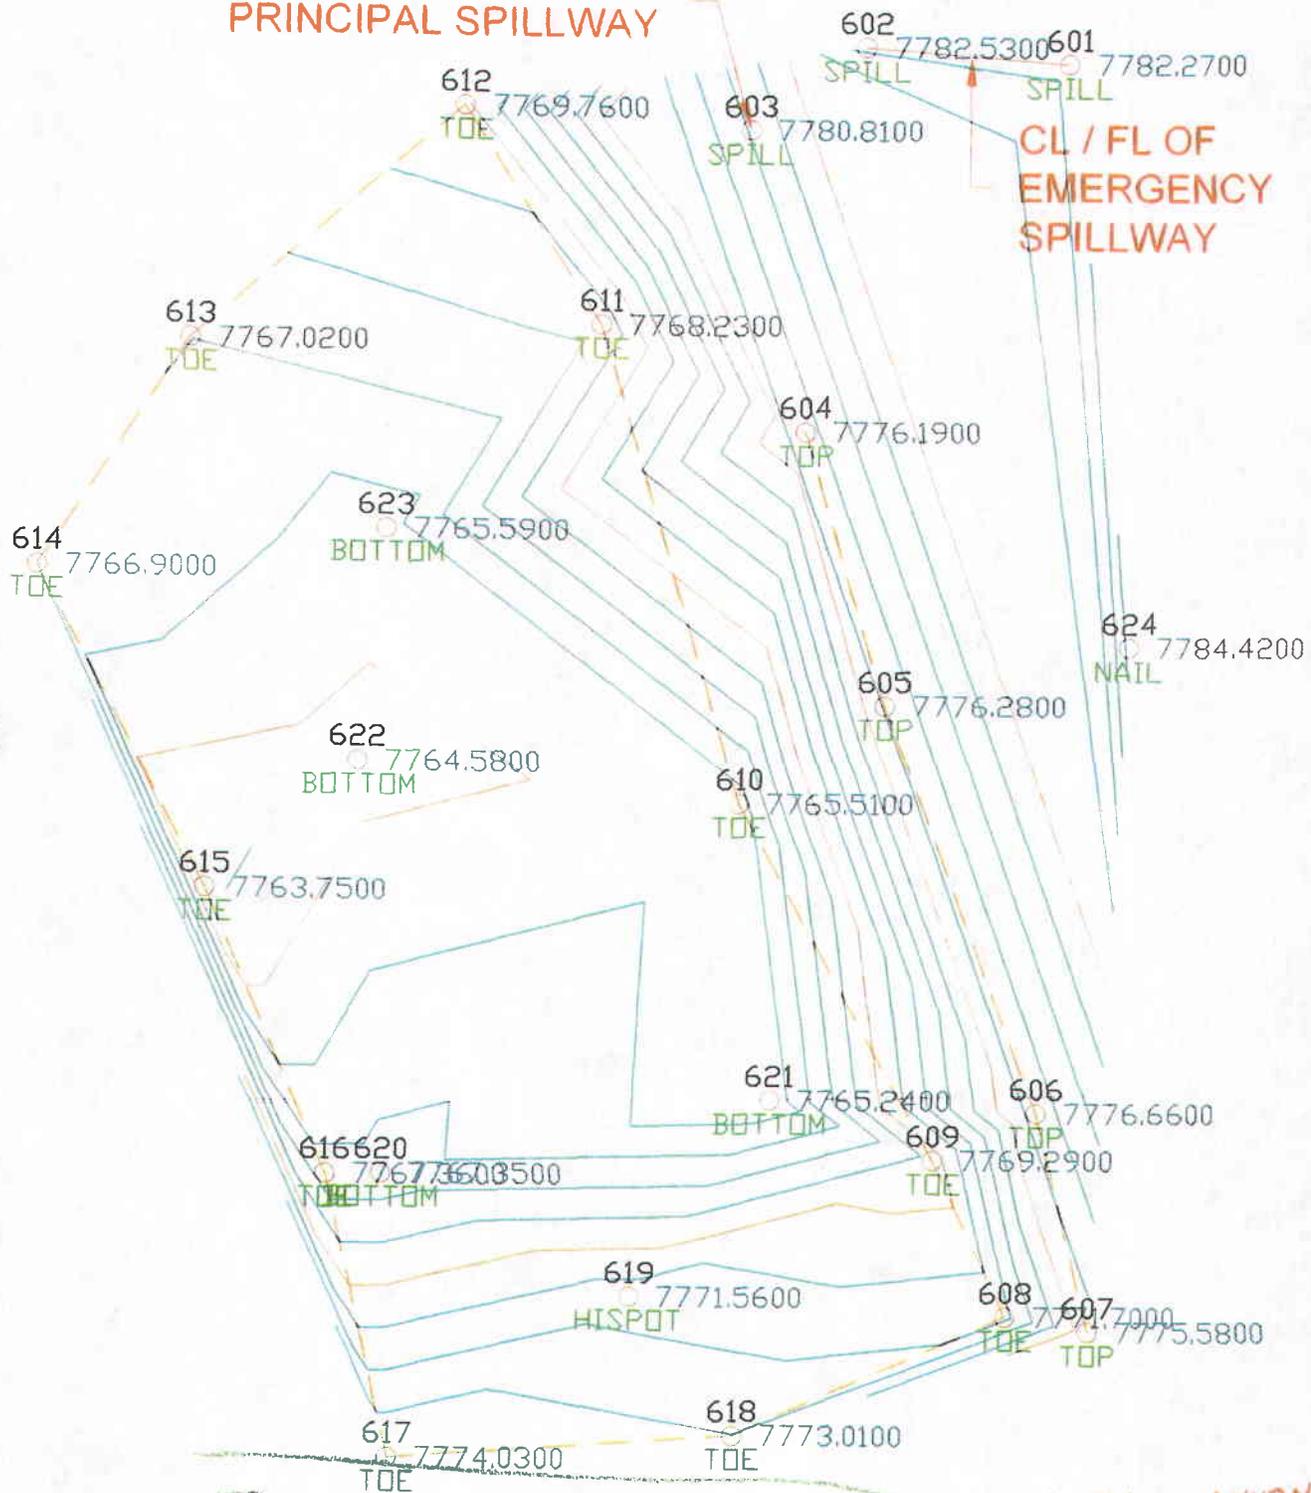
CRANDALL CANYON
SEDIMENT POND SURVEY
DATE: 12/11/09
SCALE: 1" = 20'

Post cleaning contours
Dec 16, 2009

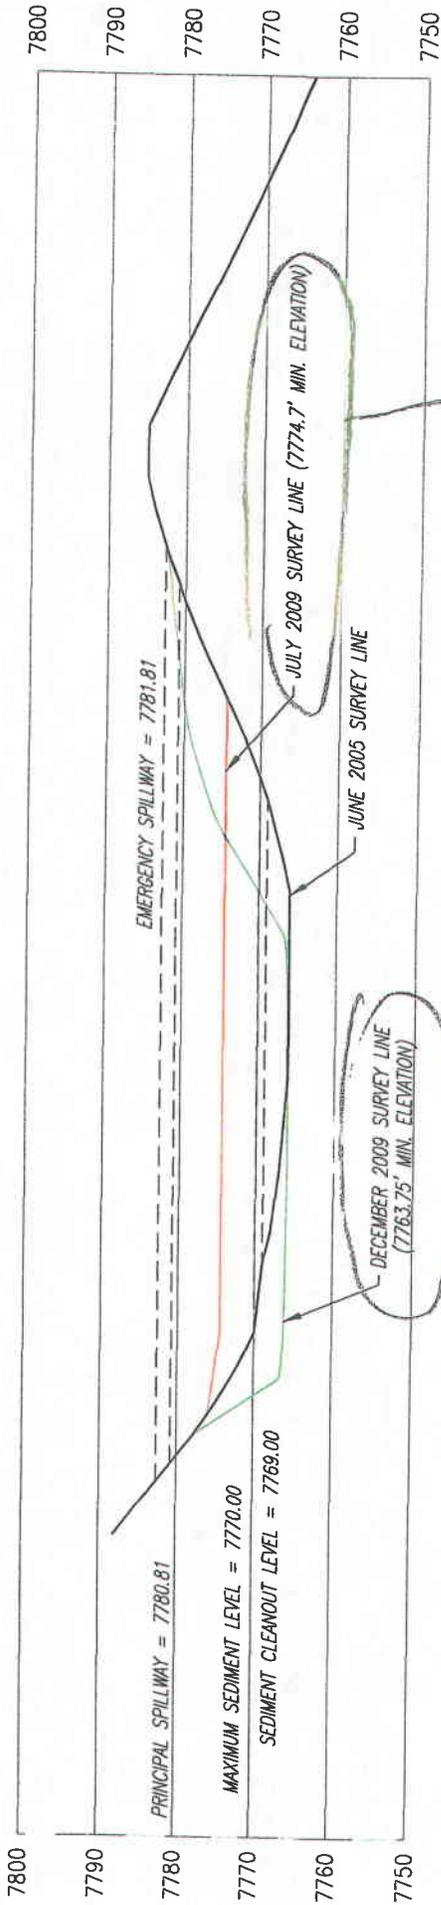
Pre-cleaning

Post-cleaning
