**GENWAL RESOURCES, INC  
CRANDALL CANYON MINES  
C/015/032**

**CHANGE TO  
APPENDIX 7-65  
MINE DISCHARGE WATER  
IRON TREATMENT FACILITY**

**TO ALLOW TEMPORARY STORAGE OF  
IRON TREATMENT SLUDGE IN  
CRANDALL CYN MINE SEDIMENT POND**

## CRANDALL CANYON MINE MINE DISCHARGE WATER IRON TREATMENT FACILITY

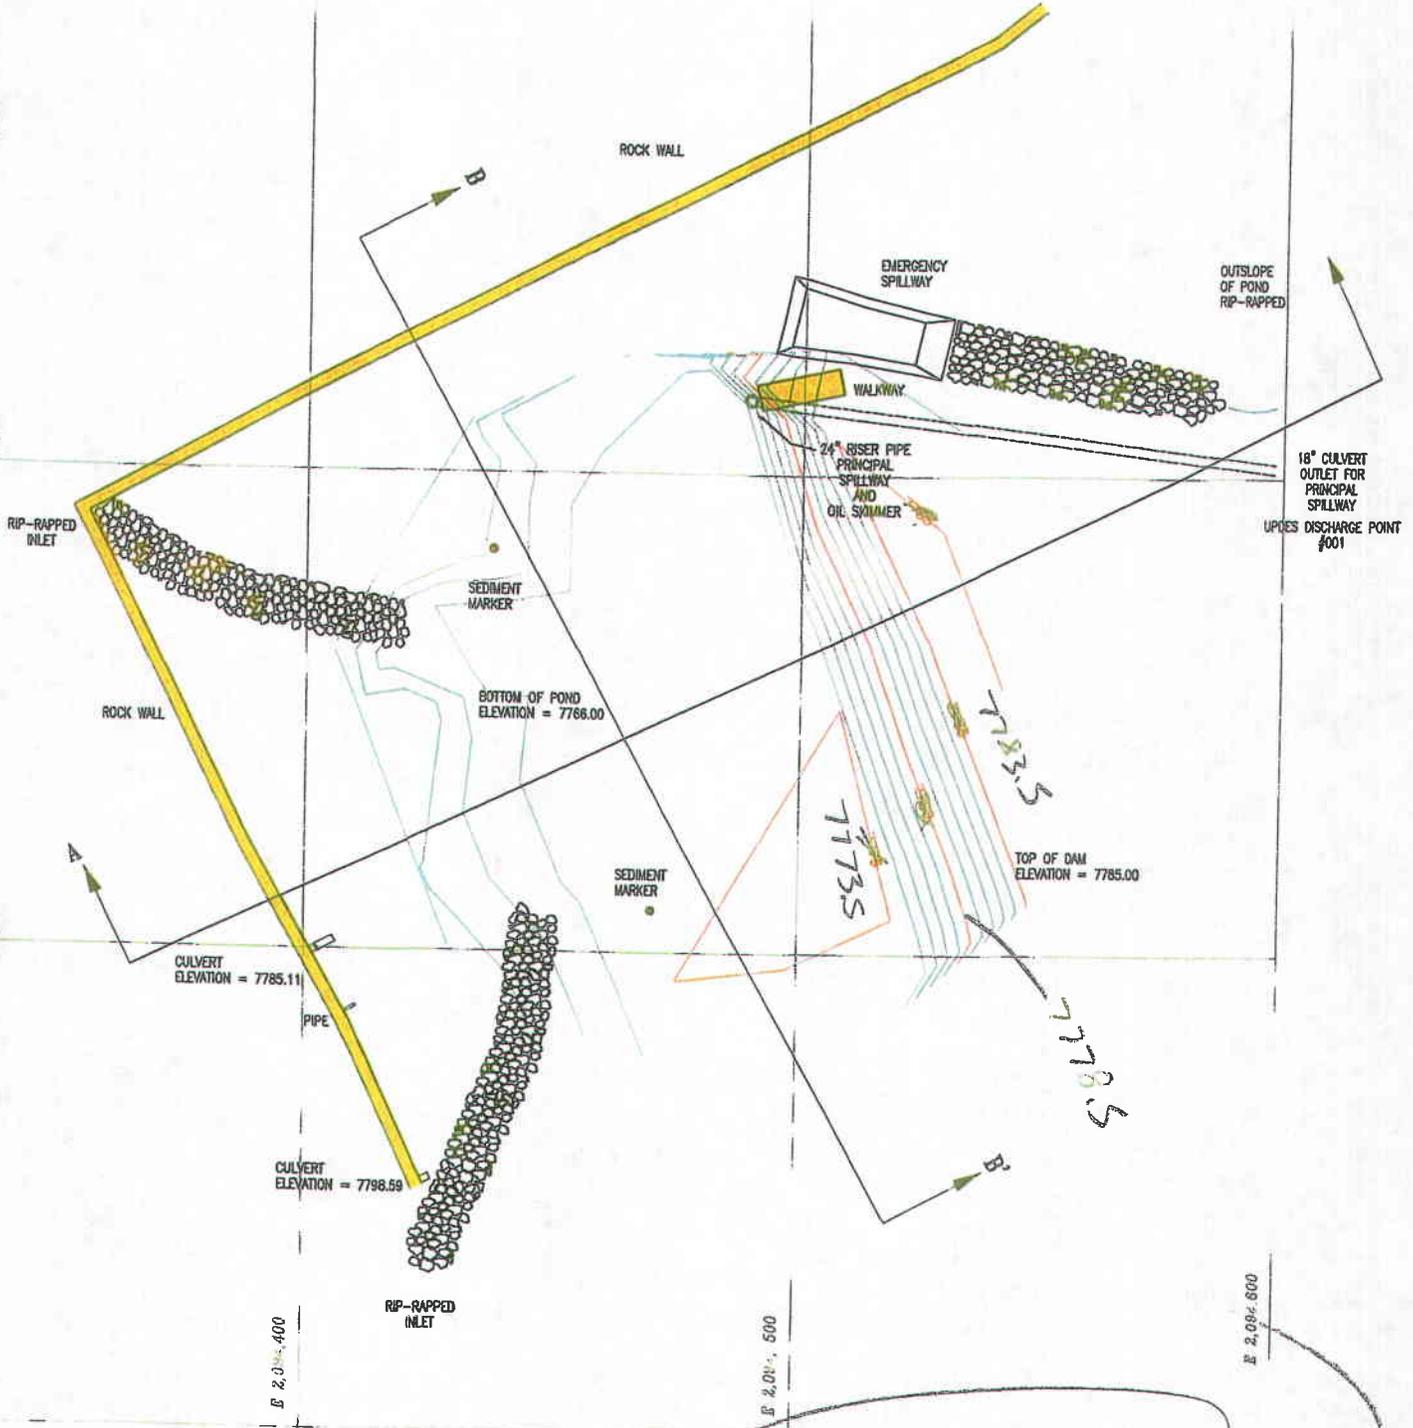
**AS-BUILT SEDIMENT POND:**

LOCATION:	ELEVATION:	VOLUME:
BOTTOM OF POND:	7768.00	0.000 AC. FT.
SEDIMENT CLEANOUT LEVEL:	7769.00	0.290 AC. FT.
MAXIMUM SEDIMENT LEVEL:	7770.00	0.437 AC. FT.
PRINCIPAL SPILLWAY:	7780.81	3.513 AC. FT.
EMERGENCY SPILLWAY:	7781.81	3.936 AC. FT.

It should be noted that in no case will the sediment level (of the combined sediment/sludge material) in the pond be allowed to accumulate above the presently approved 7770' maximum sediment level. It should also be noted that at no time will the total water level in the sediment pond be allowed to exceed the 7773.2' elevation as a result of the cleaning/testing. By not exceeding this level, the sediment pond will still maintain sufficient capacity to hold surface runoff from a 10-year, 24-hour precipitation event. A high-water level marker has been installed in the pond to make certain that this level is not exceeded during cleaning and testing. In the unlikely event that any supernate water needs to be decanted from the pond during this time, it will be decanted in accordance with the approved UPDES permit. It is encouraging to note that, should decanting be necessary, analysis of the supernate from the initial cleaning showed compliance with all UPDES parameters. It should also be noted that any sludge material deposited in the Crandall sediment pond during this time will eventually be removed and disposed of as part of the normal approved sediment pond clean-out procedure.

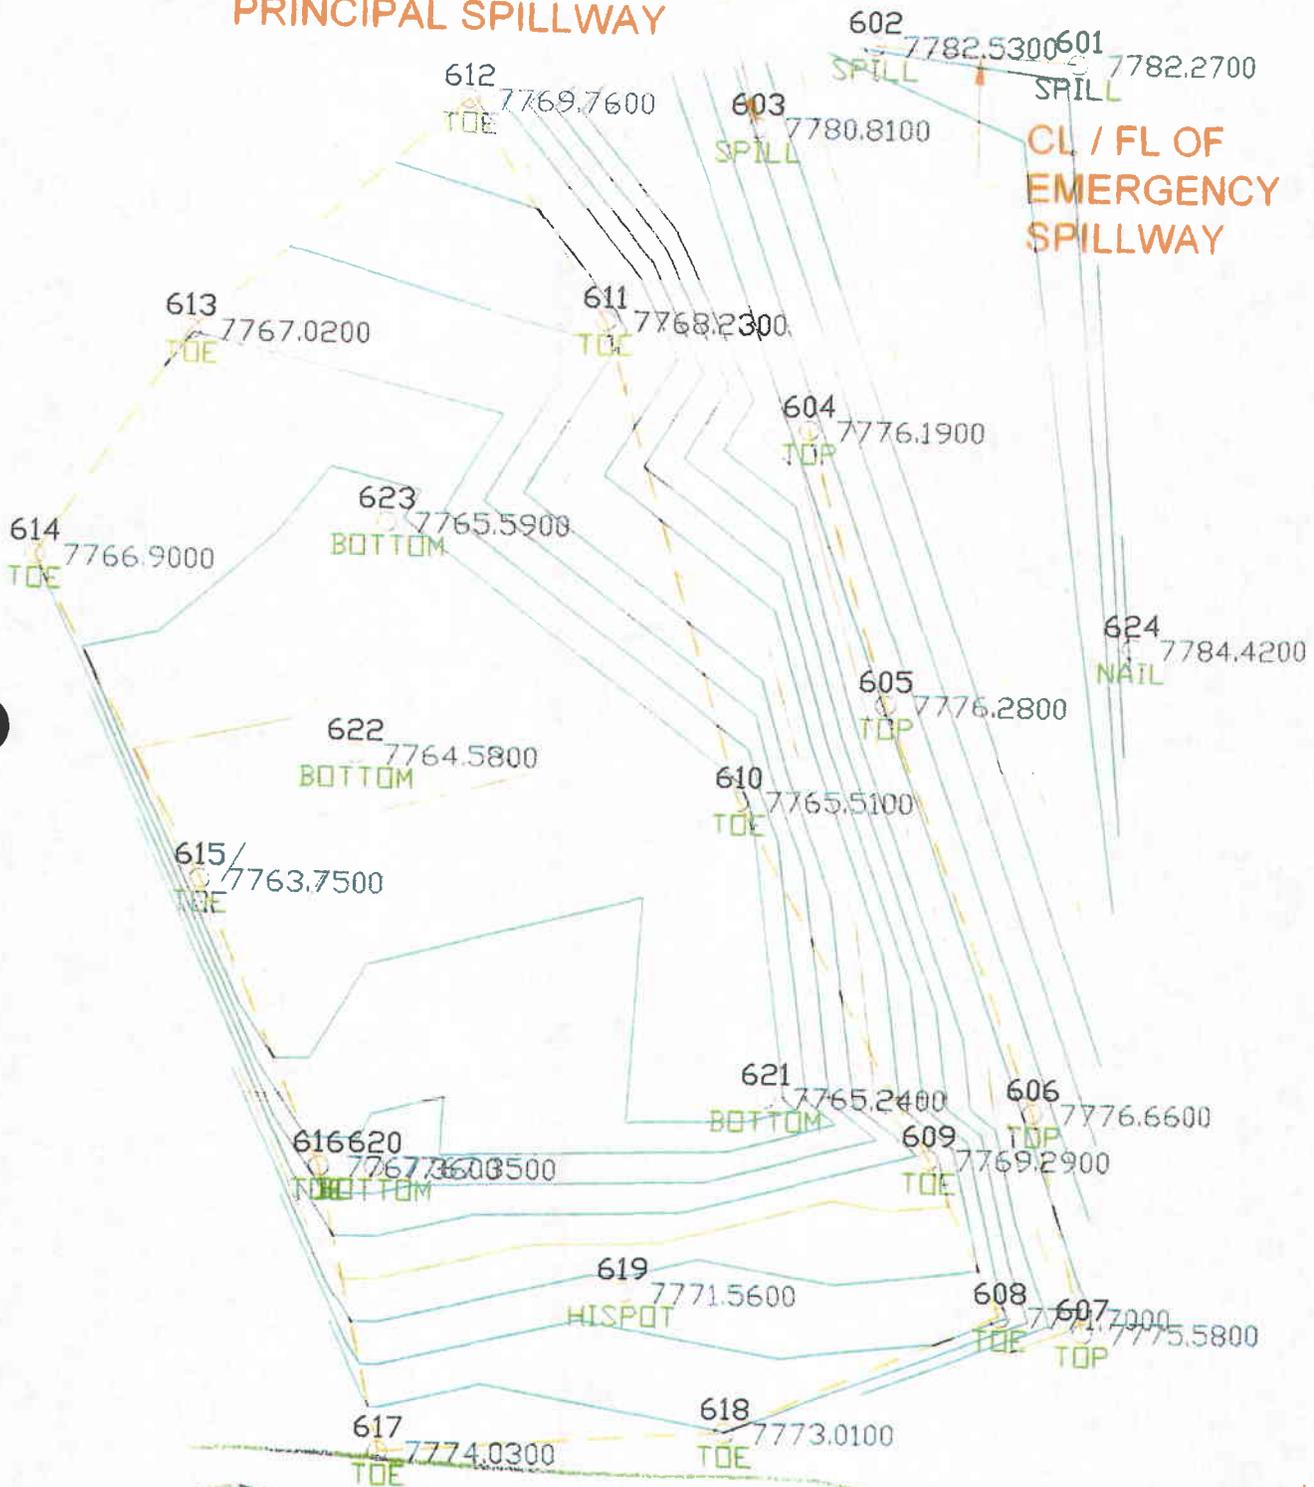
CRANDALL CANYON  
SEDIMENT POND SURVEY  
DATE: 12/10/09  
SCALE: 1" = 20'

Post cleaning contours  
Dec 16, 2009
