RE: Crandall Canyon Mine, C/015/032; Division Order 10A; Response to Division Letter of December 21, 2010

Re: Crandall Canyon Mines, C/015/032
Division Order 10A
Response to Task #3582
Bullet Items 1, 3 and 4

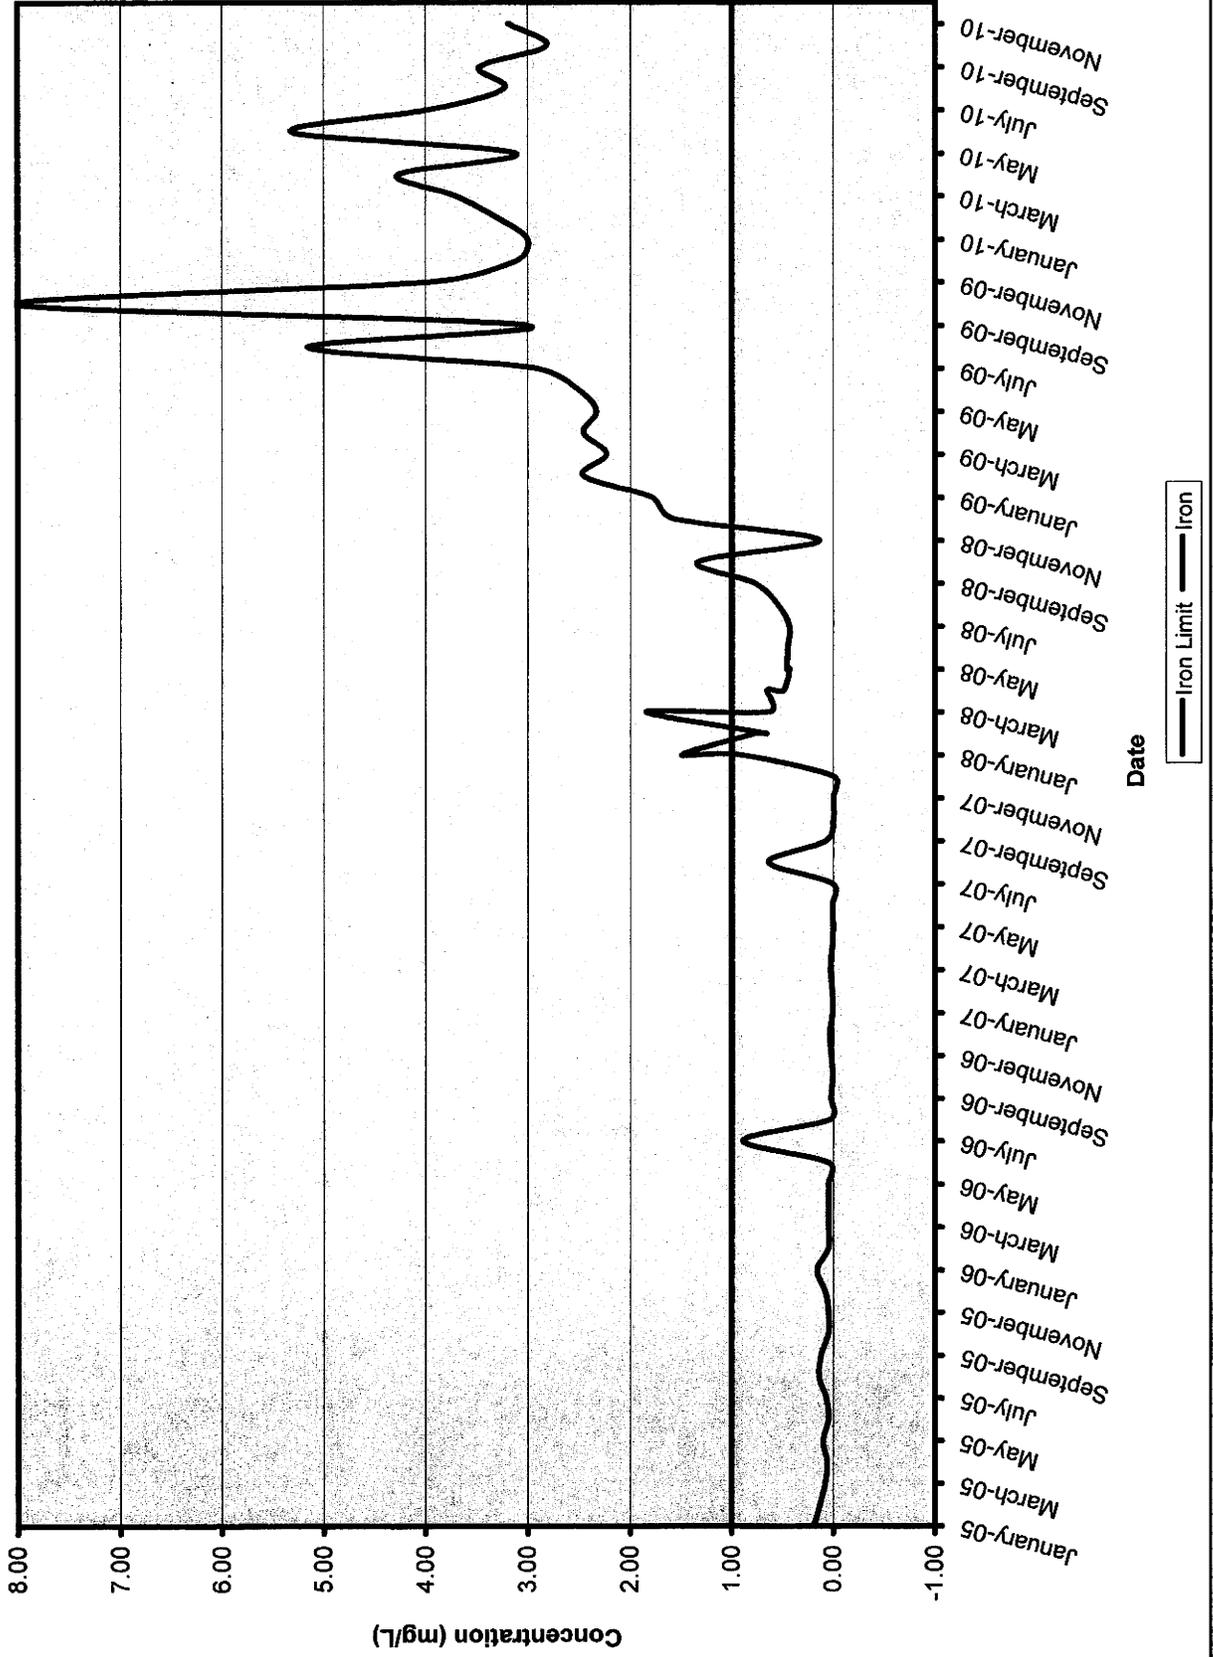
Genwal Resources, Inc. (002) - Total Iron Average
Pre-Treatment Mine Water

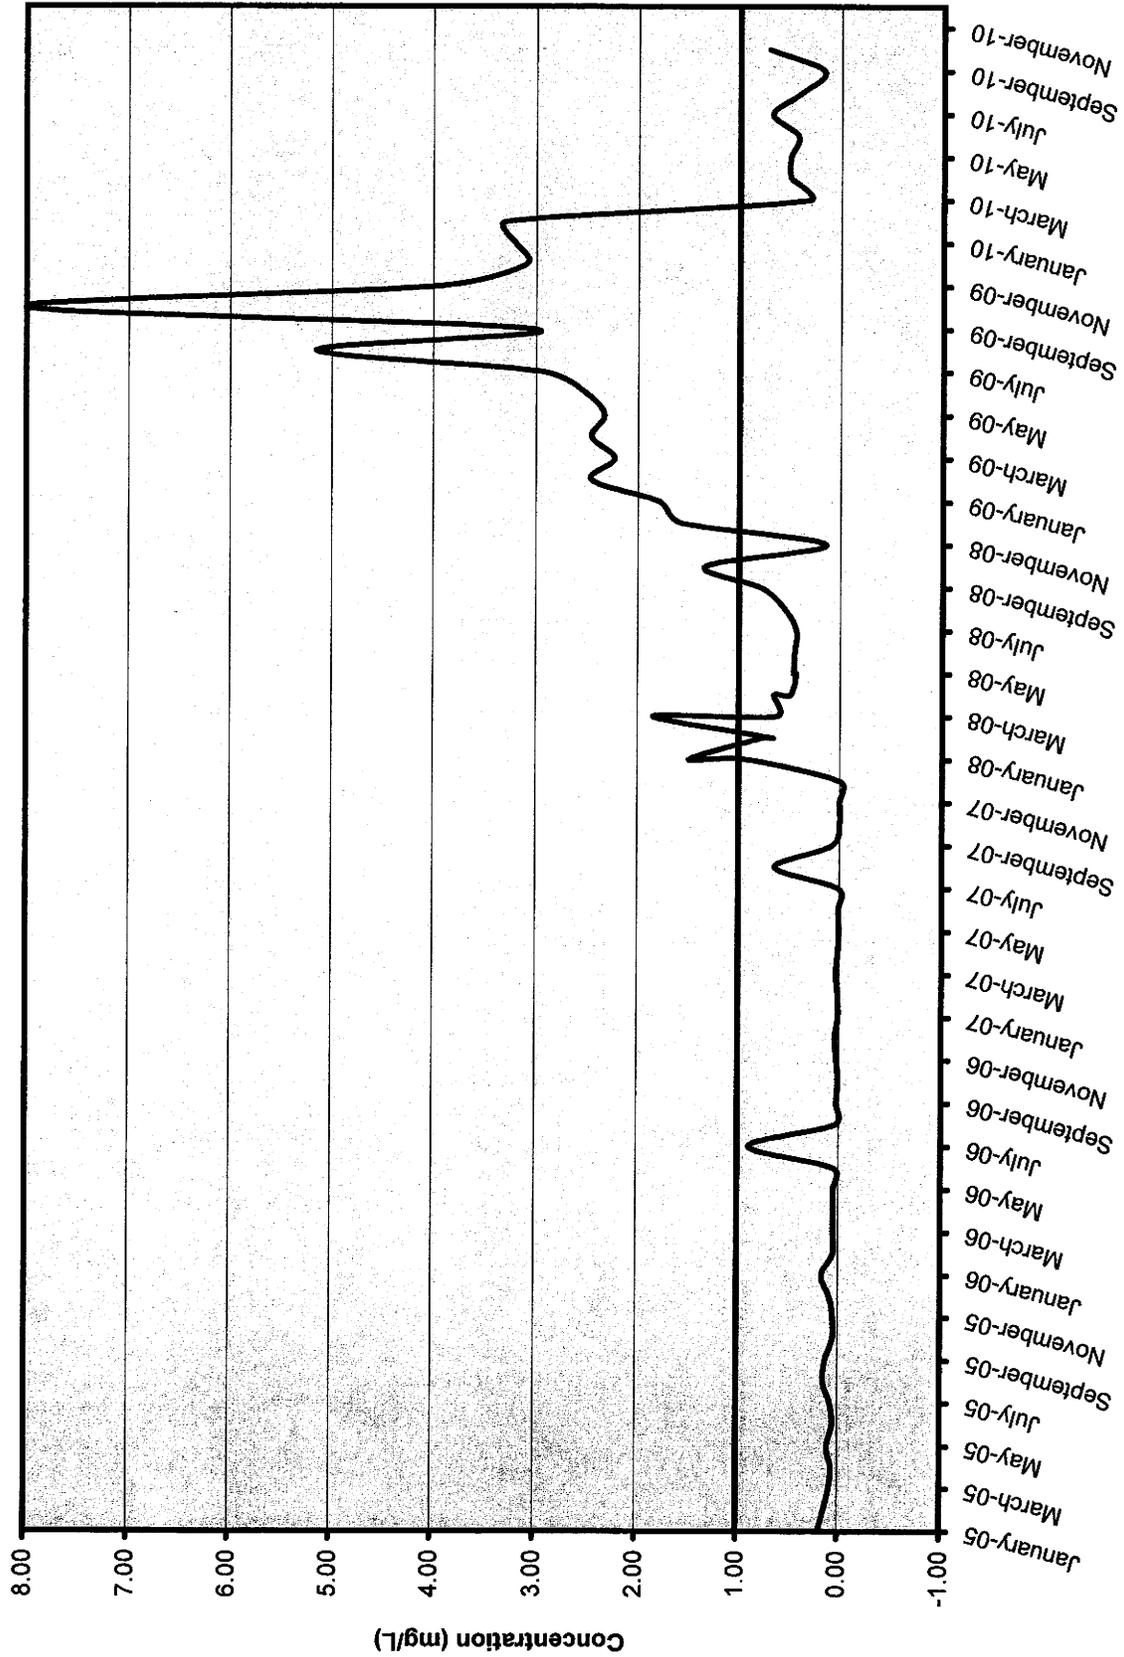
Genwal Resources, Inc. (002) - Total Iron Average
Post-Treatment Mine Water

— Iron Limit — Iron
