Inspection Report

Permit Number:	C0150032
Inspection Type:	PARTIAL
Inspection Date:	Tuesday, July 30, 2013
Start Date/Time:	7/30/2013 8:30:00 AM
End Date/Time:	7/30/2013 3:00:00 PM
Last Inspection:	Tuesday, June 25, 2013

Permittee: **GENWAL RESOURCES INC**
 Operator: **GENWAL RESOURCES INC**
 Site: **CRANDALL CANYON MINE**
 Address: **PO BOX 910, EAST CARBON UT 84520-0910**
 County: **EMERY**
 Permit Type: **PERMANENT COAL PROGRAM**
 Permit Status: **ACTIVE**

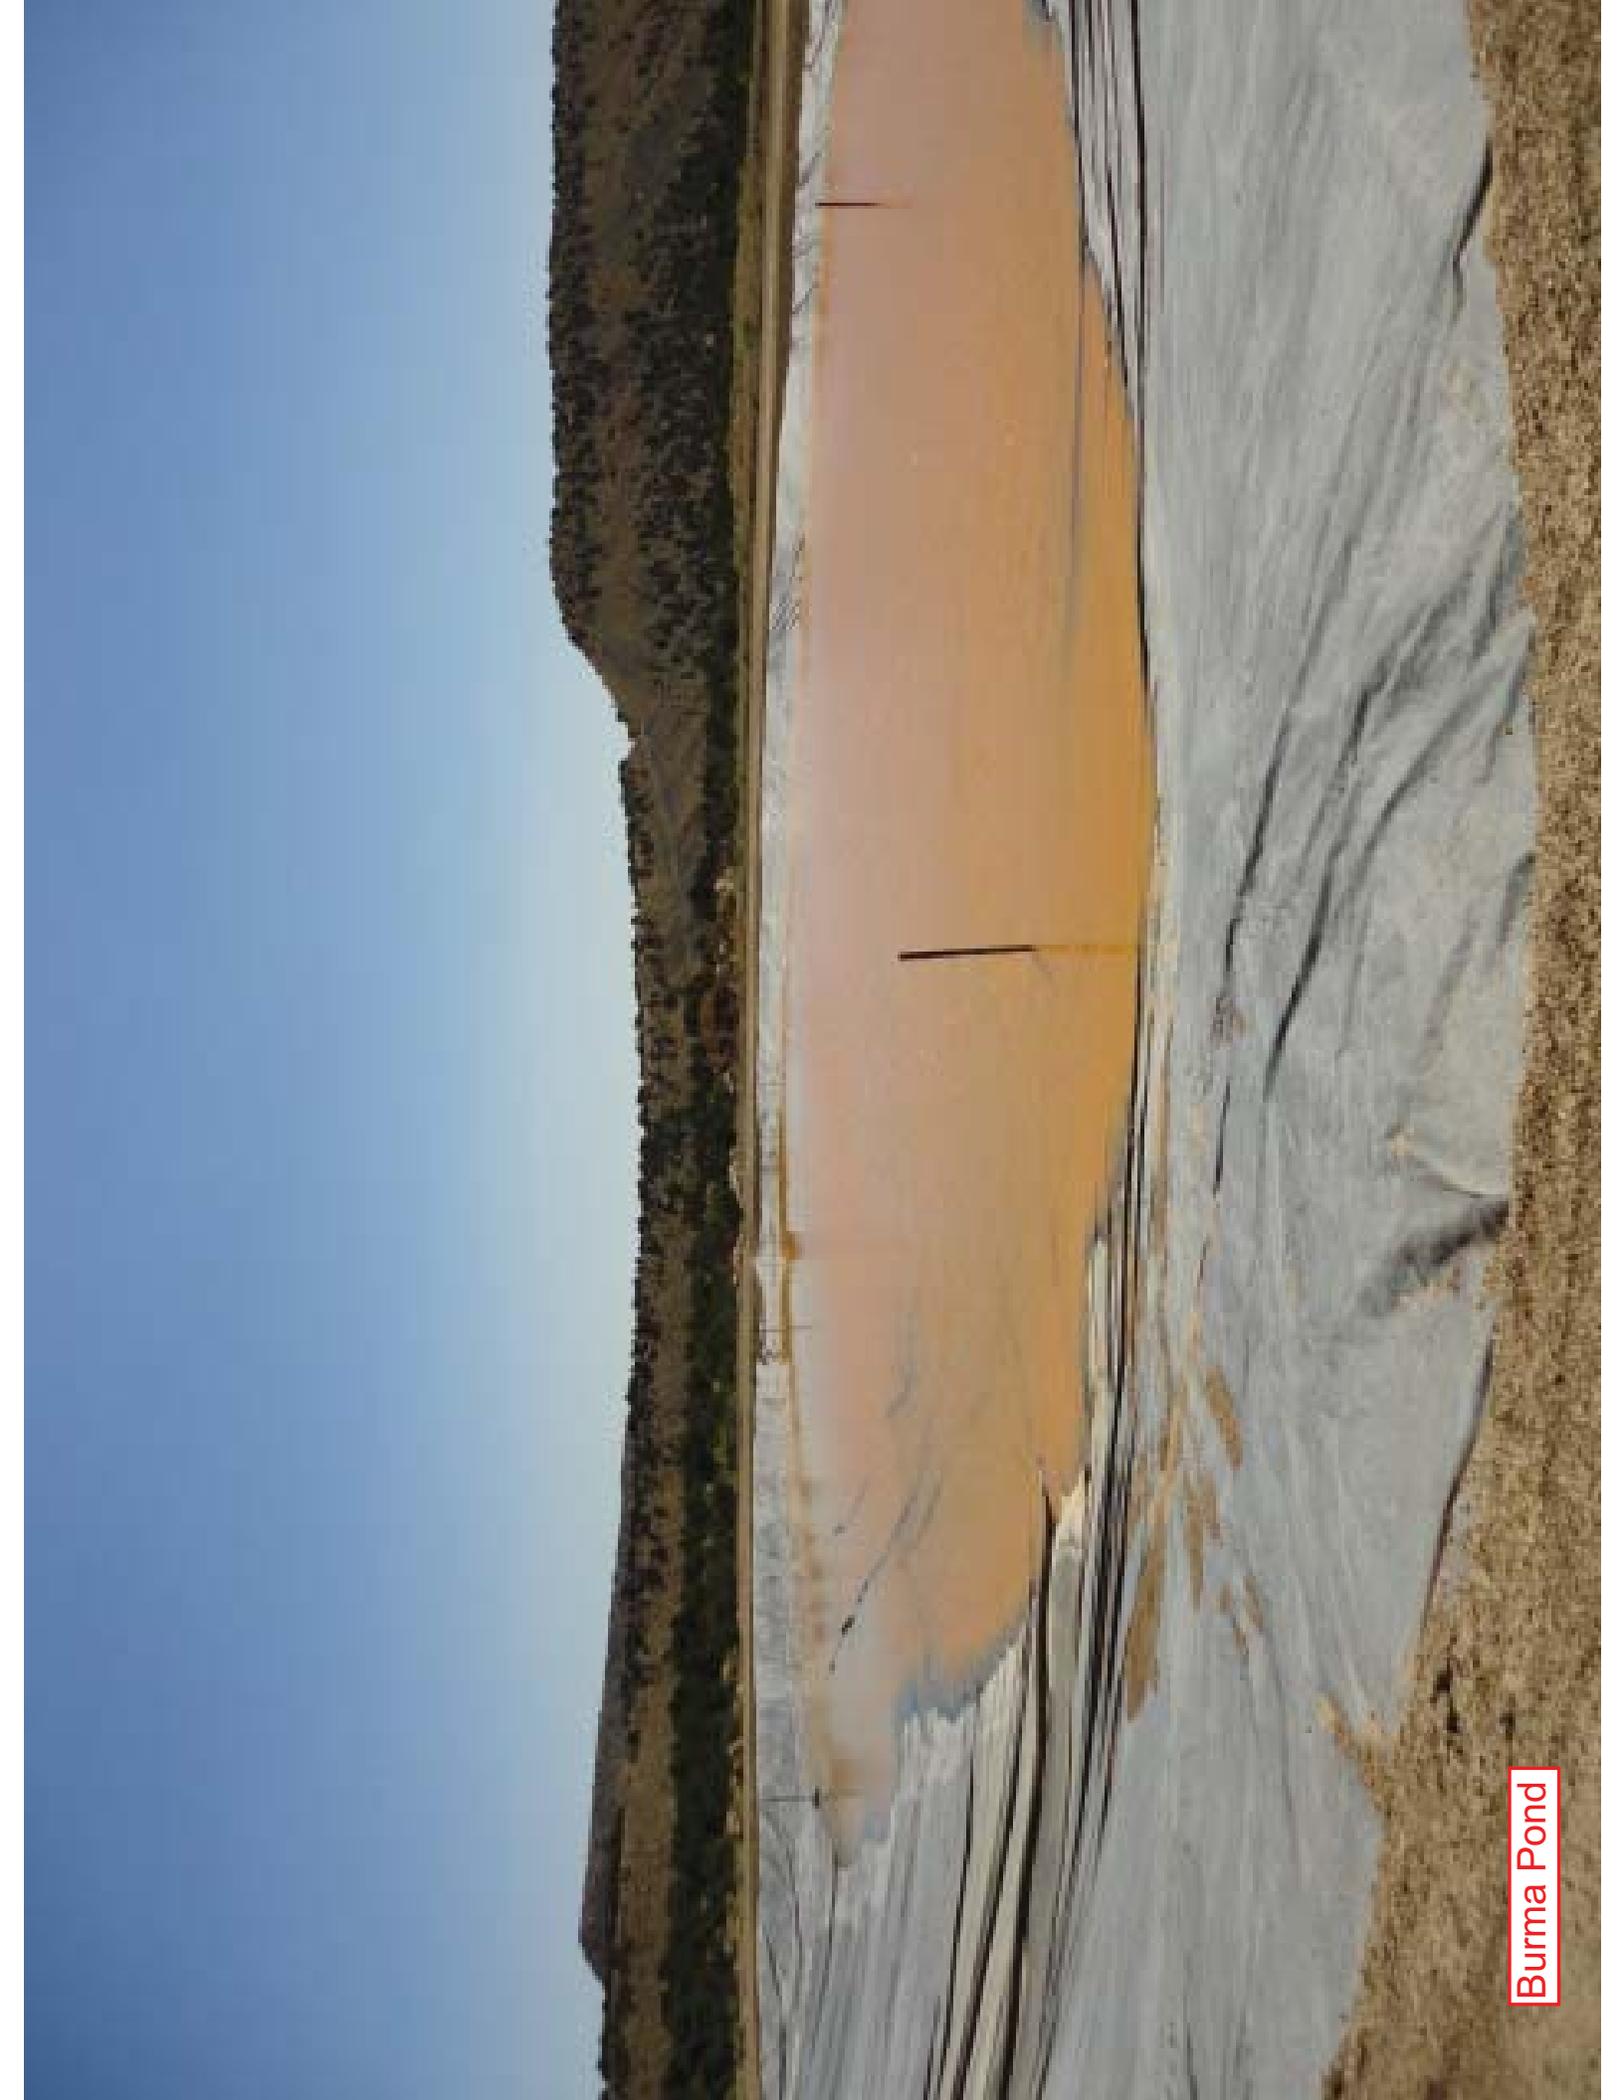
The identification signs at the Burma Pond and the Crandall Mine Site were observed as part of the partial inspection. Both signs contained the required information and were found to be in compliance.

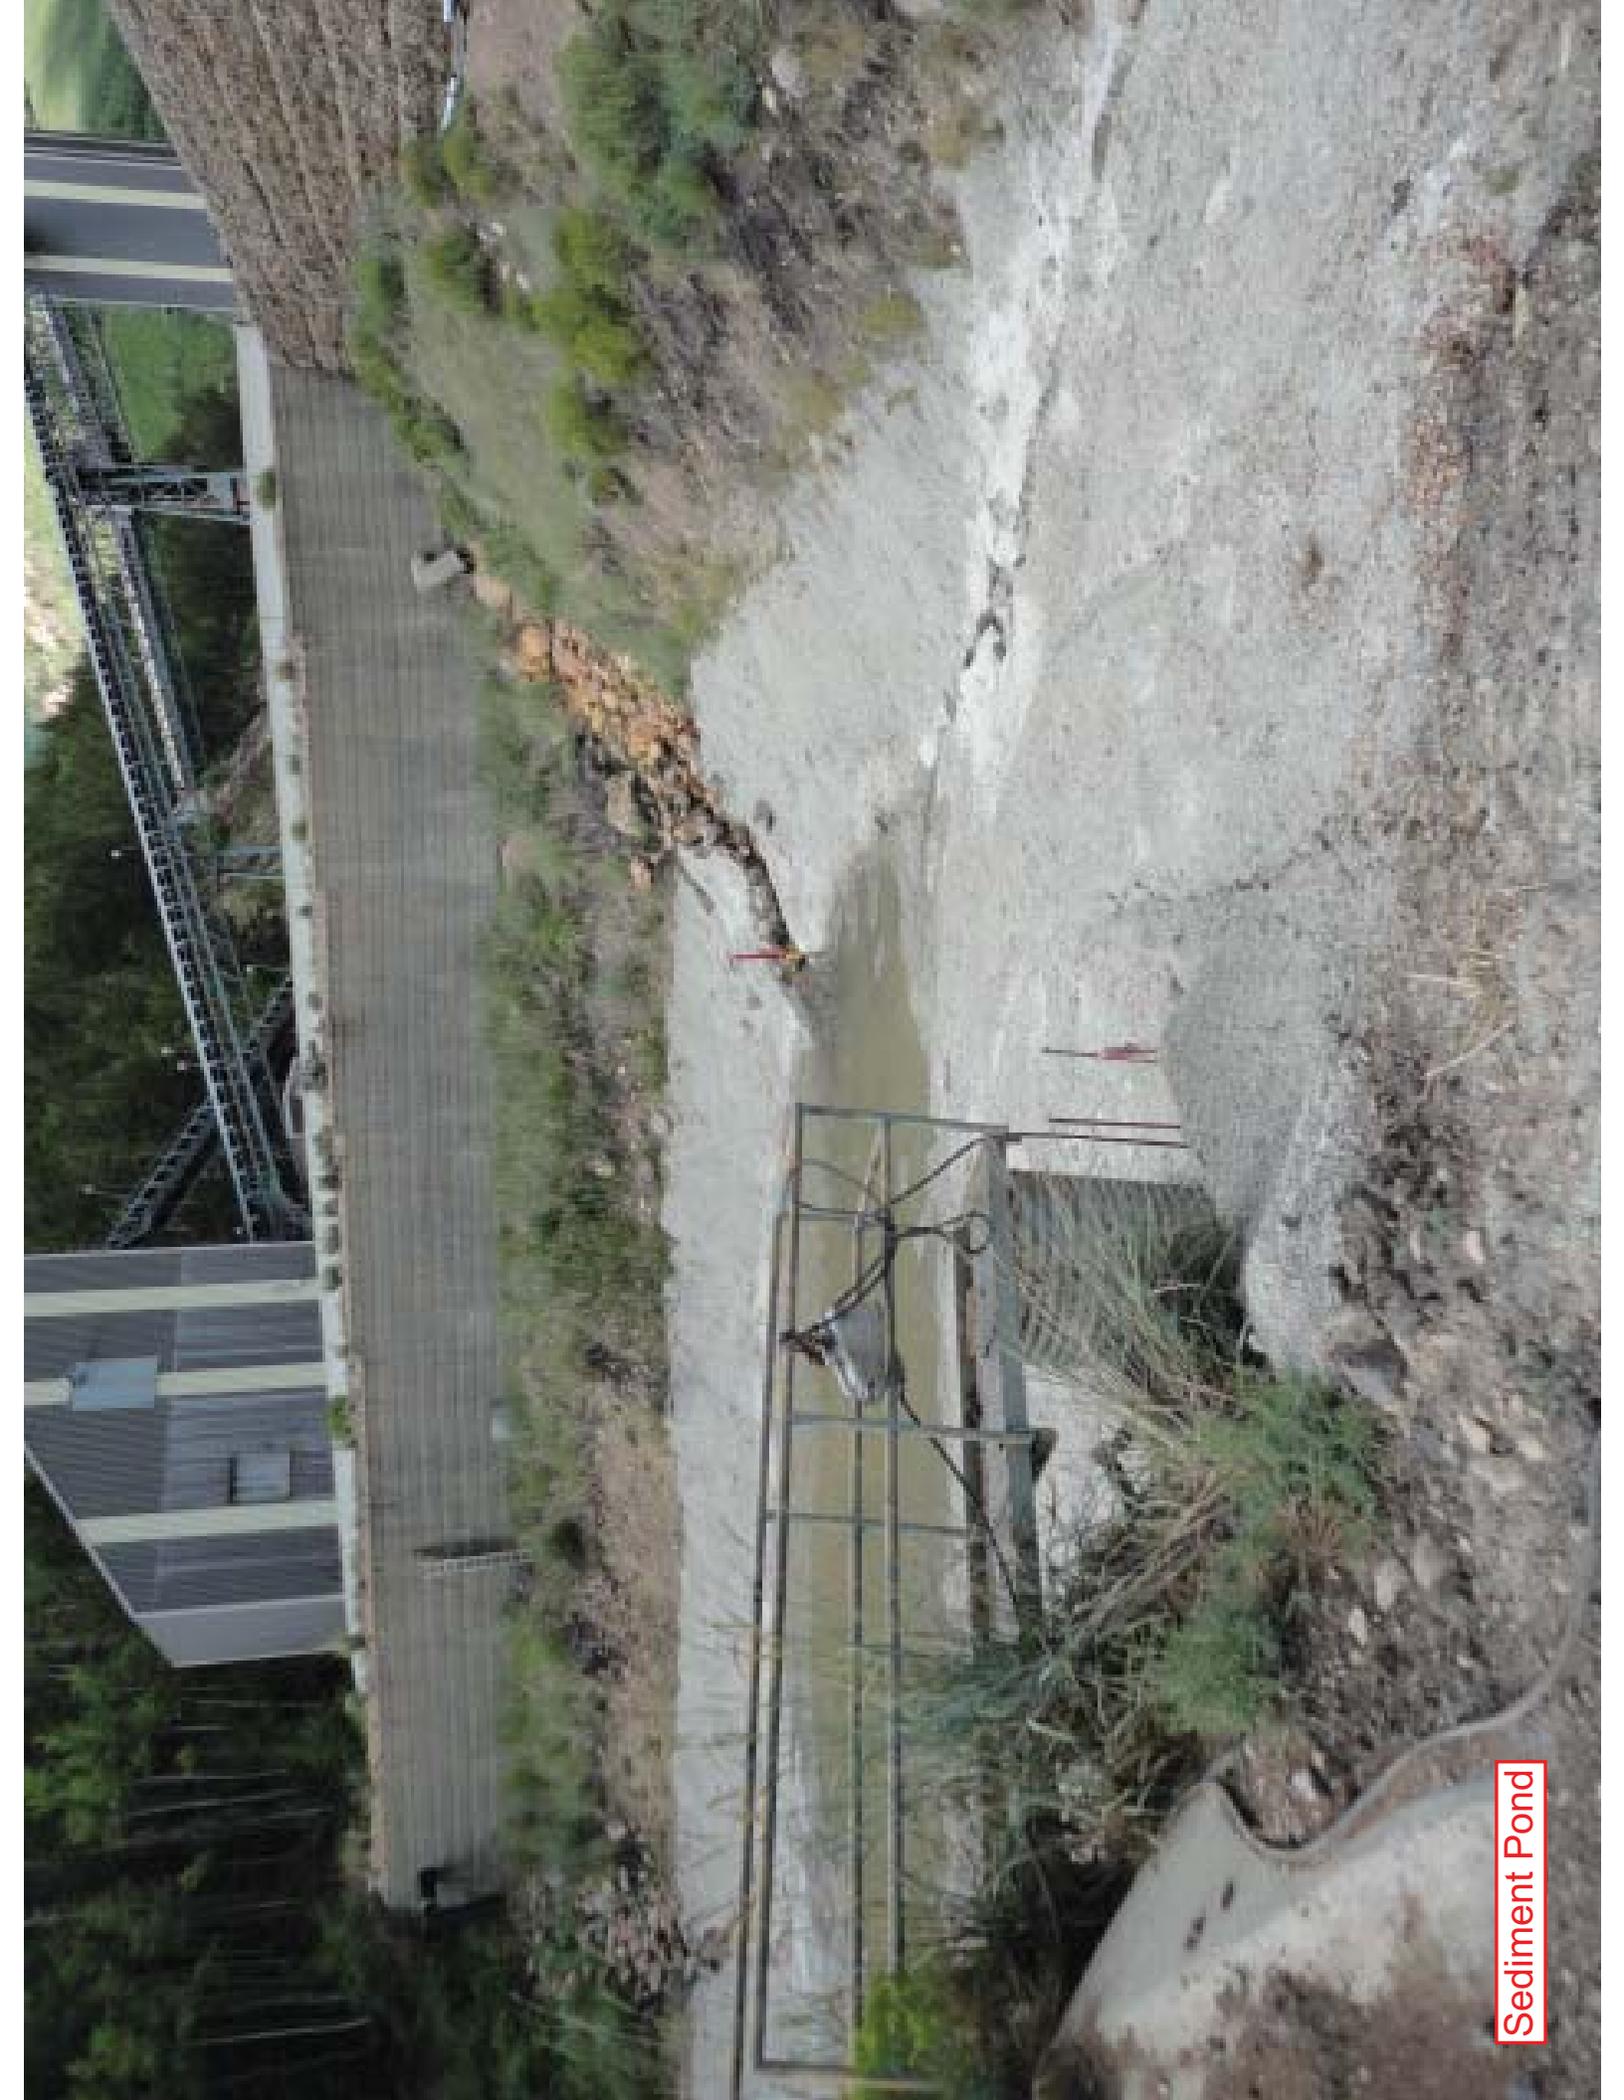
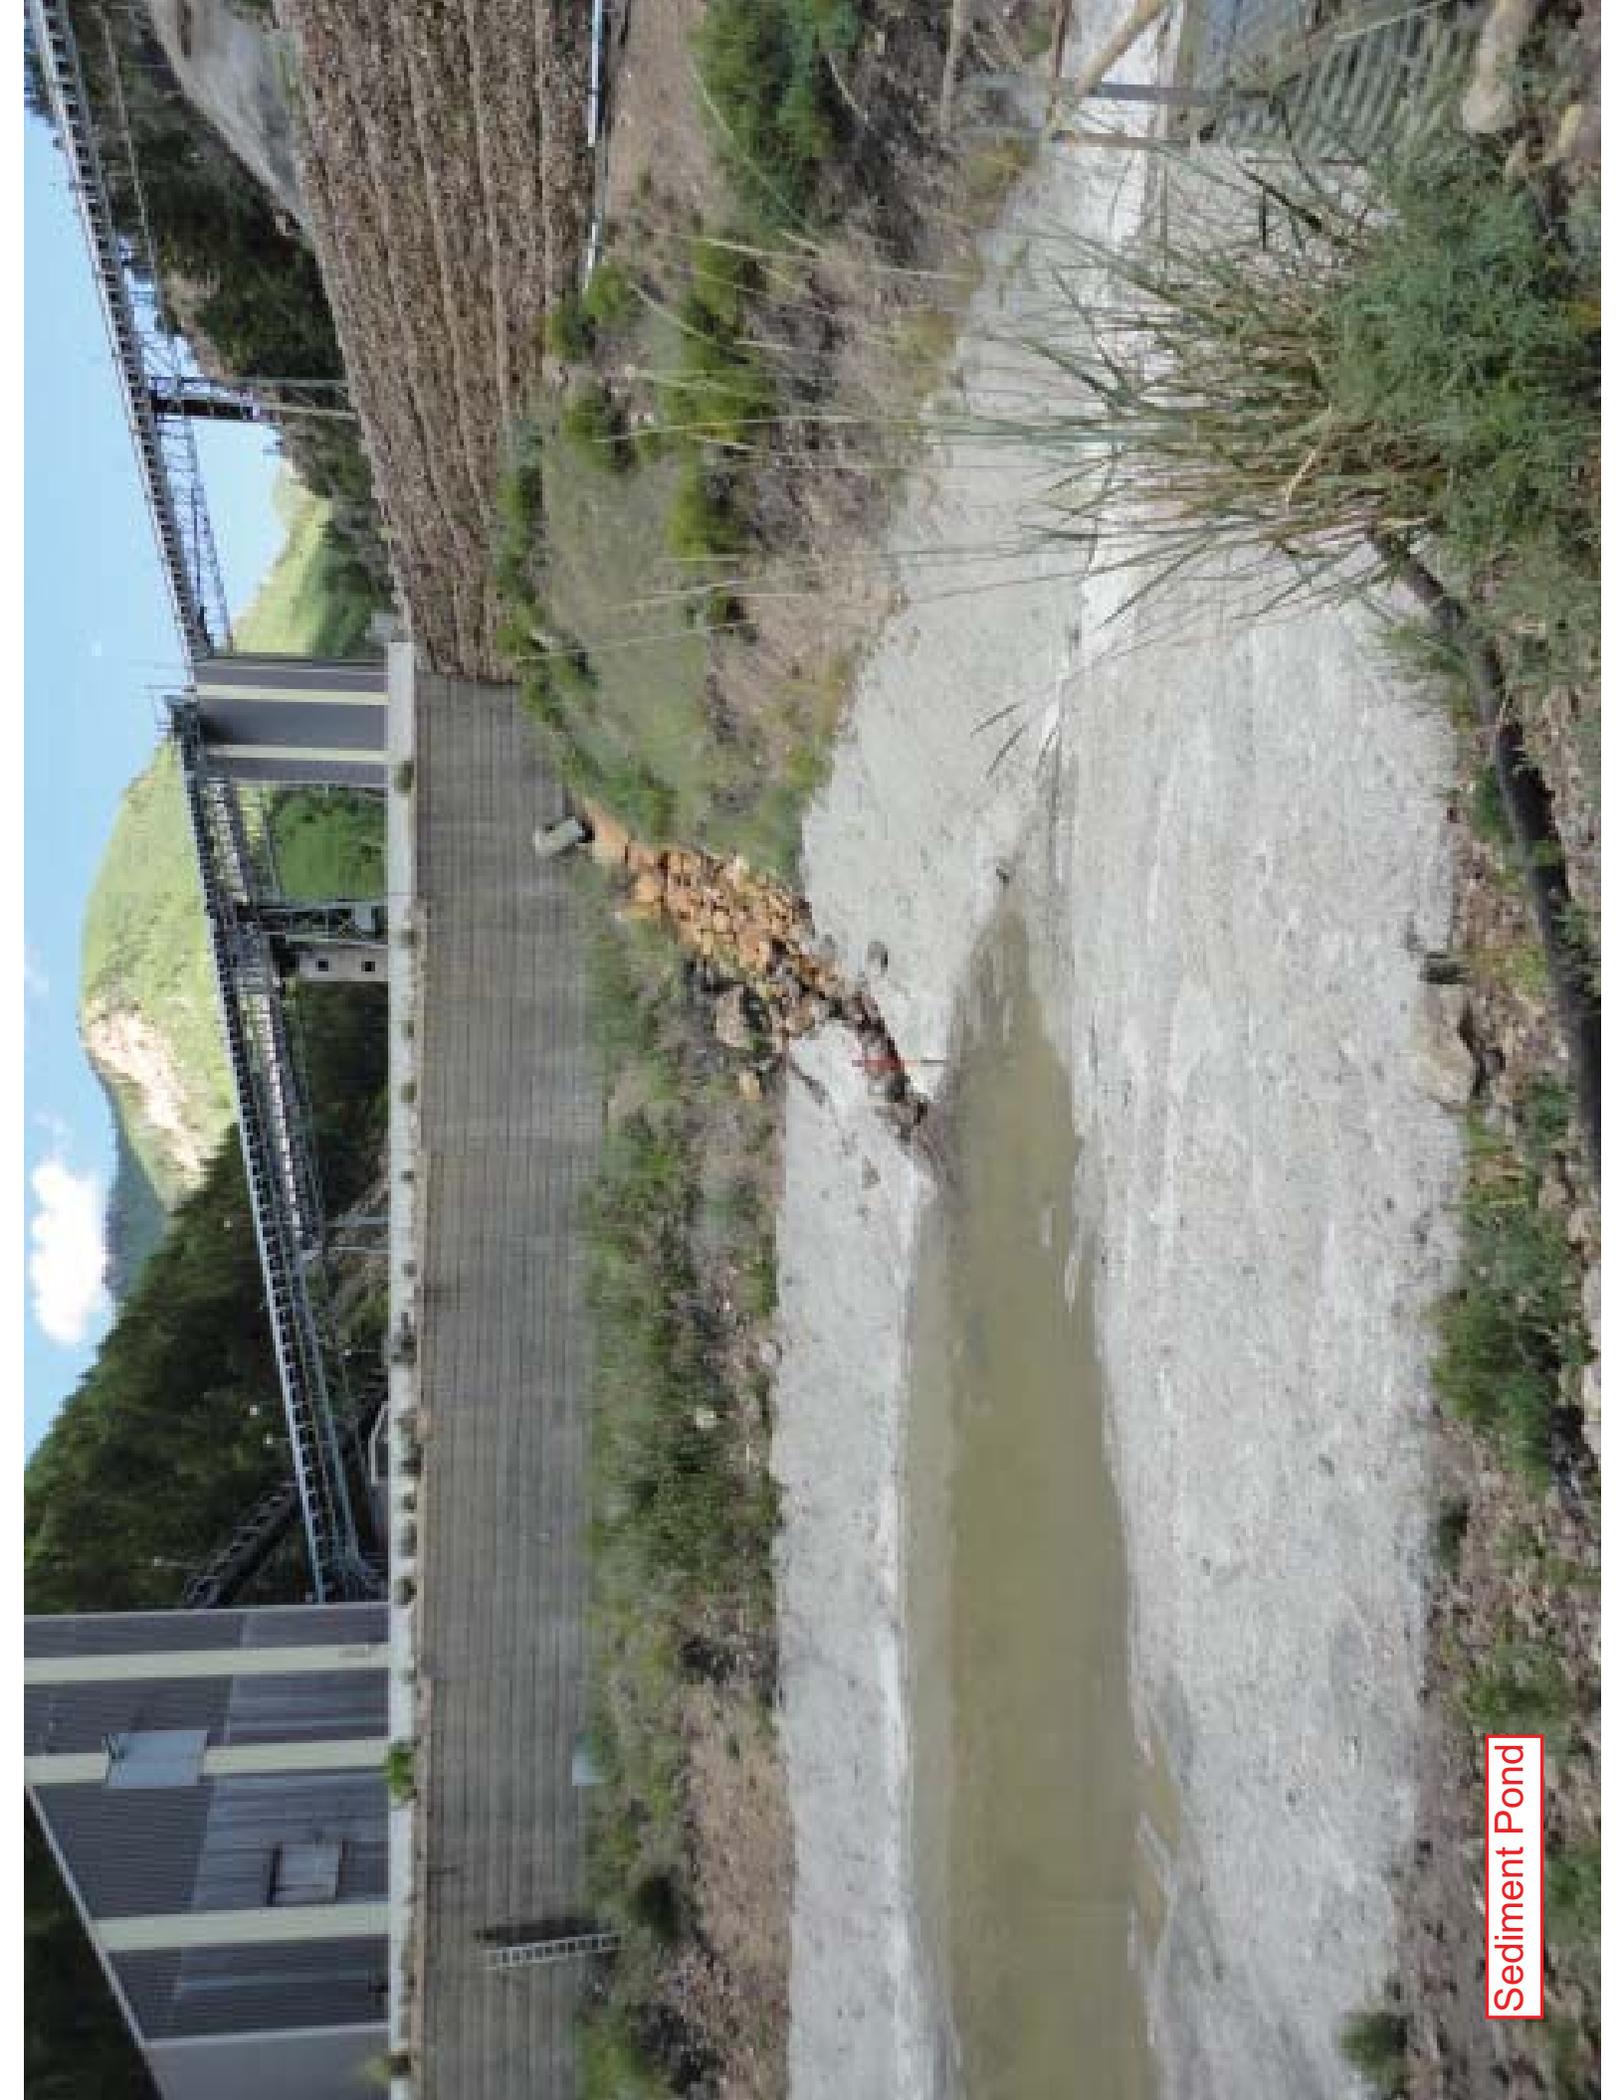
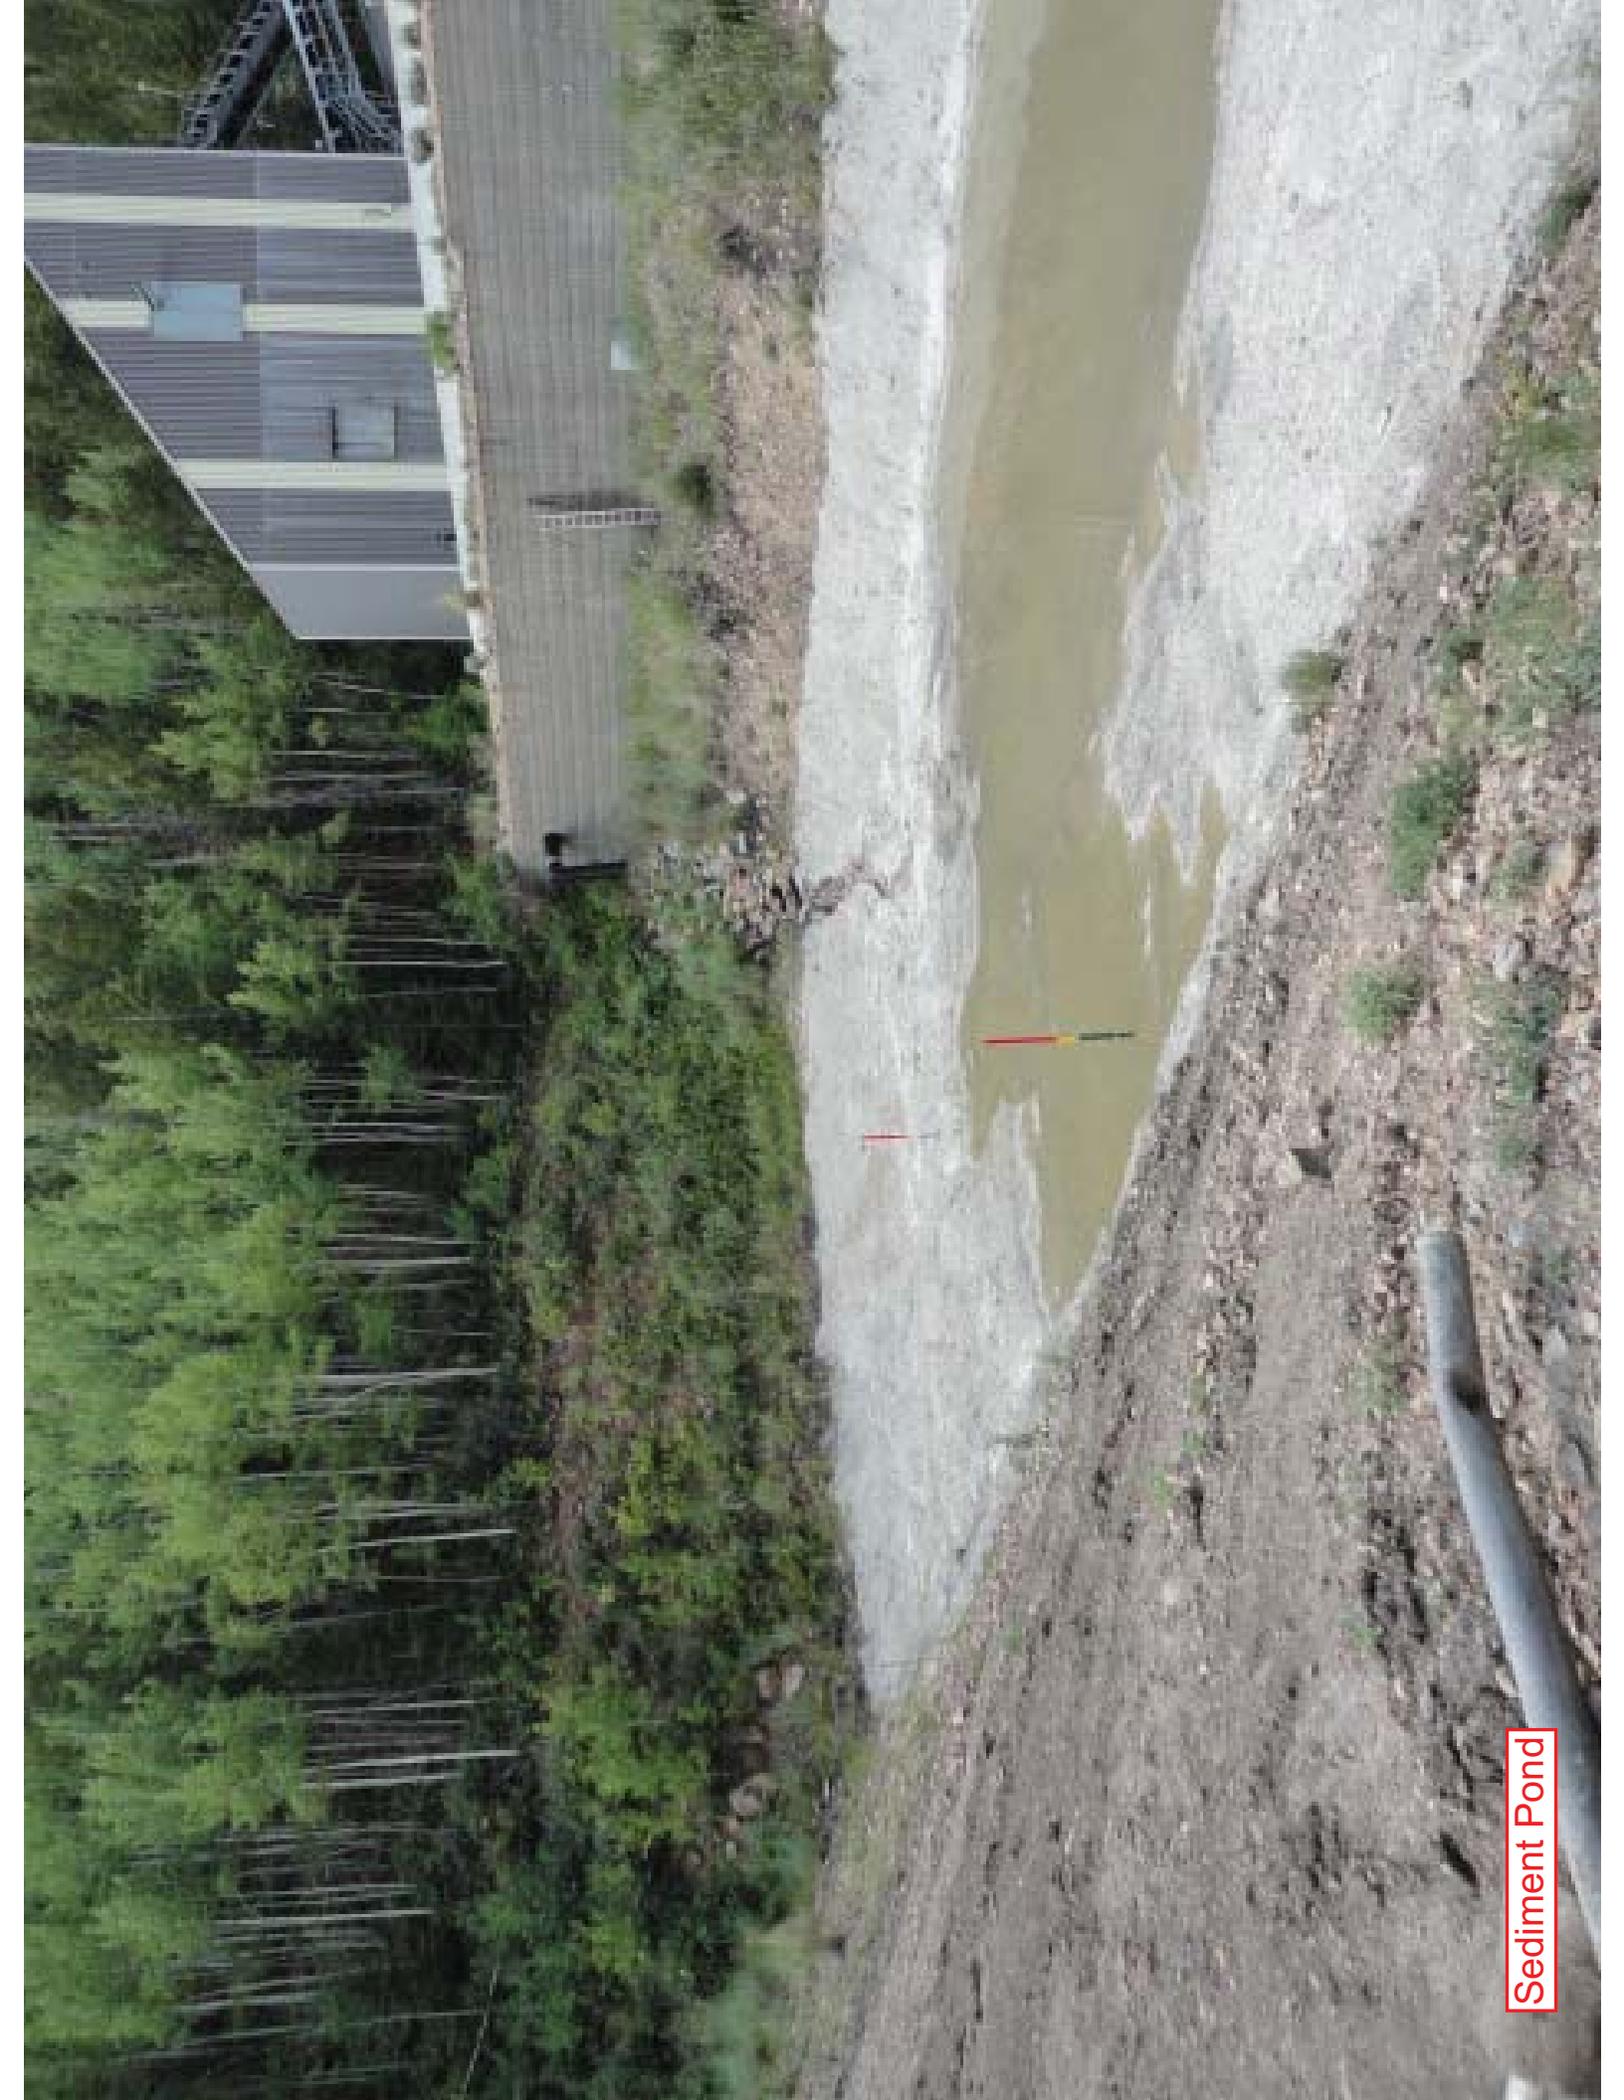
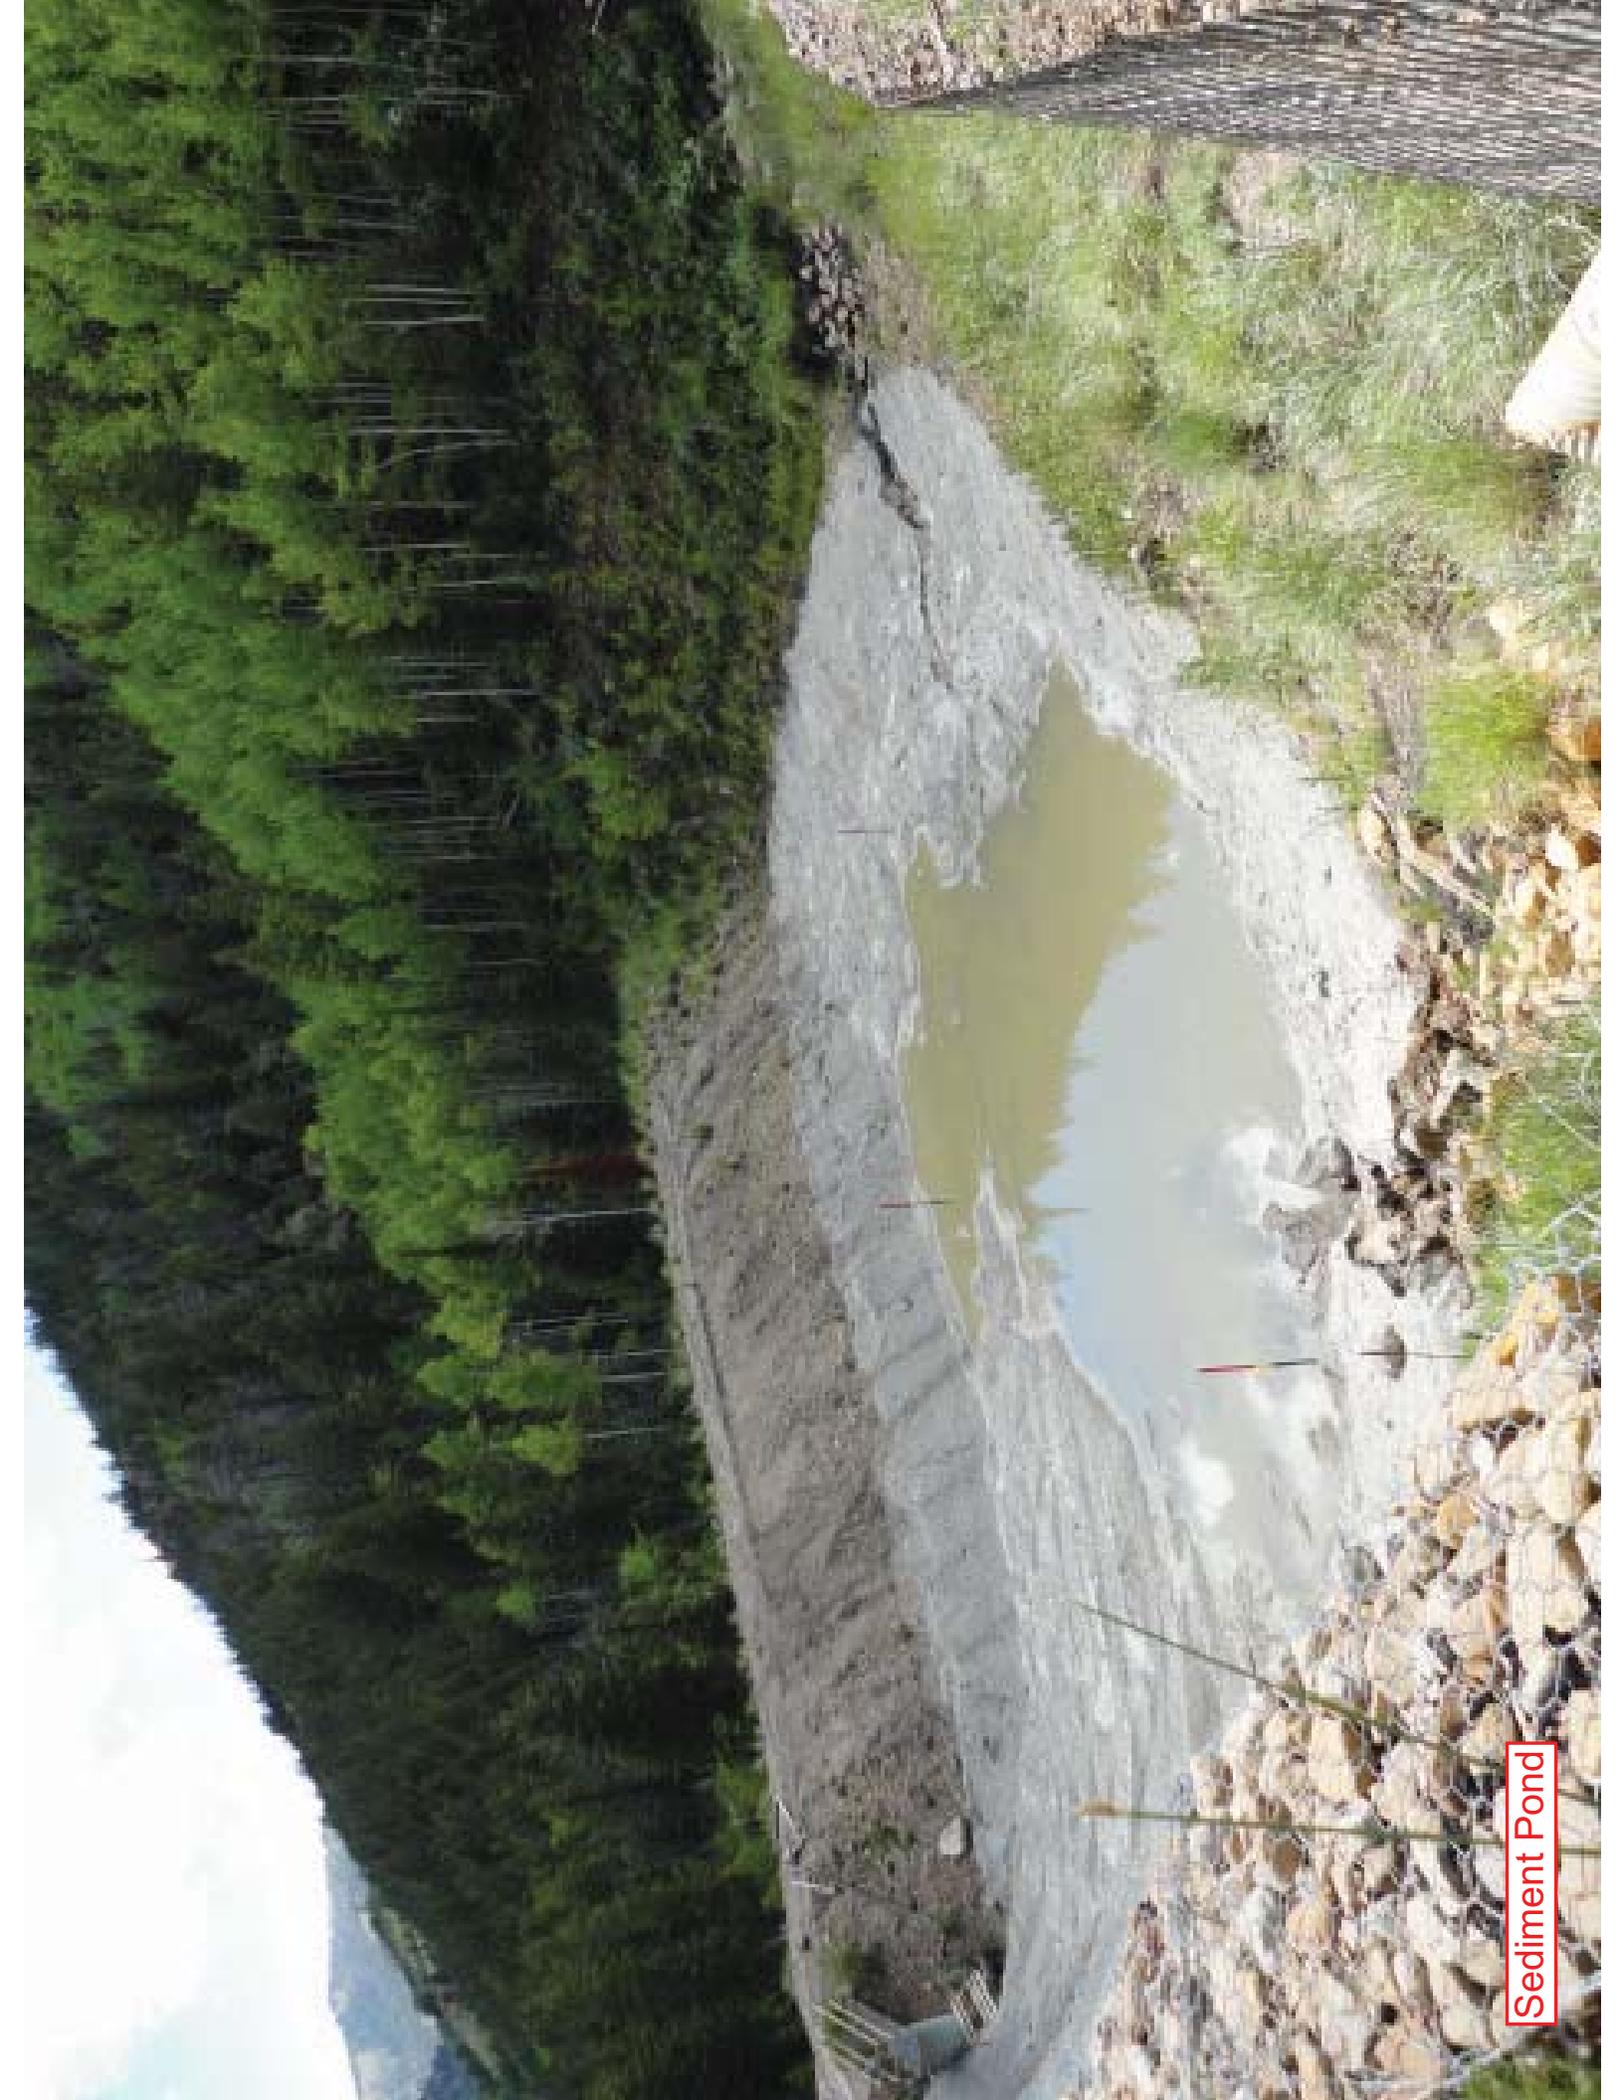
Evidence of bentonite clay placement inside the sediment pond is visible by the distinct color change between the clay and the natural ground.

Sediment Pond
