Inspection Report

Permit Number:	C0150032
Inspection Type:	PARTIAL
Inspection Date:	Tuesday, July 30, 2013
Start Date/Time:	7/30/2013 8:30:00 AM
End Date/Time:	7/30/2013 3:00:00 PM
Last Inspection:	Tuesday, June 25, 2013

Permittee: **GENWAL RESOURCES INC**
 Operator: **GENWAL RESOURCES INC**
 Site: **CRANDALL CANYON MINE**
 Address: **PO BOX 910, EAST CARBON UT 84520-0910**
 County: **EMERY**
 Permit Type: **PERMANENT COAL PROGRAM**
 Permit Status: **ACTIVE**

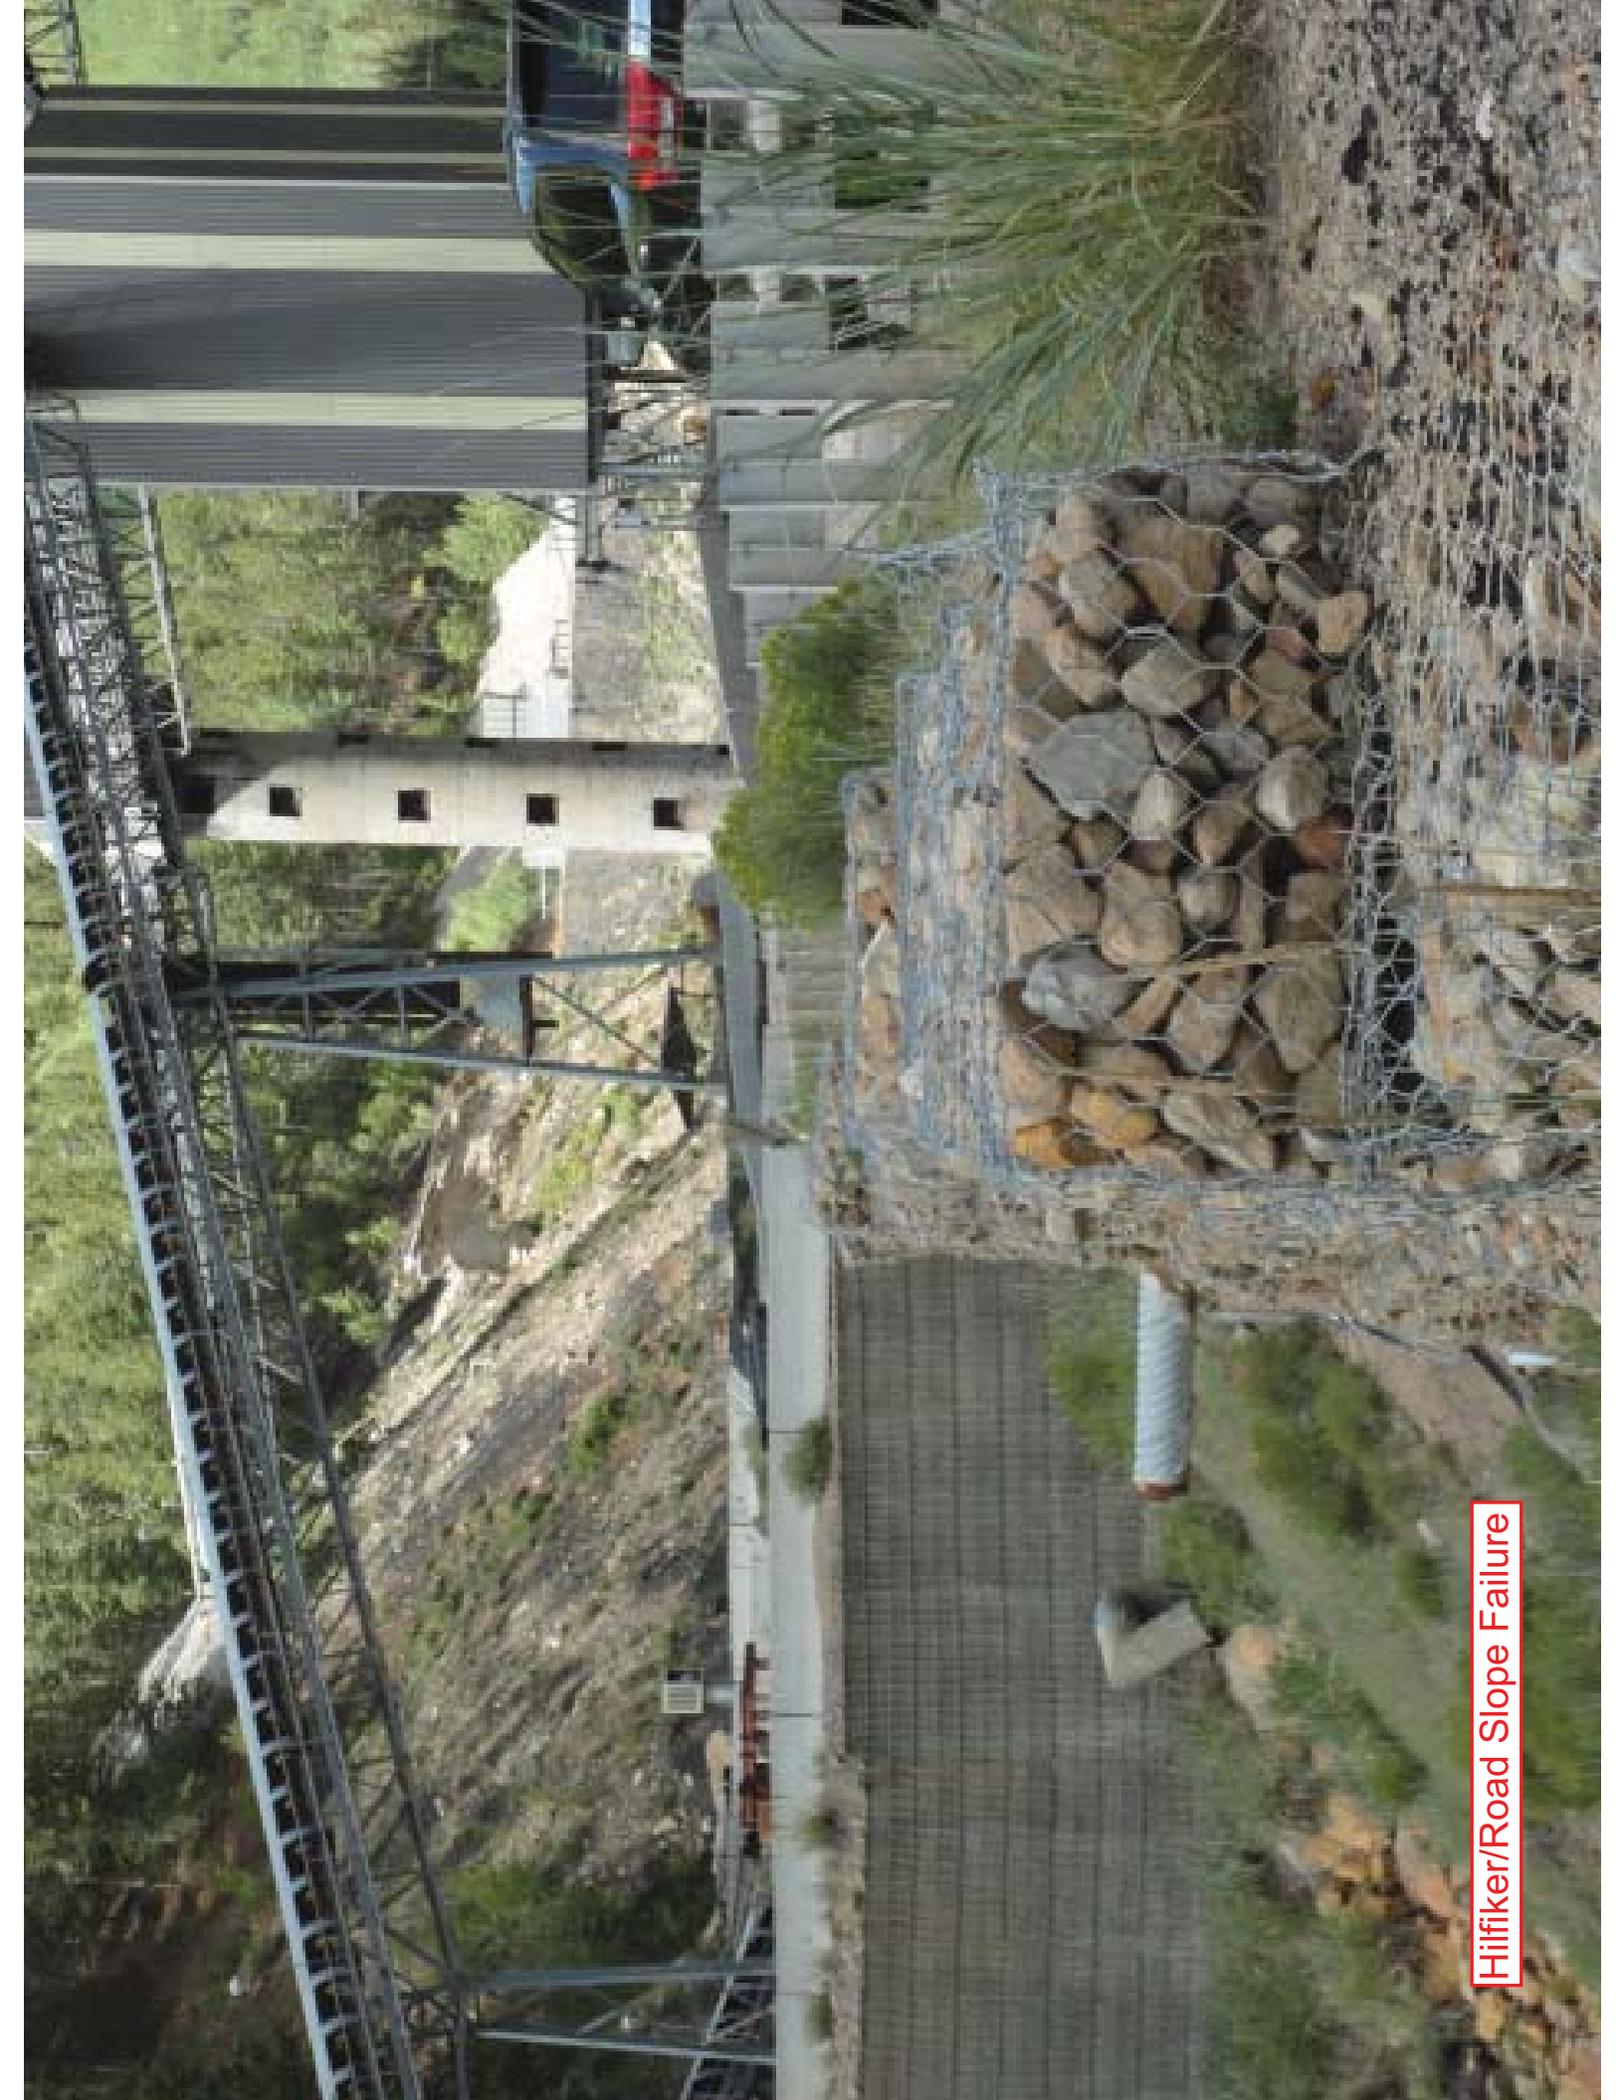
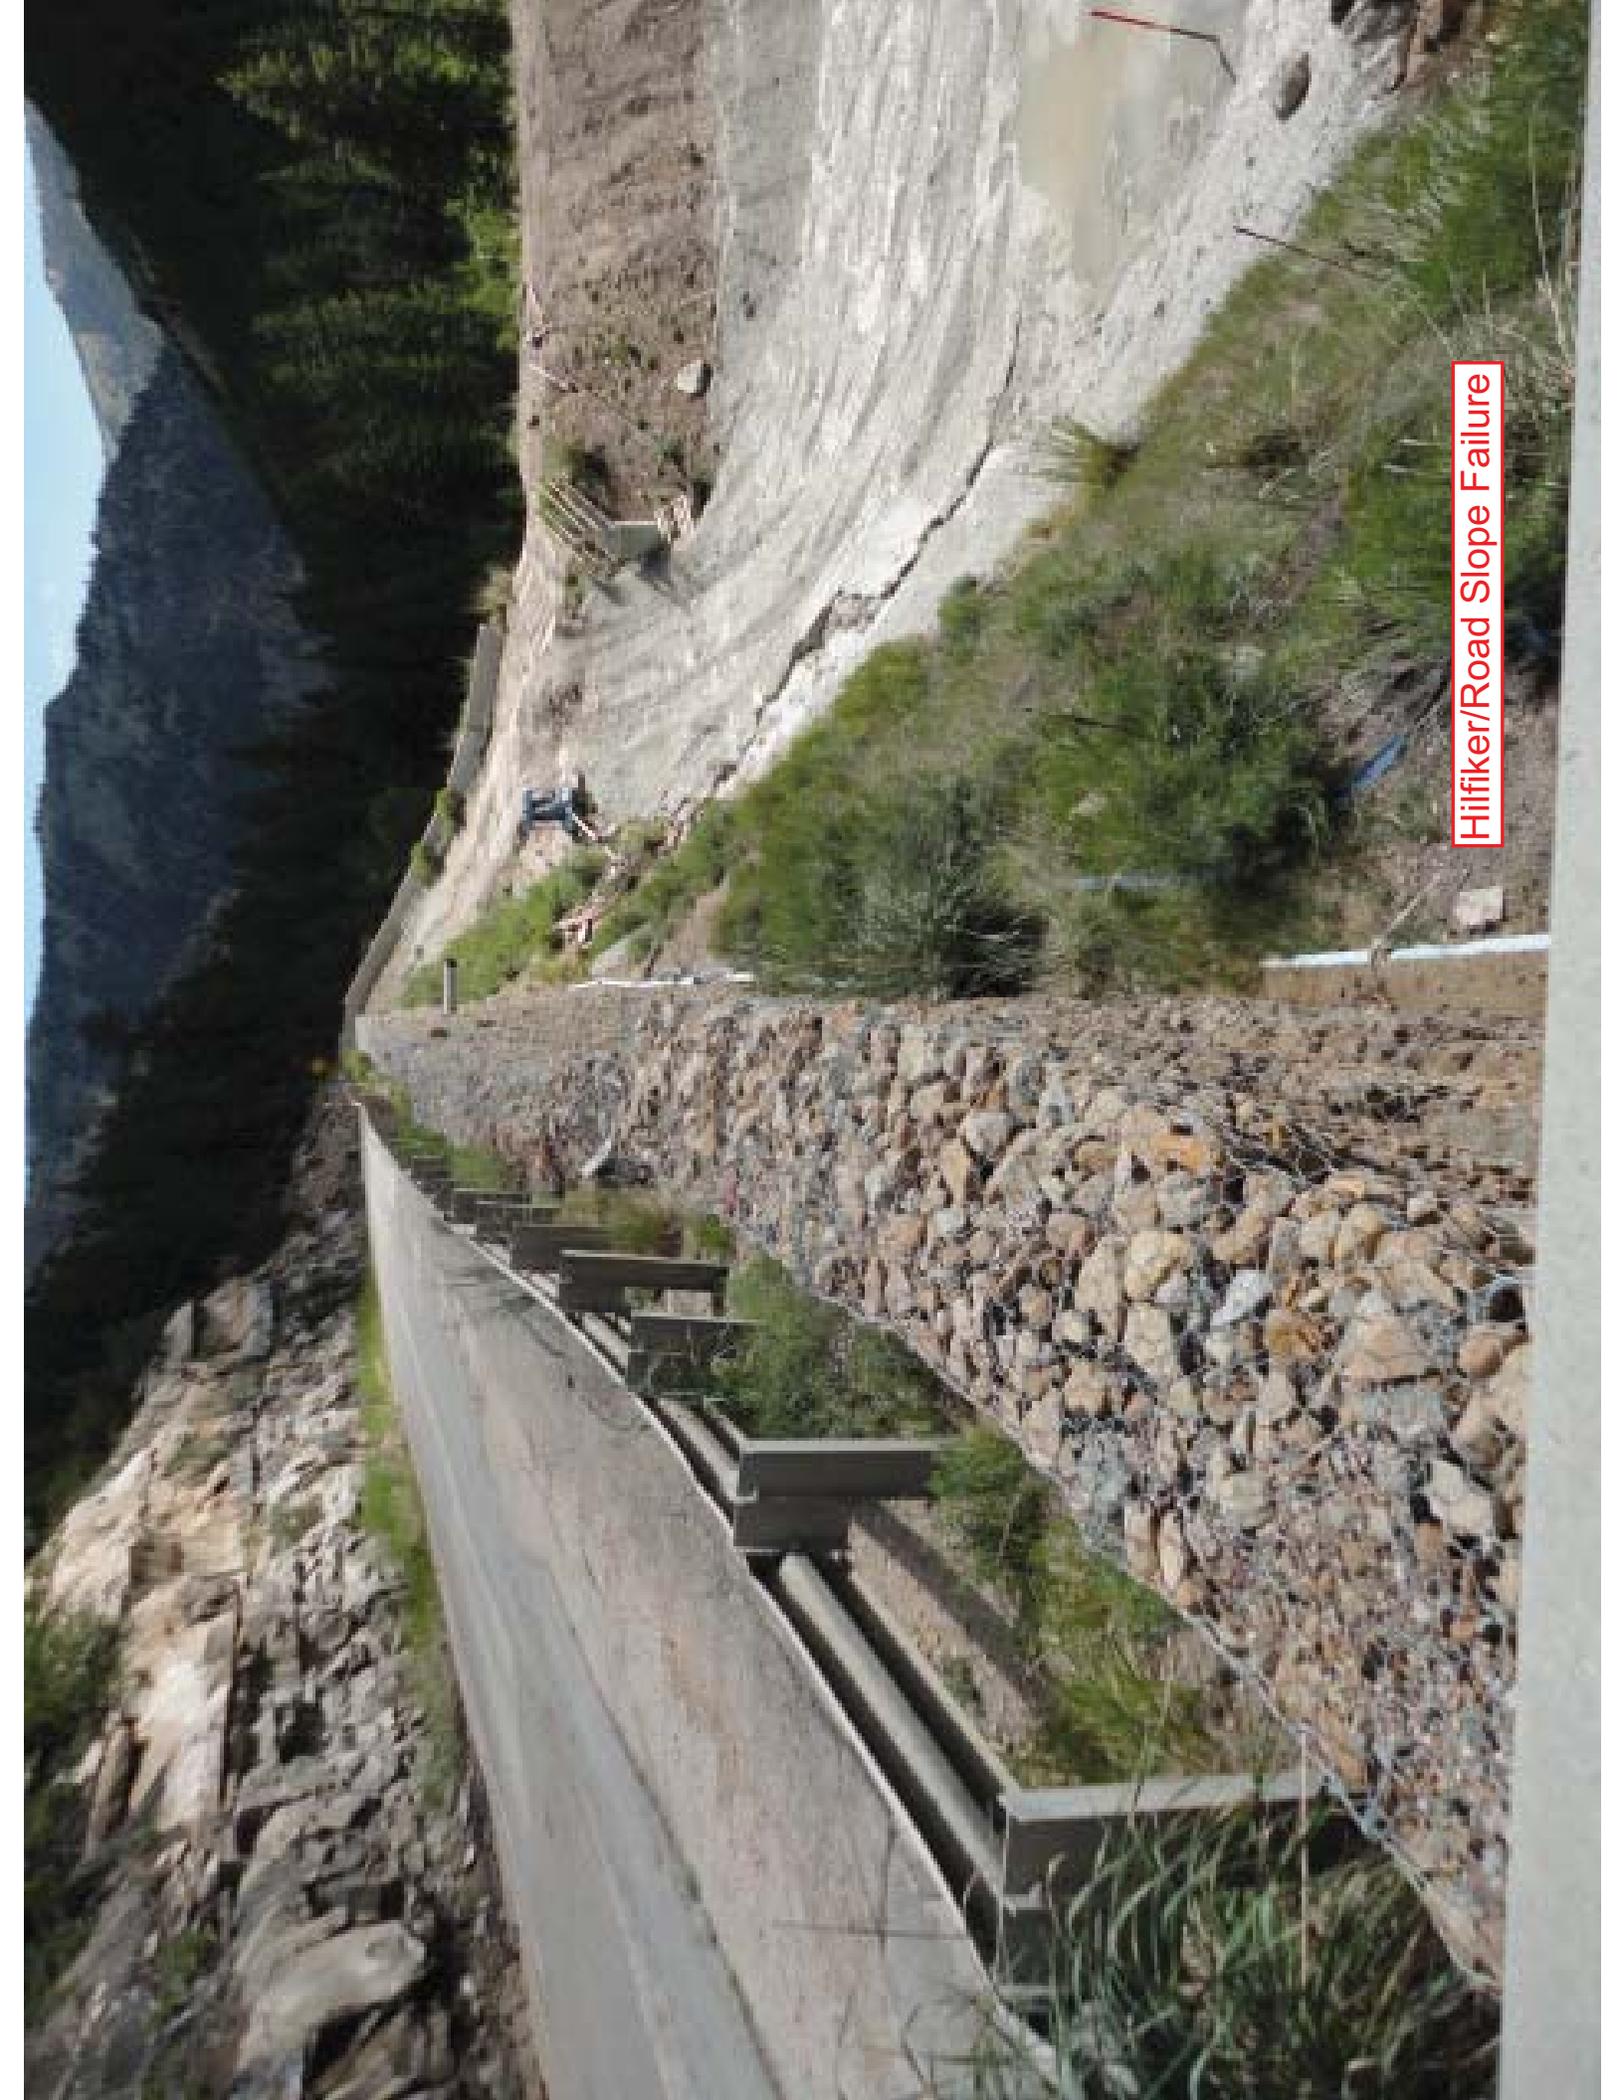
Hilfiker/Road Slope Failure

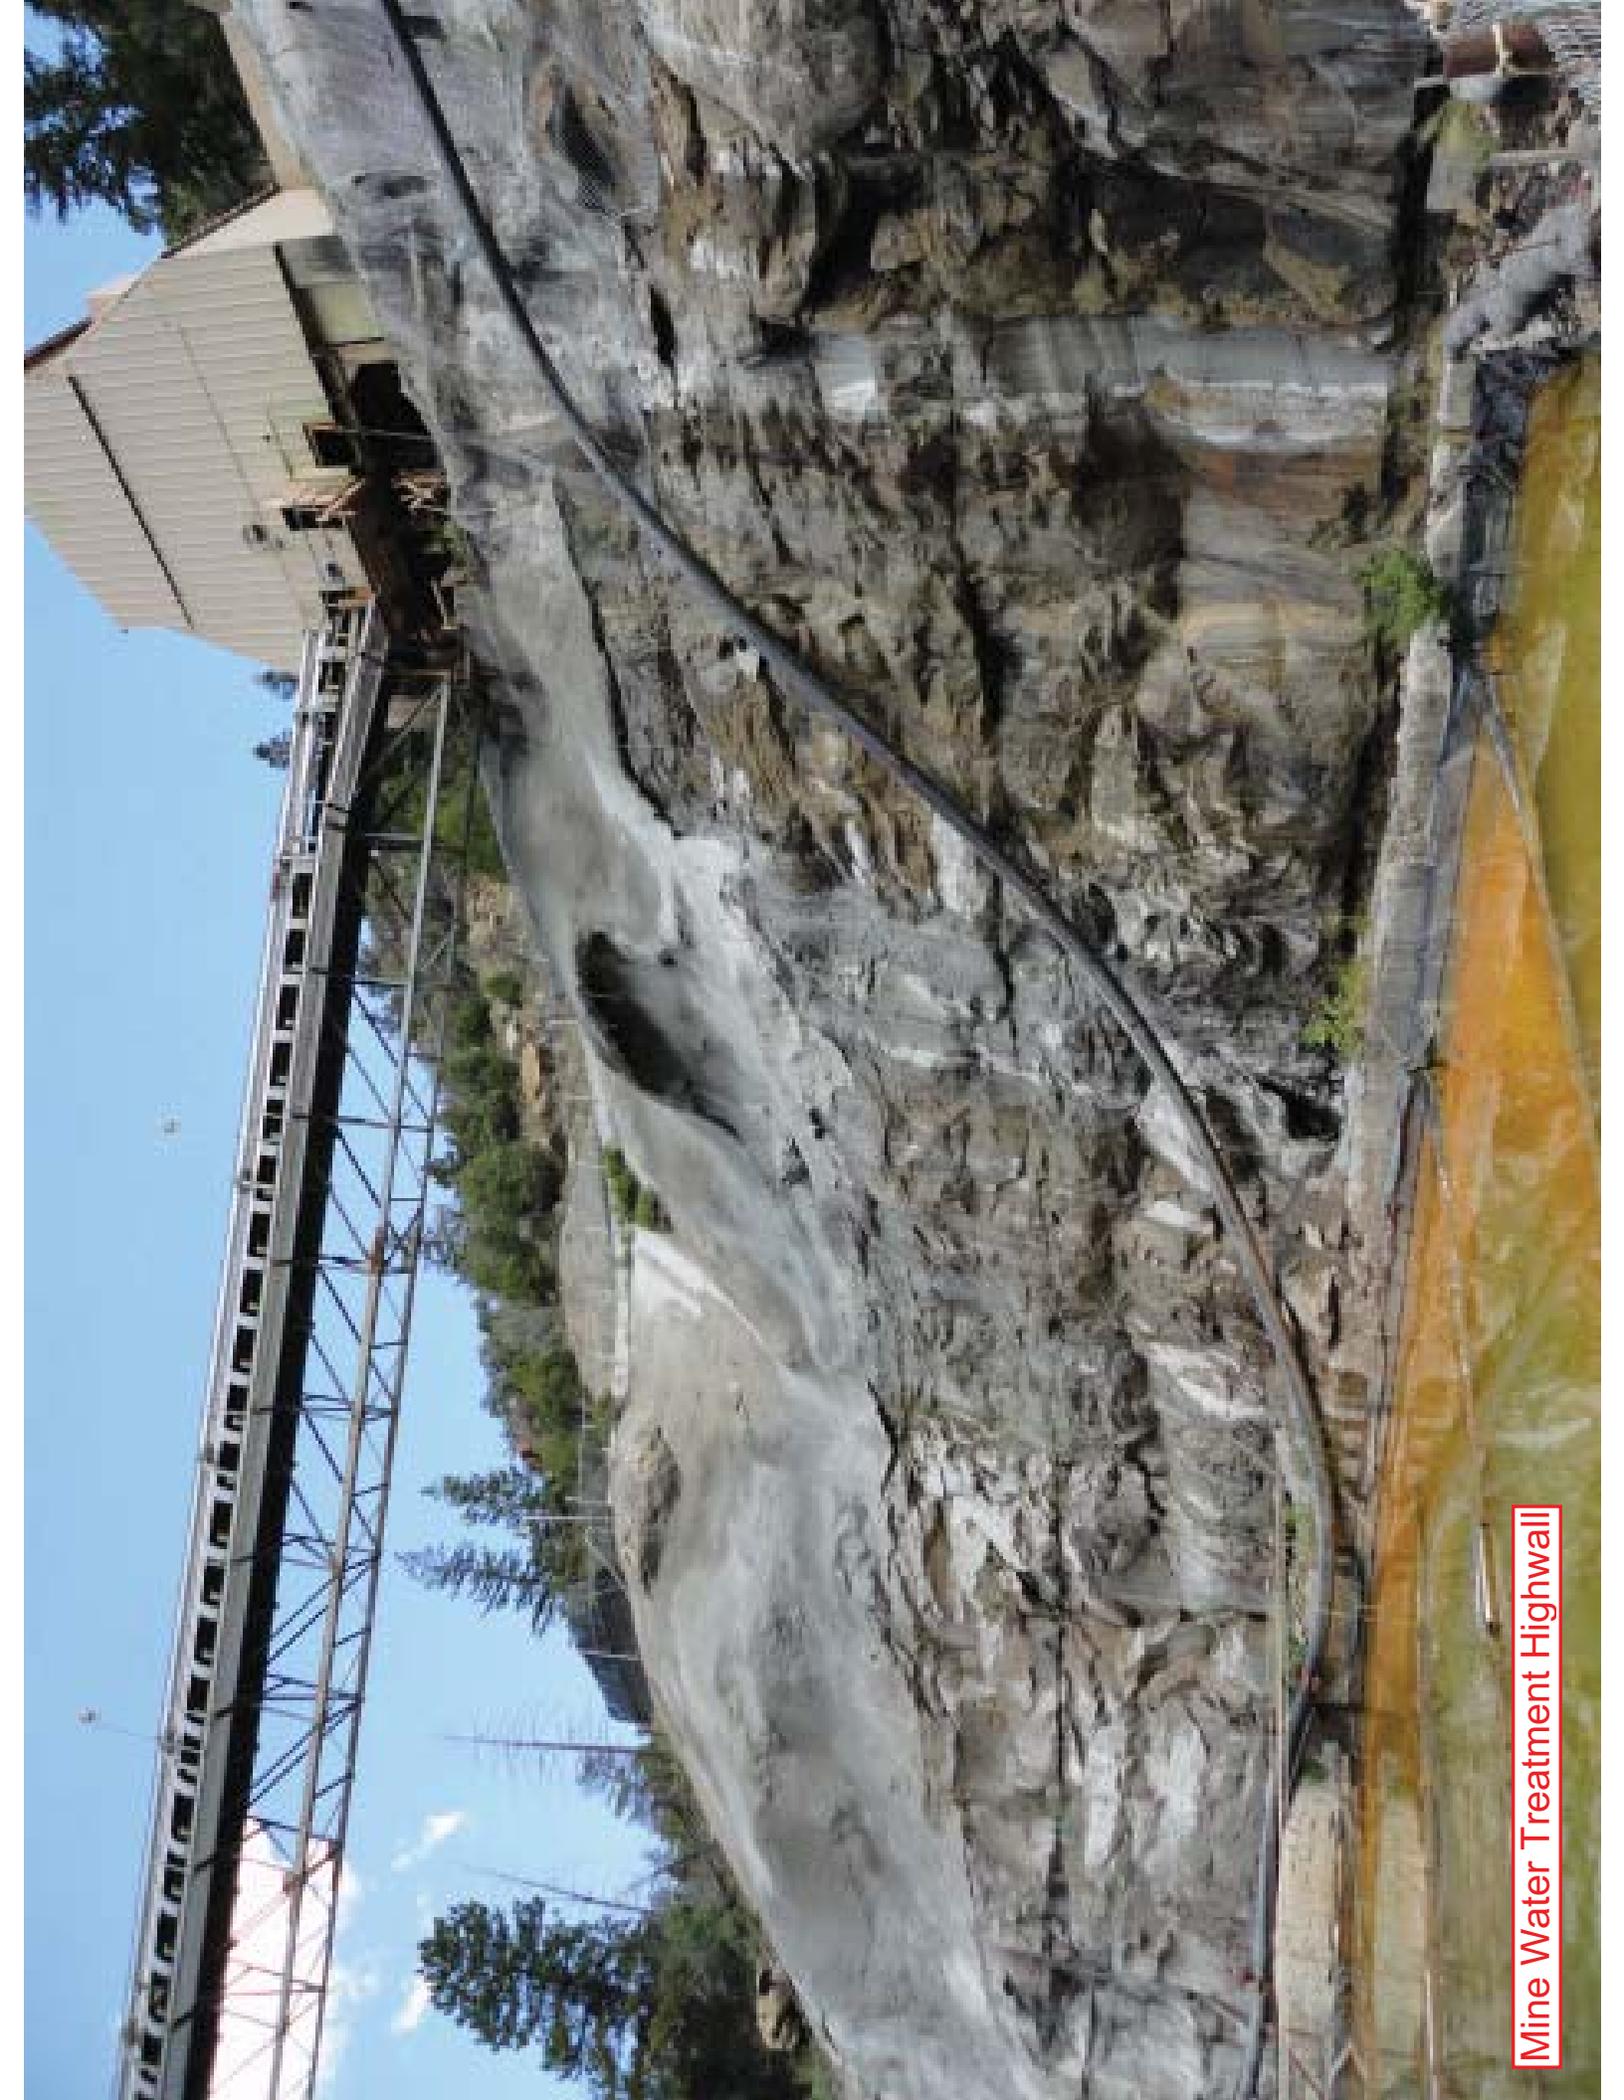
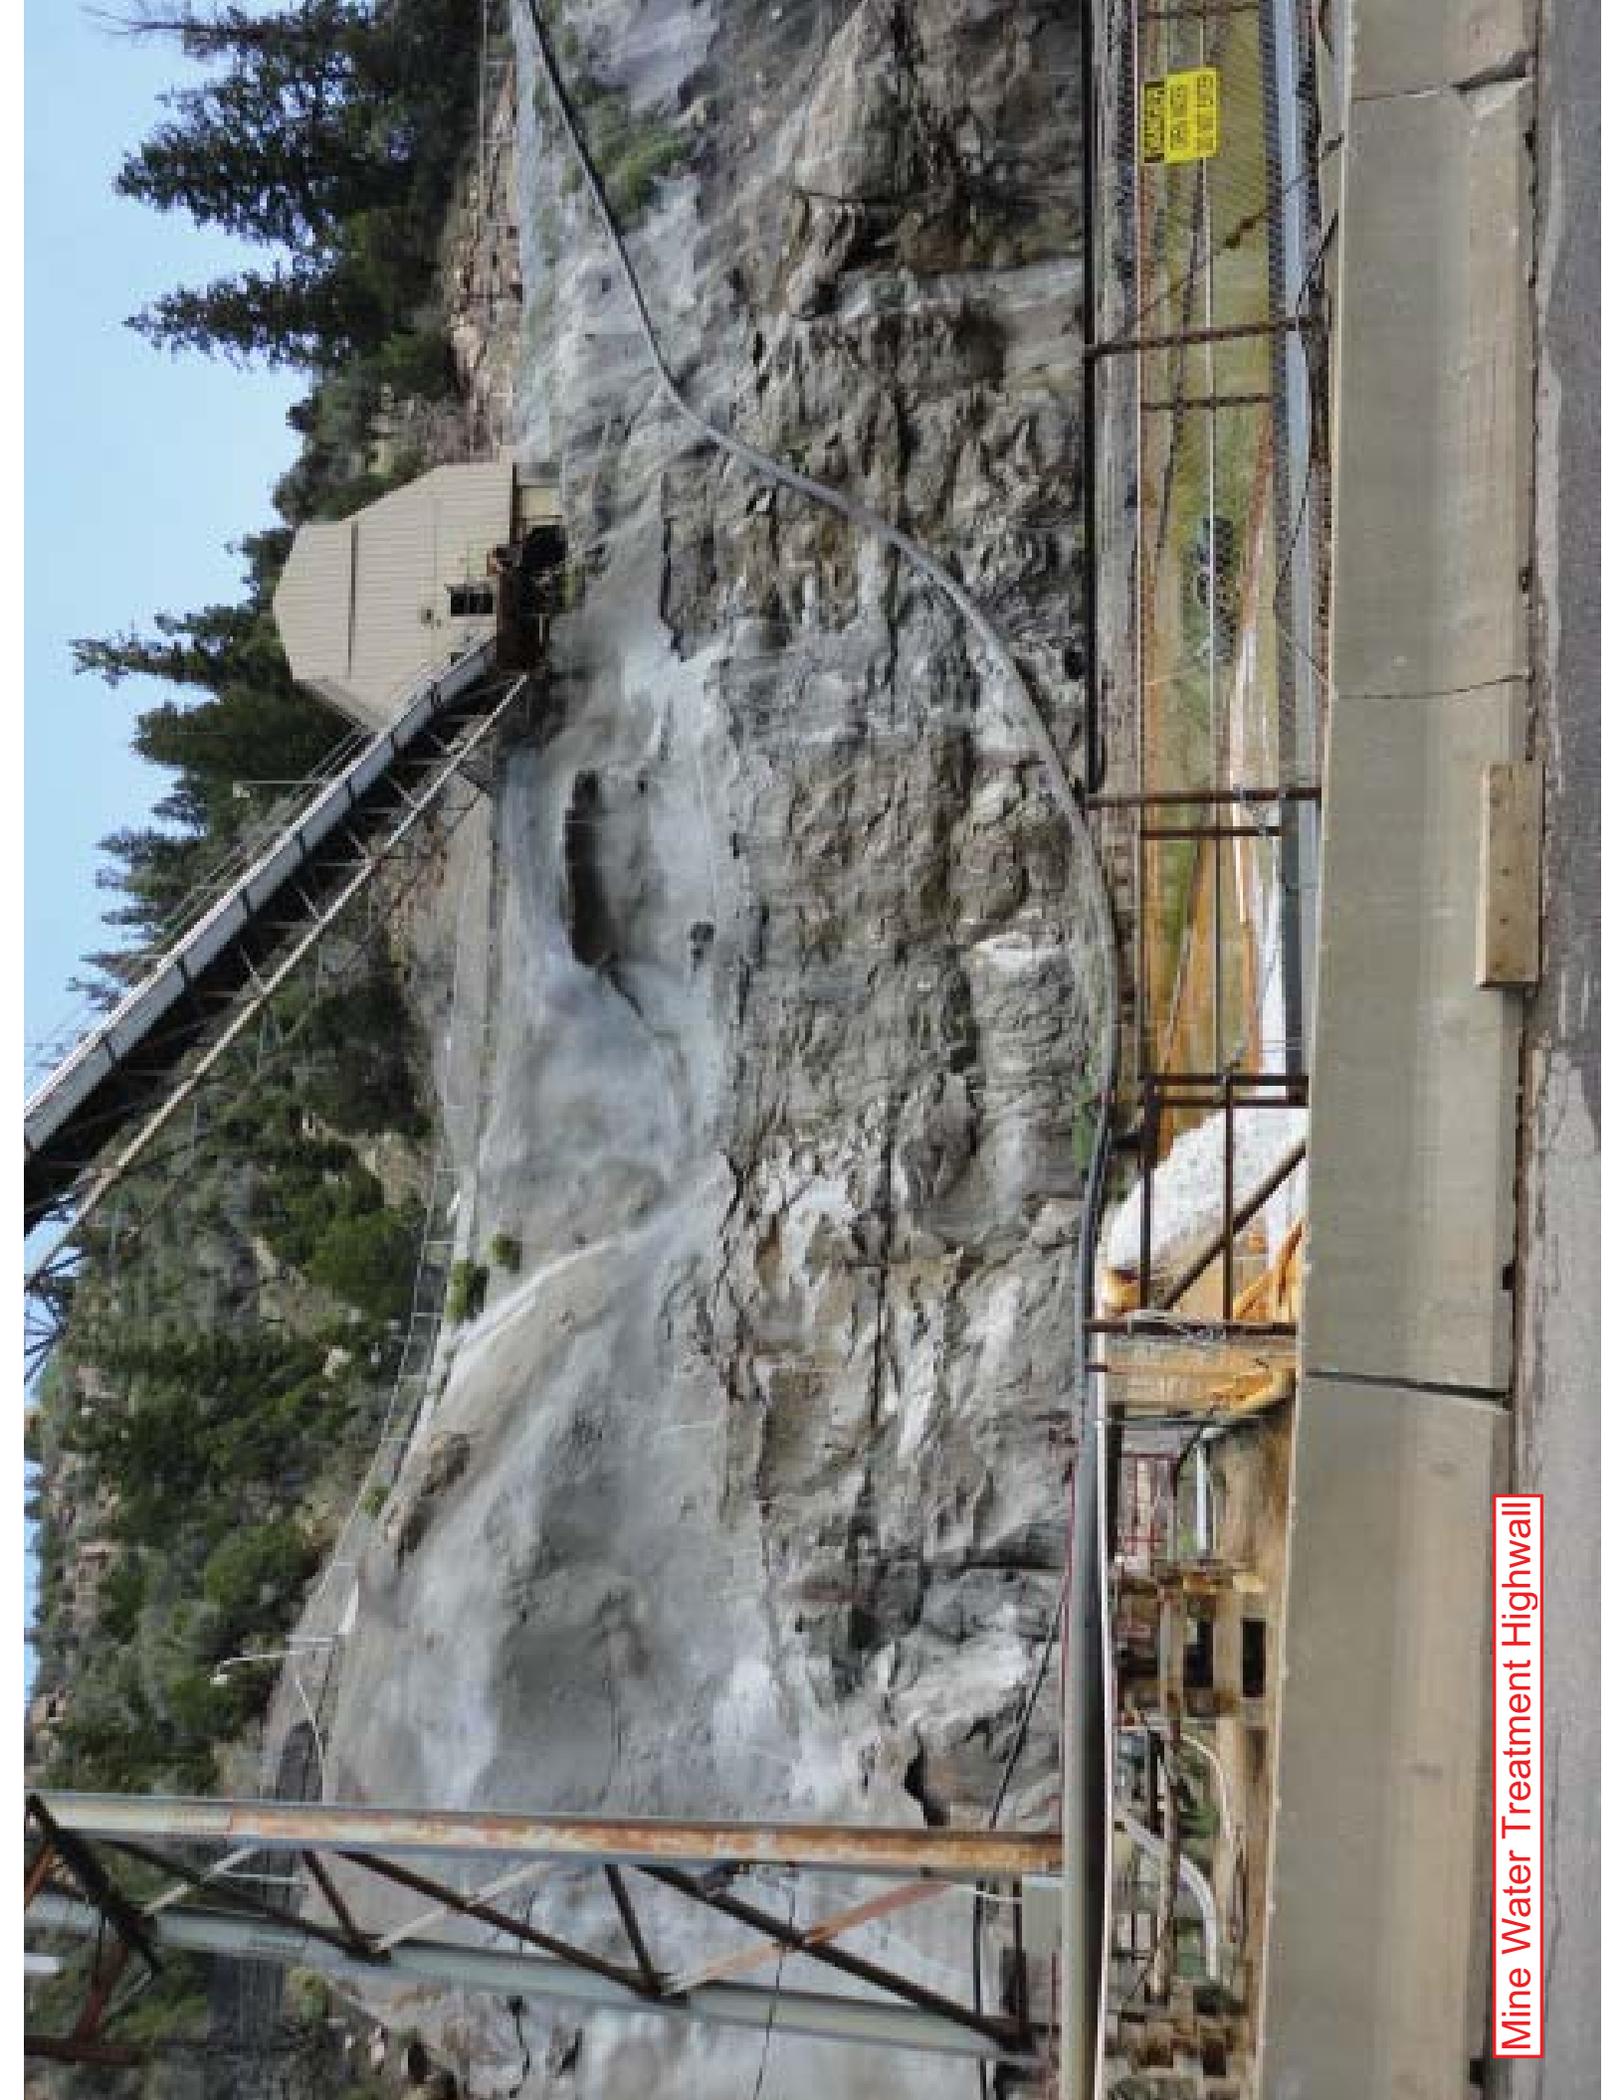
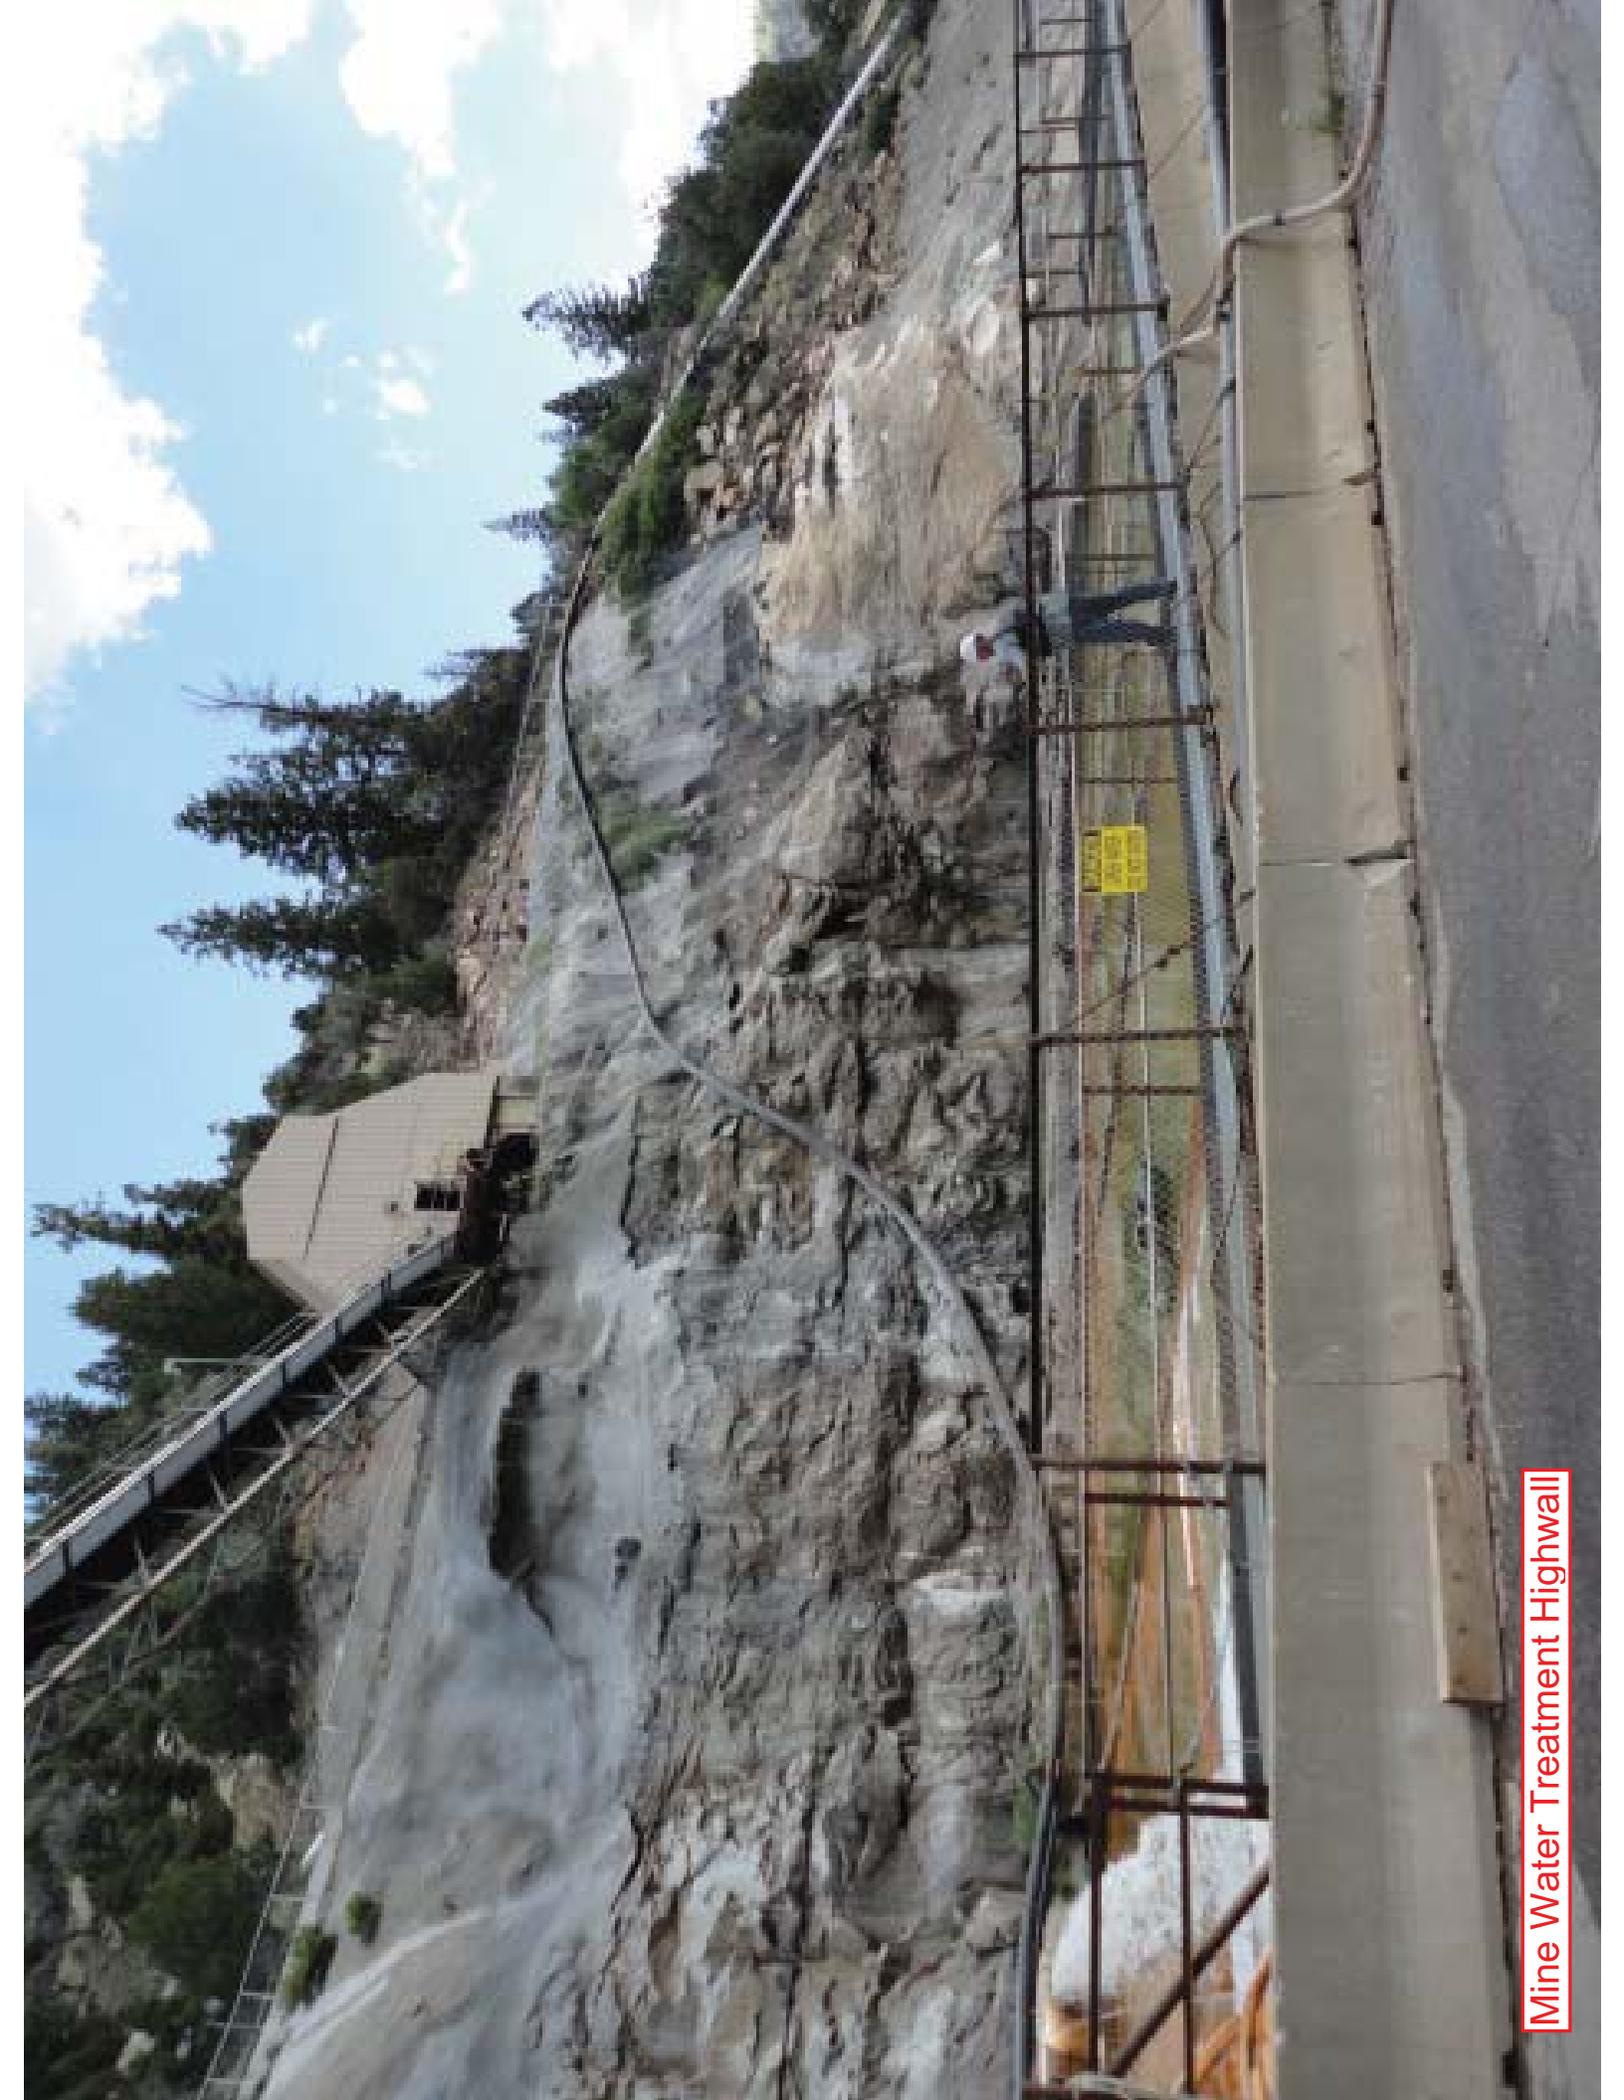
MSHA had been on site at the Crandall Mine to look at the work that has been done on the highwall above the iron treatment pond. The order has not been lifted yet.

Mine Water Treatment Highwall
