Inspection Report

Permit Number:	C0150032
Inspection Type:	COMPLETE
Inspection Date:	Thursday, November 03, 2016
Start Date/Time:	11/3/2016 10:00:00 AM
End Date/Time:	11/7/2016 1:00:00 PM
Last Inspection:	Thursday, October 13, 2016

Permittee: **GENWAL RESOURCES INC**
 Operator: **GENWAL RESOURCES INC**
 Site: **CRANDALL CANYON MINE**
 Address: **PO BOX 910, EAST CARBON UT 84520-0910**
 County: **EMERY**
 Permit Type: **PERMANENT COAL PROGRAM**
 Permit Status: **INACTIVE**

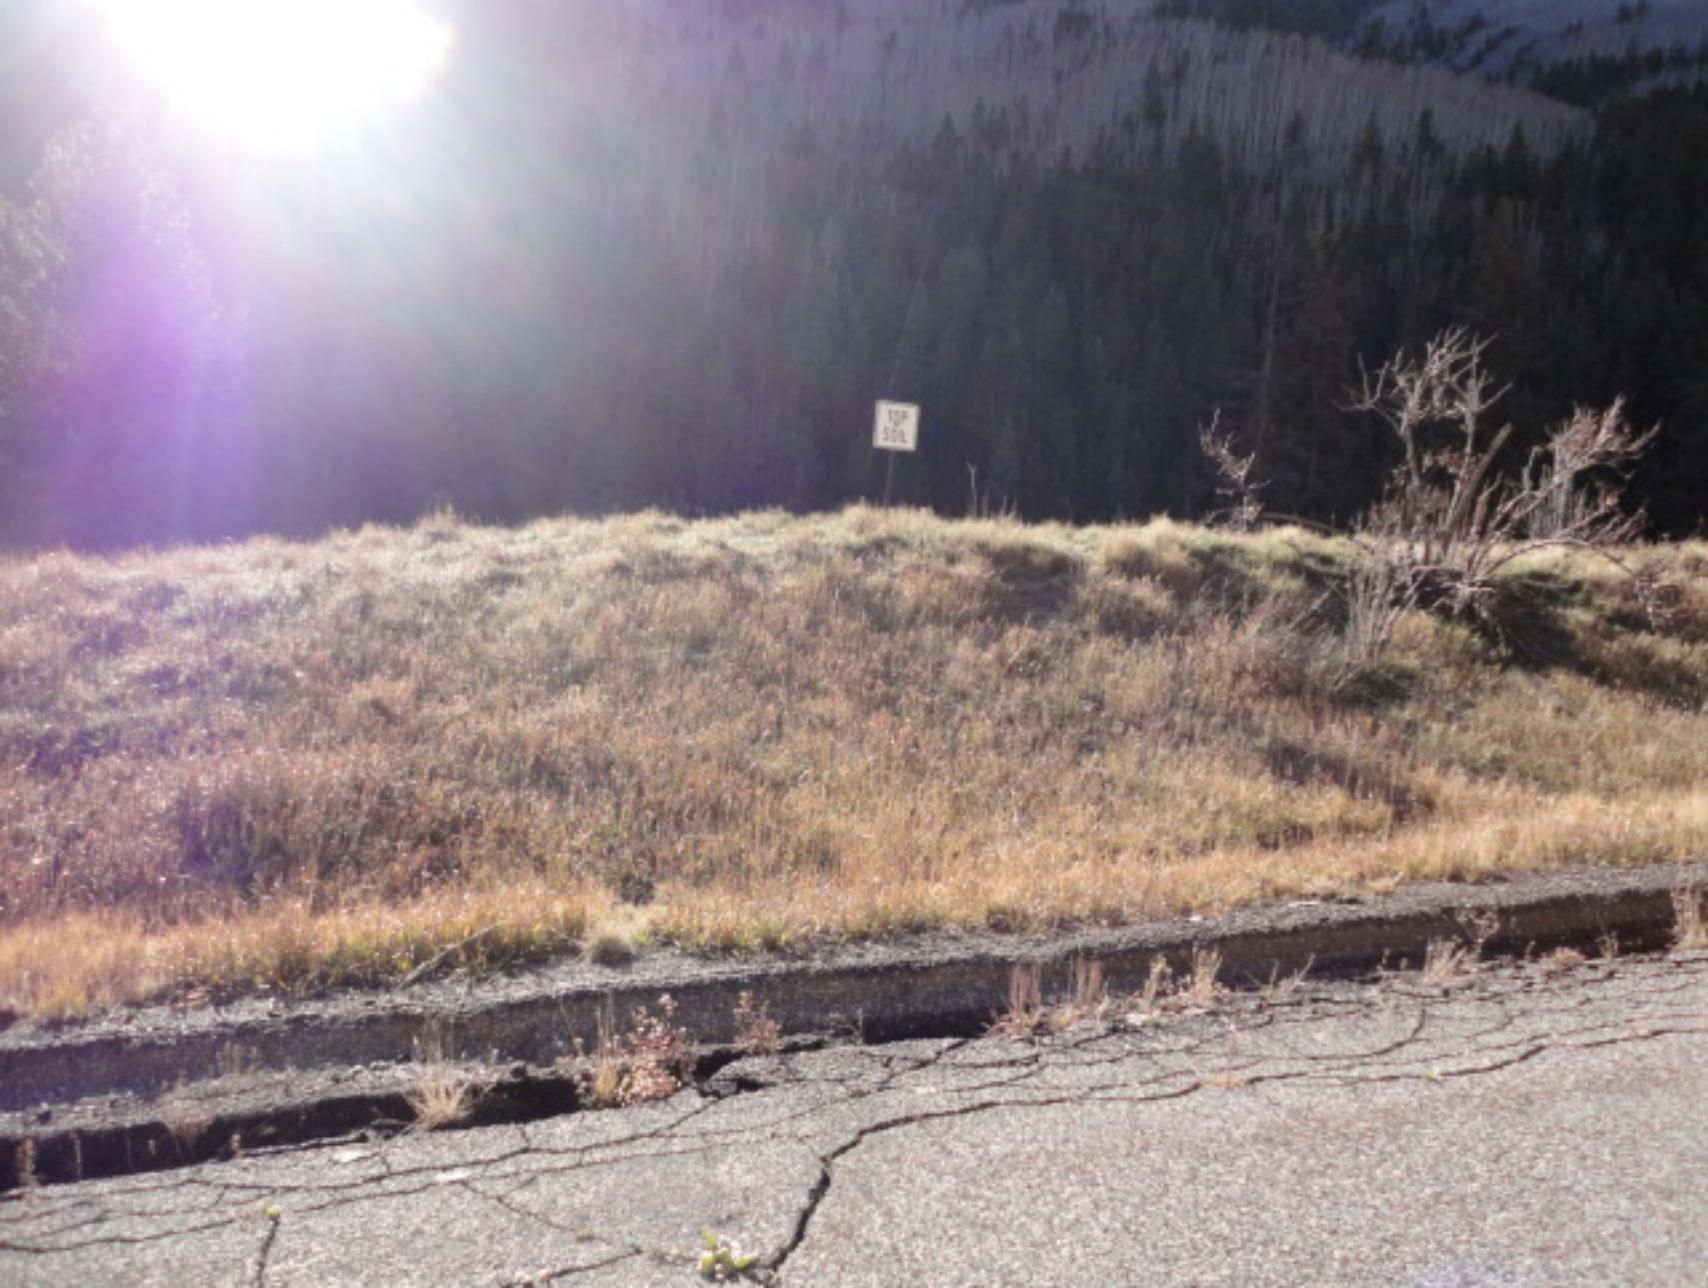
3.I inspected the topsoil piles and I did not see any signs of wind or water erosion. The topsoil piles appear to be stable. See Photo

TOP
OF
SOIL

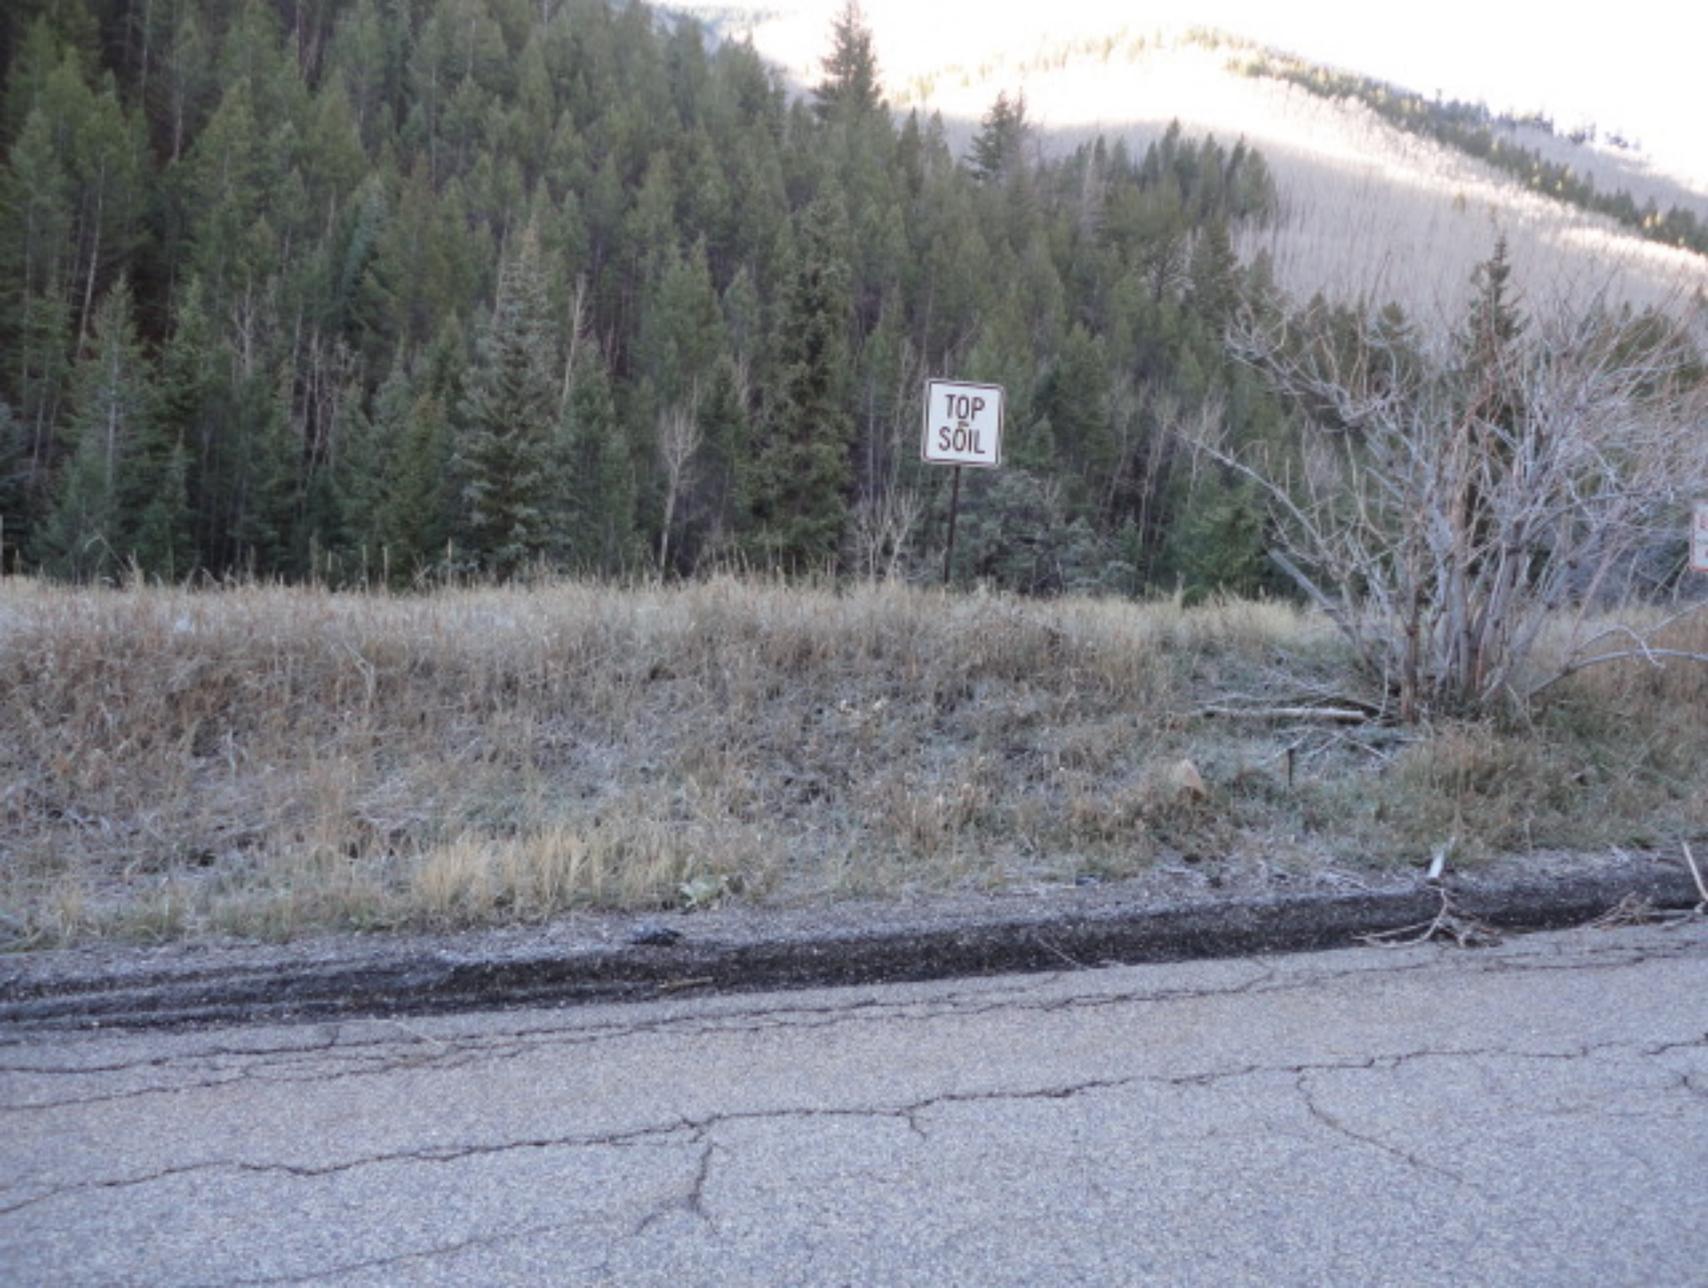
A photograph showing a paved road in the foreground with several large, irregular cracks. To the right of the road, there is a patch of dry, yellowish-brown grass and a small, leafless, greyish shrub. In the background, a dense forest of evergreen trees covers a hillside. A white rectangular sign with a black border and the words "TOP SOIL" in black capital letters is mounted on a dark post in the middle ground. The lighting suggests late afternoon or early morning, with a soft glow on the upper part of the hillside.

TOP
SOIL

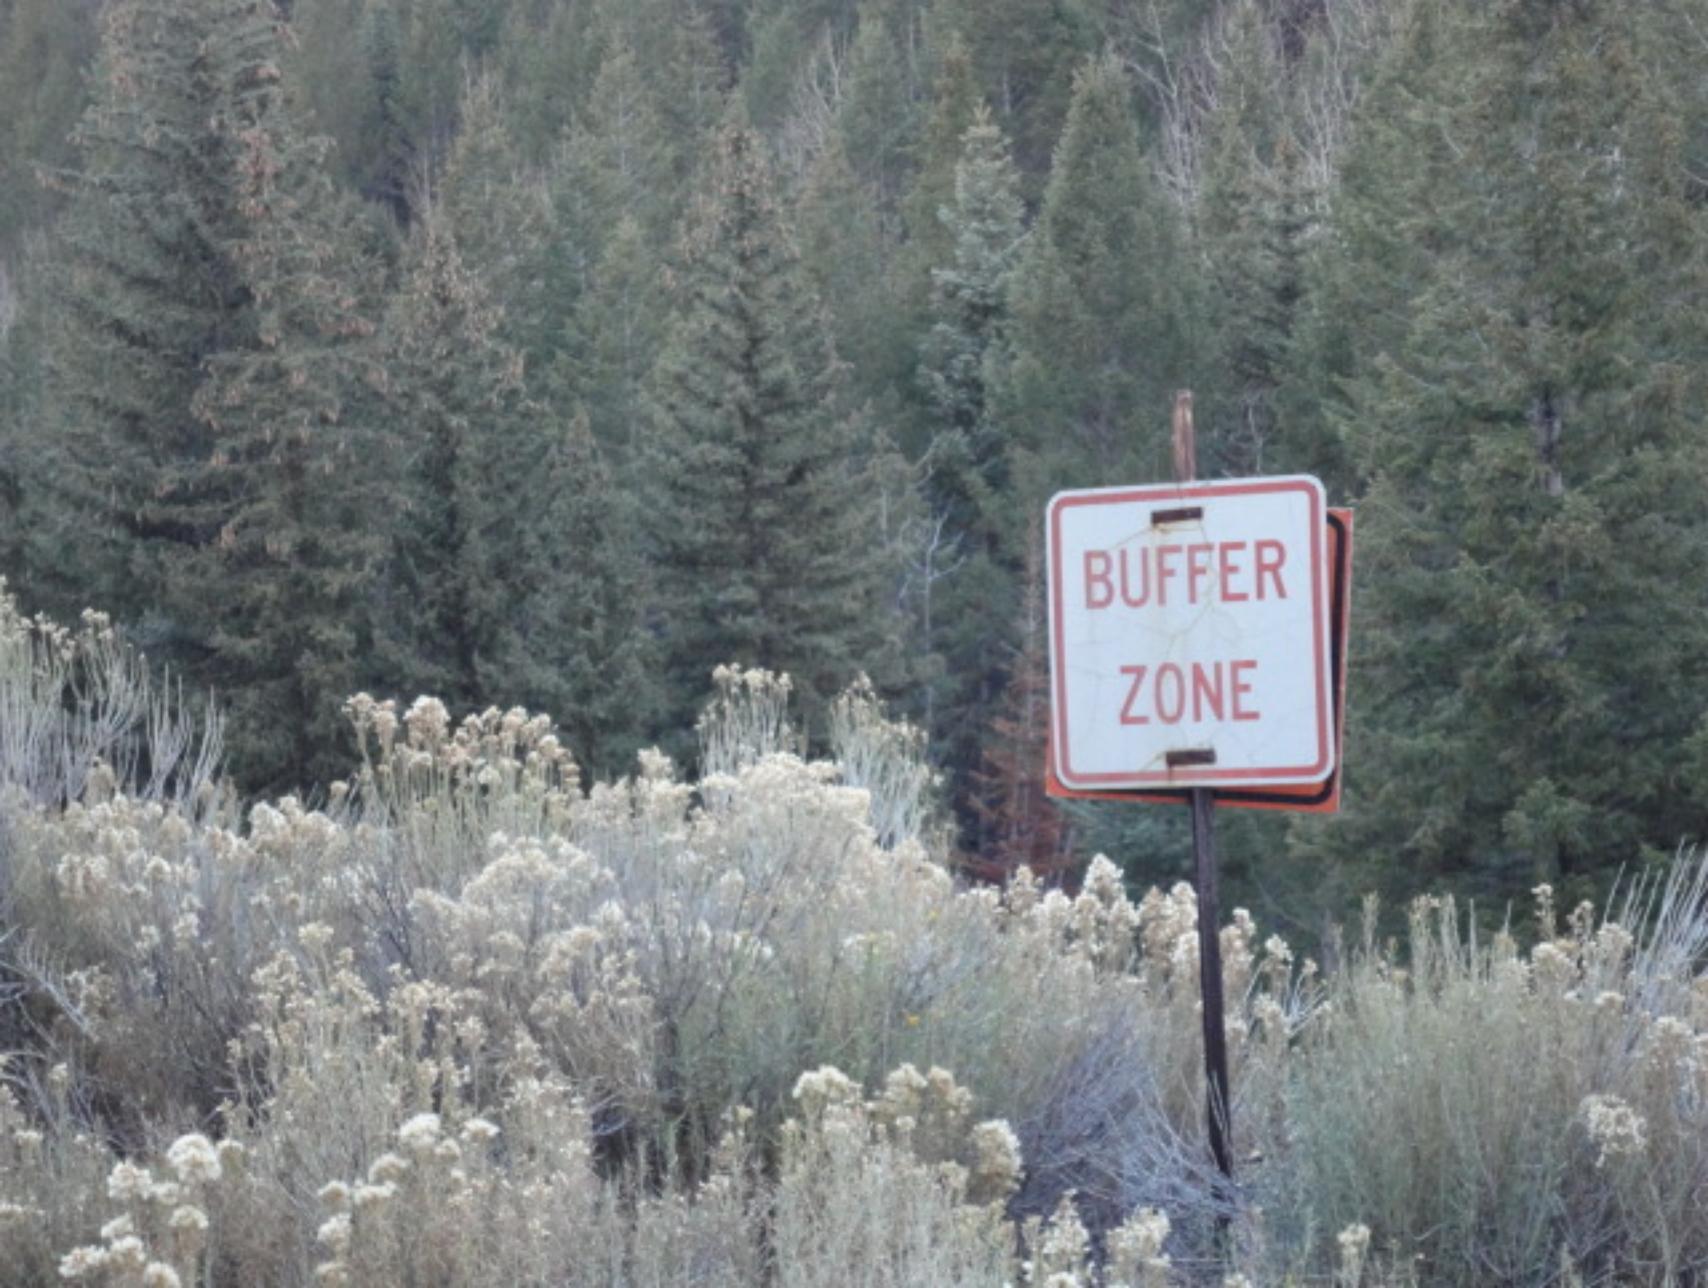
A rectangular white sign with a red border and rounded corners is mounted on a black post. The sign features the words "BUFFER" and "ZONE" in red, sans-serif capital letters, stacked vertically. The sign is positioned in a field of tall, yellow wildflowers with thin, upright stems. In the background, a dense forest of evergreen trees covers a hillside. The lighting is soft, suggesting an overcast day or late afternoon.

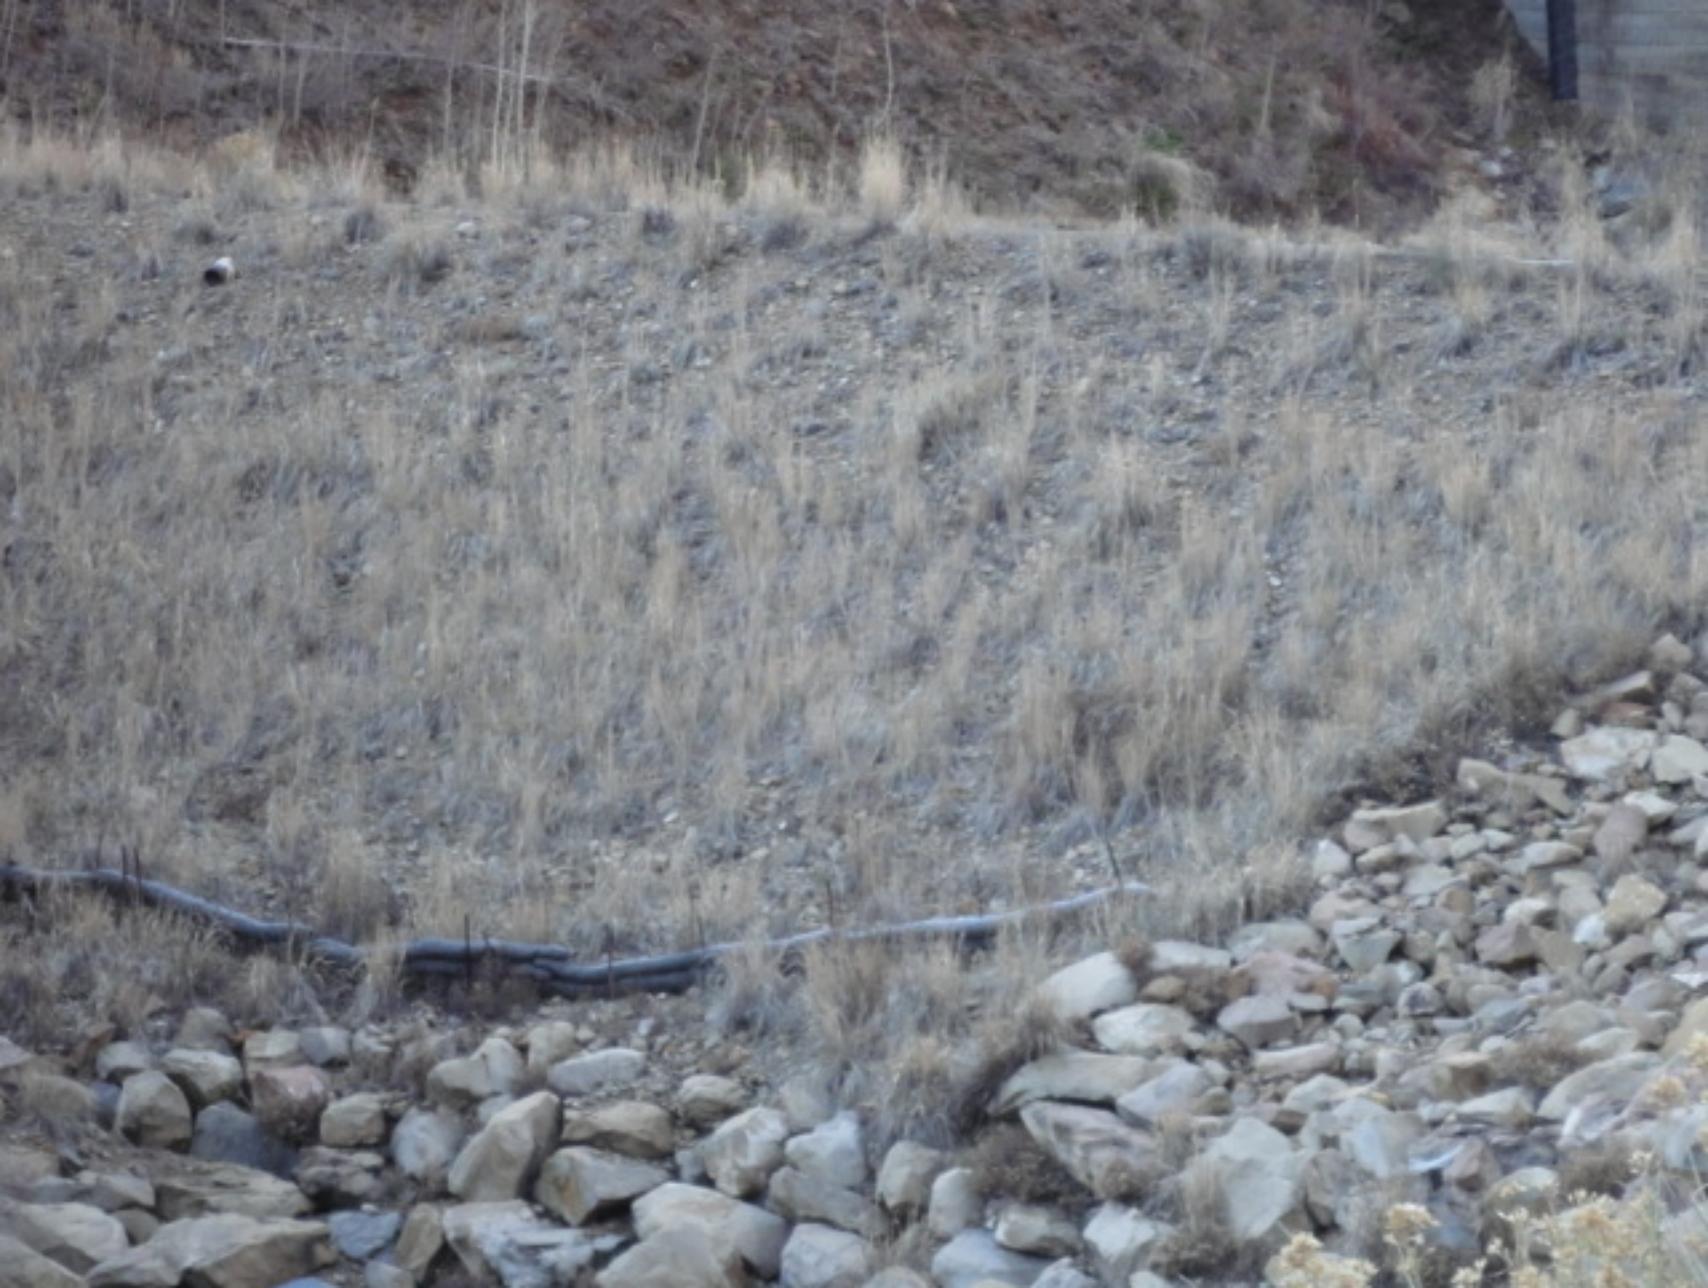
GENWAL RESOURCES INC. (PERMITTEE) A SUBSIDIARY OF-

PERMIT # C 015/032

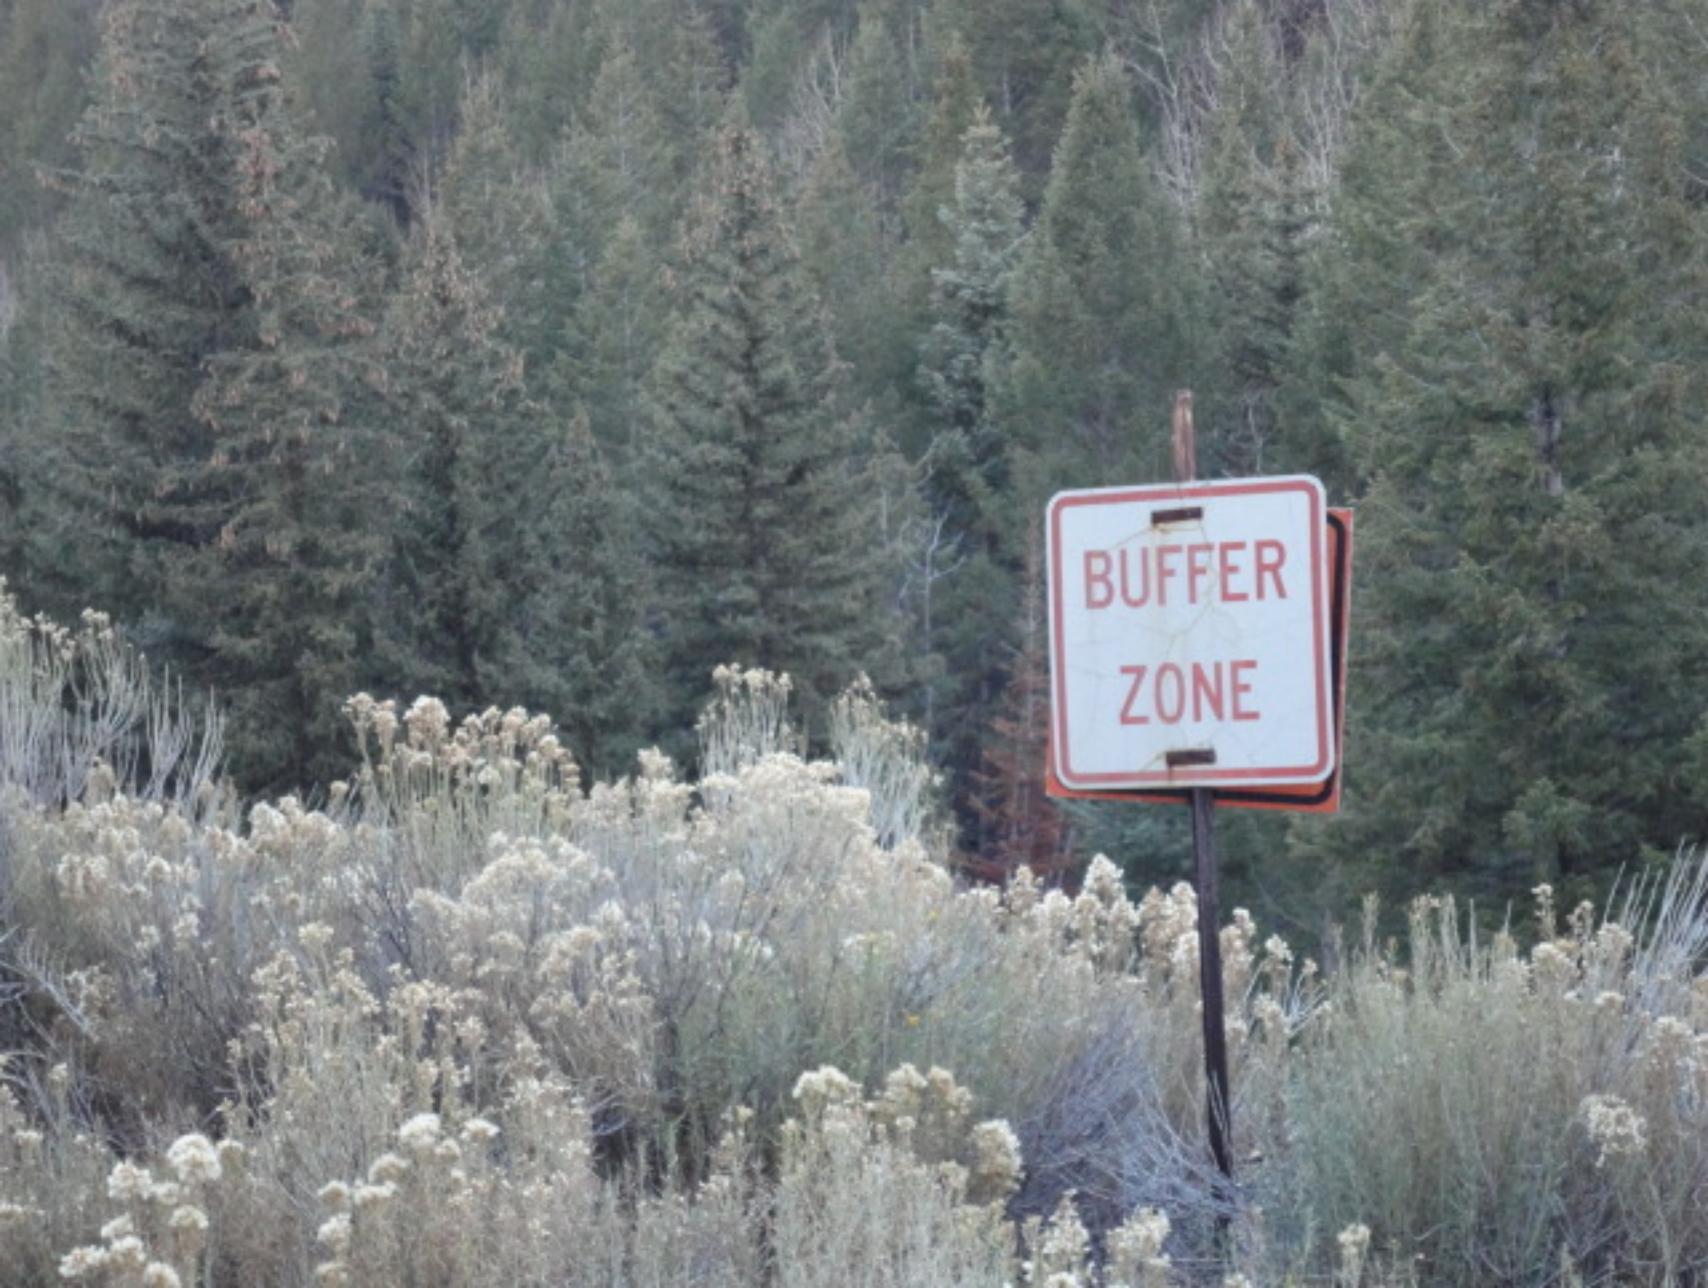
A rectangular sign with a white background and a red border is mounted on a black post. The sign features the words "BUFFER" and "ZONE" in red, bold, sans-serif capital letters, stacked vertically. The sign is positioned in a field of tall, yellow wildflowers with thin, upright stems. In the background, a dense forest of tall, dark green evergreen trees covers a hillside. The lighting is soft, suggesting an overcast day or late afternoon.
