# Inspection Report

Permit Number:	C0150032
Inspection Type:	PARTIAL
Inspection Date:	Wednesday, January 11, 2017
Start Date/Time:	1/11/2017 10:00:00 AM
End Date/Time:	1/30/2017 12:00:00 PM
Last Inspection:	Monday, December 05, 2016

Permitee: **GENWAL RESOURCES INC**  
 Operator: **GENWAL RESOURCES INC**  
 Site: **CRANDALL CANYON MINE**  
 Address: **PO BOX 910, EAST CARBON UT 84520-0910**  
 County: **EMERY**  
 Permit Type: **PERMANENT COAL PROGRAM**  
 Permit Status: **INACTIVE**

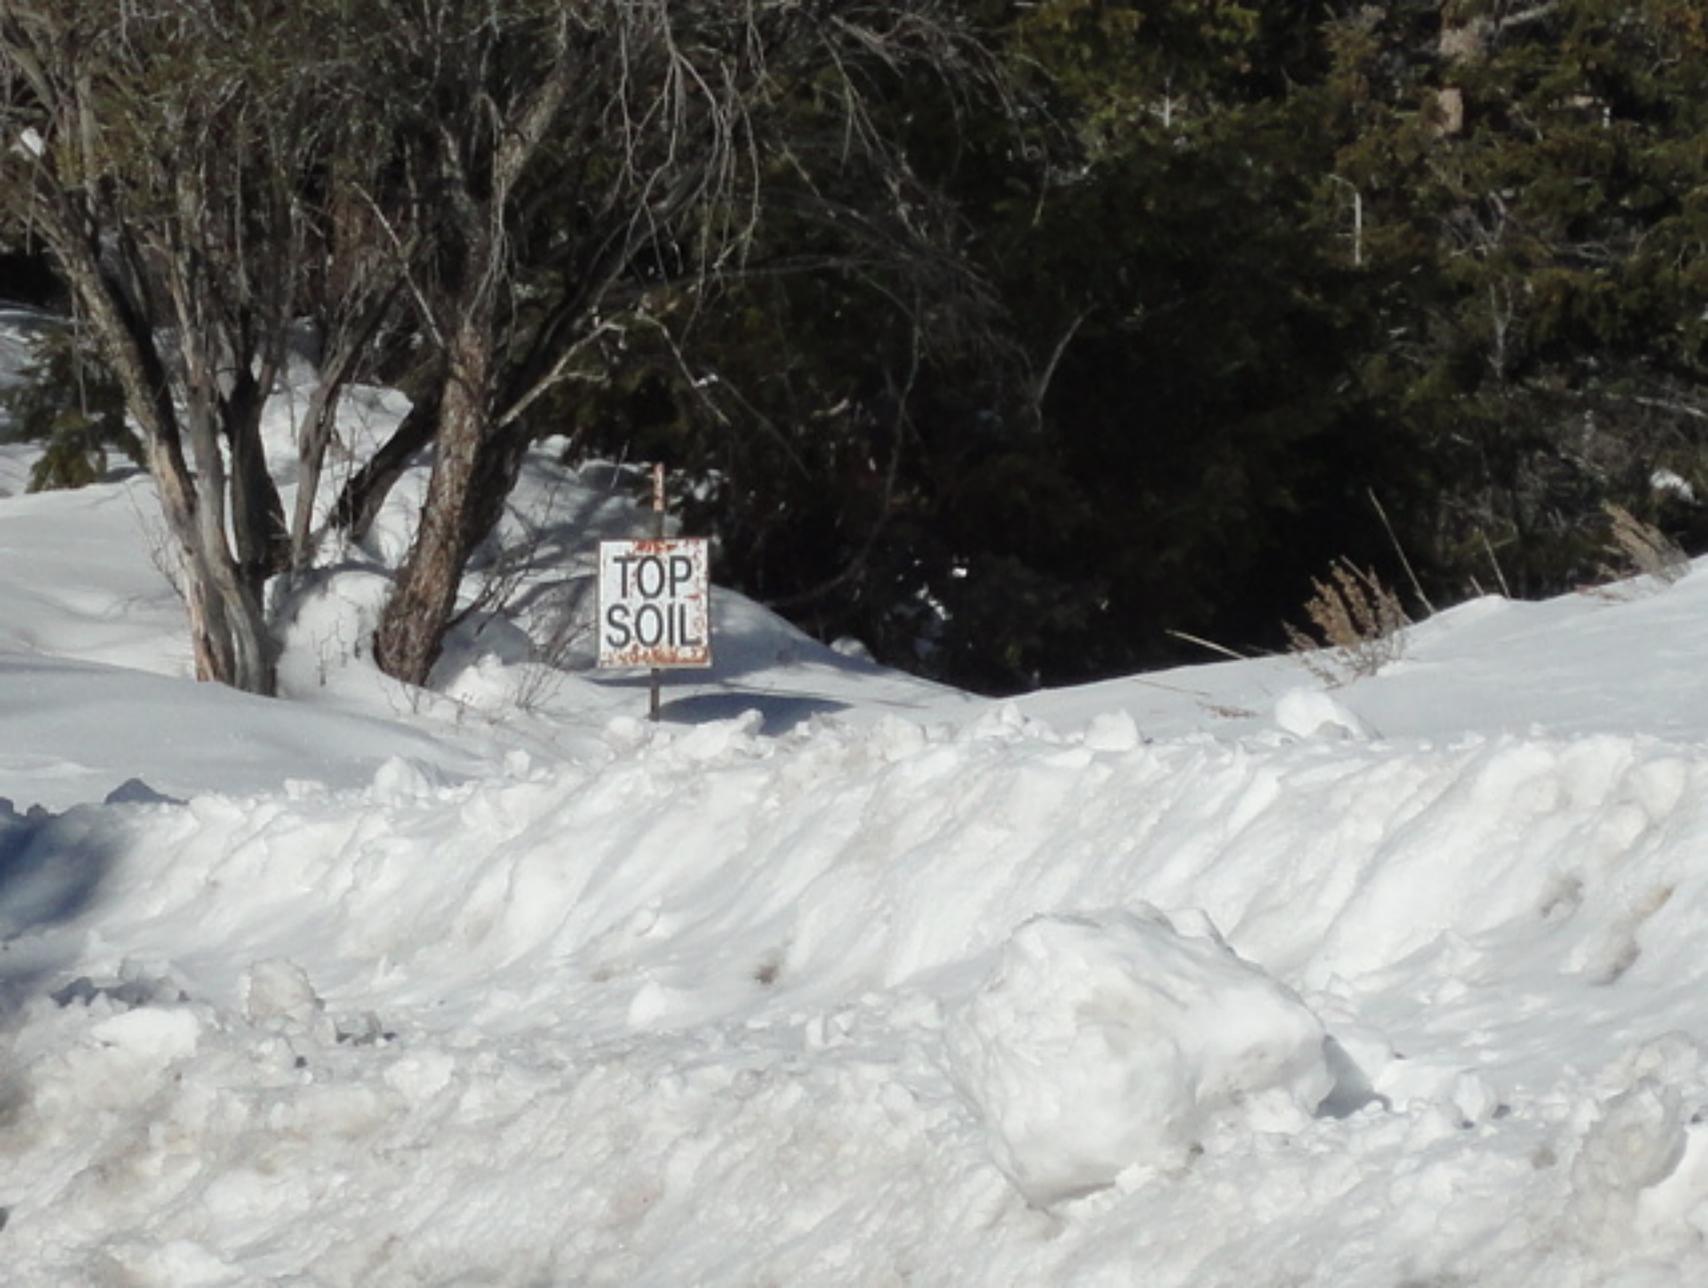
TOP  
SOIL

The topsoil piles were snow covered. It is unlikely that wind or water erosion has occurred since the piles are well vegetated. See Photos

A photograph of a snowy mountain slope. In the foreground, there is a large, textured pile of snow. In the middle ground, a small wooden sign is planted in the snow, with the words "TOP SOIL" written in black capital letters. The sign is positioned to the right of a small, bare tree. The background consists of a dense forest of evergreen trees under a clear sky.
