Inspection Report

Permit Number:	C0150032
Inspection Type:	PARTIAL
Inspection Date:	Tuesday, January 30, 2018
Start Date/Time:	1/30/2018 10:30:00 AM
End Date/Time:	1/30/2018 12:00:00 PM
Last Inspection:	Tuesday, December 19, 2017

Permittee: **GENWAL RESOURCES INC**
 Operator: **GENWAL RESOURCES INC**
 Site: **CRANDALL CANYON MINE**
 Address: **PO BOX 910, EAST CARBON UT 84520-0910**
 County: **EMERY**
 Permit Type: **PERMANENT COAL PROGRAM**
 Permit Status: **INACTIVE**

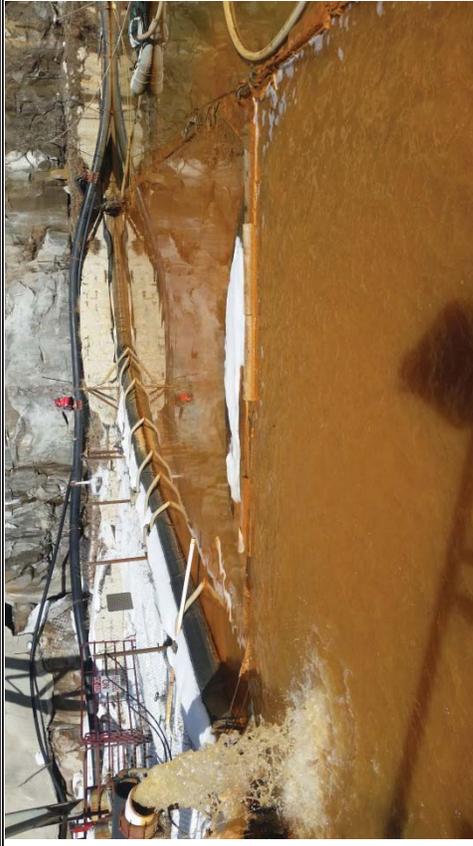
PHOTO 1 – WATER TREATMENT POND

This is cell #1 – Iron sludge is being cleaned out today from adjacent cell #2. The vacuum truck just barely exited the site with a load of sludge, bound for the Burma pond.
January 30, 2018

Water continues to discharge from the mine. Iron sludge is being cleaned out of cell #2. The sludge is dropped off at the Burma pond where the iron precipitate will settle out. Water samples were taken prior to treatment, and again at the outfall post treatment. Mine water discharge = 273gpm, Coagulation injection rate = 19.9ppm, and Flocculant injection rate = 7.66ppm.

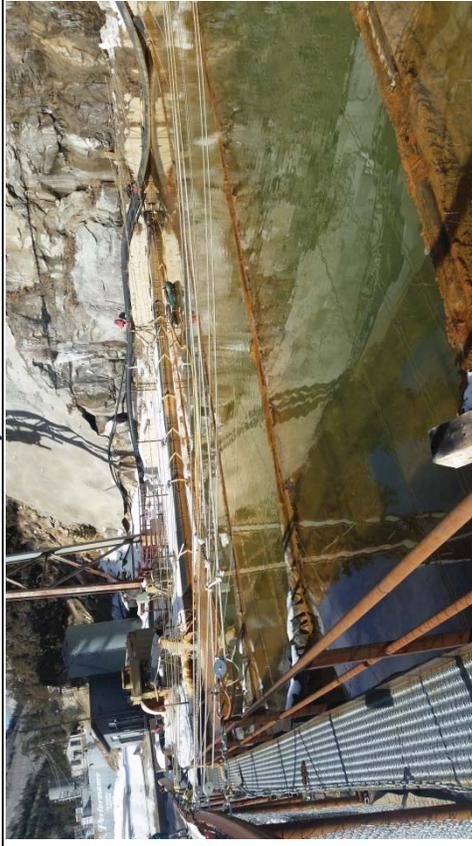
PHOTO 3 – TREATMENT POND

Another shot of the treatment pond and the highwall in the background.
January 30, 2018

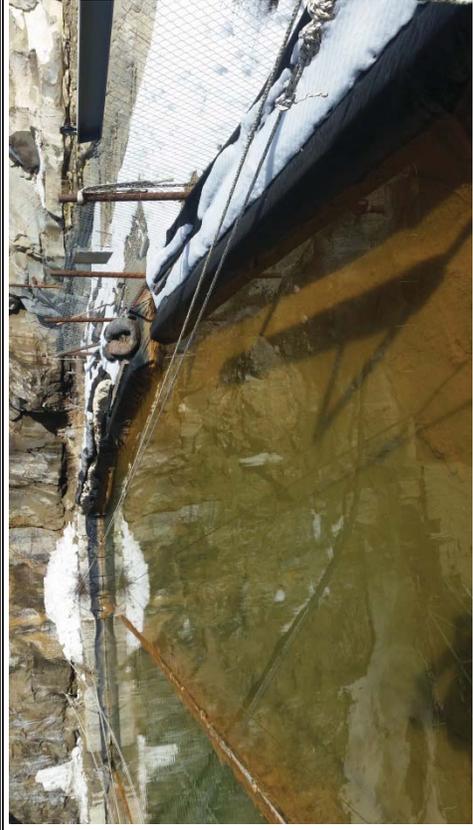
PHOTO 2 – TREATMENT POND OUTFALL

This is where sample 002 is taken. The highwall in the background was sloughing chunks of ice and snow that would pile up at the base of the wall. Water appears clear.
January 30, 2018

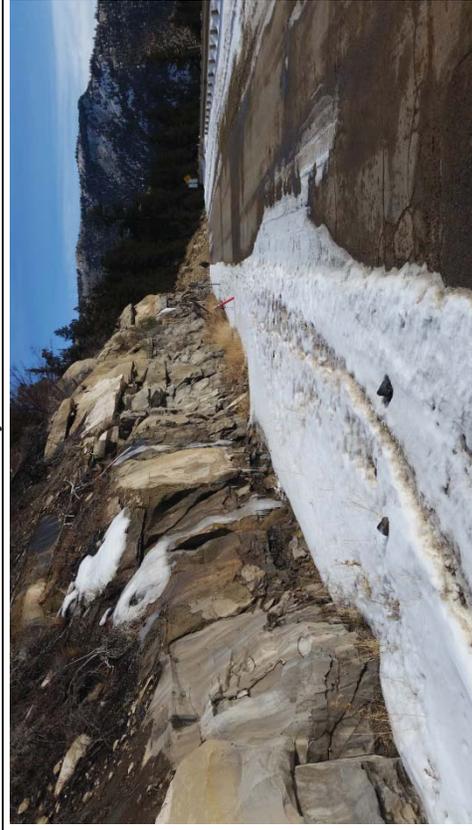
PHOTO 4 – HIGHWALL AND COUNTY ROAD

Seepage from this highwall has slowed down significantly compared to last month.
January 30, 2018

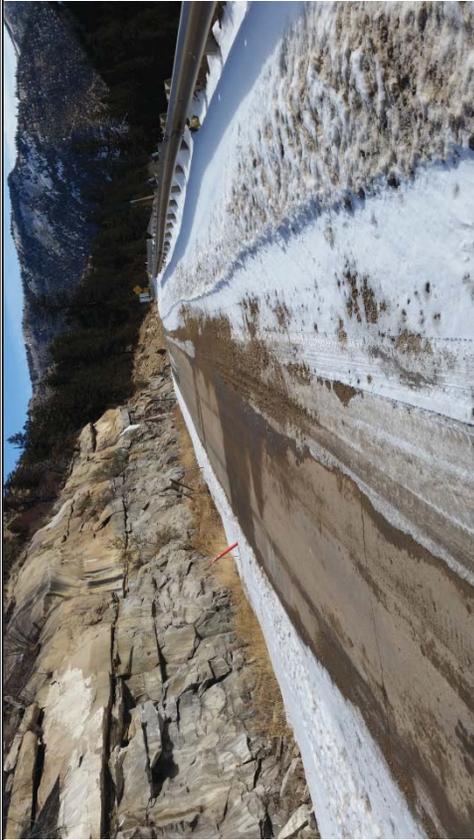
PHOTO 5 – COUNTY ROAD
This is the repaired section of county road above the gabion wall. It currently appears stable.
January 30, 2018

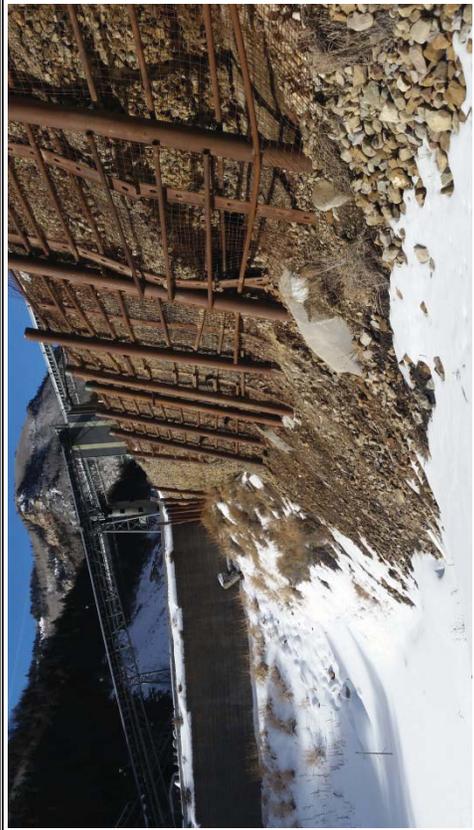
PHOTO 6 – GABION WALL SUPPORT STRUCTURES
Support structures reinforcing County road. Snow covered sediment pond on the left.
January 30, 2018

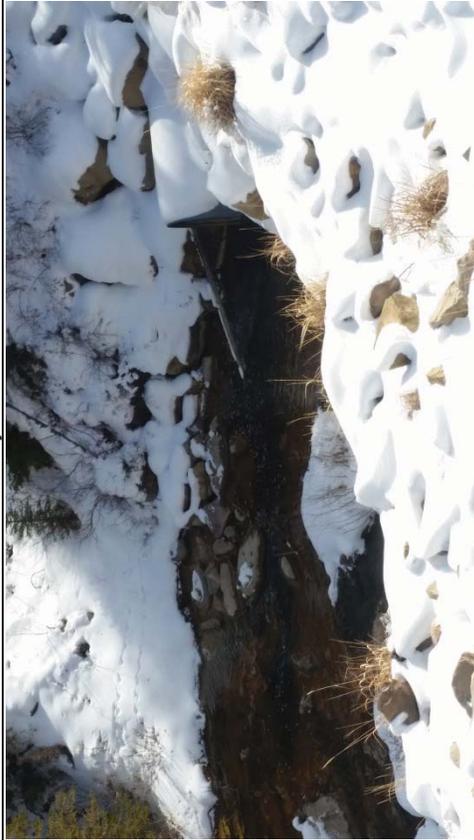
PHOTO 7 – CRANDALL CREEK
This is where Crandall Creek exits the 72” culvert running underneath the length of the site.
January 30, 2018

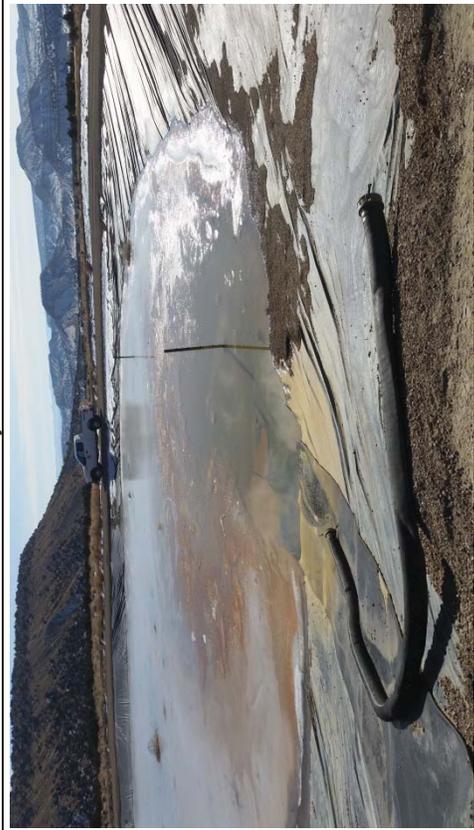
PHOTO 8 – BURMA POND
Most of this water came from the recent cleanup of cell #2.
January 30, 2018

The sediment pond was covered over with ice and snow. The Burma pond was impounding a moderate amount of water since cell #2 is currently being cleaned out.
