# Inspection Report

Permit Number:	<b>C0150032</b>
Inspection Type:	COMPLETE
Inspection Date:	Tuesday, February 25, 2020
Start Date/Time:	2/25/2020 11:00:00 AM
End Date/Time:	2/25/2020 1:30:00 PM
Last Inspection:	Tuesday, January 28, 2020

Permittee: **GENWAL RESOURCES INC**  
 Operator: **GENWAL RESOURCES INC**  
 Site: **CRANDALL CANYON MINE**  
 Address: **PO BOX 910, EAST CARBON UT 84520-0910**  
 County: **EMERY**  
 Permit Type: **PERMANENT COAL PROGRAM**  
 Permit Status: **INACTIVE**

**ATTACHMENT A – Crandall Canyon Complete Inspection, February 25, 2020**

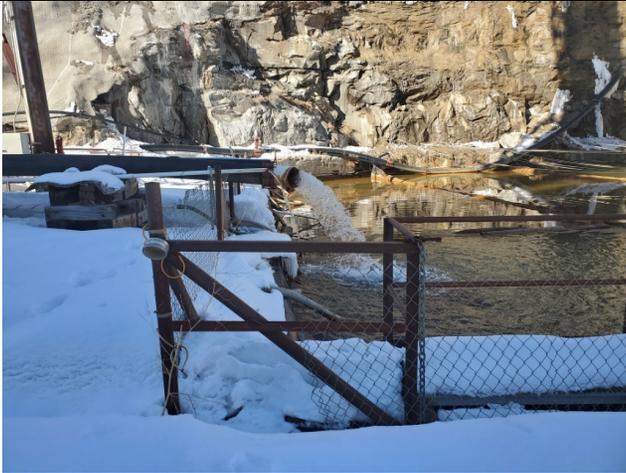
**PHOTO 1 – WATER TREATMENT FACILITY**

Overlooking the water treatment pond. Water sampling location Pre-002 is from the end of the white PVC left of center.

Water continues to discharge from the mine. Flowrate during today's inspection = 314gpm. Flocculant and coagulant were not being applied to the mine water at this time because the discharge lines had frozen in recent weeks. Samples were taken at 002 and pre-002 and delivered to the Utah State Health Laboratory in Taylorsville for processing.

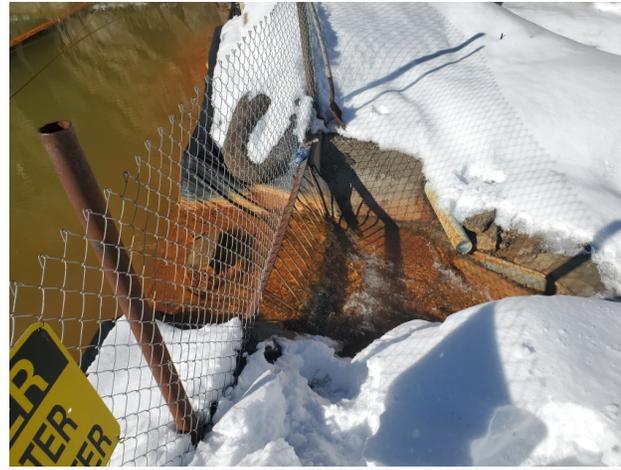
**PHOTO 2 – TREATMENT POND OUTFALL**

The water flowing through the trash rack is sampling point for UPDES discharge #002. Snow drifts are over 2' deep here.

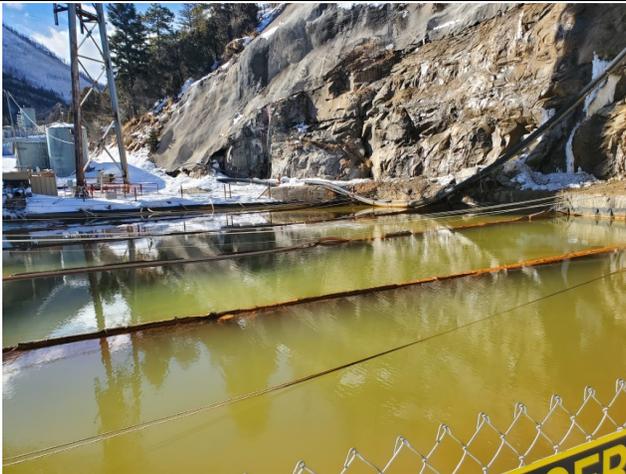
**PHOTO 3 – WEEPING HIGHWALL**

The face of the highwall overlooking the water treatment facility. No recent spalling or sloughing is evident.

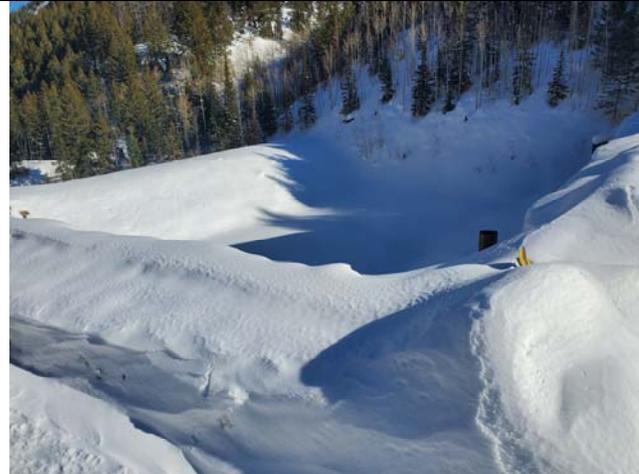
**PHOTO 4 – SEDIMENT POND**

The current level of the sediment pond was low, frozen over, and buried under snow.

Buried under at least 2 feet of fresh snow.

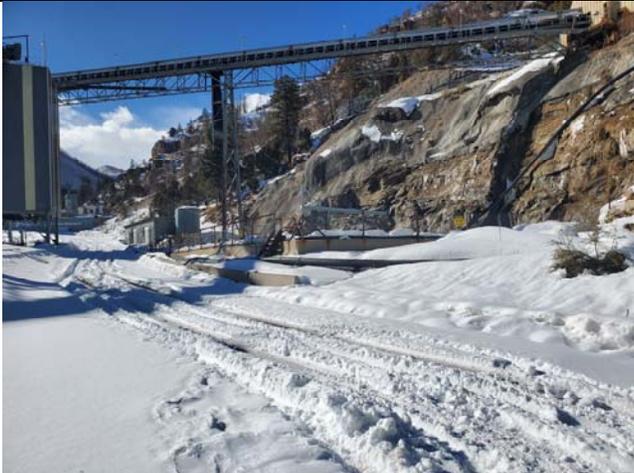
**PHOTO 5 – PRIMARY ROAD**

The roads into the site were covered with approximately 8 - 10 inches of fresh snow from a recent storm. None of the roads were plowed at the time of inspection, and full access was limited.

Unplowed roads were covered with approximately 10” of fresh snow.

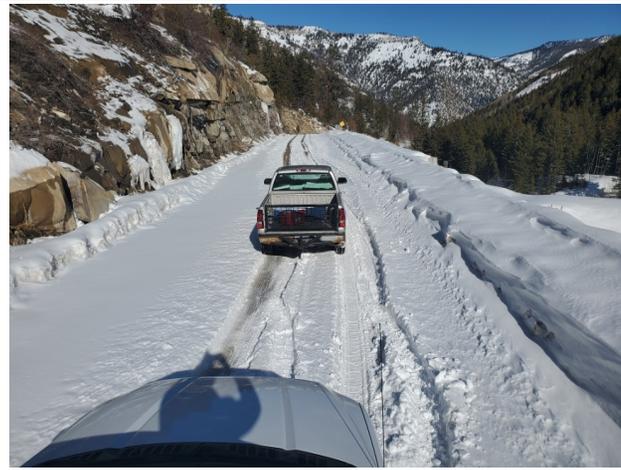
**PHOTO 6 – PRIMARY ROAD**

Unplowed roads were covered with approximately 10” of fresh snow.

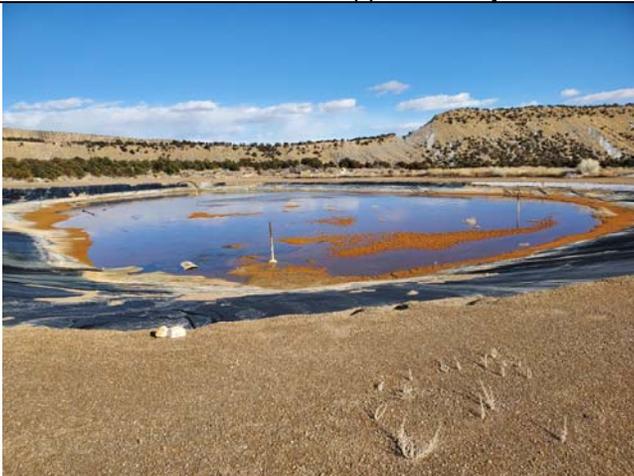
**PHOTO 7 – BURMA POND**

Pond was approximately 30% full.
