# Inspection Report

Permit Number:	C0150036
Inspection Type:	PARTIAL
Inspection Date:	Thursday, September 3, 2020
Start Date/Time:	9/3/2020 8:00:00 AM
End Date/Time:	9/3/2020 12:00:00 PM
Last Inspection:	Tuesday, August 11, 2020

Permittee: **CASTLE VALLEY MINING LLC**  
 Operator: **CASTLE VALLEY MINING LLC**  
 Site: **CASTLE VALLEY WASTE ROCK SITE**  
 Address: **5550 W. BEAR CANYON ROAD, P.O. BOX 475 HUNTINGTON UT 84528**  
 County: **EMERY**  
 Permit Type: **PERMANENT COAL PROGRAM**  
 Permit Status: **ACTIVE**

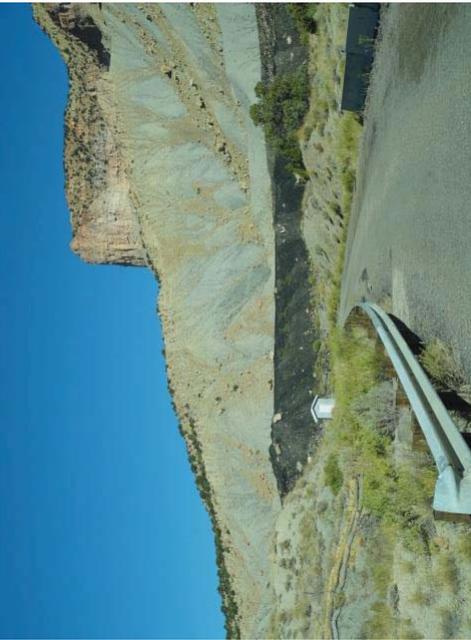
<p><b>PHOTO 3</b></p>	<p>CWWR Topsoil Pile</p>

Topsoil piles at the CVWR site are placed all around the exterior perimeter of the disturbed area. The various piles are identified by topsoil pile storage signs.

Protection for these topsoil piles is provided by vegetation, earthen berms and/or straw wattles.

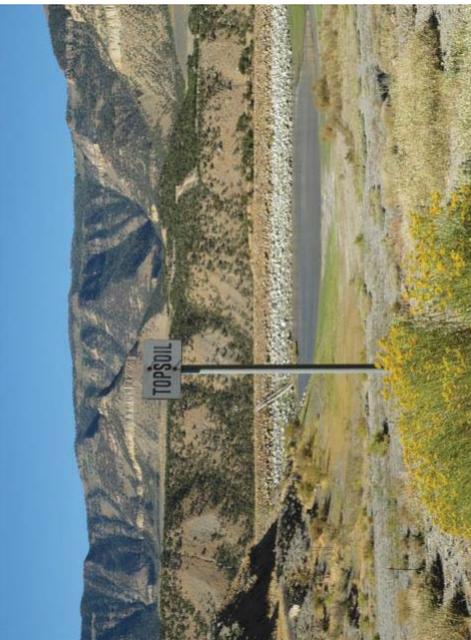
<p><b>PHOTO 4</b></p>
<p>CWWR Waste rock Site Overview</p>		<p>CWWR Topsoil Pile</p>

No waste material has been placed in the waste rock site since the previous inspection. The waste rock site is graded and compacted in lifts.

There are two cells in the waste rock site. The upper cell which is near completion and the lower cell which is where material is currently place. The site appeared stable. No visible hazards were observed.

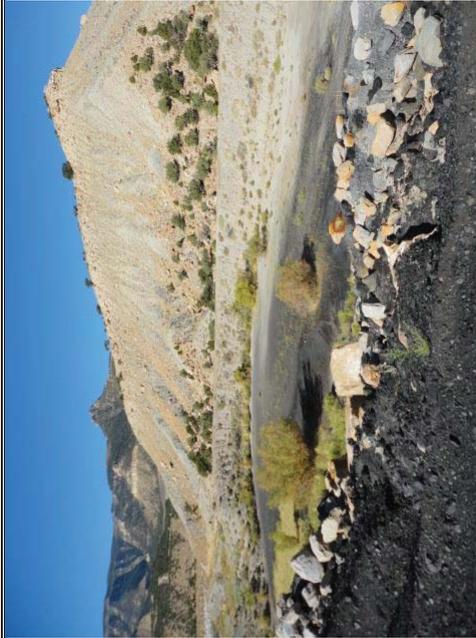
**PHOTO 5**

There is one large self contained sediment pond at the CVWR waste rock site.

The pond was checked during the partial inspection and found to be dry. Embankments were stable. No visible hazards were observed.

CVWR Sediment Pond

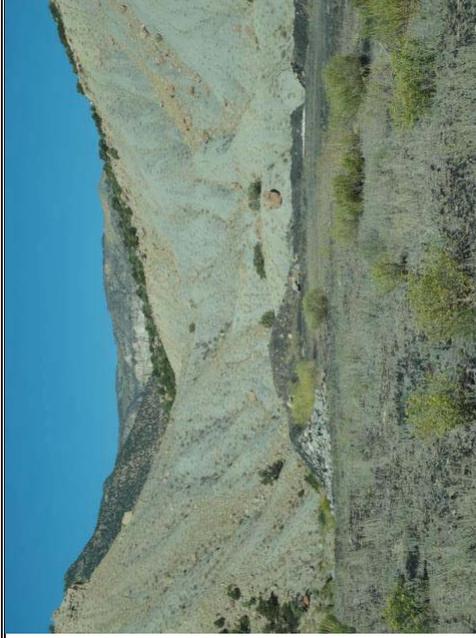
**PHOTO 6**

CVWR Waste Rock Upper Lift

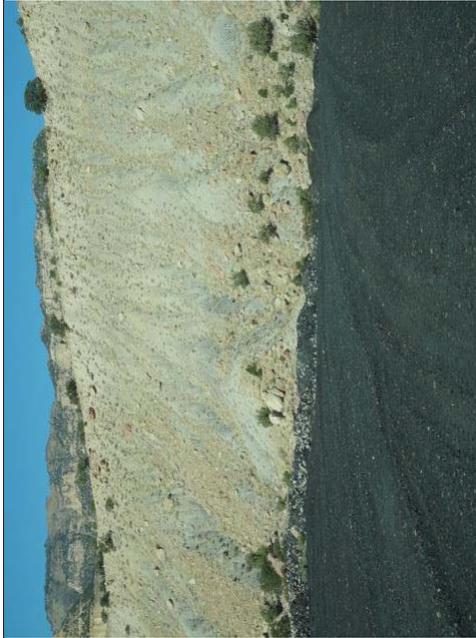
**PHOTO 7**

CVWR Waste Rock Lower Lift
