Subject: Completion of Mid-Term Review, Task ID #4317, Alton Coal Development, Coal Hollow Mine, C/025/0005

Inspection Report

Permit Number:	C0250005
Inspection Type:	TECHNICAL
Inspection Date:	Tuesday, April 30, 2013
Start Date/Time:	4/30/2013 9:00:00 AM
End Date/Time:	4/30/2013 2:00:00 PM
Last Inspection:

Site: COAL HOLLOW

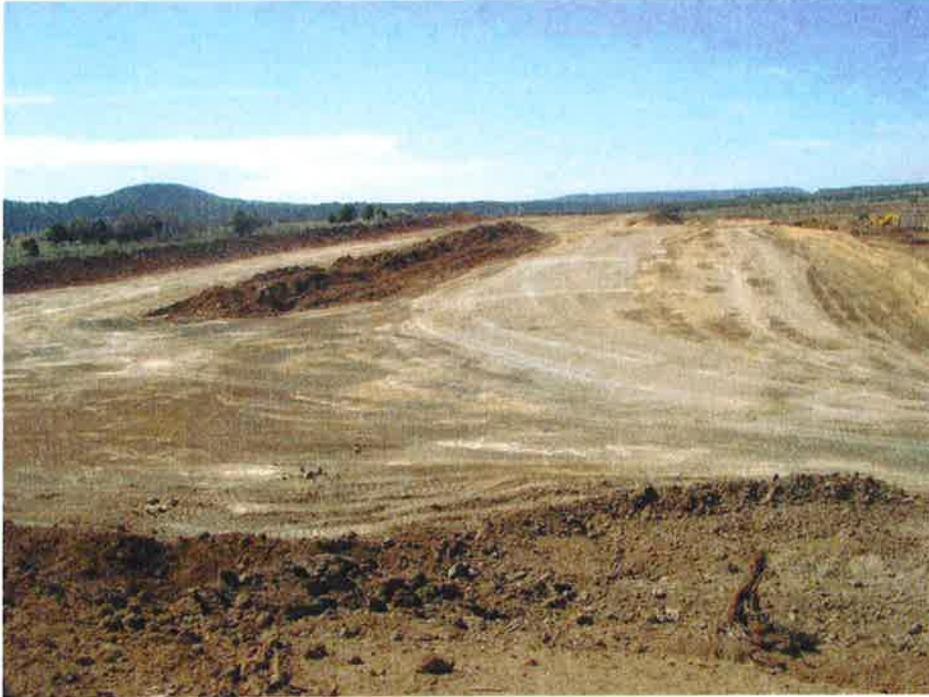
Topsoil from Pit #9 has been windrowed and is ready for live haul. Topsoil pile #4 has been surface roughened using a ripper. There is a compacted area on the east side that needs to be ripped. The longterm pile needs to be treated with mulch and seeded. The berm is formed of uncompacted topsoil approximately 30" high and 36" wide. A discussion of berm sizing ensued. The pile was seeded in February before additional material from Pond 4 was added and before the entire pile received surface roughening treatment. Some vegetation was able to germinate and grow with the spring moisture. The pile is now dry and the outlook for moisture is limited through the spring and summer. The Division agreed that seeding the pile could wait until the weather was more favorable (late fall). The mulch will be crimped into the pile now.

Pit 9 windrowed topsoil

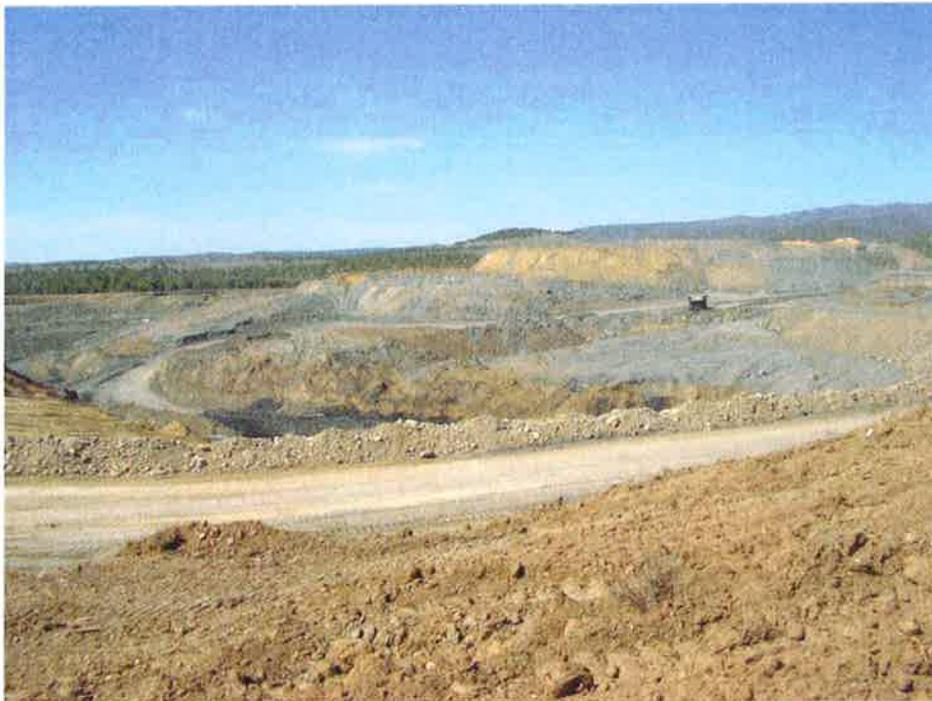
Topsoil pile #4 foreground. Coal in seen in Pit 6. Backfilled pits 5 and 4 in mid ground. Excess Spoil pile over pits 2 and 1 in background.

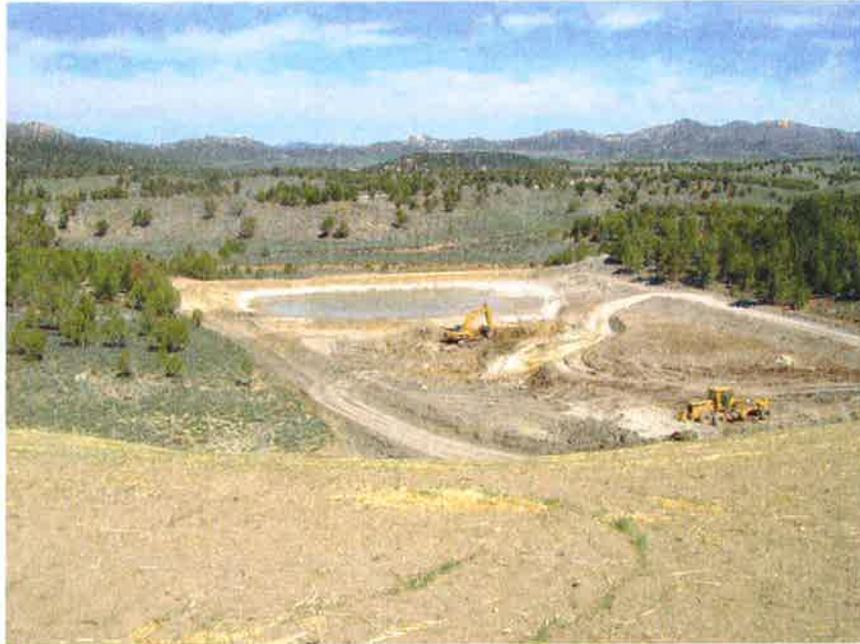
Ponds 1, 1b, 2, 3, and 4 were observed. Pond 3 is currently being expanded to the approved December 2012 amendment. Pond 4 is currently being constructed in accordance with the approved MRP Phase 1 design.

Enlarging Pond #3.

R645-301-732.200 The Permittee shall update MRP Appendix 5-2 to reflect the enlarged capacities of Pond 3. [KMH]

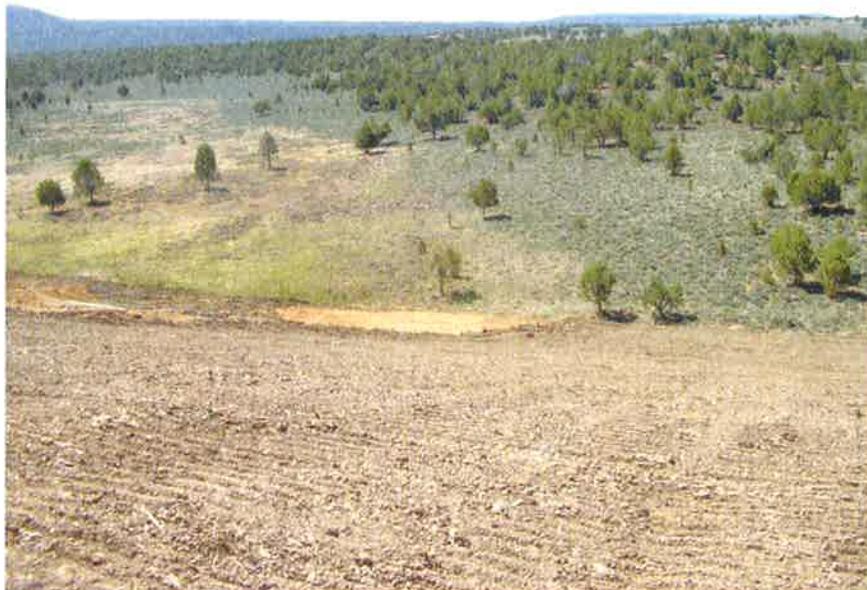
The spoils pile area was inspected and the south slope of the pile is currently being worked. Installation of a sediment control measure such as a straw waddle was discussed and the operator said they could have something installed by June 1 in the area.

topsoiled south slope of Excess Spoil pile

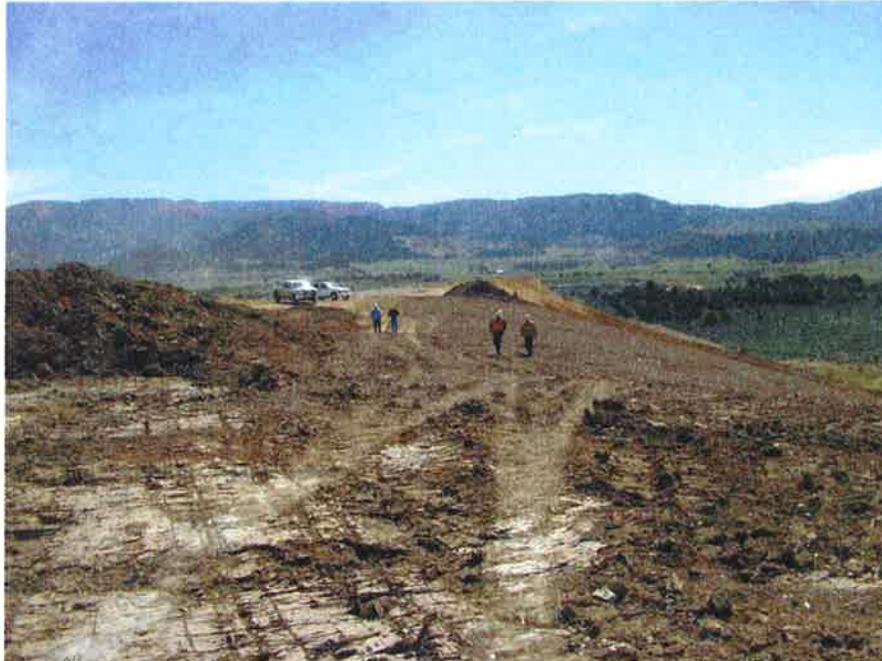
The west toe of the reclaimed Excess Spoil pile is green with Triticale. The upper slopes of the reclaimed pile are showing less growth, perhaps due to the drying effects of the wind. Work continues on spreading the remaining topsoil from Topsoil pile #3 onto the west slope of the Excess Spoil Pile. The Permittee suggested and the Division agreed that the contemporaneous reclamation should be seeded this summer with Triticale only and wait to seed the final mix until more favorable conditions of late fall/winter.

redistributed topsoil, subsoil on the Excess Spoil pile.

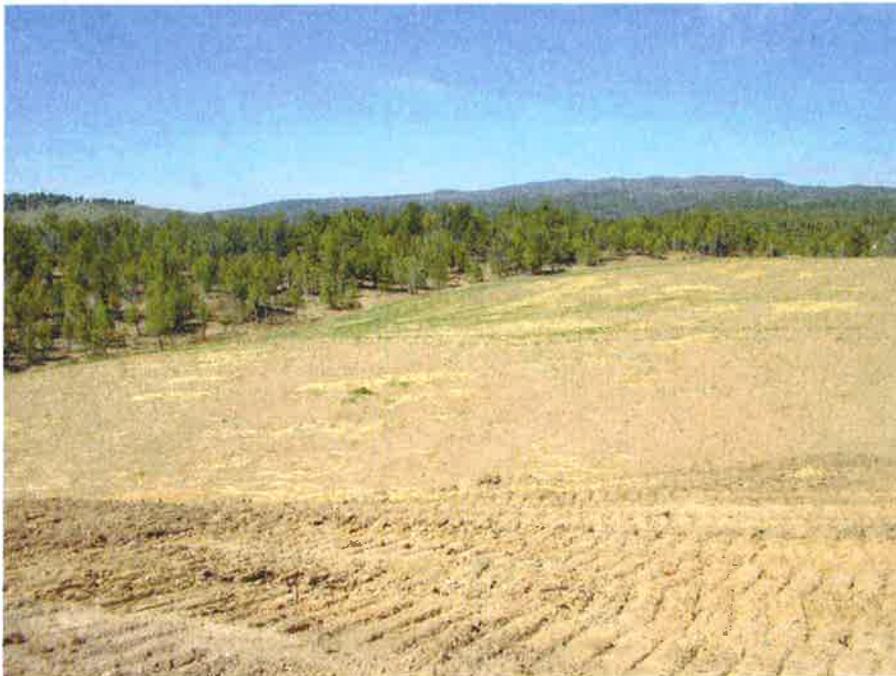
First year growth on the Excess Spoil pile.

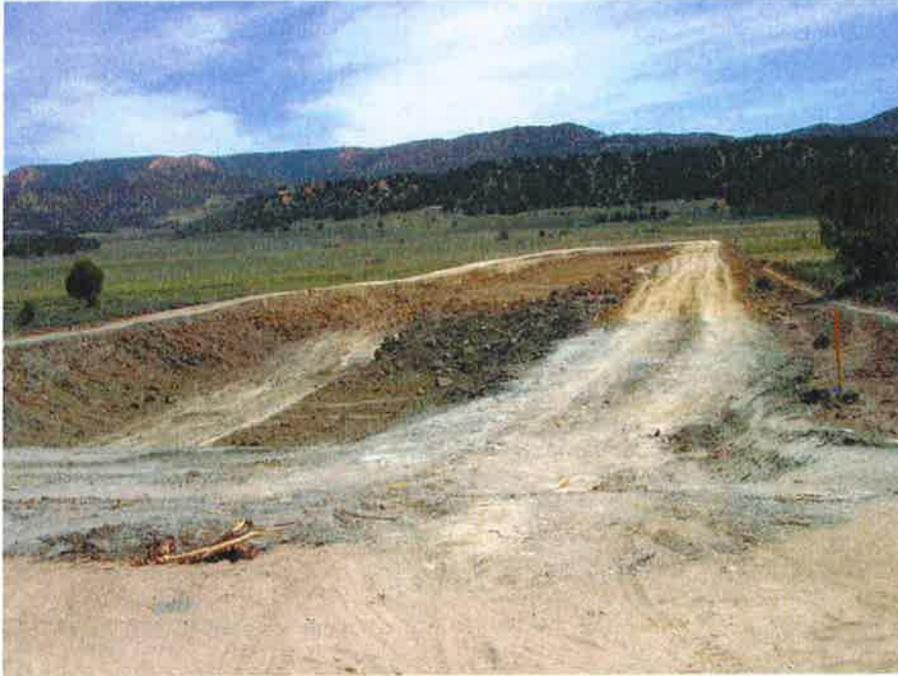
New surface disturbance included construction of pond 4 during the end of the active lekking and the beginning of the nesting period for the Sage Grouse. According to personal observations from Dustin Schaible (DWR Wildlife Biologist), Rhet Boswell (DWR habitat Biologist) and Dr Steven Petersen (ACD Biologist) on Monday, May 6th pond 4 is located at the South end of the active historic lek and in nesting and brood rearing habitat.

Pond 4 construction view from County road.

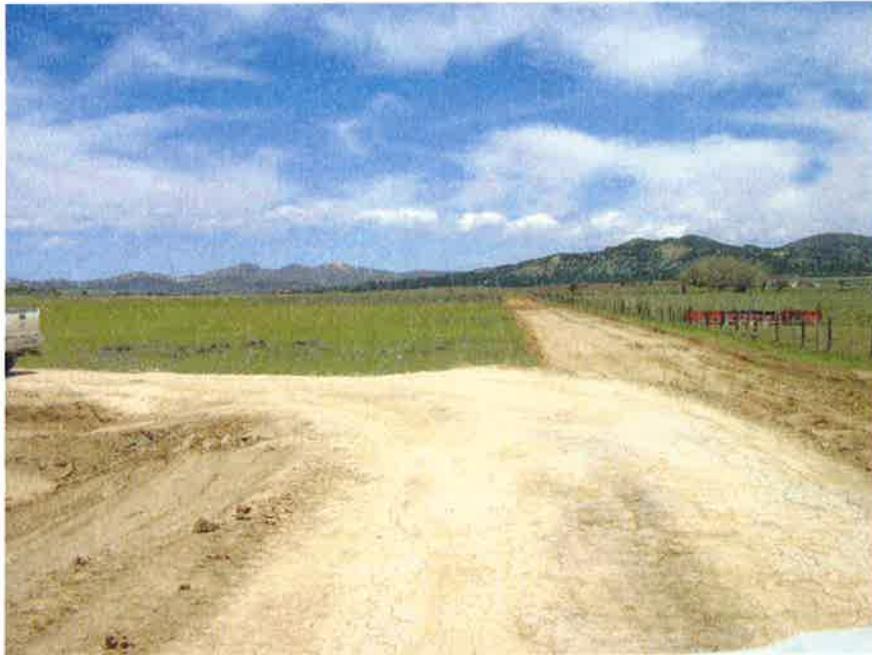
Ditch construction north of Pond 4.

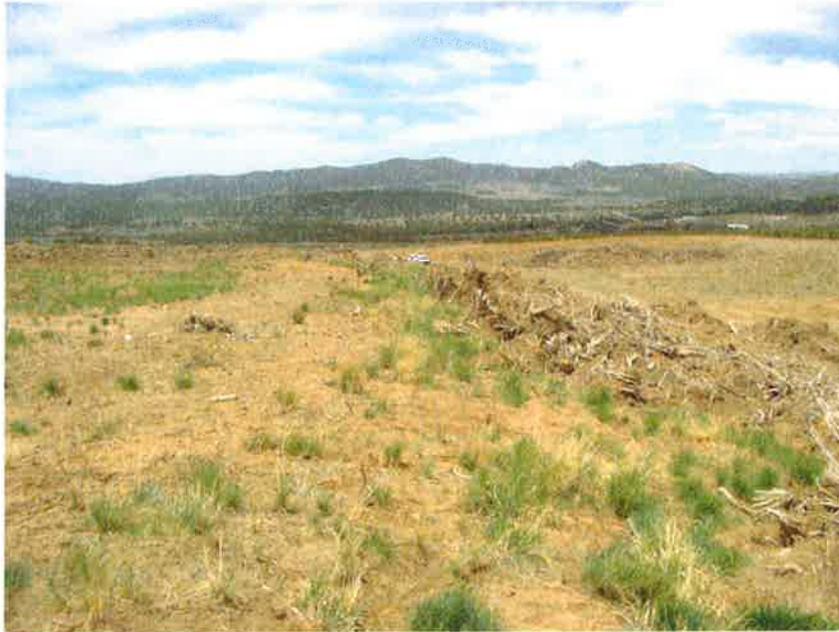
Topsoil Pile #1, Topsoil pile #2 and Subsoil pile #1 were evaluated. Vegetation was seeded in the Spring of 2011 and is now in its second year. Burying the seed with a harrow was successful. Broadcasting the seed on the mixture of slash and soil was not successful. The slash does provide an effective erosion cover.

Topsoil pile #2. Subsoil pile on right.

Thistle control on all topsoil piles is recommended.

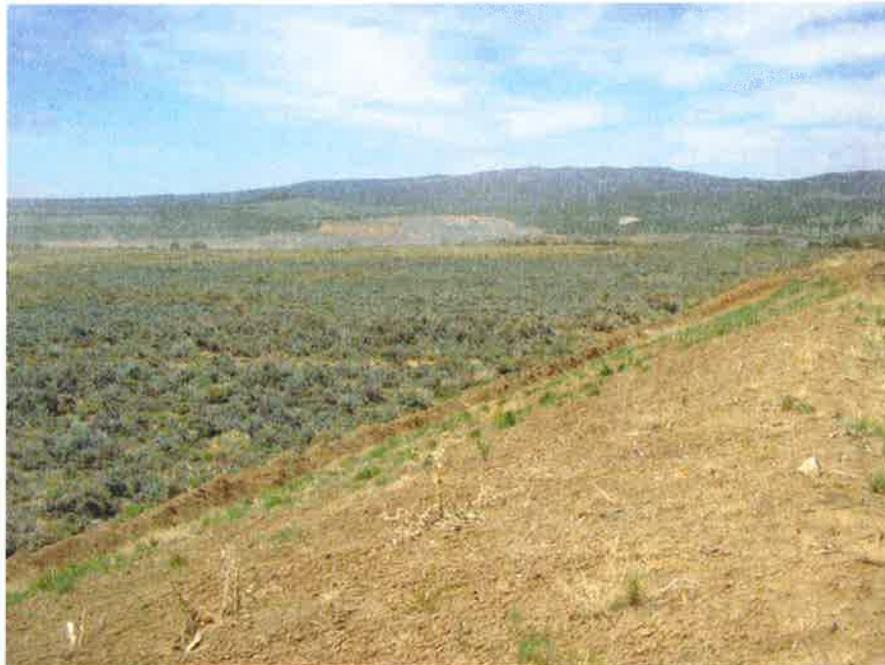
Slope and berm around Topsoil Pile #2

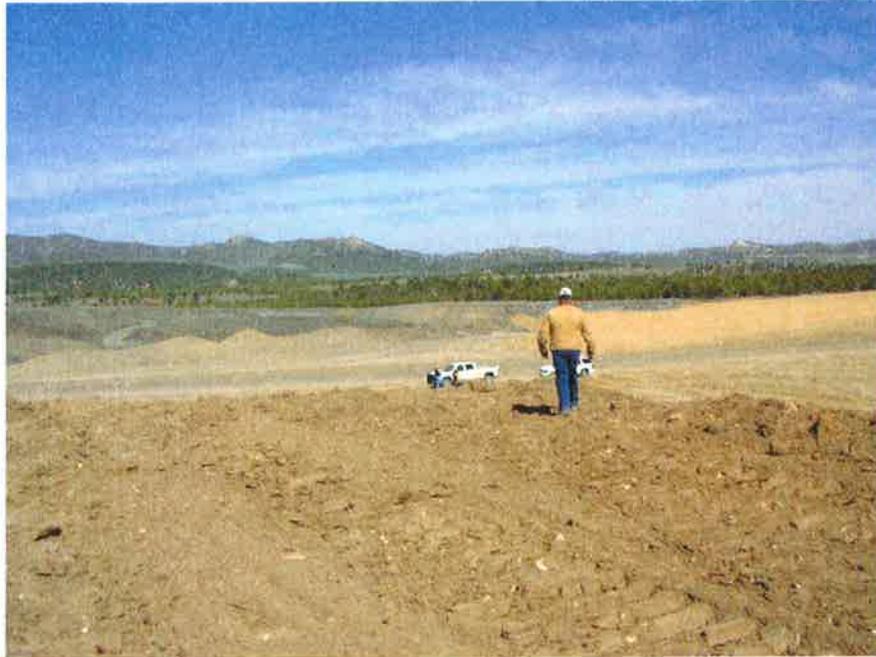
Topsoil pile #4. Subsoil stockpile #2 on right side background.

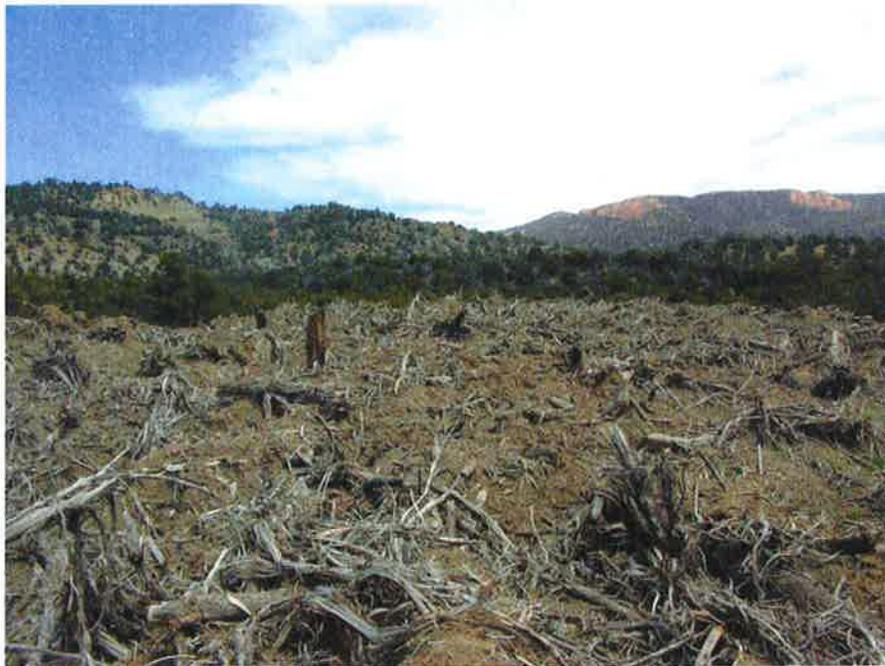
Slash on topsoil pile #1.

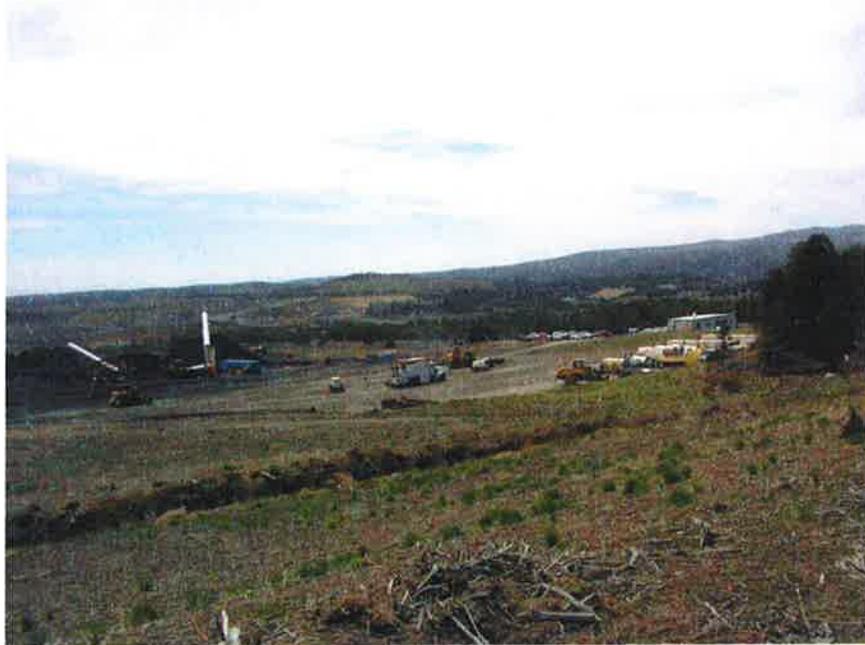
Topsoil pile #1 foreground, facilities farground.

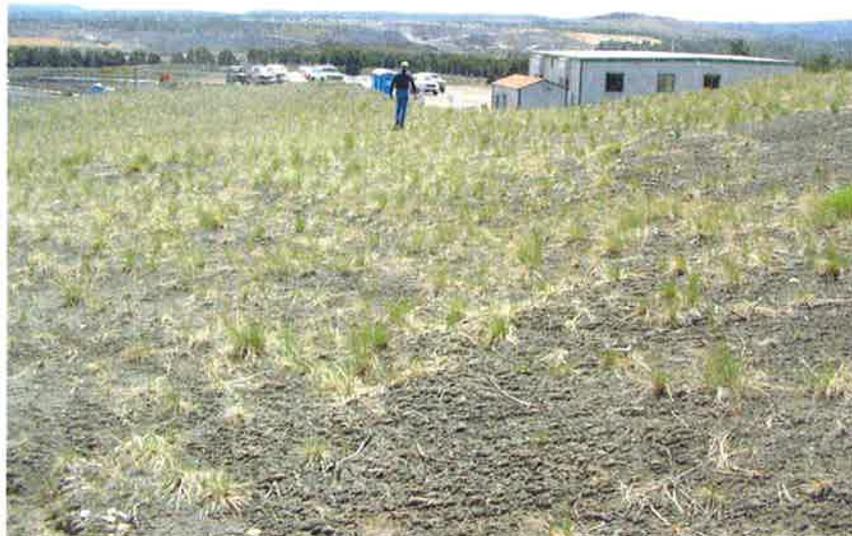
Facilities slope.
