# Inspection Report

Permit Number:	<b>C0250005</b>
Inspection Type:	BOND RELEASE
Inspection Date:	Wednesday, March 30, 2016
Start Date/Time:	3/30/2016 10:00:00 AM
End Date/Time:	3/30/2016 12:30:00 PM
Last Inspection:	Tuesday, March 29, 2016

Site: **COAL HOLLOW**

Eleven people participated in the bond release inspection (Task 5097) for the Phase bond release of 31.017 acres in BRP1-6, (2.898 acres), BRP1-7 (25.822 acres) and BRP1-8 (2.297 acres). Of the eleven, five were DOGM staff, 4 were ACD employees. The two others were Byard Kershaw representing Kane County Commission and Louis Pratt representing Kane County Road Department.

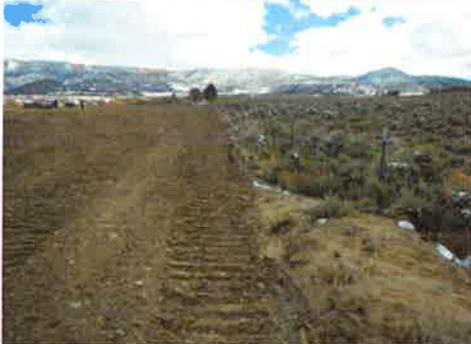
I walked the perimeter of the 2.9 acre release area Pit 1B. The area has been restored to a very gently graded area. The southern boundary of the release area seamlessly joins with its undisturbed boundary to the south (Photo 1) (KS).

<p><b>PHOTO 1</b> Looking east at southern boundary of Pit 1B bond release area. March 30, 2016</p>	<p><b>PHOTO 2</b> Looking north at HWT 3-A backfilled and graded area. March 30, 2016</p>

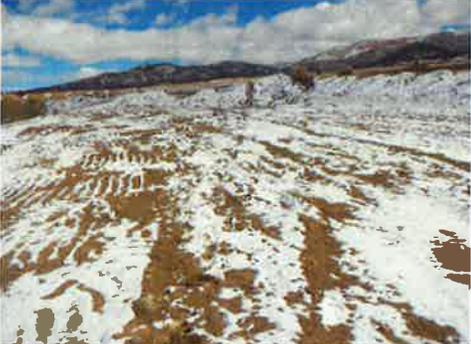
We walked the HWT 3-A bond release area (Photos 2 – 4). This area falls within the MSHA berm surround the excavated pit of HWT2. The area has been brought back to the correct backfilled elevation and is properly graded, however final drainage to the Sink Valley Wash will be reestablished only after HWT2 is completely backfilled (KS).

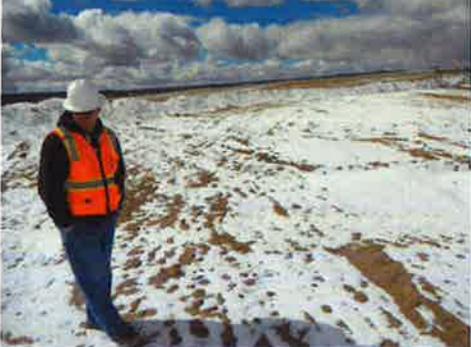
<p><b>PHOTO 3</b> Looking south at HWT 3-A in BRP1-8 backfilled and graded area. March 30, 2016</p>	<p><b>PHOTO 4</b> Looking west at HWT 3-A backfilled and graded area. March 30, 2016</p>

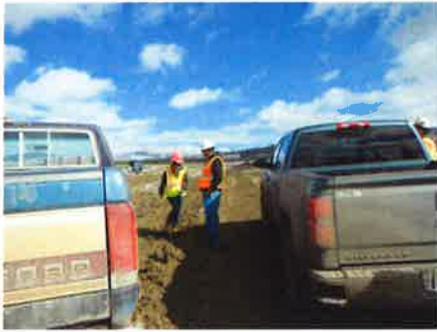
**PHOTO 5**  
At South end of County Road in BRP1-7, looking North.  
March 30, 2016

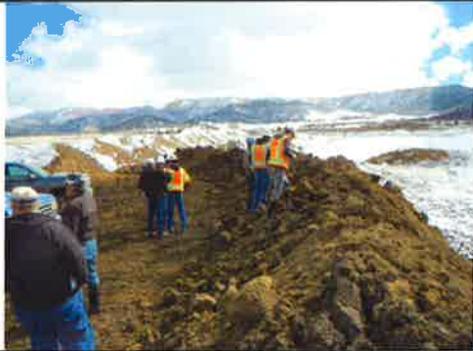
**PHOTO 6**  
Looking East at bond release group on rim of HWT 2B in BRP1-7.  
March 30, 2016

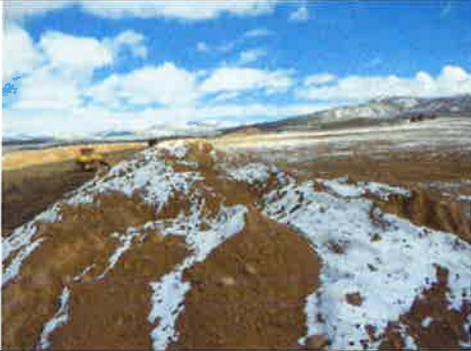
**PHOTO 7**  
Looking North from South end of BRP1-7 at haul road on left, subsoil  
berm center, BRP1-7 on right.  
March 30, 2016

Prior to Phase 2 bond release, Areas BRP1-6 and BRP1-7 will require surface roughening of existing haul roads, application of bermed subsoil over the haul roads and application of 18,282 CY of topsoil, followed by nutrimulch and seed. (PB)

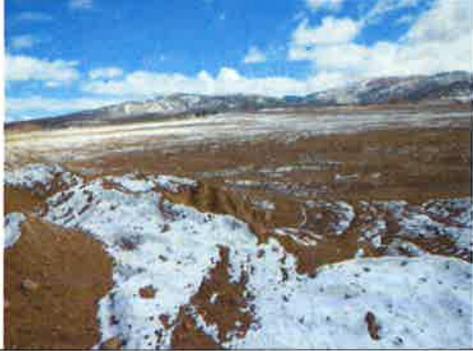
**PHOTO 8**  
Looking North from HWT 2A at BRP1-7.  
March 30, 2016

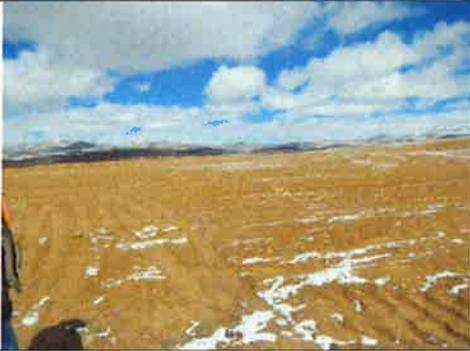
**PHOTO 9**

Looking North across BRP1-7. Subsoil berms in the distance are on the South rim of Pit 10.  
March 30, 2016

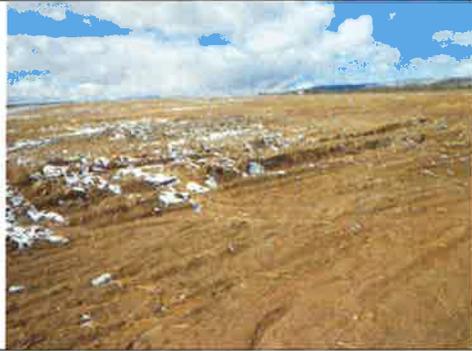
**PHOTO 10**

BRP1-8 is a 2.297 acre portion of HWT 3 (identified on Figure 1 as HWT 3A) within the E1/2 E1/2 of Sec 30 T 39 S, R 5W. BRP1-8 has both topsoil and subsoil applied and the area was recently treated with nutrimulch, but has not been seeded (personal communication with Kirk Nicholes 3/30/2016). Some equipment ruts were noted in BRP1-8 during the bond release inspection on 3/30/2016 and these were repaired the next day.

Looking South at BRP1-8 equipment ruts.  
March 30, 2016

No slides or subsidence were witnessed during the inspection at any of the three sites. All bond release areas had been graded to within AOC and showed no signs of instability (CP). BRP1-7 had some equipment ruts that were repaired the next day (personal communication with Kirk Nicholes, 4/6/2016) (PB).

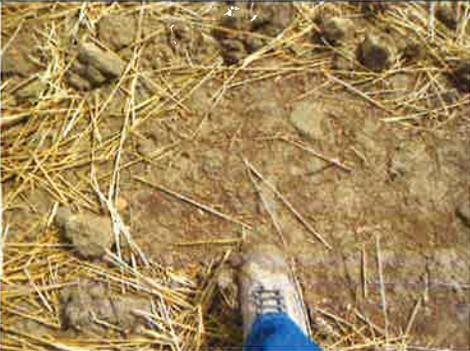
**PHOTO 11**

Nutrimulch and straw in BRP1-8.  
March 30, 2016

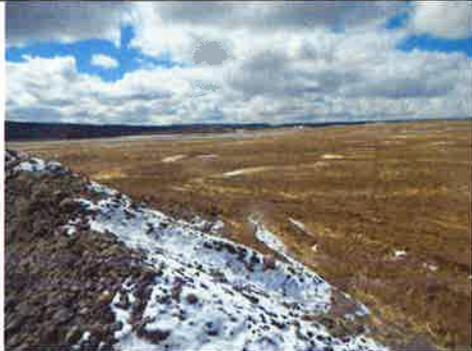
**PHOTO 12**

Looking South at stakes marking East edge of BRP1-8. Berm on left is edge of HWT 3-B slope.  
March 30, 2016

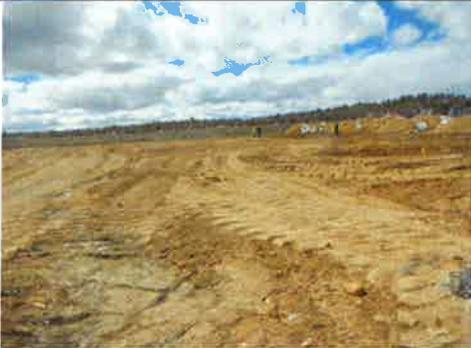
**PHOTO 13**  
Looking S at BRP1-6 (Pit 1B)  
March 30, 2016

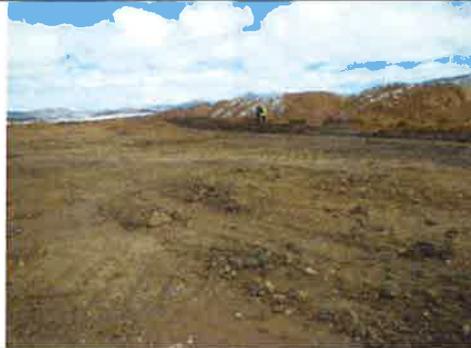
This Phase 1 bond release does not include topsoil application or seeding. BRP1-6 is a 2.898 acre portion of Pit 1 (identified on Figure 1 as Pit 1B) within N1/2 N1/2 Sec 30, T39 S, R5W. It was formerly beneath the Excess Spoil Pile. BRP1-6 was backfilled in February 2016 and has subsoil placed in all but the haul road. BRP1-6 has a haul road running through it with subsoil berms on either side ready for placement. No topsoil has been placed in BRP1-6. To cover BRP1-6 with 8 inches of topsoil (0.666 ft) will require 3,118 CY of topsoil.

**PHOTO 14**  
Looking North at haul road bisecting BRP1-6 and subsoil piles.  
March 30, 2016

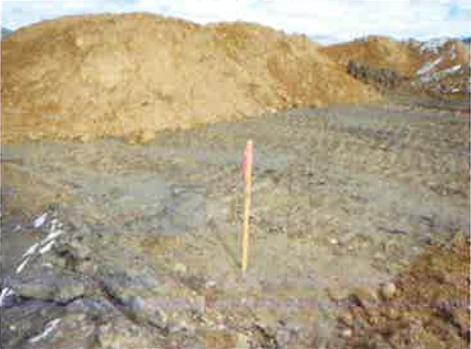
**PHOTO 15**  
BRP1-6 on East side of haul road and subsoil piles.  
March 30, 2016

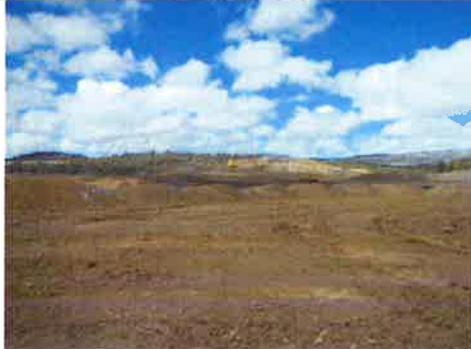
A remnant of the Excess Spoil pile remains West of BRP1-6. It will be consumed in the backfilling and grading of HWT 2B and HWT 3B shown on Figure 1 of the Bond Release application (Task 5097). (PB)

**PHOTO 16**  
Looking W across BRP1-6 at subsoil pile along haul road to Spoil Pile.  
March 30, 2016

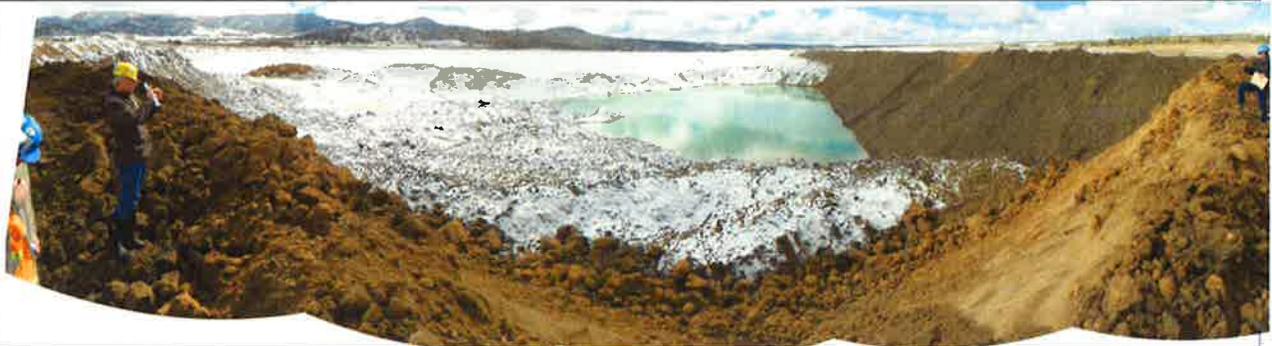
**PANORAMA 1**

Looking south at remaining void of HWT 2 that still needs to be backfilled.  
March 30, 2016

The primary haul roads throughout the facilities and access towards the underground mine appeared to be stable and controlling drainage to the appropriate areas. In addition to the primary haul roads associated with the underground mining operations, there are two temporary haul roads through the bond release areas, shown on Figure 1. The operator maintains the two roads as spoil haul roads from the excess spoil pile and HWT-2. All roads throughout the mine are regularly maintained by a grader. The site had received snow the previous day and the warm weather had started to thaw the surface. The site's clay used as backfill maintains moisture and is extremely slippery when wet, causing traction and rutting problems for heavy equipment at the site. The wheeled equipment was witnessed having difficulty staying on the road. Track equipment onsite was assisting the wheeled equipment through wetted and rutted areas. The grader and dozers were in the process of grading out extensive ruts within the roadways to maintain an even and level driving surface. The subsoil to reclaim the temporary roads to AOC is stored along the length of the roads as the road berms. Photos were taken to document the location and approximate volume is adequate for reclamation of the roads at the completion of the backfilling of HWT-2 in July 2016 (CP).

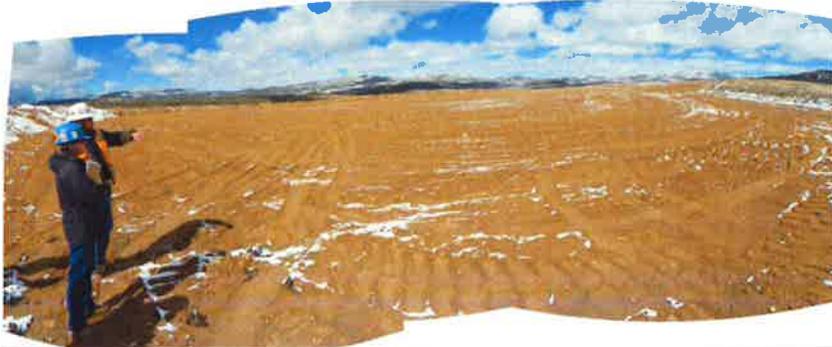
**PANORAMA 2**

The areas referenced here can be found on the map 'Overview Proposed Bond Release 16\_1'. We walked along the southern boundary of HWT-2A (Panorama 2). The backfilled area along the eastern edge of HWT 2-A seamlessly joins the edge of the undisturbed ground to the east. The hydrologic divides in this bond release area have been properly graded to match the pre-existing topography. It appears runoff within the HWT 2-A area will flow to the south into the Sink Wash watershed, while the majority of area within HWT 1-B will break along a divide and flow into the Lower Robinson Creek watershed (KS).

Looking north at the 5.2 Acres of backfilled bond release HWT 2-A area.  
March 30, 2016

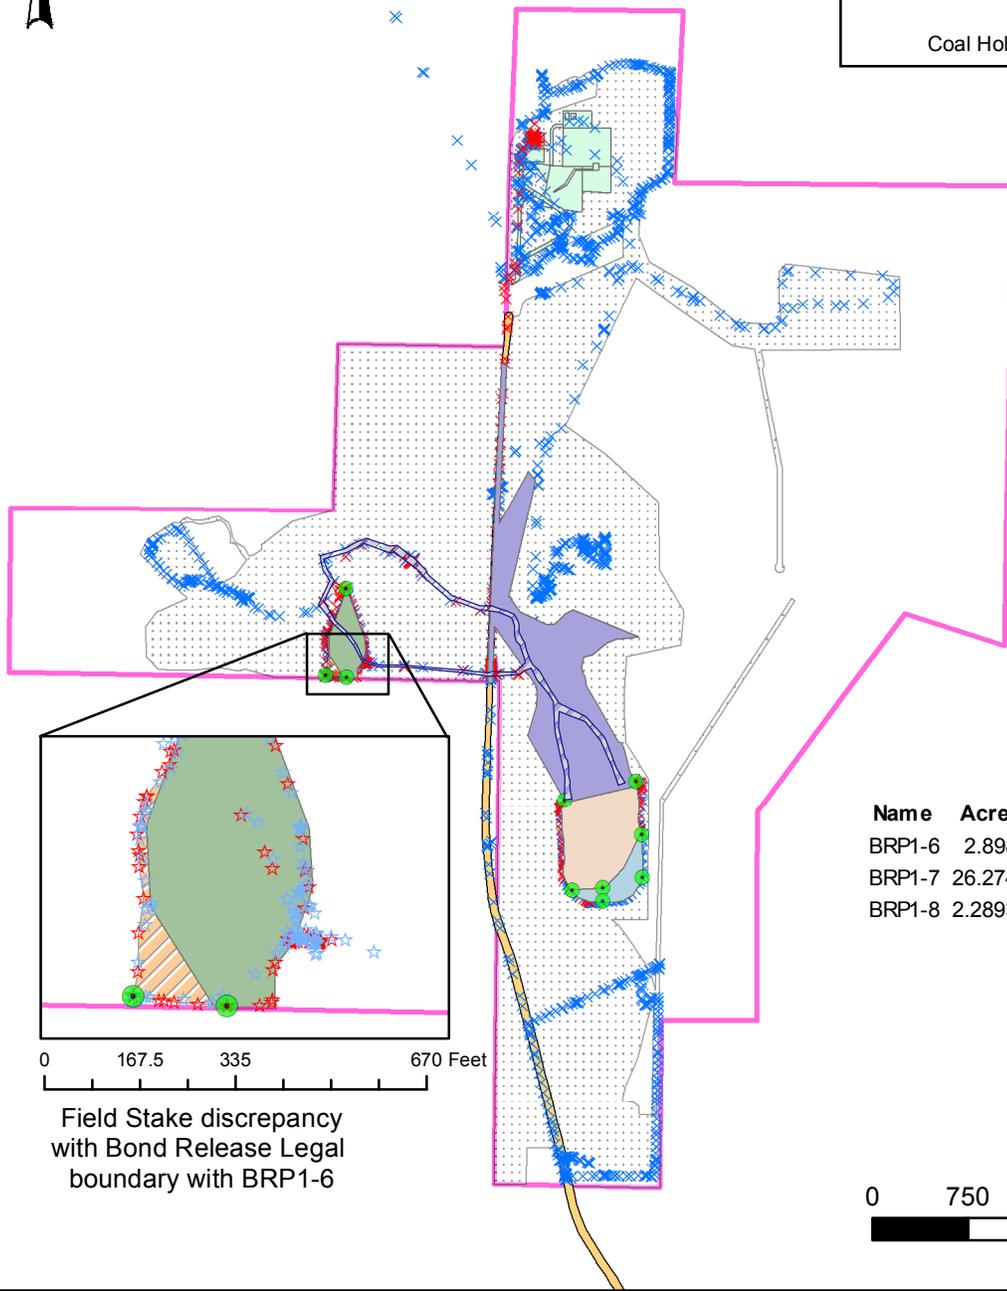
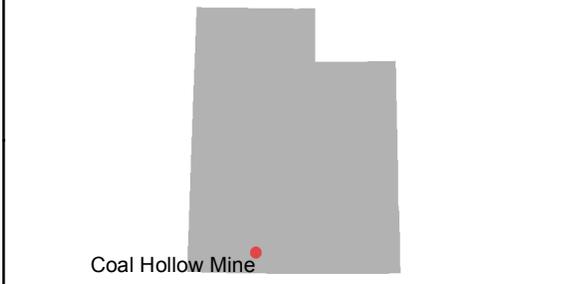
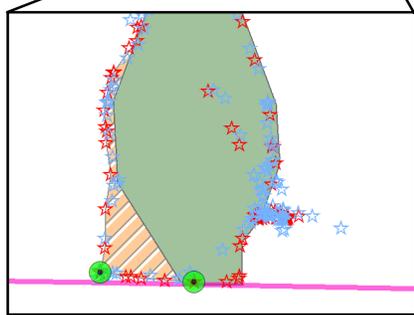
TITLE  
**PHASE I BOND RELEASE INSPECTION  
 TASK #5097**

The boundary of the bond release areas BRP 1-6 through BRP 1-8 were staked and flagged by pink tape. The site appears to have been backfilled and graded back to AOC to the extent possible, see Photos. The Division staff tracked the inspection route with GPS, see Figure 1. GPS points of various stakes for each of the bond release areas were taken to verify bond release extents shown on Drawing 5-19. Figures 1-D through 1-F show the backfill cross sections averaged around 7.6 feet for BRP 1-6, 8.1 feet for BRP 1-7, and 1.9 feet for BRP 1-8 below the original contour. Overall the graded areas in the bond release blended with the surrounding area well and no sign of water pooling or rills. The bond release area requested was for 31.1 acres. The Division received a copy of the Kane County's approval of the county road reclamation via email on 3/31/2016 from Louis Pratt. The Application for bond release is recommended for approval. Please see the Technical Findings and Analysis of Task 5097 for further details regarding grading details.(CP). Mr. Pratt was present during this bond release inspection and was satisfied with the backfilling and grading of the County Road to date. Further road construction to County specifications for compaction, road base, borrow ditch construction etc., will be under County supervision. (PB).

Field Stake discrepancy with Bond Release Legal boundary with BRP1-6
