Inspection Report

Permit Number:	C0250005
Inspection Type:	PARTIAL
Inspection Date:	Wednesday, April 06, 2016
Start Date/Time:	4/6/2016 10:00:00 AM
End Date/Time:	4/6/2016 5:30:00 PM
Last Inspection:	Tuesday, March 29, 2016

Permittee: **ALTON COAL DEVELOPMENT LLC**
 Operator: **ALTON COAL DEVELOPMENT LLC**
 Site: **COAL HOLLOW**
 Address: **463 North 100 West, Suite 1, CEDAR CITY UT 84720**
 County: **KANE**
 Permit Type: **PERMANENT COAL PROGRAM**
 Permit Status: **ACTIVE**

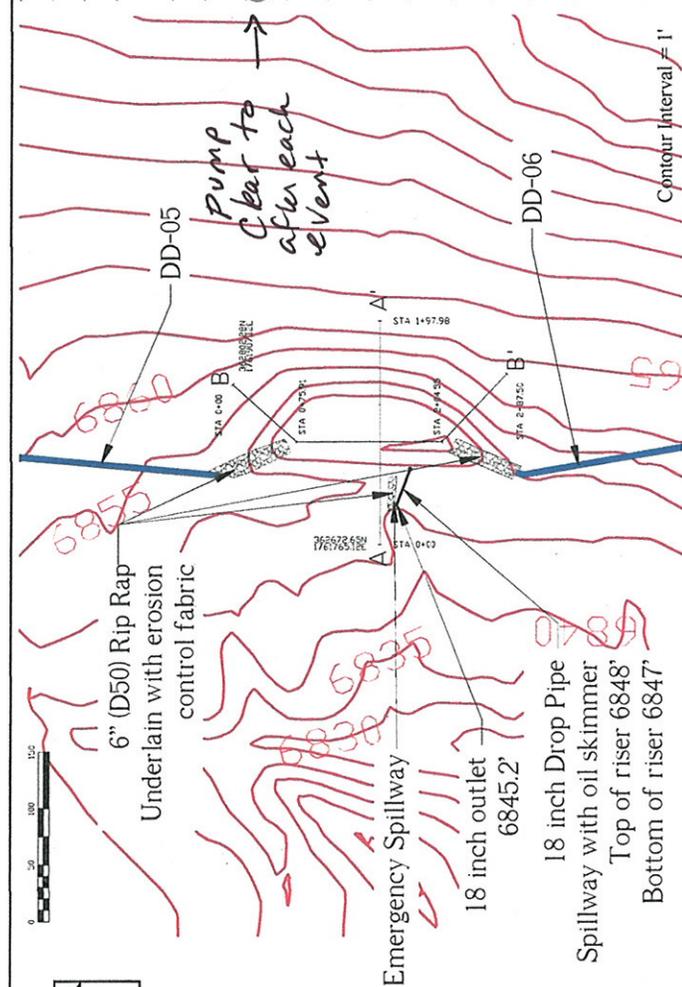
DRAWN BY: A. CHRISTENSEN
 CHECKED BY: DS
 DATE: 3/31/2016
 SCALE: 5-67A

SEDIMENT
 IMPOUNDMENTS
 AS-BUILT DETAILS

As-Built Pond Storage Volumes			
Sediment Control Structure No. 5			
Water Elev (ft)	Area (Acres)	Average Area (Acre-Ft)	Volume Accumulated (Acre-Ft)
6840.00	0.010		0.057
6841.00	0.103	0.057	0.057
6842.00	0.137	0.120	0.176
6843.00	0.161	0.149	0.325
6844.00	0.184	0.172	0.497
6845.00	0.207	0.195	0.692
6846.00	0.232	0.220	0.912
6847.00	0.259	0.246	1.158
6848.00	0.292	0.276	1.434
6849.00	0.329	0.310	1.744
6850.00	0.363	0.346	2.090

Sediment ponds 5 & 6 are roughed in and were evaluated by Dan Guy, P.E. on April 1. Mr. Guy's certified pond inspection was requested during the inspections and was promised by email, but were not received by the end of business on 4/7/2016 and were therefore included as a required abatement to NOV 21174 in the modification issued 4/7/2016. as of this writing (4/11/2016) the pond certifications have not been received. The Riprap installations on pond inlets were observed and photographed. All riprap should have a D50 of six inches. Riprap looked large at the pond inlets especially at the toe. Riprap at the emergency spillway had been removed and replaced at pond 6 to meet the D50 specifications. The 18 pipe outlet at each pond was re-installed to meet the specifications. The 18 inch pipe outlet at Pond 6 was partially plugged and would be cleared. At both ponds 5 & 6, the riprap spillway to the County road culvert remains to be installed and will require clearing a path through the County road topsoil stockpile on the other side of the permit area (fence) before it can be installed. The embankment of Pond 5 was driven over by heavy equipment and is now lower than the spillway, so needs repair. The geotextile installed at spillway of pond 5 was folded back on itself and needs repair. Repair of the above was included as abatement to NOV 21164 in the modification sent on 4/7/2016.

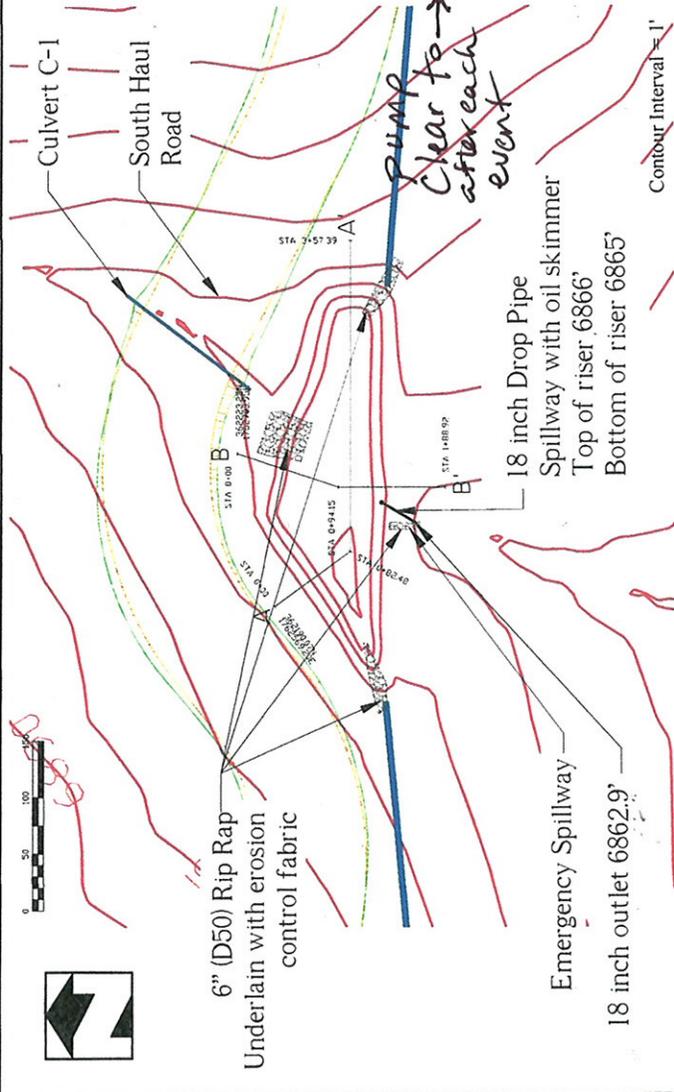
CHECKED BY: A. CHRISTENSEN
 DRAWN BY: 5-68A
 DATE: 3/31/2016
 SCALE:

SEDIMENT
 IMPOUNDMENT 6
 AS-BUILT DETAILS
 COAL HOLLOW

Water Elev (ft)	Area (Acres)	Average Area (Acre-Ft)	Volume (Acre-Ft)	Accumulated Volume (Acre-Ft)	Stage
6855.00	0.024				Bottom Pond
6856.00	0.106	0.065	0.065	0.065	
6857.00	0.258	0.182	0.182	0.182	
6858.00	0.298	0.278	0.278	0.278	
6859.00	0.330	0.314	0.314	0.314	
6860.00	0.360	0.345	0.345	0.659	60% Sediment Cleanup
6861.00	0.391	0.376	0.376	1.034	Max Sediment Level
6862.00	0.419	0.405	0.405	1.439	
6863.00	0.449	0.434	0.434	1.873	
6864.00	0.479	0.464	0.464	2.338	
6865.00	0.510	0.495	0.495	2.832	
6866.00	0.544	0.527	0.527	3.359	Principle Spillway
6867.00	0.586	0.565	0.565	3.924	Emergency Spillway
6868.00	0.635	0.610	0.610	4.534	Top of Dike

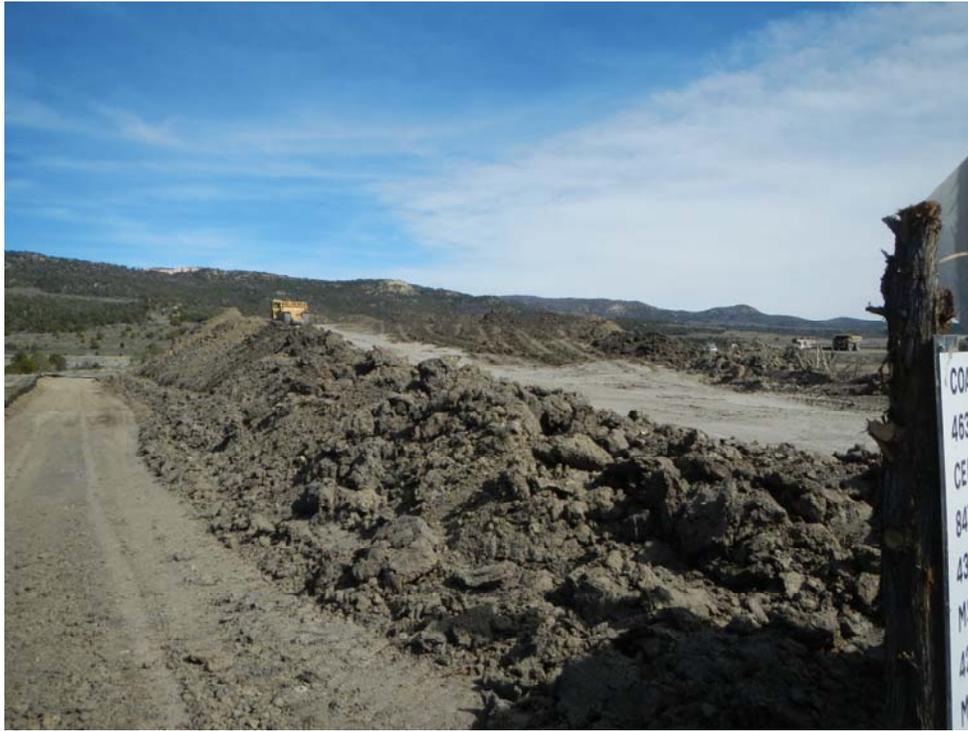
Below: Pond 6 is roughed in. Topsoil needs to be picked up from around the pond. A loader is loading topsoil from Pit 1 into haul trucks in the background.

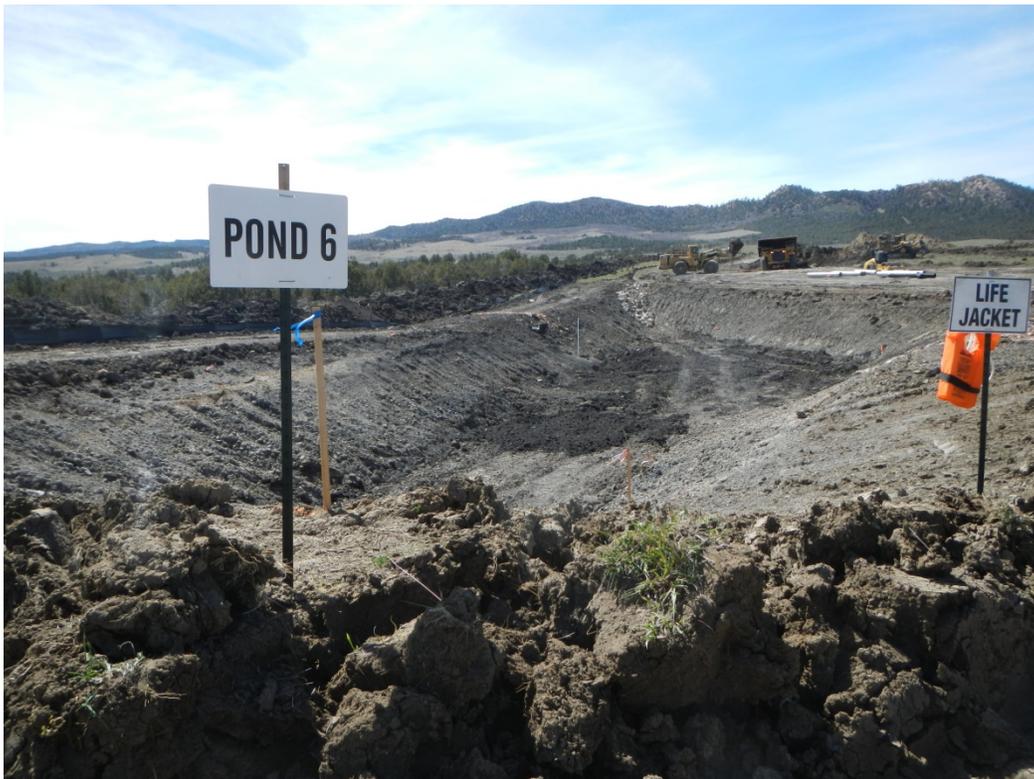
Above: Pond 6 appears to have had fill added. Below: Pond 6 Embankment needs rock removed.

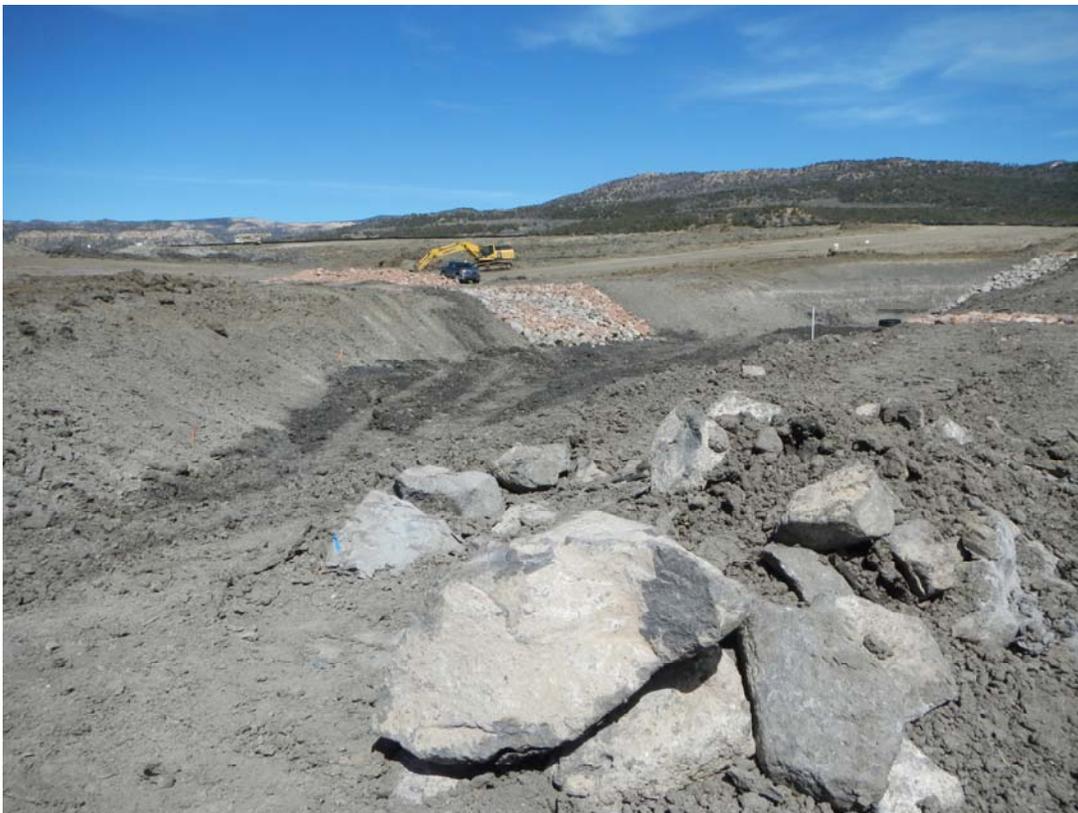
Above: Pond 6 Emergency spillway outlet.

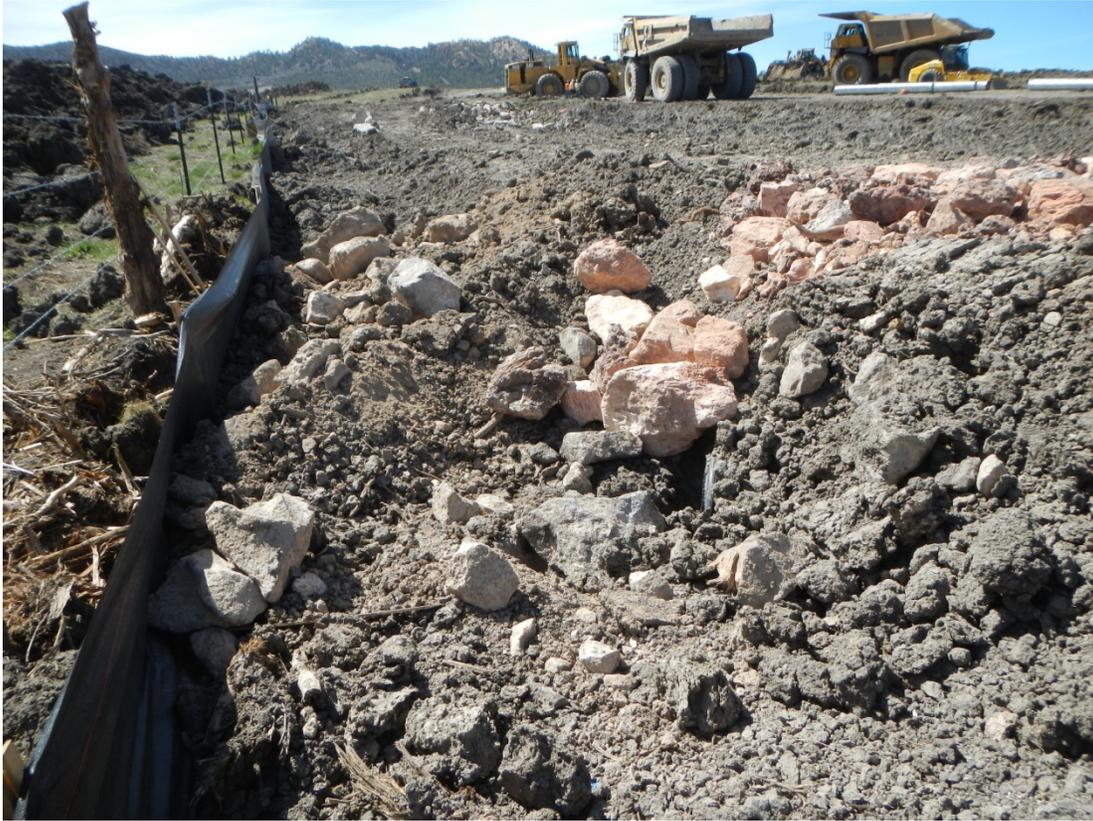
Below: Ditch 7 (D7) to Pond 6.

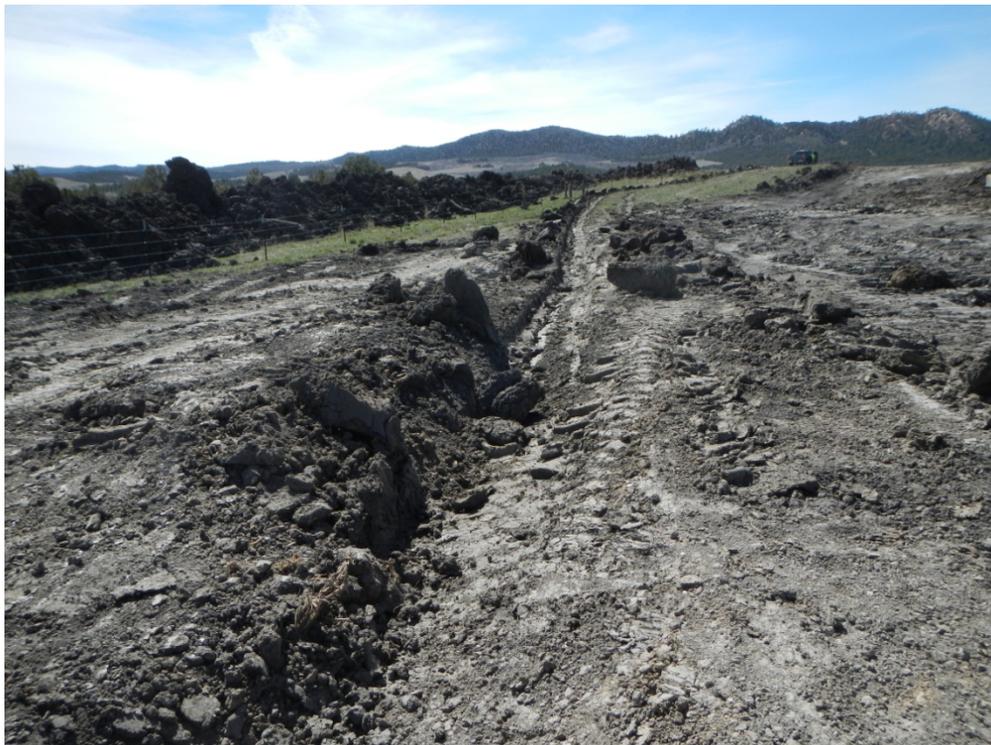
Above: Ditch 8 (D8) to pond 6 and incomplete South Haul Road.

There is no drainage control in place on the temporary haul road. The south haul road culverts are not in place. The south haul road ASCA 1 is not in place. The south haul road is not in place. Installation of the south haul road and all culverts was included in the modification of the NOV 21174 issued April 7, 2016.

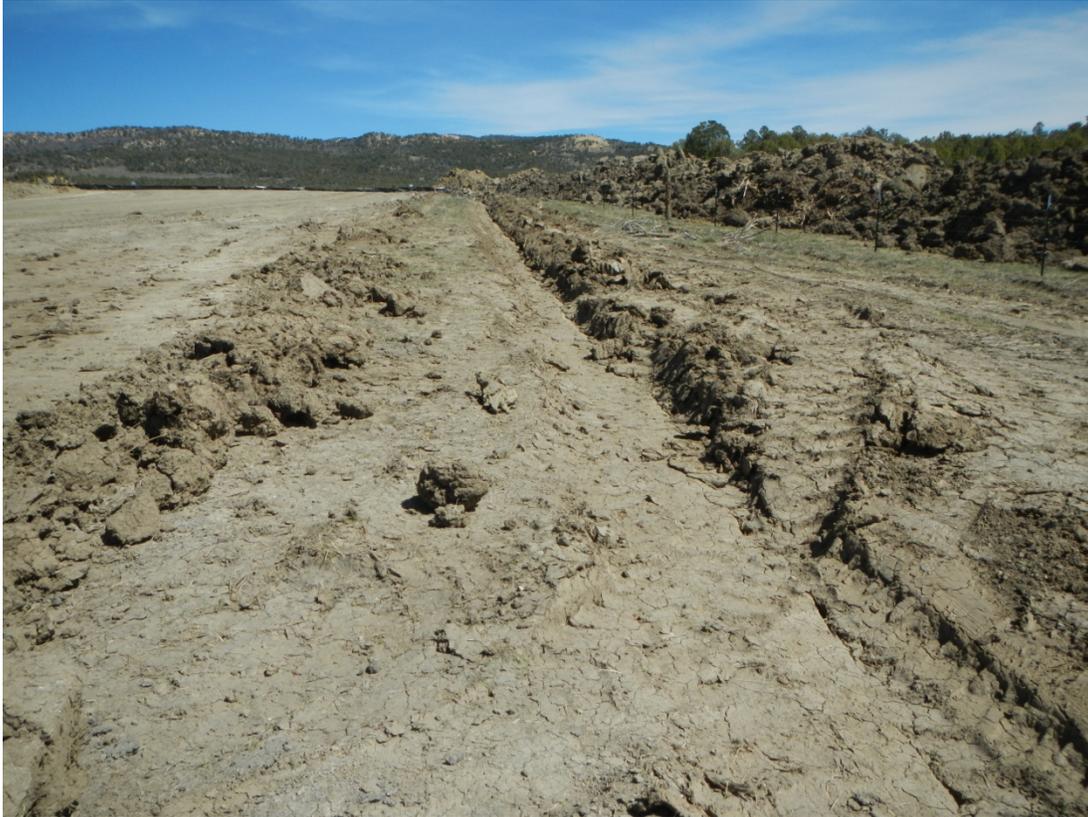
Below: Looking West over the spoil pile. Truck is dumping on the first lift while topsoil salvage is not complete in the center of the excess spoil pile.

Spoil certification was requested at the outset of the inspection, but was not available. Mr. Nichols stated that Dan Guy had inspected and certified the foundation preparation and that he would email the certification to me. The certification was not received by close of business on April 7, 2016 and was included in the modification to NOV 21174 sent April 7, 2016. Two haul trucks (120 Ton trucks) were moving overburden from the north end of Pit 1 to the spoil pile. The first lift is being placed across the west half of the spoil pile. The center portion of the spoil pile still has topsoil in place. This topsoil must be removed. Completing removal of topsoil from the spoil pile was included in the abatement measures described in the modification of the NOV 21174 sent April 7, 2016.

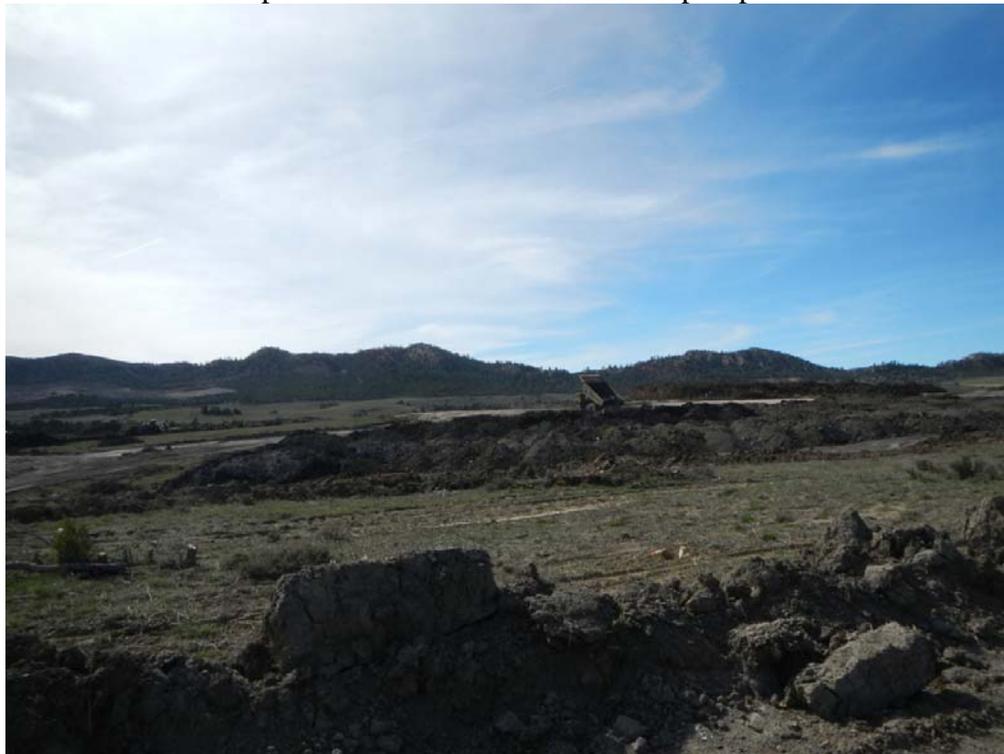
Above: Pond 5 pipe outlet and emergency spillway. Note geotextile installation needs repair.
Below: D6 to Pond 5. Note traffic on pond embankment has compacted embankment below spillway elevation.
Note sediment marker is in place, but not marked with elevations for clean out or draw down.

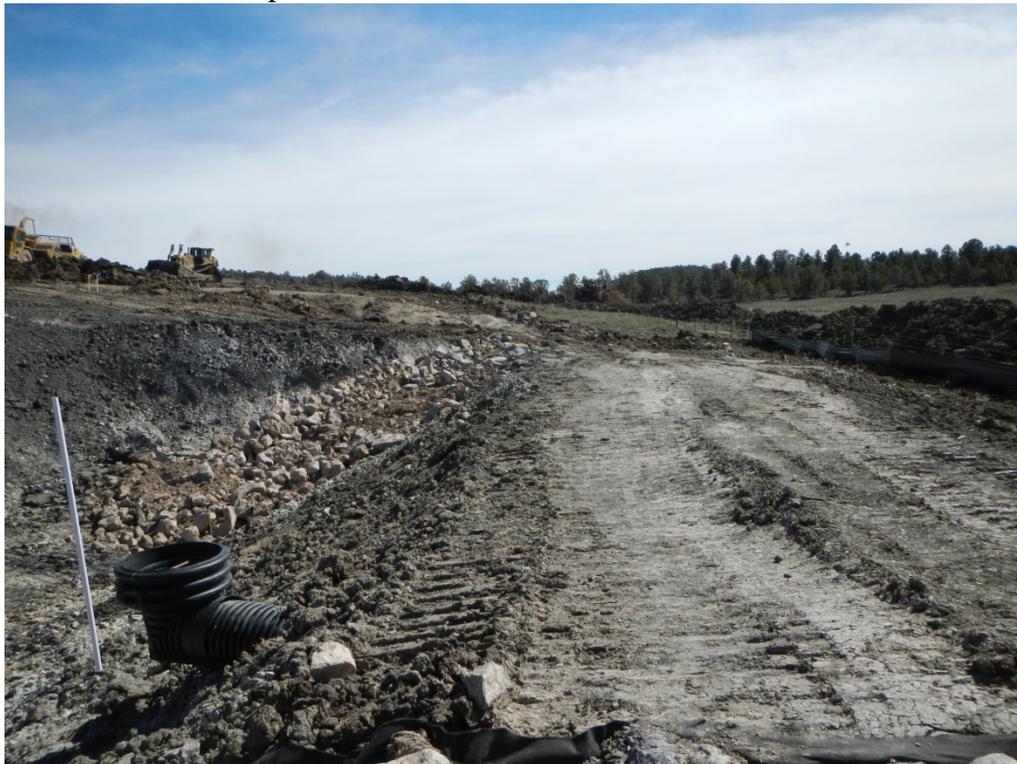
Above: Ditch D5 to Pond 5 in center of frame. Haul trucks are moving spoil from Pit 1.
Below: Mining has proceeded from the north end of Pit 1 rather than the south end. Coal is exposed in Pit 1.

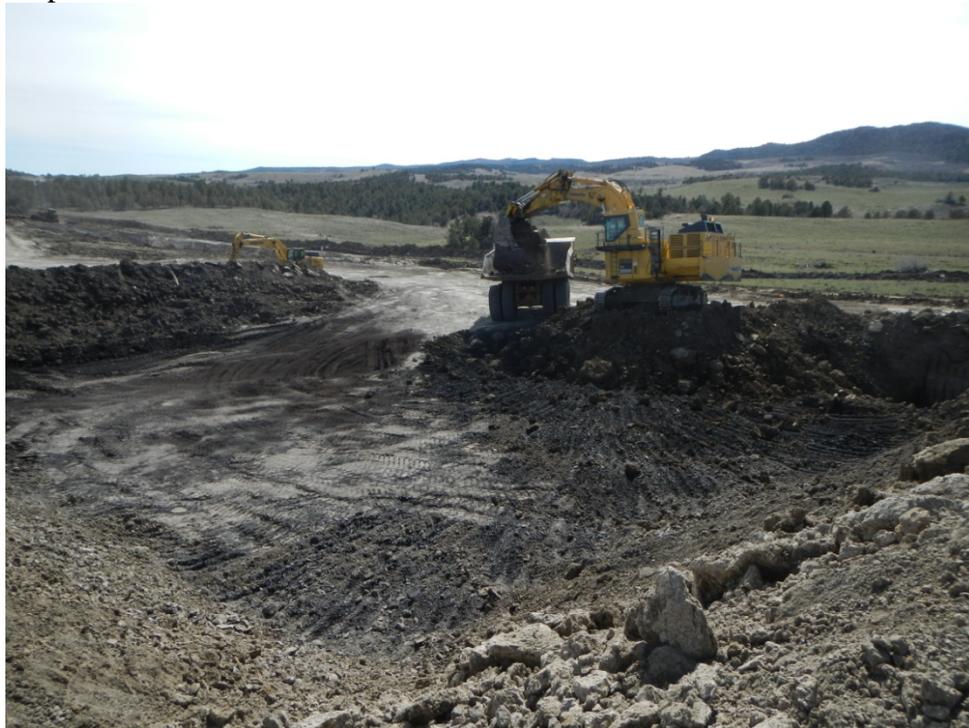
Above: Removing topsoil with scraper and dozer from Pit 1 area just west of Pond 5
Below: Temporary haul road runs through subsoil pile from County road to Pit 1.

Area 1 topsoil will be removed to a depth of 14 inches from all active mining areas (pits, ponds, roadways, haul roads, storage and repair yards, etc. Subsoil to a depth of 2.6 feet will also be removed from Pit 1, Pond 5 and Pond 6 and stockpiled in the subsoil stockpile. Roadways, subsoil and spoil piles will be placed on top of native subsoil which is demarcated by plastic fencing on 100 ft centers (MRP, Section 231.100). All material to be removed will be removed before any mining or other surface disturbance takes place (MRP Section 232.600). Area 1 topsoil has been removed from the ponds from 2/3 of the spoil pile, from 1/2 the subsoil pile, and during the inspection was being removed from Pit 1 south end. Articulated scrapers were moving the topsoil with the aide of a dozer. Area #1 topsoil pile is under construction, across the county road. It is approximately 25 - 30 ft high at the east end. Silt fence and fence surrounds the site on the north and east. The access road around pile will be eliminated when pile receives final grading to 3h:1v slope. Area 1 subsoil pile is under construction. During the inspection a temporary haul road from the north end of Pit 1 east to the county road runs through the designated location of the subsoil pile. Subsoil has been stockpiled north of this temporary road only. Although mining in Pit 1 has begun, topsoil remains to be removed from parts of the spoil pile, and from ditch 8, ditch 7, ditch 6 and ditch 5 locations and adjacent to pond 6 where a random pile of topsoil was left. Subsoil remains to be removed from ditch 5 (to lower the ditch) and from the extent of Pit 1, which was underway. Topsoil and subsoil truck counts will be verified with a survey at completion of pile construction. Mining is underway and topsoil/subsoil salvage has not been completed as described in the MRP Section 231.100 and 232.600, therefore NOV 21174 includes the requirement to collect all topsoil and subsoil as described in the MRP from Area 1.

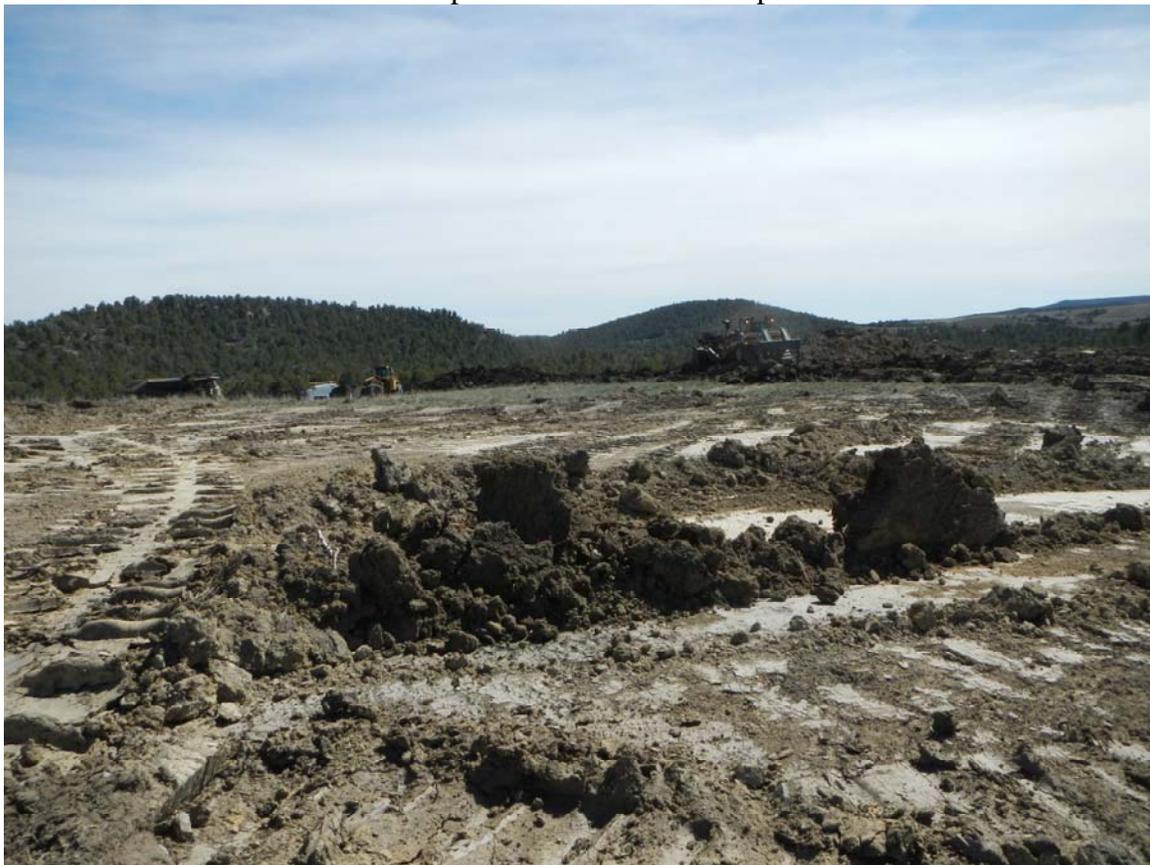
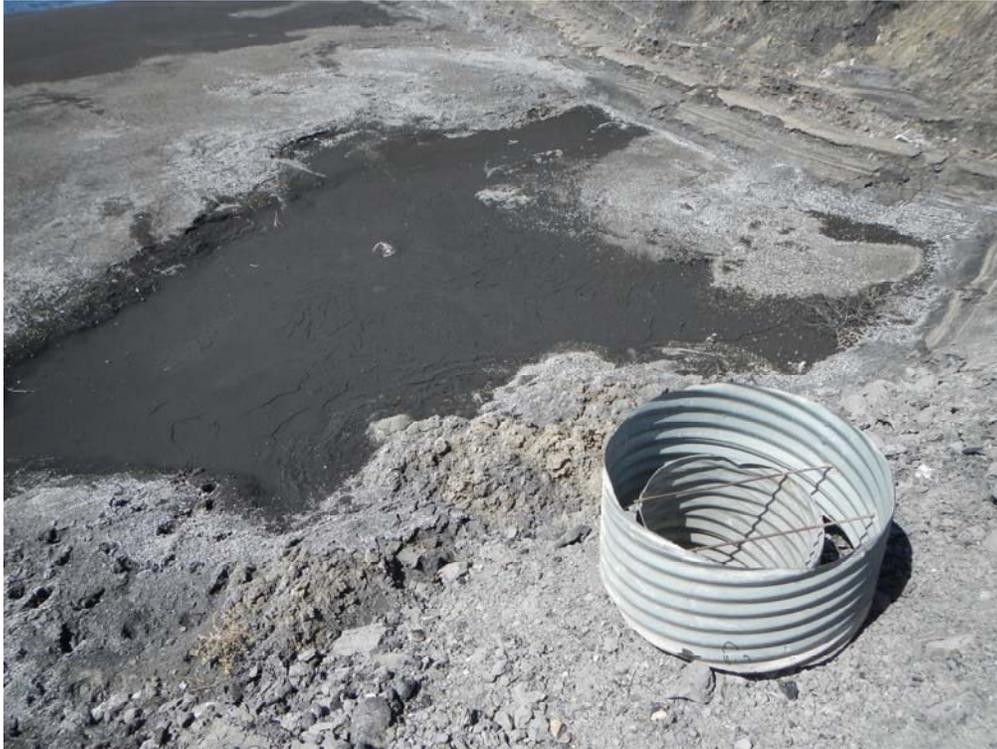
Repairs to Pond 1 Spillway above and Pond 2 Spillway below.

New gaskets were installed in the pond 1 and pond 2 outlets. Therefore, NOV 21166 was terminated.

Sediment ponds 1 & 2 have gaskets installed and are no longer leaking. According to mine personnel, gaskets were not initially installed due to time constraints. Water samples taken on March 3, 2016 do not show exceedence of any UPDES parameters. NOV 21166 will be terminated.
