# Inspection Report

Permit Number:	C0250005
Inspection Type:	PARTIAL
Inspection Date:	Wednesday, August 31, 2016
Start Date/Time:	8/31/2016 8:30:00 AM
End Date/Time:	8/31/2016 1:00:00 PM
Last Inspection:	Tuesday, August 16, 2016

Permittee: **ALTON COAL DEVELOPMENT LLC**  
 Operator: **ALTON COAL DEVELOPMENT LLC**  
 Site: **COAL HOLLOW**  
 Address: **463 North 100 West, Suite 1, CEDAR CITY UT 84720**  
 County: **KANE**  
 Permit Type: **PERMANENT COAL PROGRAM**  
 Permit Status: **ACTIVE**

A site visit was conducted at the Coal Hollow mine on August 31st, 2016. The primary purpose of the inspection was to observe Mike Herkimer of the Division of Water Quality as he conducted inspections of the mine's UPDES and Storm Water Permits. Sediment pond 3, 5, and 6 were visited. ASCA's at the NPL and at the main mine were inspected as well as sediment control measures in Pit 10.

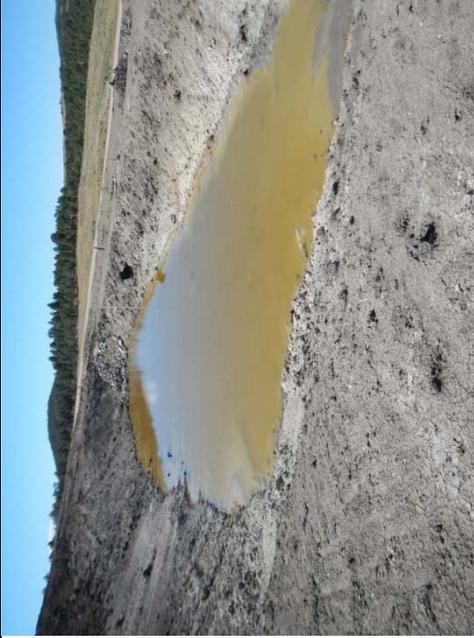
**PHOTO 1**

Sediment pond 3, 5 and 6 were visited. A large rain event occurred at the site within the last week. Pond 5 held a foot of runoff that shed from the reclaimed area of pits 1 and 2 (Photo 1). The mining sequence has left Pond 6 with a very small contributing area. Pit 4, constituting the majority of the contributing area of Pond 6, is mined down to coal therefore reducing potential runoff volumes from rain storms (Photo 2). Pond 3 has been drawn down to remove accumulated sediment (Photo 3). Only water from the Pit 10 sump was discharging into the pond (Photo 4). The sump in the bottom of Pit 10 appears to be nearly complete (Photo 5). The pump was lowering the water level within the sump when we were there.

Pond 5 with 1 foot of standing water  
August 31, 2016

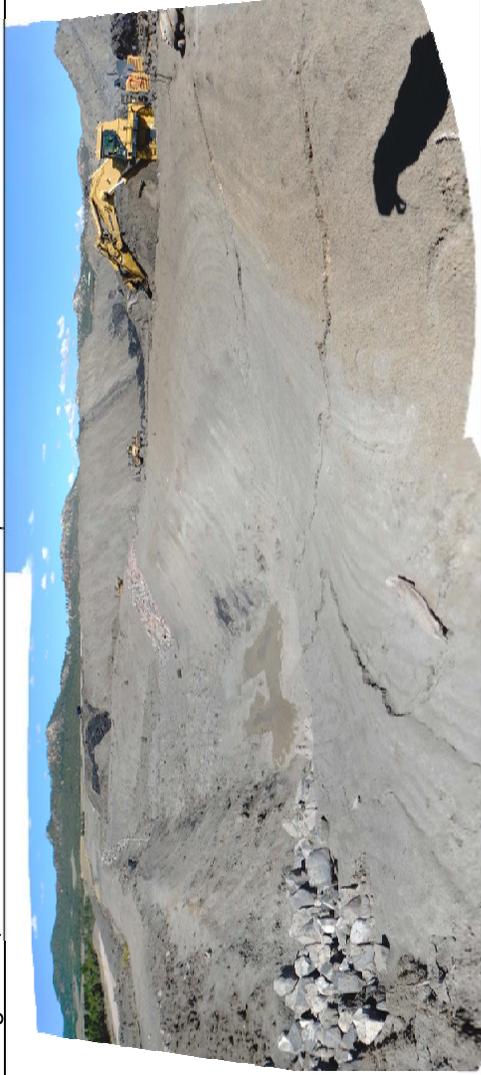
**PHOTO 2**

Pond 6 on the left with Pit 4 to its right. The track hoe is excavating the southern haul road.  
August 31, 2016

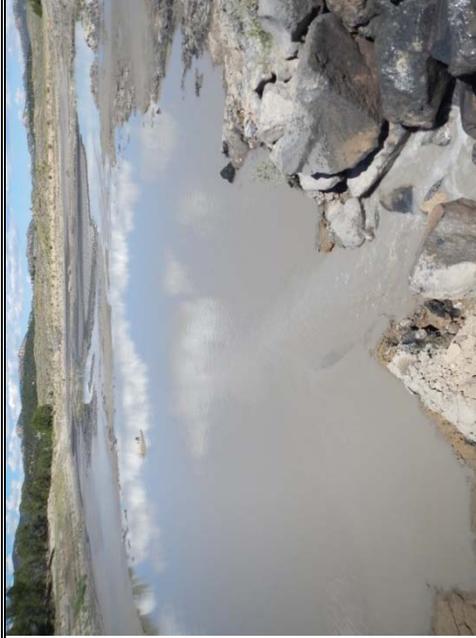
**PHOTO 3**

Pond 3 with the water level drawn down.  
August 31, 2016

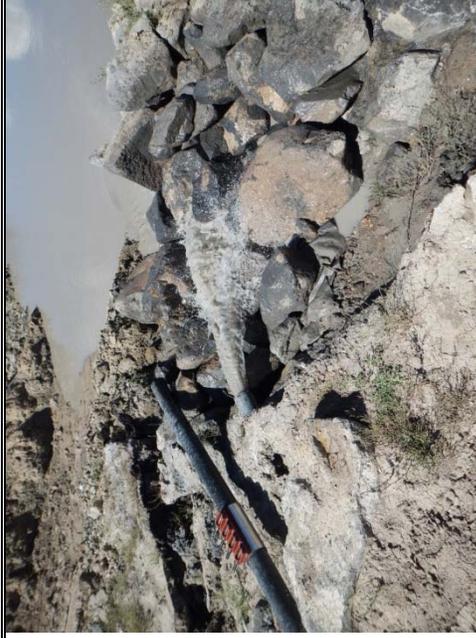
**PHOTO 4**

Pit 10 discharging to Pond 3.  
August 31, 2016

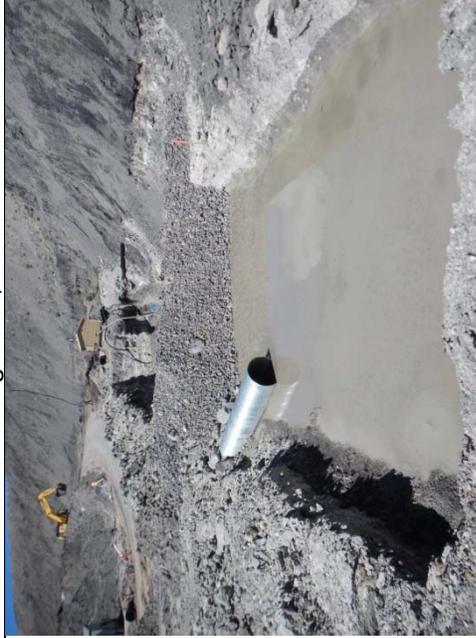
**PHOTO 5**

Sump in the bottom of Pit 10.  
August 31, 2016

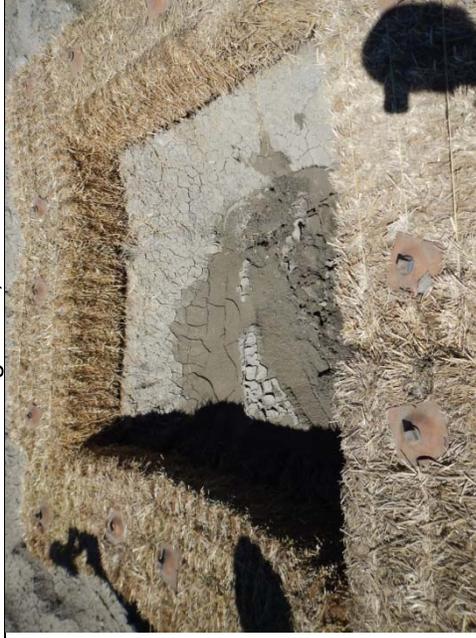
**PHOTO 6**

Multiple areas treated by BTCA's were overwhelmed by recent rain events. ASCA-1 in the North Private Lease (between the haul road and the county road) has failed and has not been maintained (Photo 6). This failure has allowed sediment to flow into the drop inlet of C-2 and off the permit area (Photos 7, 8, 9). NOV #21185 is issued for not maintaining ASCA-1 and for allowing suspended solids to exit the permit area.

NPL ASCA-1 has failed and has not been maintained.  
August 31, 2016

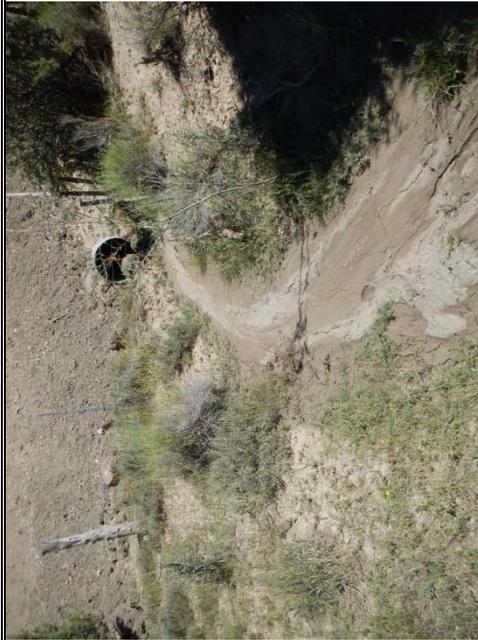
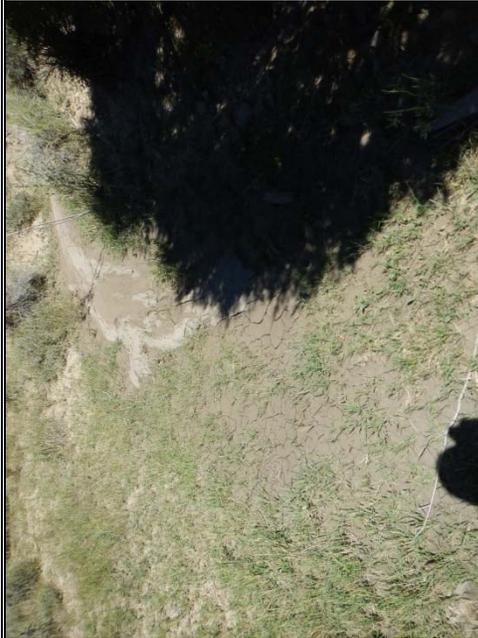
<p><b>PHOTO 7</b> Outlet of C-2. Sediment deposited off permit area. August 31, 2016</p>	<p><b>PHOTO 8</b> Sediment plume is shown deposited further down from C-2. August 31, 2016</p>

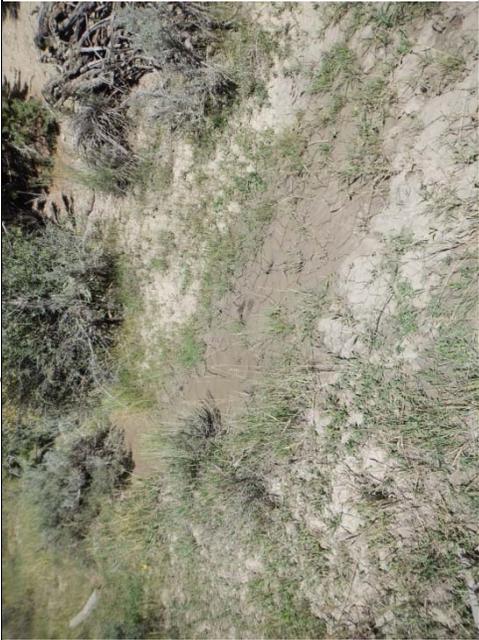
<p><b>PHOTO 9</b> Lower extent of sediment plume deposit down from permit area. August 31, 2016</p>	<p><b>PHOTO 10</b> Straw wattle in ASCA-1 needs to be maintained. August 31, 2016</p>

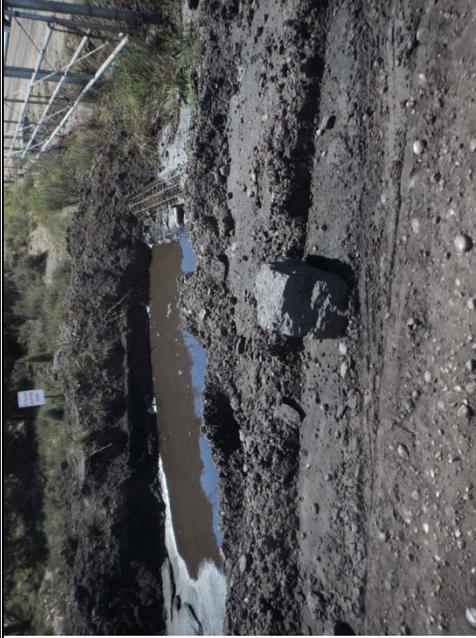
**PHOTO 11**

ASCA at main entrance must be maintained.  
August 31, 2016

The ASCA at the entrance requires immediate maintenance (Photo 11). The straw bales need to be replaced in the borrow ditch south of the entrance road. The captured and accumulated sediment must be removed from the check dams on both sides of the road.
