# Inspection Report

Permit Number:	<b>C0250005</b>
Inspection Type:	PARTIAL
Inspection Date:	Wednesday, November 16, 2016
Start Date/Time:	11/16/2016 10:30:00 AM
End Date/Time:	11/17/2016 1:30:00 PM
Last Inspection:	Wednesday, October 26, 2016

Permittee: **ALTON COAL DEVELOPMENT LLC**  
 Operator: **ALTON COAL DEVELOPMENT LLC**  
 Site: **COAL HOLLOW**  
 Address: **463 North 100 West, Suite 1, CEDAR CITY UT 84720**  
 County: **KANE**  
 Permit Type: **PERMANENT COAL PROGRAM**  
 Permit Status: **ACTIVE**

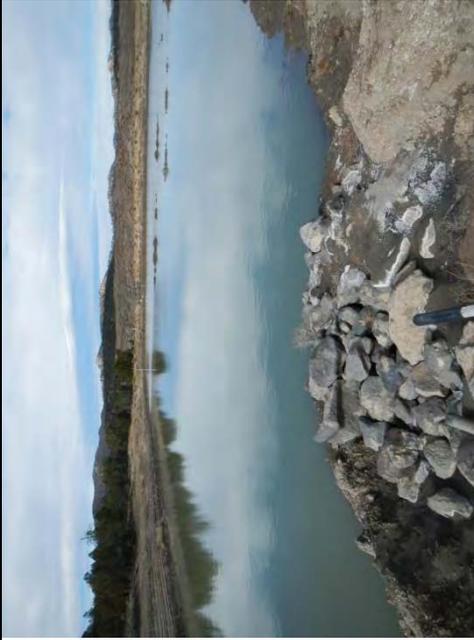
Dan Guy was inspecting ponds. Pond 3 was low and the pit 10 pipes were visible. Their locations were marked with GPS.

**PHOTO 1** Pit 10 pipes and pond 3

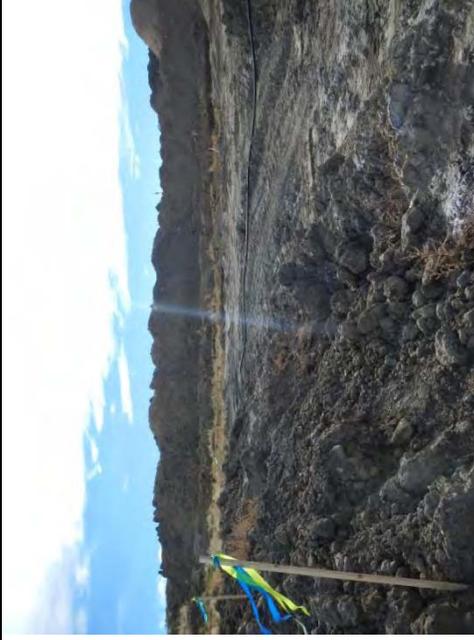
Topsoil is distributed across the BRP1-10 area and Pit 3 in the North Lease. Topsoil at the excess spoil pile in the South Lease has not been moved. This pile will be moved to BRP1-1 while the weather is dry (ASAP). There is a small seep at the base of this topsoil pile. The location of the seep was marked with GPS.

Diversion ditch B-1T-U was surveyed in. The survey locations were marked with GPS.

**PHOTO 2** Survey flags locate D-B-1T-U location. Remaining excess spoil topsoil pile in distance.

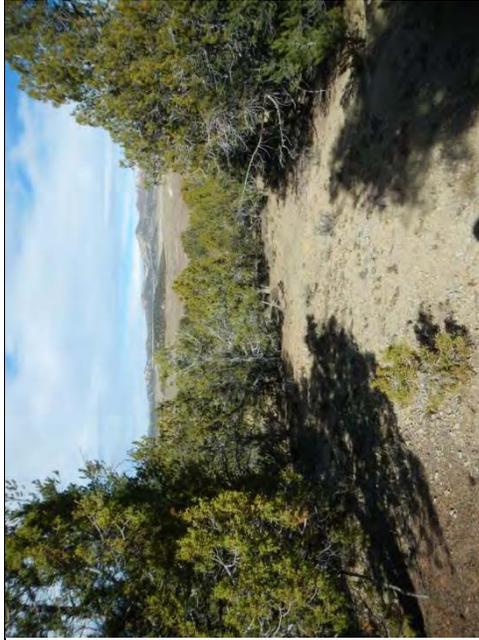
**PHOTO 3** Pit B1 10 acre additional area to be mined.

Big Horn Archaeological will be on site next week during topsoil salvage from the Pit B1 extended area (10 acres west of the excess spoil pile).

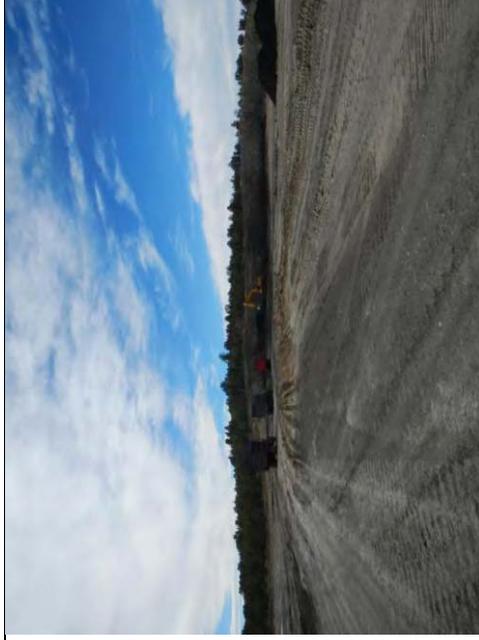
Drainage ditches along primary haul road to Pit B1 were groomed and the haul road was completed with road base, in accordance with the Rules but beyond the requirement of the MRP. Thank you.

**PHOTO 4** Coal trucks line up on primary road to haul the first coal out of Pit B1.

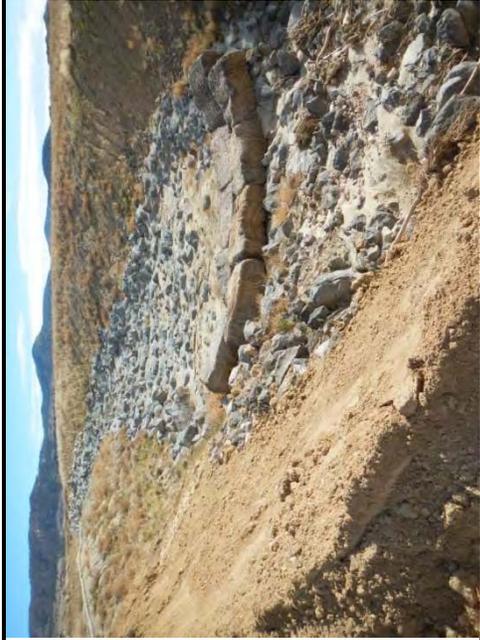
Lower Robinson Creek diversion has been reclaimed. The connection between undisturbed and reclaimed Lower Robinson Creek will be restored immediately after seeding the reclaimed diversion (scheduled for Saturday November 19, 2016). Water is currently ponded in the undisturbed Lower Robinson Creek outside the permit boundary. Ties on the one ton straw bales will be cut and the bales will be scattered at the transition zone prior to allowing water to flow into the reclaimed channel. The Stream Alteration Completion Report will be filed.

<p><b>PHOTO 5</b> Temporary diversion fill and reclaimed Lower Robinson Creek.</p>

Sediment control needs to be installed on the reclaimed Lower Robinson Creek diversion slope.

The reclaimed Lower Robinson Creek diversion is scheduled for seeding this Saturday 11/19/2016. Subsoil Pile #2 also requires seeding. The disturbed portion of Topsoil pile #2 also requires seeding.

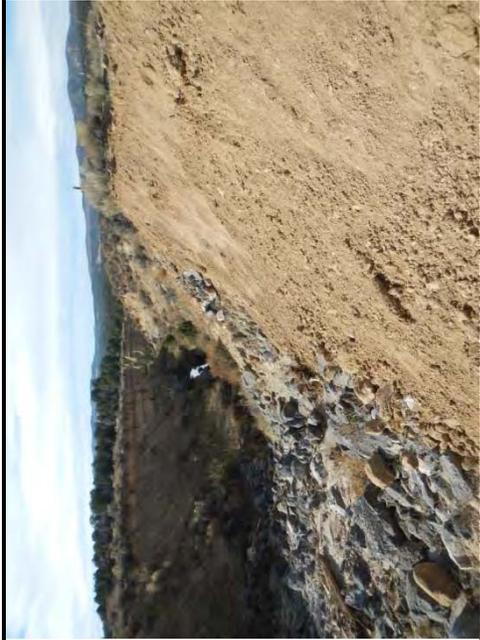
<p><b>PHOTO 6</b> Lower Robinson Creek downstream of permit boundary and temporary diversion fill in foreground.</p>

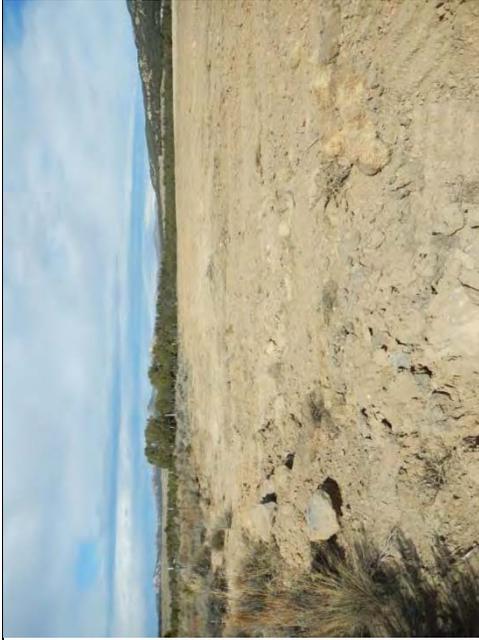
<p><b>PHOTO 7</b> Surface of reclaimed temporary diversion.</p>

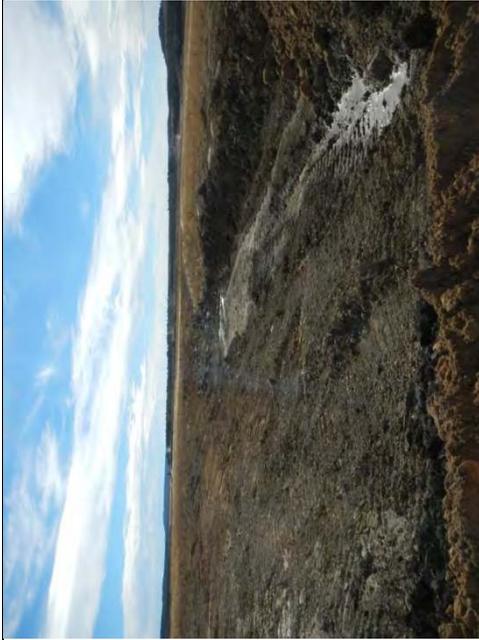
<p><b>PHOTO 8</b> Upper end of reclaimed Lower Robinson Creek within the permit area.</p>

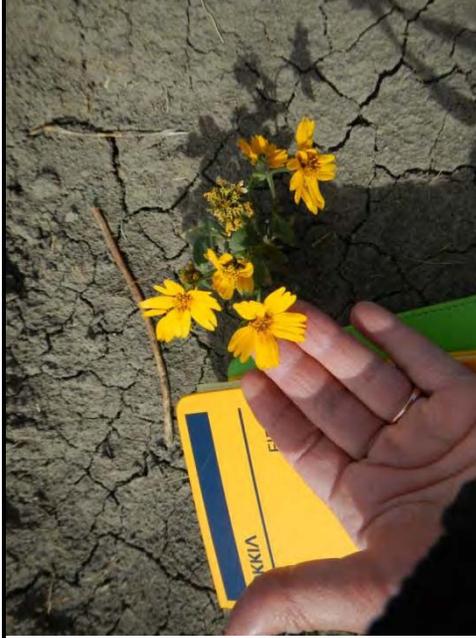
**PHOTO 9**

Composite blooming on Area 1 realigned County Road berm.

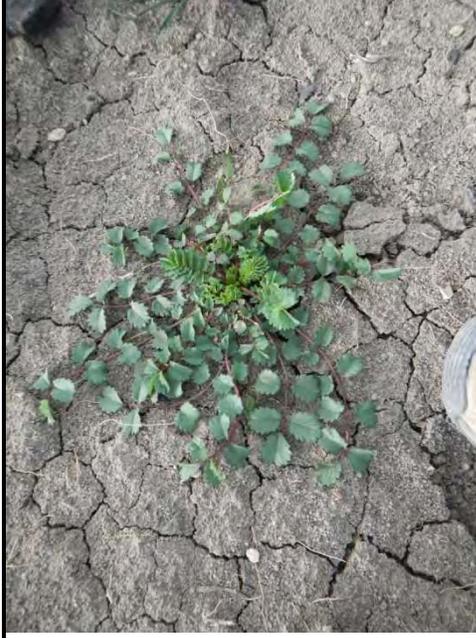
**PHOTO 10**

Small burnett 'volunteer' on clay soils of realigned Co Rd. berm.

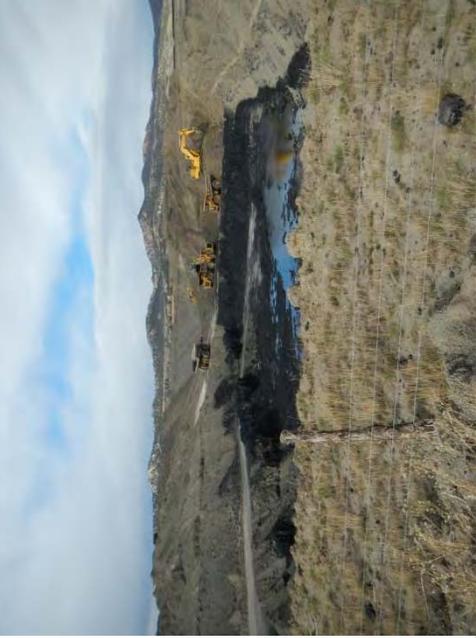
**PHOTO 11**

Overburden from Pit 6 was being moved to Pit 5. Subsoil was being hauled to the subsoil pile. The distinction between the two was impossible to see by an observer.

Three haul trucks are moving spoil from Pit 6.

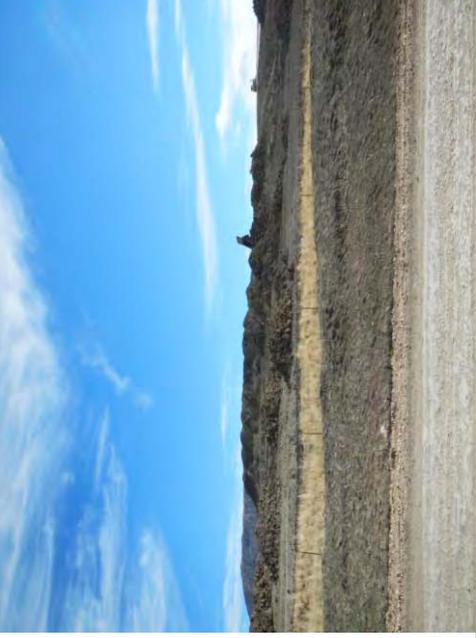
**PHOTO 12**

Topsoil stockpiled on North Lease Pits 1, 2, 3.
