Inspection Report

Permit Number:	C0250005
Inspection Type:	COMPLETE
Inspection Date:	Wednesday, December 07, 2016
Start Date/Time:	12/7/2016 9:00:00 AM
End Date/Time:	12/8/2016 4:00:00 PM
Last Inspection:	Wednesday, November 16, 2016

Permittee: **ALTON COAL DEVELOPMENT LLC**
 Operator: **ALTON COAL DEVELOPMENT LLC**
 Site: **COAL HOLLOW**
 Address: **463 North 100 West, Suite 1, CEDAR CITY UT 84720**
 County: **KANE**
 Permit Type: **PERMANENT COAL PROGRAM**
 Permit Status: **ACTIVE**

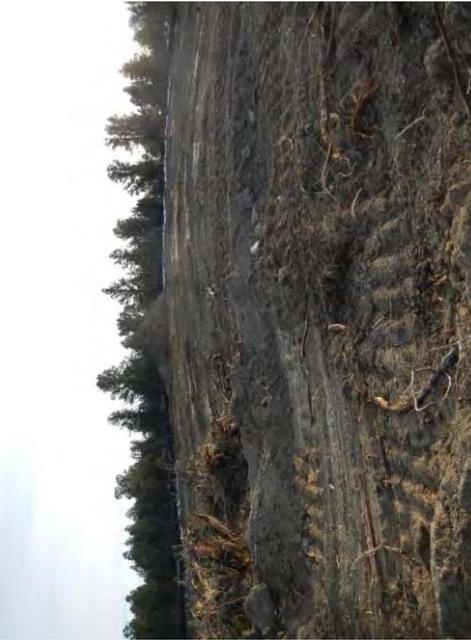
Pit B1: Topsoil has been recently removed from a strip along the length of the Excess Spoil highwall and the South permit boundary. A dozer was pushing topsoil into piles within the 7.45 acre Pit B1 addition circumscribed by B-1T_U and B-1T_L ditches. Pit B1 topsoil from both locations will be placed in topsoil pile #6 shown on Dwg 2-2.

<p>A landscape photograph showing a large, flat, brownish area, likely a topsoil salvage pit. The foreground is covered in sparse, dry vegetation and some scattered rocks. In the background, there are trees and a clear sky.</p>	<p>PHOTO 1 Topsoil salvage Pit B1</p>

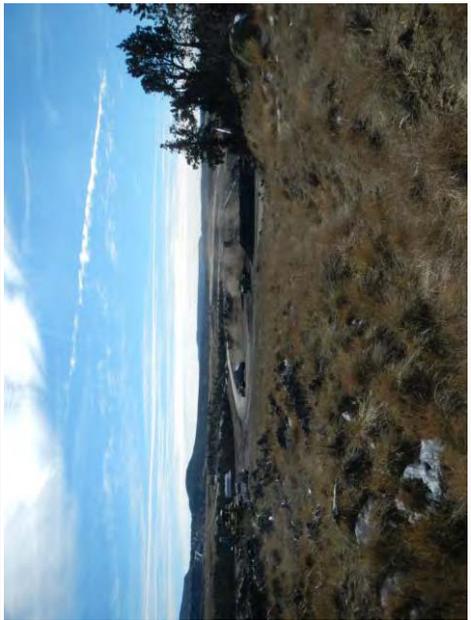
Topsoil Pile #1 was stable and well vegetated.

<p>A landscape photograph showing a large, flat, brownish area, likely a topsoil pile. The foreground is covered in sparse, dry vegetation and some scattered rocks. In the background, there are trees and a clear sky.</p>	<p>PHOTO 2 Topsoil Pile #1 foreground of raw coal pile.</p>

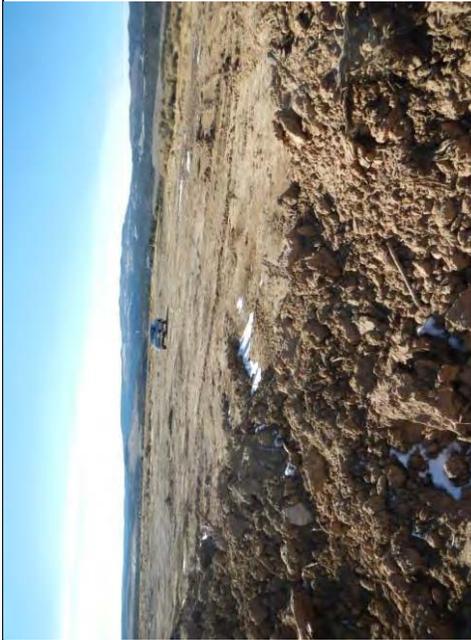
Topsoil was removed from Stockpile #2 this Fall to reclaim Lower Robinson Creek diversion and 2016 Phase 1 bond release areas. The newly formed West border of Topsoil pile #2 was re-bermed. The area of removal was seeded. The new boundary of the pile is shown on the attached map.

<p>A landscape photograph showing a large, flat, brownish area, likely a topsoil pile. The foreground is covered in sparse, dry vegetation and some scattered rocks. In the background, there are trees and a clear sky.</p>	<p>PHOTO 3 Standing on Topsoil #2 berm looking at former footprint of pile.</p>

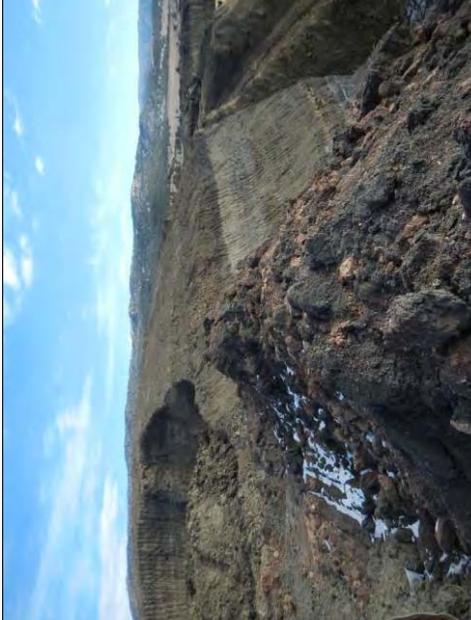
The North Lease topsoil pile has been partially utilized for reclamation. The remaining pile has been encroached upon by Pit 6. Our track along the high wall of Pit 6 is attached. Our GPS track along the highwall is attached. This track was on topsoil. R645-301-234.230 requires that topsoil is placed in a stable location. Therefore NOV 21191 was issued for failure to protect the topsoil.

Failure to protect topsoil at the North lease. North lease topsoil stockpile has been encroached upon by Pit 6. North lease topsoil forms the pit 6 high wall.

<p>A landscape photograph showing a large, flat, brownish area, likely a topsoil pile. The foreground is covered in sparse, dry vegetation and some scattered rocks. In the background, there are trees and a clear sky.</p>	<p>PHOTO 4 North Lease Topsoil Pile at PTI 6 highwall edge, Subject of NOV 21191.</p>

NOV 21191 was issued during this inspection for failure to protect the topsoil at the North Lease.

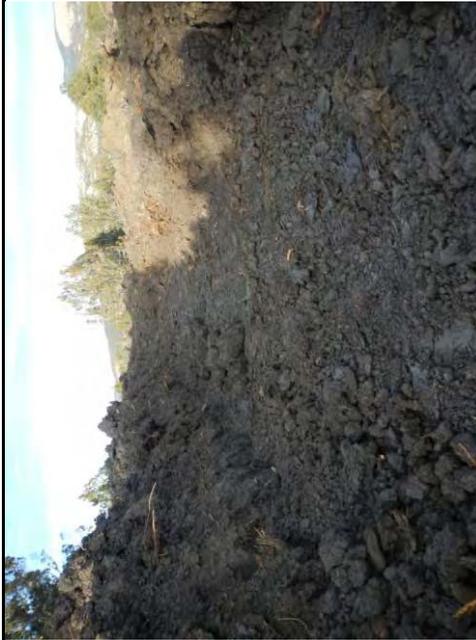
South Lease (designs are in App. 5-2):
B-1T-U and B-1T-L the pit B1 upper and lower ditch/berm were newly cut in approximately 18 inches below the topsoil.

PHOTO 5 Ditch B-1T-U under construction

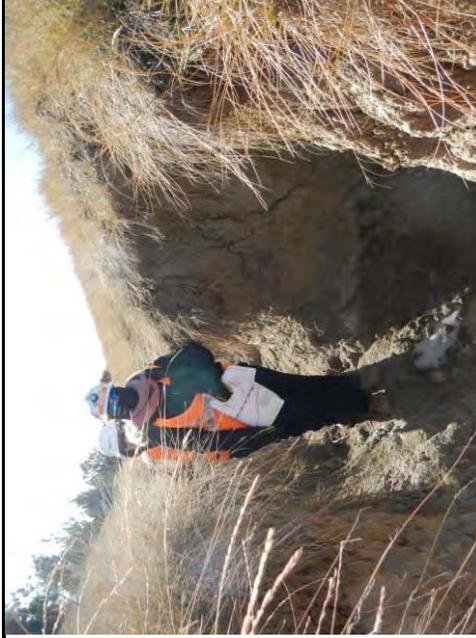
PHOTO 6 ditch D3 needs maintenance

East of the boneyard, D3 requires repair and armoring to bring the ditch back to design standards of 4.5 ft wide and 2h:1v side slopes.

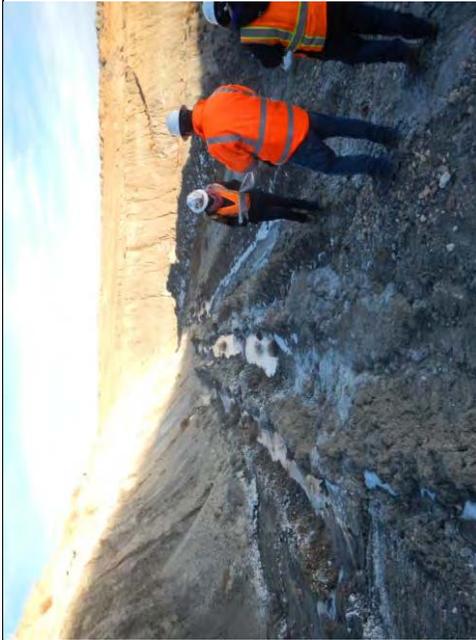
PHOTO 7
P10-NO2 needs maintenance

Culverts P10-02, P10-03, P10-04, P10-05, P10-06, P10-08 require maintenance. Ditch P10-NO2 requires maintenance. Ditches P10-SO1 (mid section above the former cascading drainage), P10 S03 (at its beginning) and P10SO4 (at bathhouse waterline) must be completed. Riprap in ditch P10-R04 requires better placement. Culvert P10-08 requires maintenance.

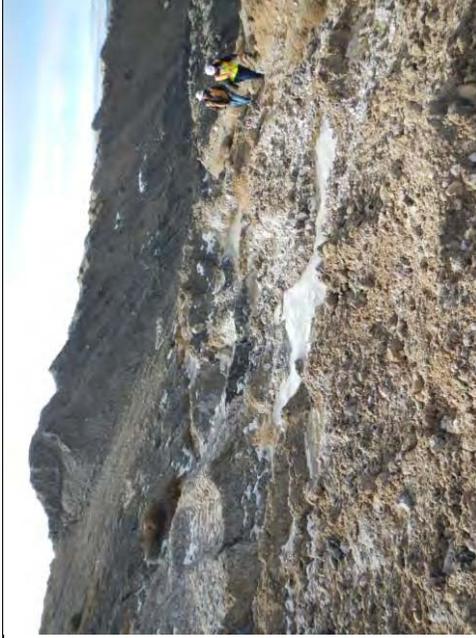
PHOTO 8
P10-S01 not completed

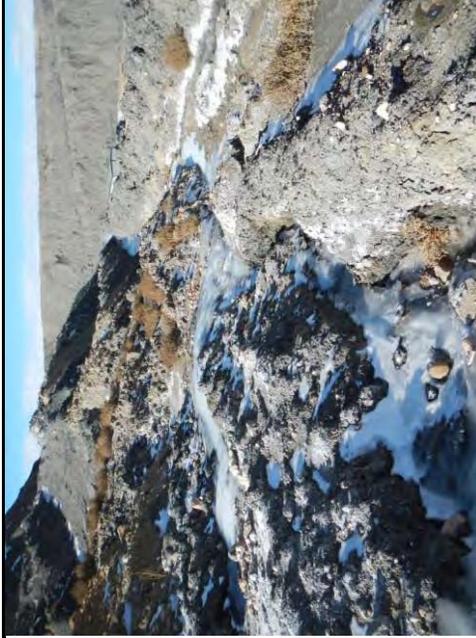
PHOTO 9

P10—S03 reach is not completed to outlet of P10-10.

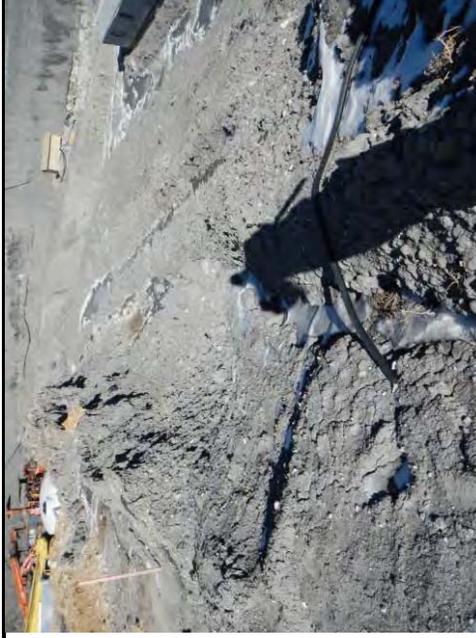
PHOTO 10

P10-S04 requires improvement at bathroom water line.

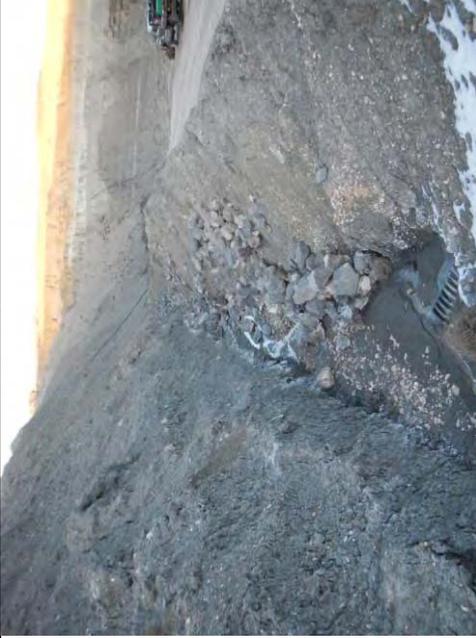
PHOTO 11

P10-R04 riprap and Culvert P10-08 outlet require maintenance

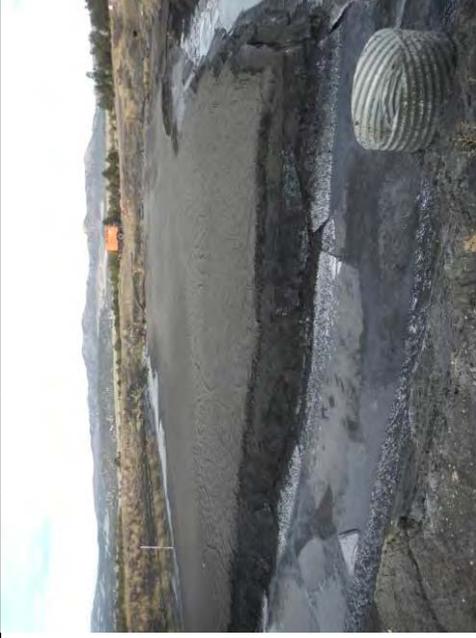
PHOTO 12

Quarterly P.E. certified inspection of the ponds was conducted on 11/16/2016. All pond sediment elevations were below 60% (cleanout). Ponds were photographed. Pond 1 is cleaned of sediment from around the edges. Pond 1B had both inlets repaired and was cleaned out. Pond 1 and 1B clean out was placed on the excess spoils pile for placement in the Pit B1 backfill. Pond 2 had sediment removed from the inlet. Pond 3 was cleaned out. Pond 2 and 3 sediments have been placed in the excess spoil pile for soil suitability testing.

Pond 1 requires further sediment removal.

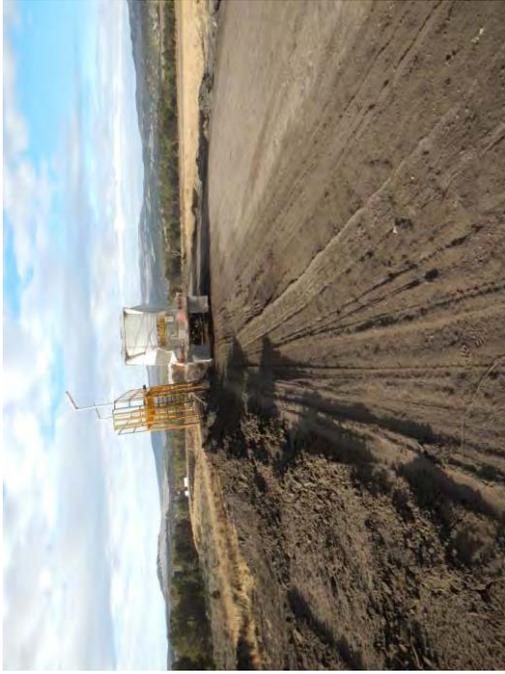
The County road at the entrance to the facilities yard was recently widened to accommodate box trucks and tandem coal trucks. The turn is still a tight one and chunks of coal that have fallen off trucks have been ground to a fine dust. The dust is carried by wind and water. Locations of coal fine dust were noted on undisturbed land inside and outside the permit area. We observed the opacity of the dust behind the vehicles traveling through the entrance gate. The opacity appeared to be above the limit established by the Air Quality permit. On the second day of this inspection, the water truck was seen watering the roads.

PHOTO 17 Coal fine accumulation on berm and road

Erosion of the East side borrow ditch of the Primary haul road north of C13 and through the berm of the raw coal pad must be repaired. Coal fines should be scooped up in this location to reduce dust. This work was requested to be completed promptly.

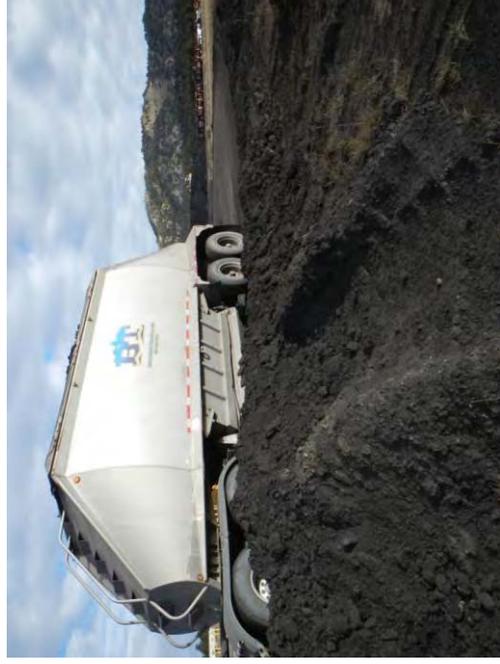
PHOTO 18 Coal fines on haul road berm

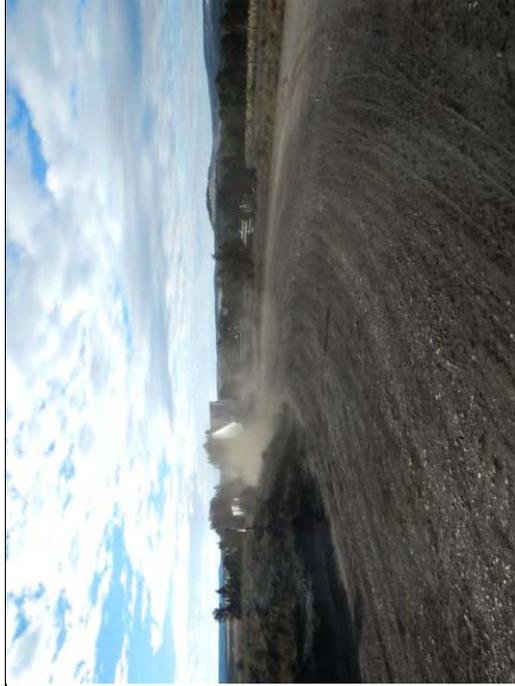
We discussed the requirements of the Air Quality permit DAQE AN140470005 (issued 11/20/2015) with regard traffic speed and opacity limits and whether more could be done to implement these limits. We observed high dust volumes along the primary haul road to the raw coal stockpile pad, and the primary loadout road near C6 and at the pond 1 spillway outlet, and the primary road at the facilities gate. We observed the box trucks had sides raised by two feet and were overfilled. We observed rock spills along the length of the county road outside the permit area. The spilled coal gets finely ground and becomes dust under the truck traffic. We took GPS points of coal fine deposition inside and outside the permit area. Outside the facilities gate, the accumulation is approximately 1/4 inch.

PHOTO 19 Coal fines create dust.

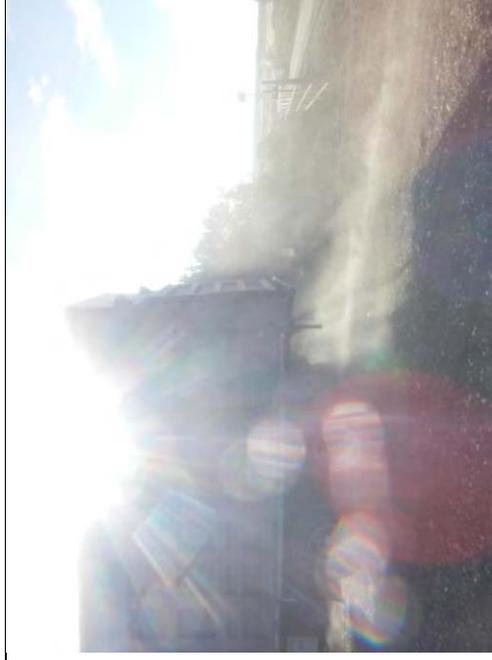
PHOTO 20 Truck traffic creates dust at entrance.

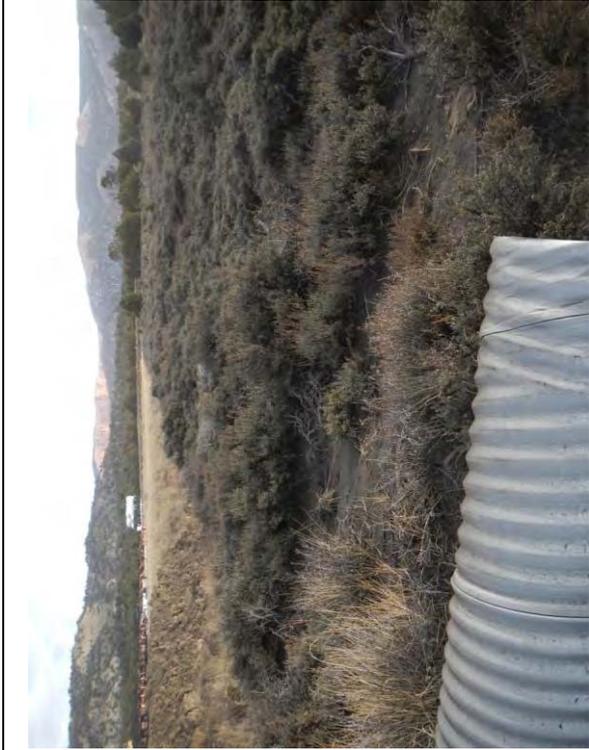
PHOTO 21 Coal dust on undisturbed within the permit area

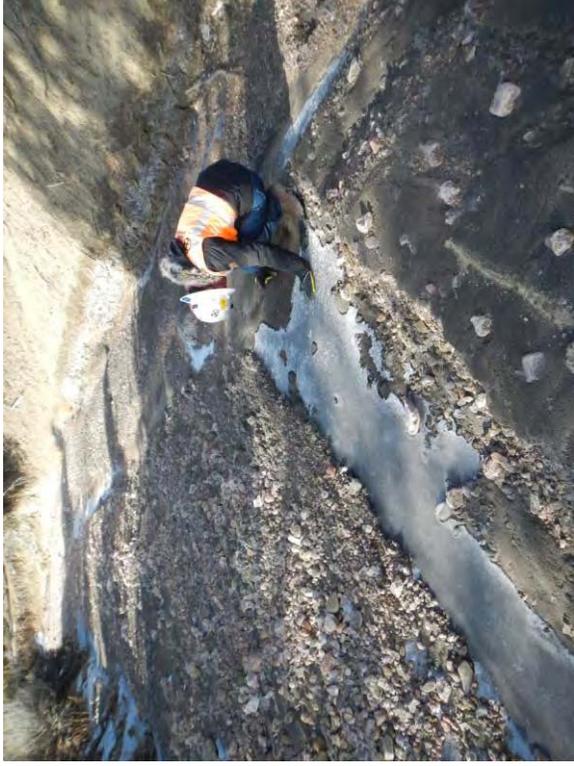
Ducks were in Pond 4. Coyote tracks seen in Lower Robinson. Coal fines were observed in Lower Robinson Creek immediately NW of the air monitoring site.

PHOTO 22 Coal fines in Robinson Creek

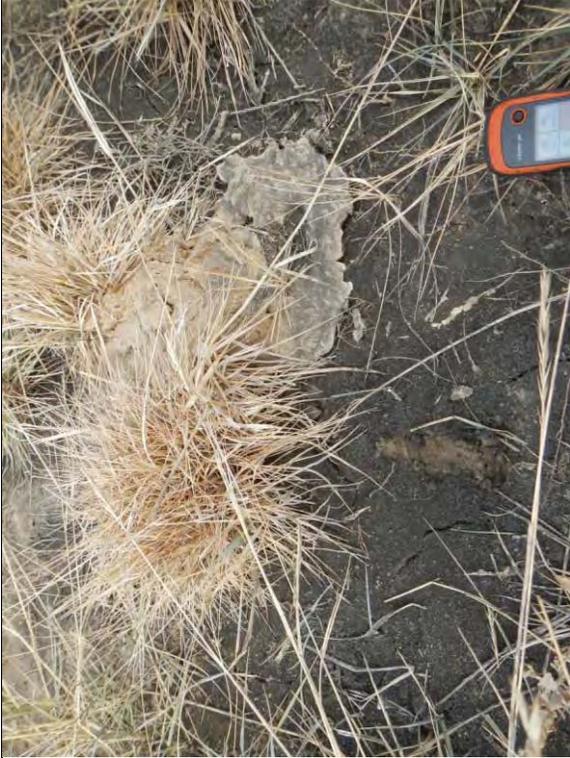
PHOTO 23 South Lease reclaimed Pit 6 coal fines on cow pie.

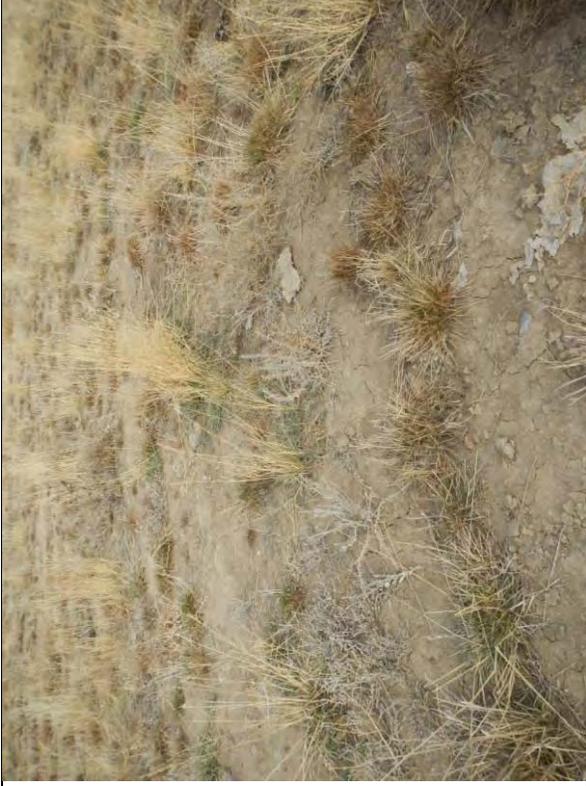
PHOTO 24 Further from haul road, reclaimed SL Pit 5 topsoil is not covered with coal fines, but reclaimed area is heavily grazed.
