Alton Coal Development, LLC

Subject: 2016 Coal Mining Annual Report; Alton Coal Development LLC, Coal Hollow Mine,
C/025/0005

Permittee: Alton Coal Development, LLC
 Mine: Coal Hollow Mine Permit Number: C/025/0005
 Title: MRP Annual Report 2016 amendments to permit

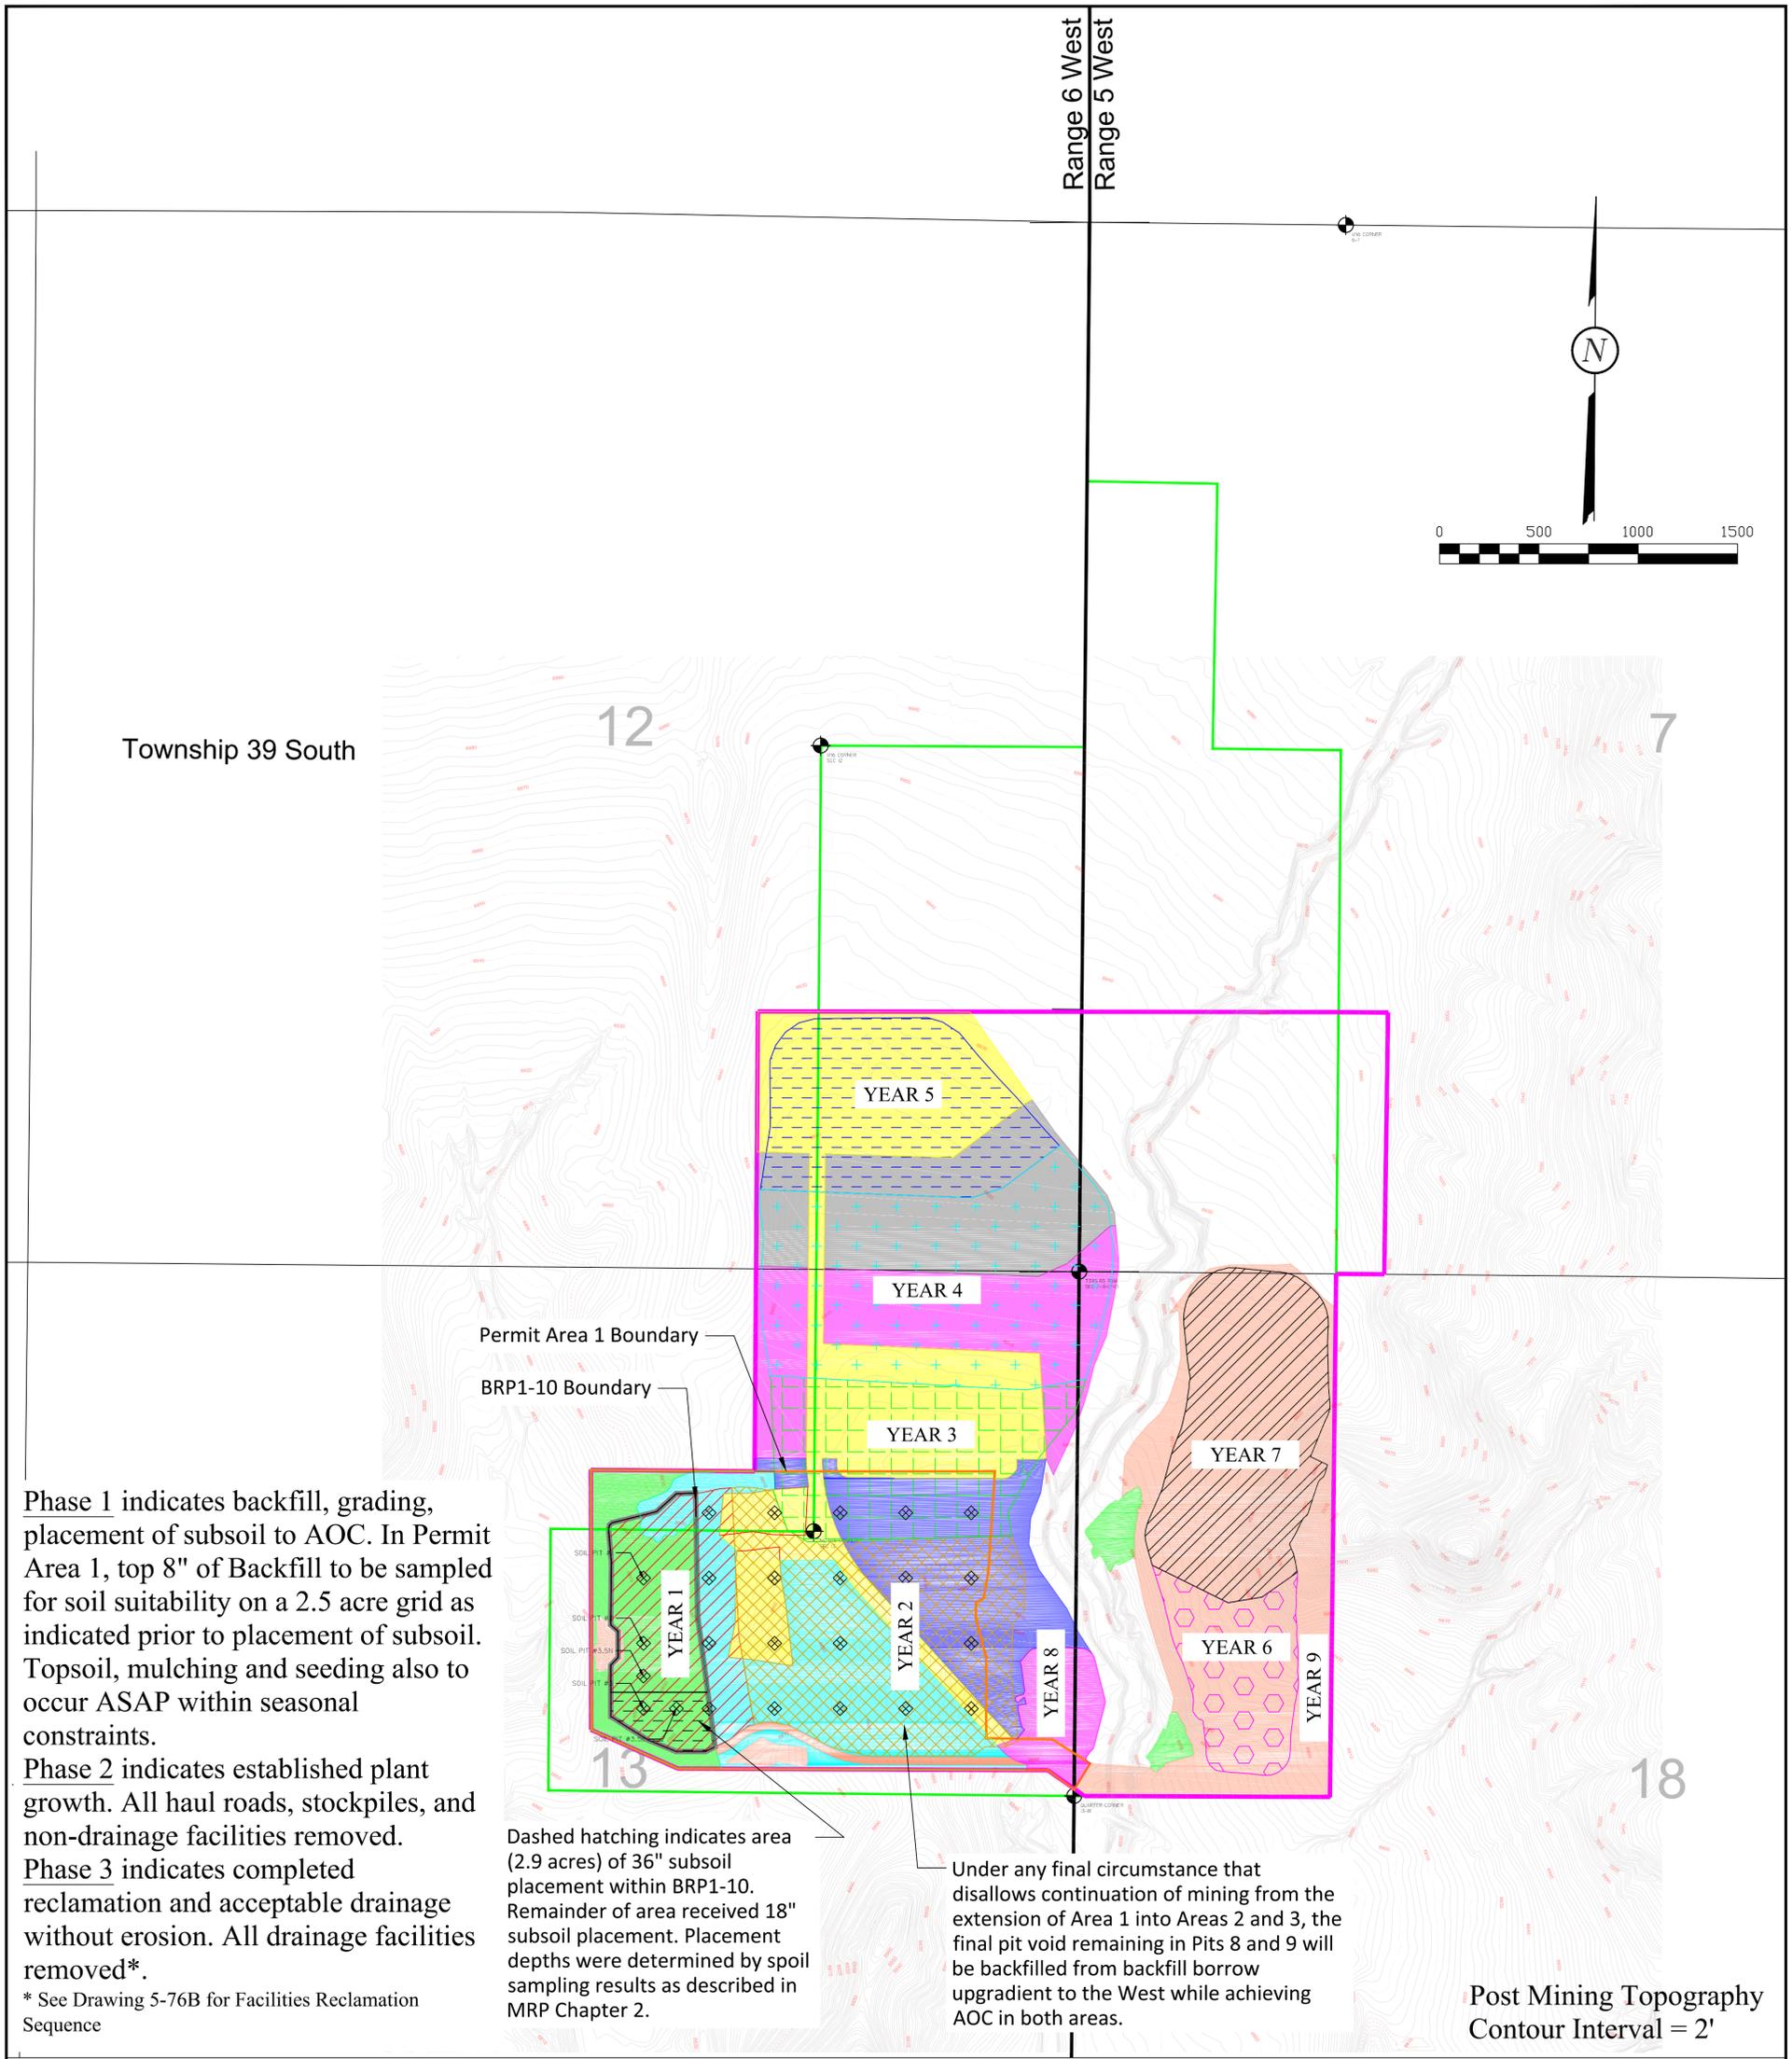
Phase 1 indicates backfill, grading, placement of subsoil to AOC. In Permit Area 1, top 8" of Backfill to be sampled for soil suitability on a 2.5 acre grid as indicated prior to placement of subsoil. Topsoil, mulching and seeding also to occur ASAP within seasonal constraints.

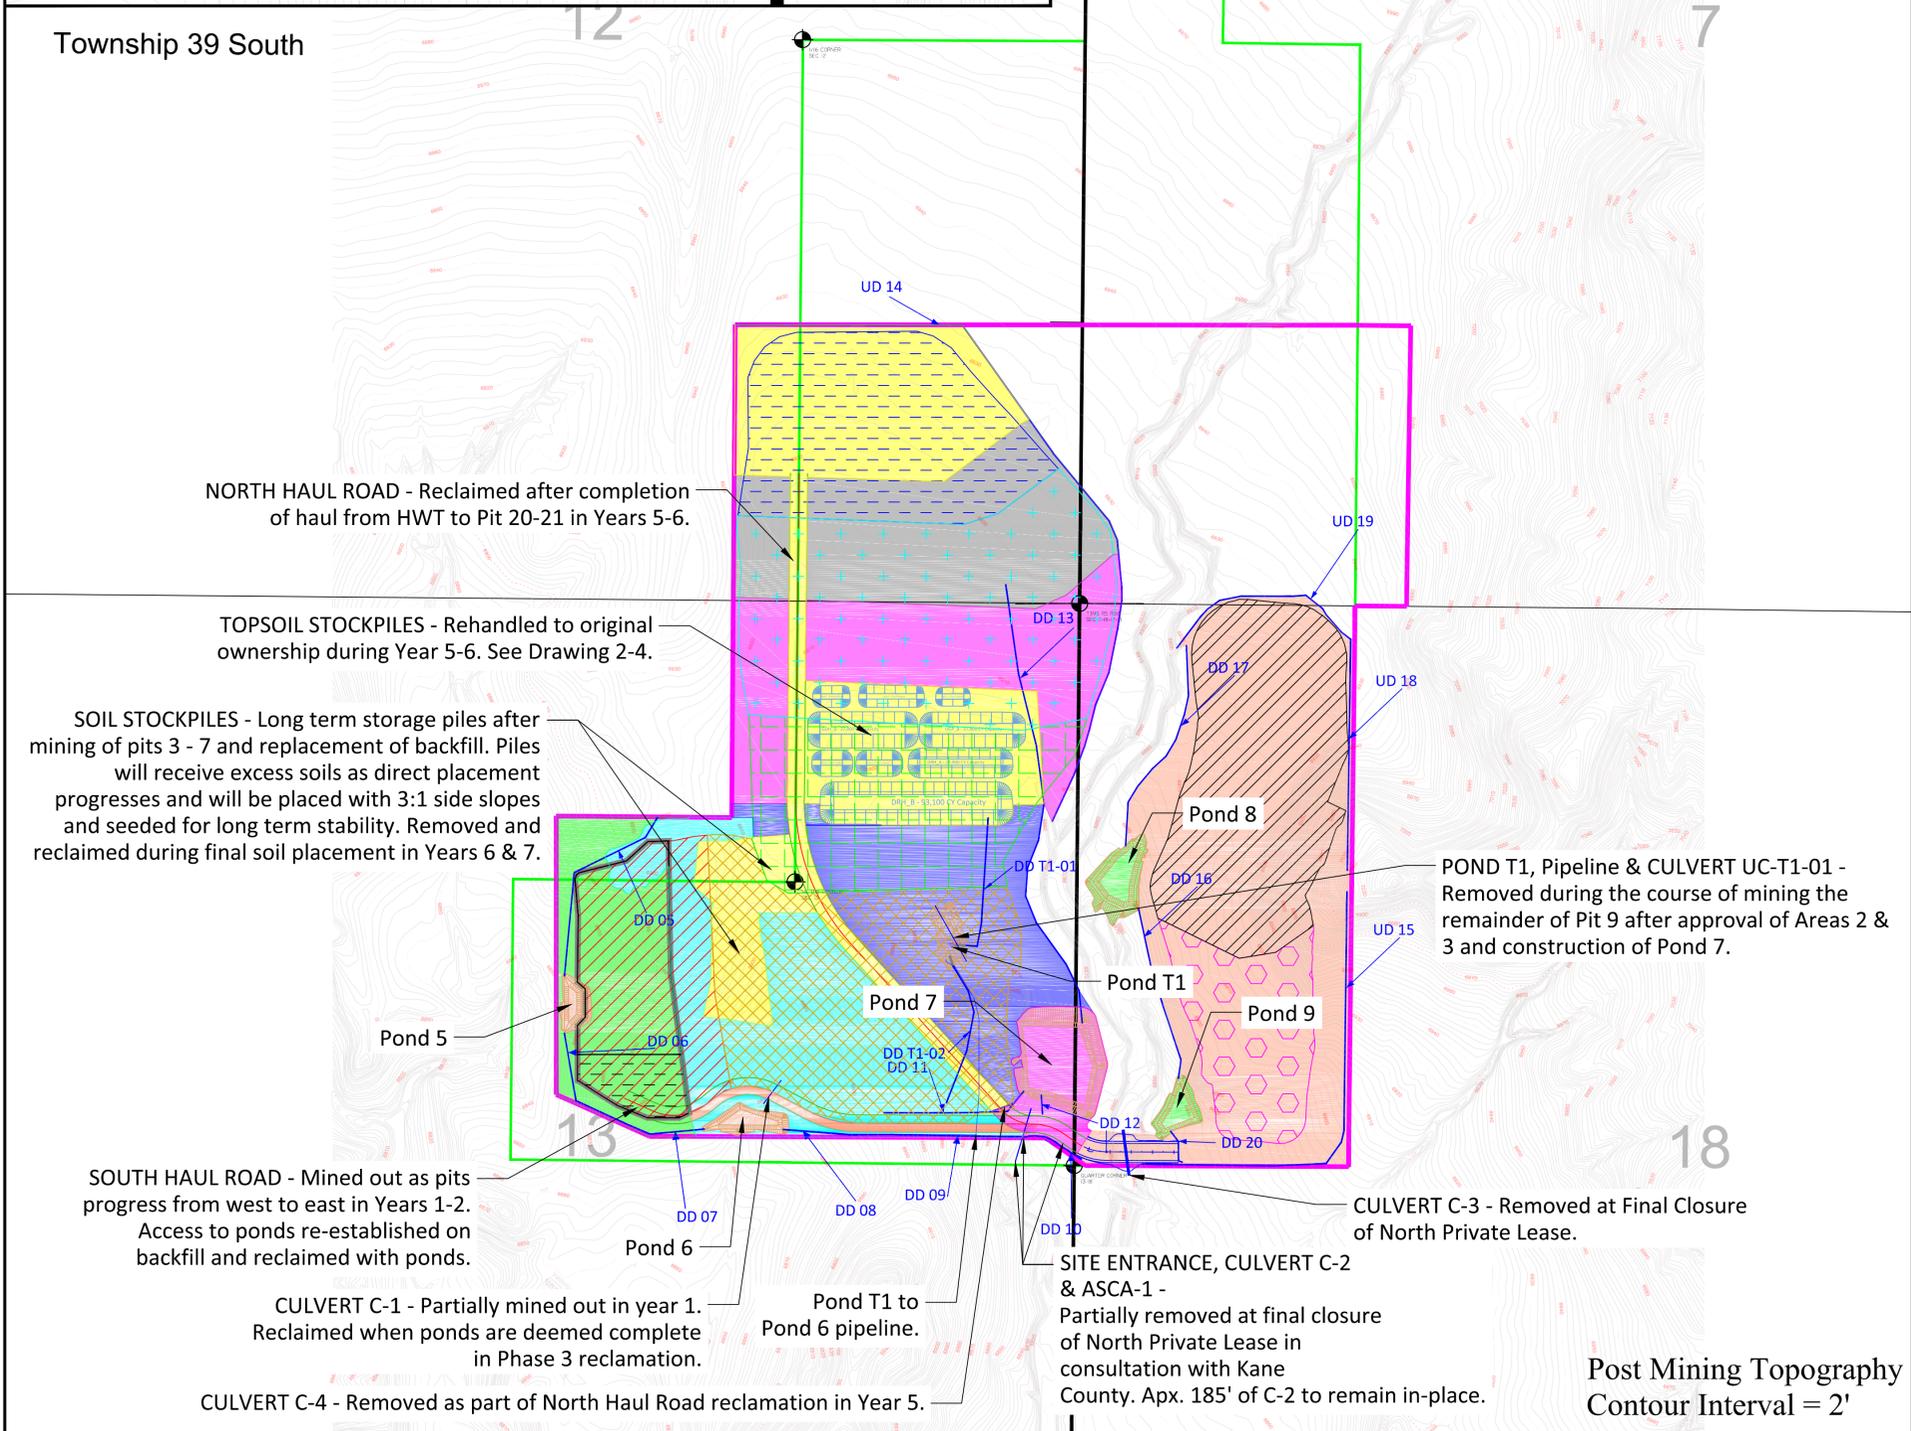
Phase 1 Reclamation:	Phase 2/Surface Mulch & Seeding:	Phase 3 Reclamation to be completed and released within the 5-10 year timeframe from Phase 1. Ponds, culverts and ditches (except Area 1 extension) to be assessed and reclaimed as Phase 3 nears completion. Area 1-A structures will be removed as mining advances.
Year 1 Reclaim = 17.9 Acres	Year 1 Seeding = 16.2 Acres	Contour Interval = 2'
Year 2 Reclaim = 34.7 Acres	Year 2 Seeding = 25.0 Acres	
Year 3 Reclaim = 24.1 Acres	Year 3 Seeding = 22.3 Acres	
Year 4 Reclaim = 39.3 Acres	Year 4 Seeding = 22.2 Acres	
Year 5 Reclaim = 24.3 Acres	Year 5 Seeding = 23.8 Acres	
Year 6 Reclaim = 11.6 Acres	Year 6 Seeding = 49.3 Acres	
Year 7 Reclaim = 26.4 Acres	Year 7 Seeding = 57.8 Acres	
Year 8 Reclaim = 00.0 Acres	Year 8 Seeding = 5.8 Acres	
Year 9 Reclaim = 00.0 Acres	Year 9 Seeding = 2.5 Acres	
Total Ph. 1 Reclamation = 178.4 Acres	Total Ph. 2 Reclamation = 224.9 Acres

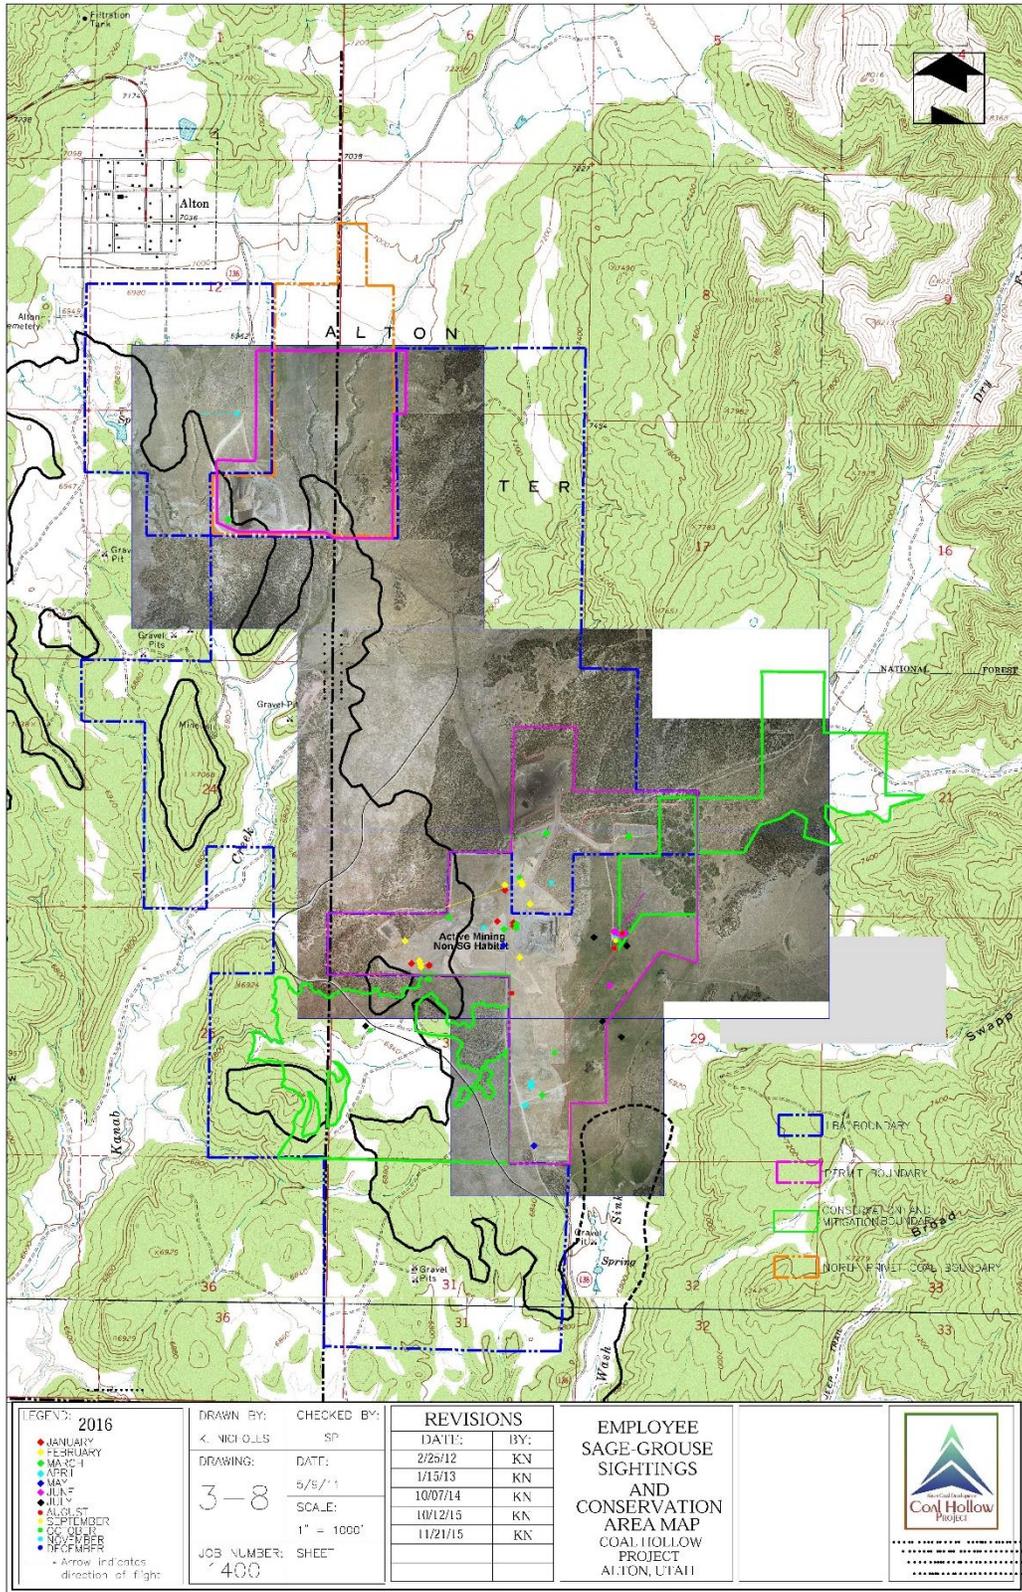
Figure 1. Location of sage-grouse observations made by ACD employees in 2016.

ACD mine employee are trained in sage-grouse conservation strategies, and how to identify sage-grouse from other bird species. When reported, Kirk determines the exact location where birds were observed and identifies the coordinate location for that observation. The results of these sightings are used to assess population patterns and trends within the mining area (Table 1, Figure 1). This information is used to assess habitat use patterns.

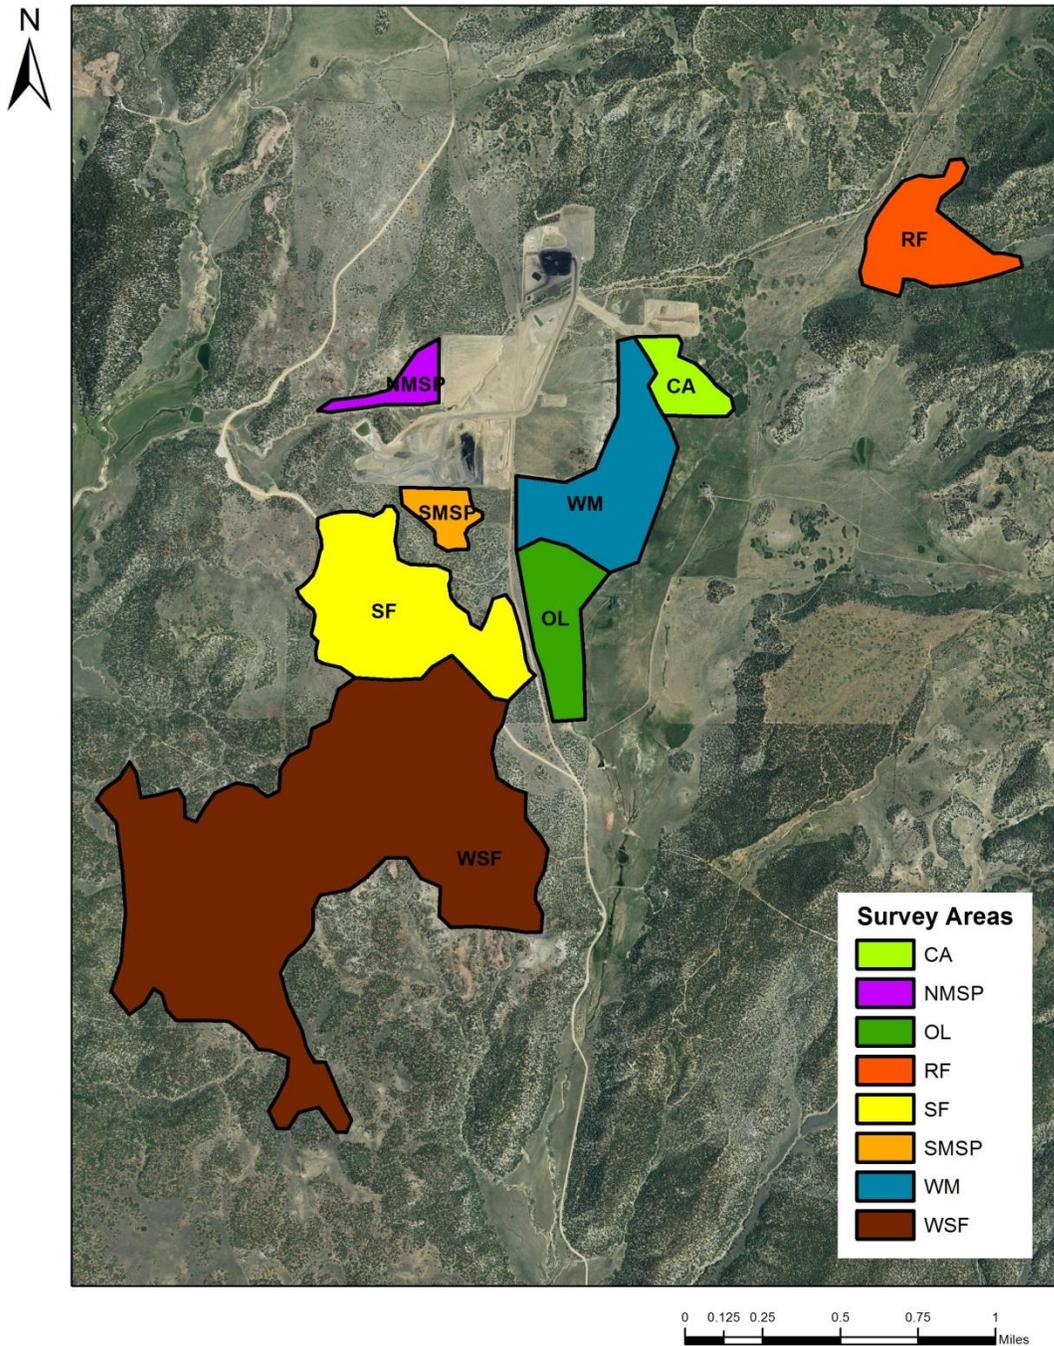
During each survey, all areas where birds may be found were searched (Figure 2). These areas included 1) the sagebrush flat area 0.5 km south of the open coal pits (SF), 2) the new lekking area located at the top of the ridge at the south end of the sagebrush flat area, 3) the sagebrush patch located just south of the spoils pile (SMSP) and north of the spoils piles (NMSP), 4) the original lekking area (OL), 5) the wet meadow (WM) located in grass/rush/sedge community surrounding the well, 6) the sagebrush area immediately east of the open mine along the lower bench, 7) the conservation area east of the mine site along the upper bench (CA), 8) the bullhog area located south of the new lek, and 9) Ford's Pasture located 10 miles south of Sink Valley.

Figure 2. Location of survey areas for greater sage-grouse during the 2012-2016 monitoring seasons. CA = Conservation area, NMSP = North mine sagebrush patch, OL = Original lek, Rabbitbrush field, Sagebrush flat, SMSP = South mine sagebrush patch, WM = Wet meadow, and WSF = West sagebrush fields. Additional sites not shown above include the corridor (C) and the alfalfa fields (AF) south of Alton.

A summary of the results recorded for each monthly sage-grouse survey is provided in table 2. Of all sites observed during surveys, birds were most consistently found in the sagebrush flat area south of the mine, within the new lek area, in the bullhogged area south of the new lek, and in the region surrounding the conservation area (Figure 2).

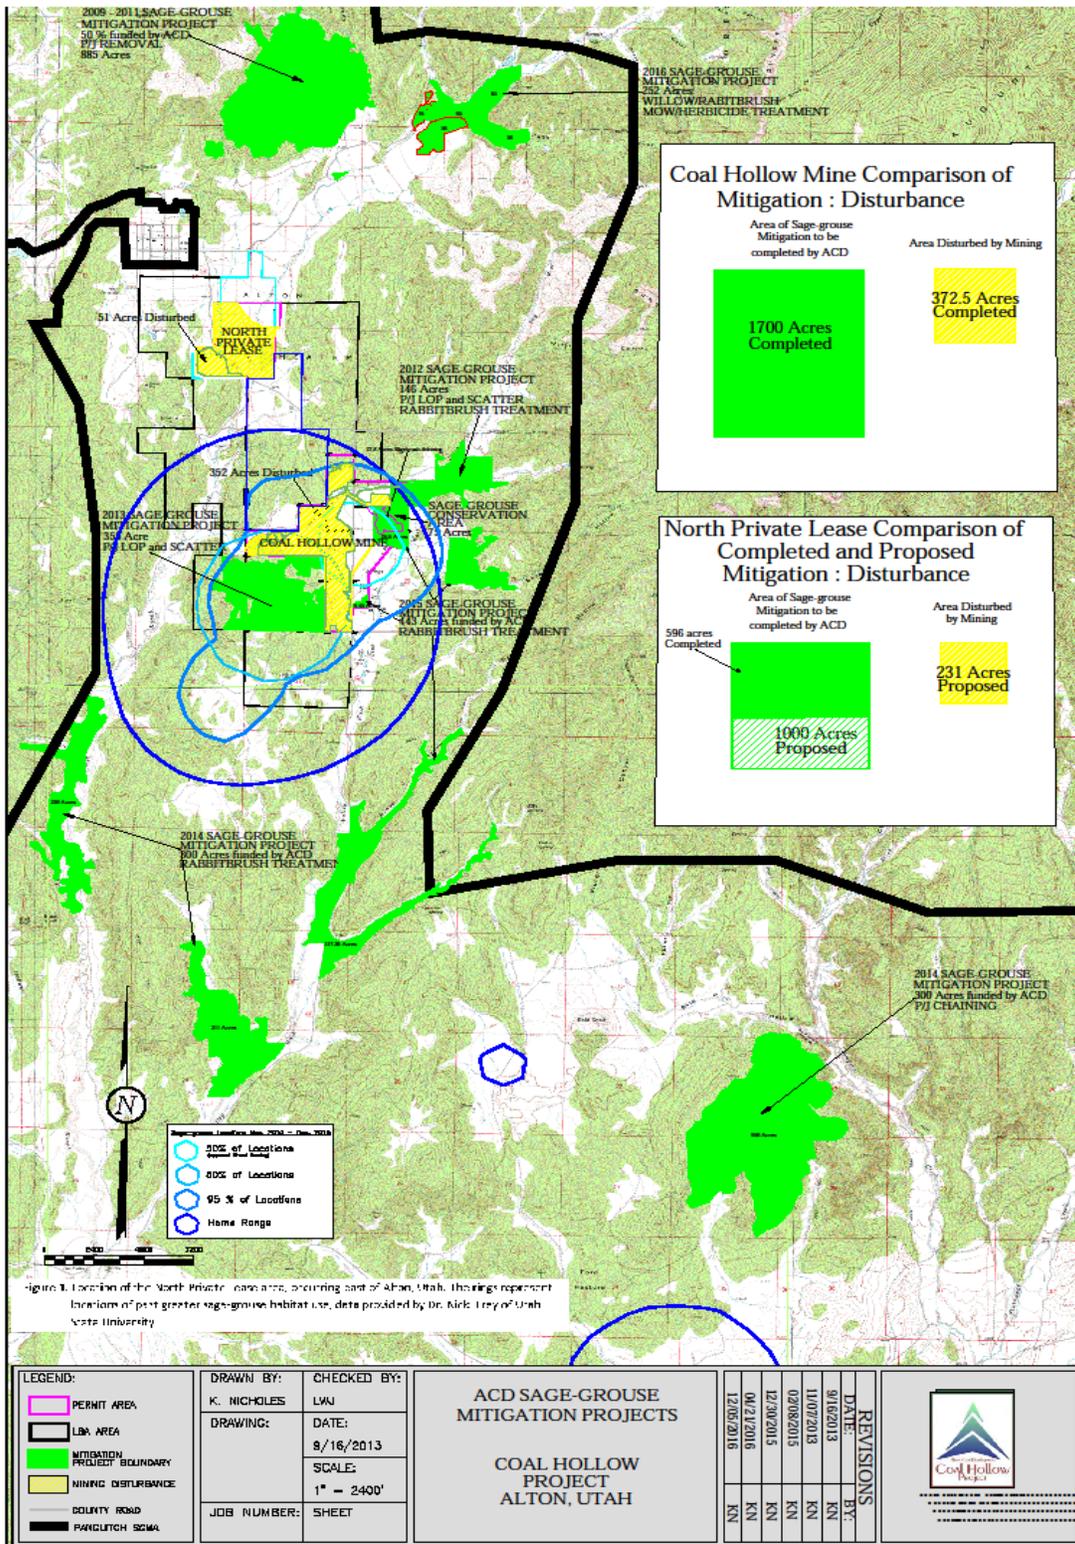
Figure 7. Total mitigation completed for the mine to date.

Land improvements in relation to coal mining are a primary goal for ACD. Most improvements are designed to improve habitat conditions for sage-grouse. To date, a total of 2,296 acres have been treated by ACD (Figure 7).

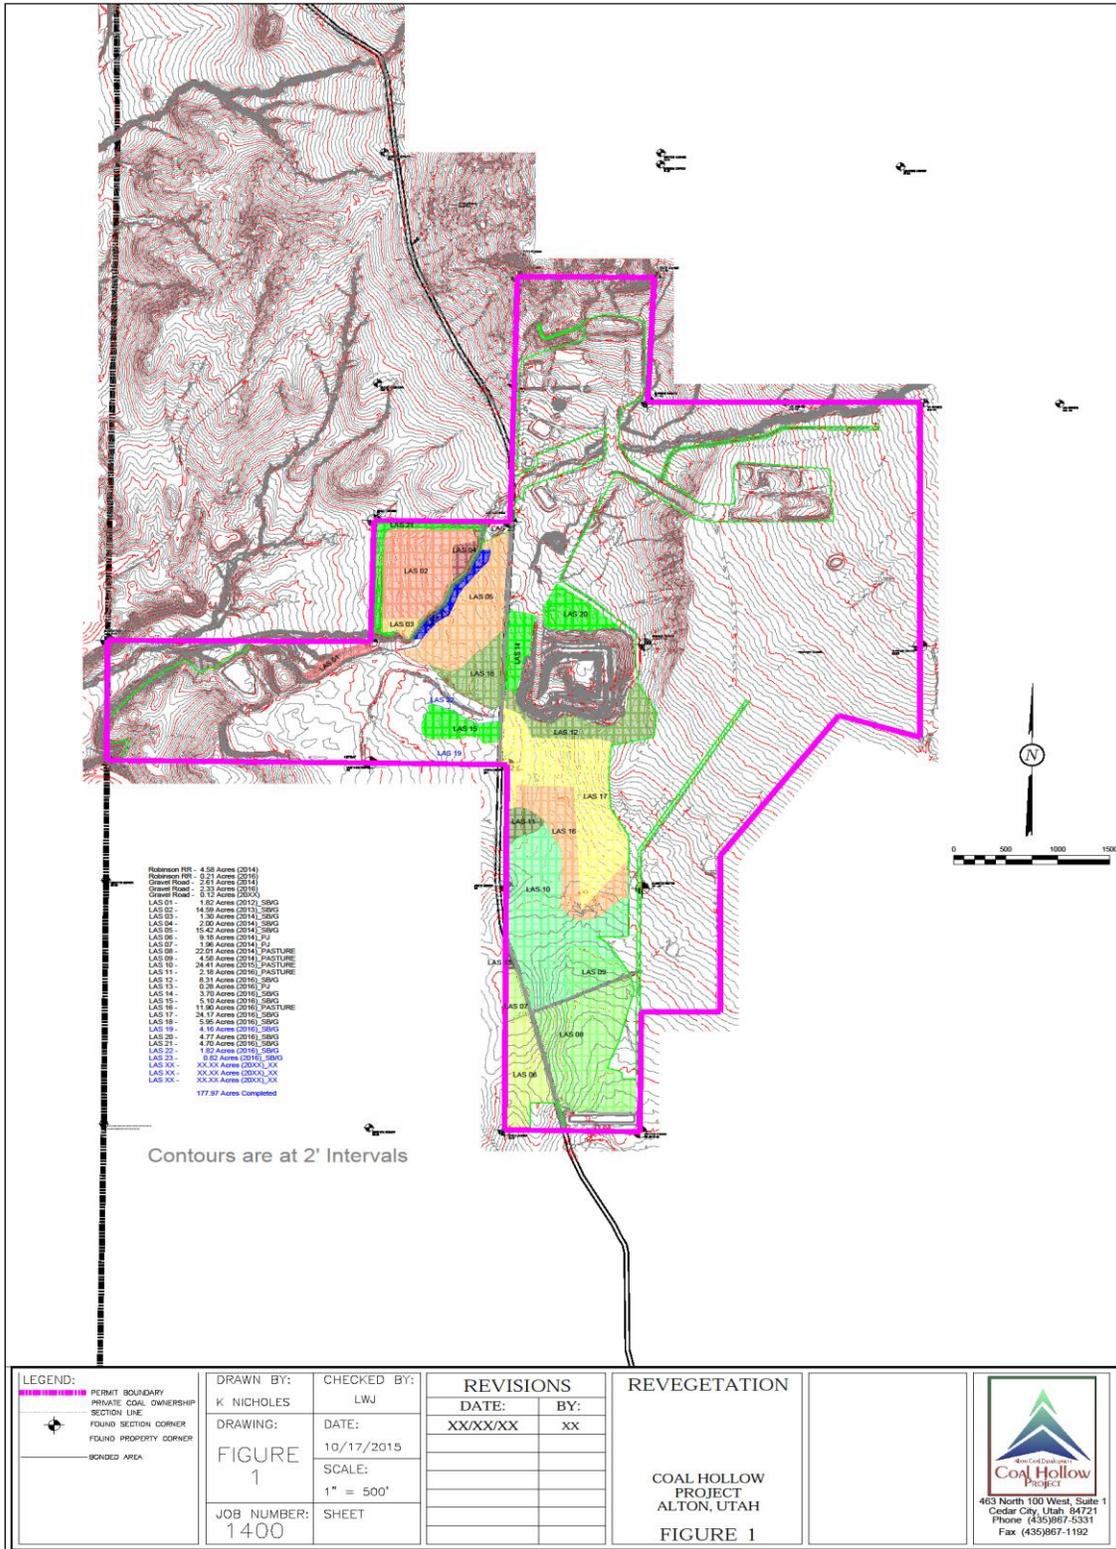
Figure 8. Post-mining reclamation completed to date (Dec. 2016). These areas have been seeded with a mix of native and introduced grass, forb and shrub species. Total area treated is 178 acres.

Following mining operations, the landscape has been recontoured to resemble pre-mining landform conditions. Topsoil was then replaced and reseeded using a mix of native and introduced shrub and herbaceous species. Seed was distributed using a seed drill pulled behind a John Deer tractor. To date, a total of 178 acres of land has been reclaimed (Figure 8). Most reclamation has been completed within the Sink Valley area, however, 11 acres have been reclaimed to date in the North Lease area, located 2 miles northwest of the mine crushing facility and headquarters (Figure 9).

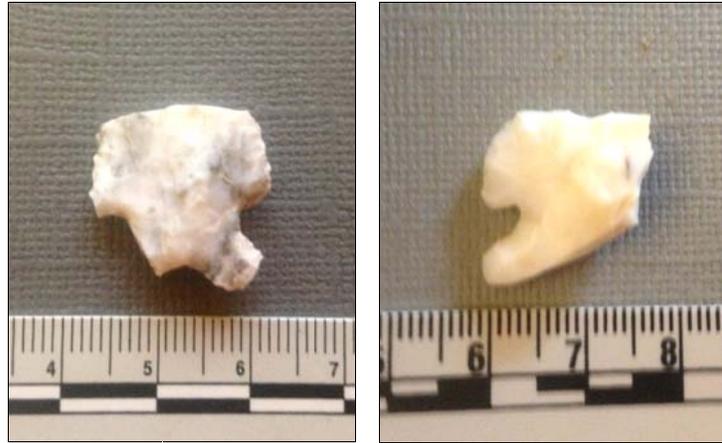
Figure 10.5. Elko Series points from 42KA3097

Elko Series points make up half of the projectile point types recovered during the Tier I mitigation from sites 42KA3077 and 42KA3097. Of the six Elko points collected (two from 42KA3077 and four from 42KA3097), one was an Elko Eared point, four were Elko Corner-notched points, and one was an Elko Side-notched point (Figures 10.4-10.6). Elko Series points are characterized by large, triangular blades with straight to slightly convex edges. The corner- and side-notched varieties have slightly concave to convex bases, while the Elko Eared points are side-notched and have markedly concave or deeply notched bases. Elko Series points span over a 7000 year period beginning about 6000 BC (Holmer 1986; Justice 2002), and are found throughout the Archaic period as well as the Formative Period, and are typically not considered diagnostic. The eared variety may be temporally diagnostic of the Late Archaic period. In the eastern Great Basin and northern Colorado Plateau, Elko Eared points terminate during the late Archaic at Hogup and Cowboy Caves (Holmer 1986), and have been radiocarbon dated to the Late Archaic period elsewhere on the Colorado Plateau (Geib et al. 2001; Janetski 1999). One of the Elko Series specimens recovered and analyzed from the project was made from black obsidian while the other five were made from various colors of chert. Only one of the Elko series points was complete and the other five were basal fragments. Trace element analysis on the obsidian point revealed it was of the a Wild Horse Canyon volcanic glass chemical type, suggesting that the artifact, or at least the material from which it was fashioned, was obtained from the Mineral Mountains in Beaver County, approximately 70 miles to the northwest.

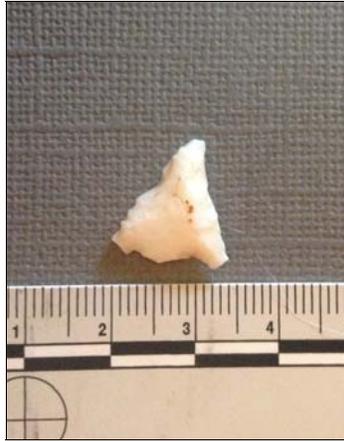
Figure 10.7. Rose Spring Series point from 42KA3097

One Rose Spring Corner-notched point was recovered from 42KA3097 during the project (Figure 10.7). Rose Spring Corner-notched points are small and characterized by thin, narrow,

triangular blades and corner notches. The corner notches create squared shoulders or barbs and a narrow, slightly contracting stem (Heizer & Hester 1978; Justice 2002). The barbs do not extend as long as the base and blade is often slightly serrated with straight edges. The appearance of these points marks the beginning of bow and arrow technology, and typically date to about AD 300-950 on the Colorado Plateau (Geib et al. 2001; Holmer & Weder 1980; Justice 2002), although they have also been associated with late Fremont occupations (Marwitt 1968; Talbot et al. 2000:395). The Rose Spring Corner-notched specimen collected from the project was made from chert and showed evidence of having been re-worked.

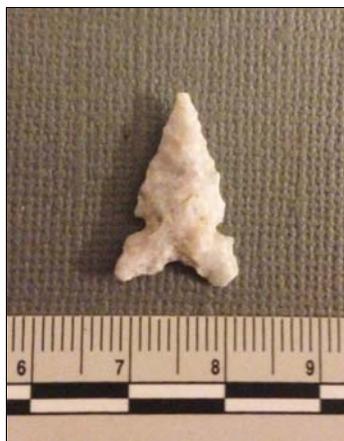
Figure 10.8. Desert Side-notched point from 42KA3077

One Desert Side-notched projectile point was recovered from site 42KA3077 (Figure 10.8). Desert Side-notched points are characterized by a triangular shape with squared to wing-like side-notched tangs, and a V-shaped basal notch (Holmer & Weder 1980; Justice 2002). This point type is diagnostic of the Southern Numic expansion into the region around AD 1300 (Geib et al. 2001; Justice 2002) and continued into historic times. The specimen from the project was a complete point made of translucent white chert.

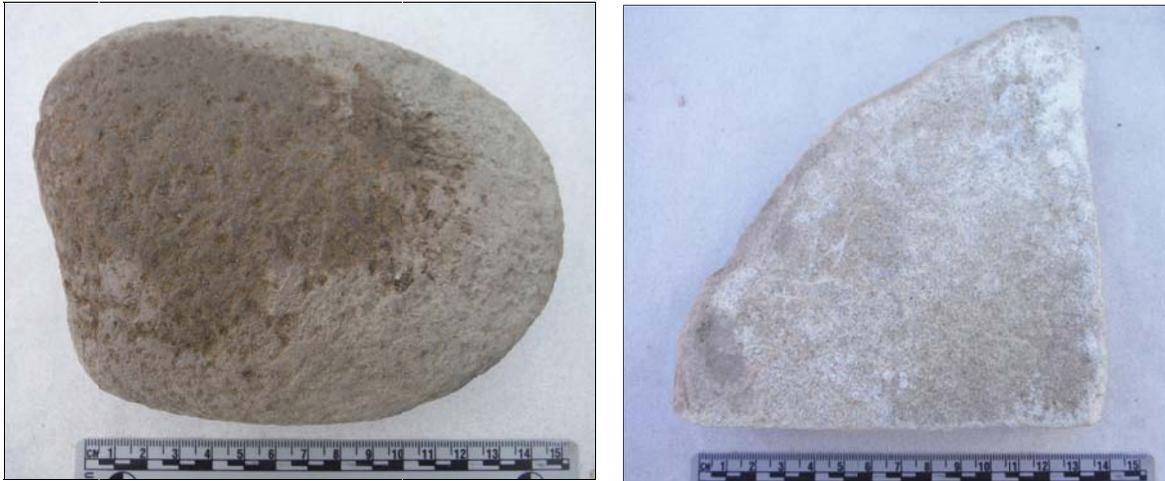
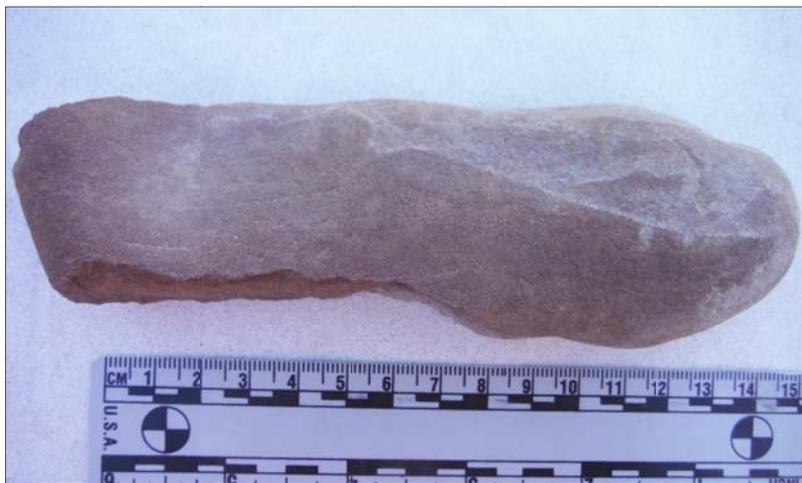
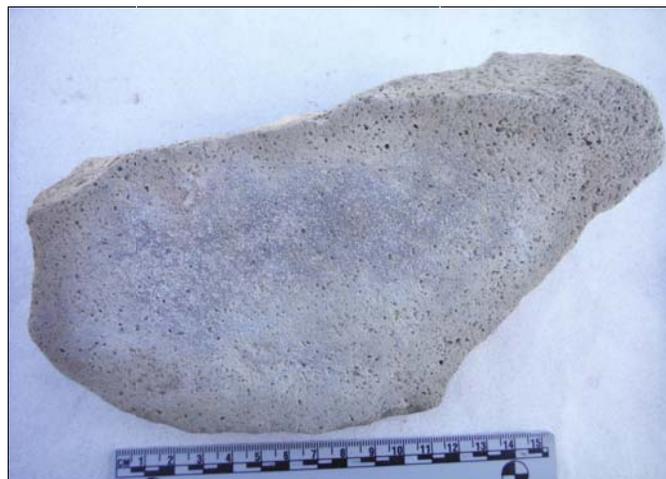
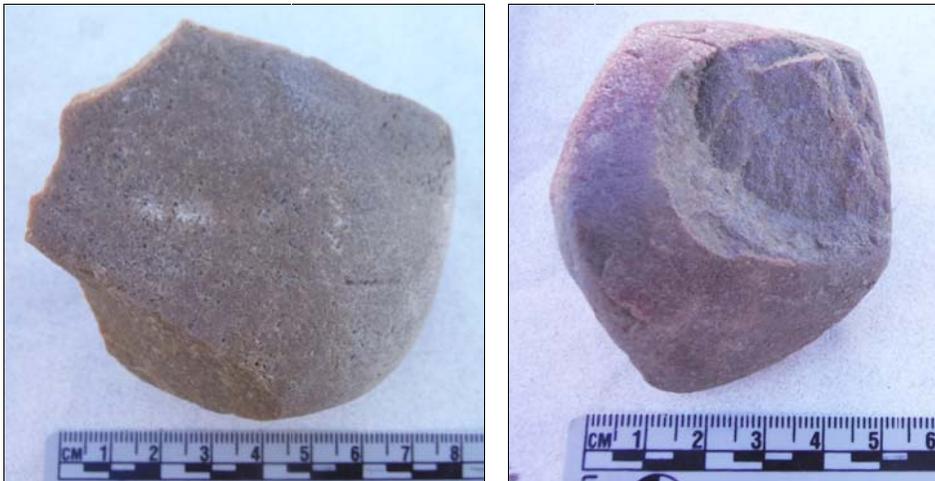
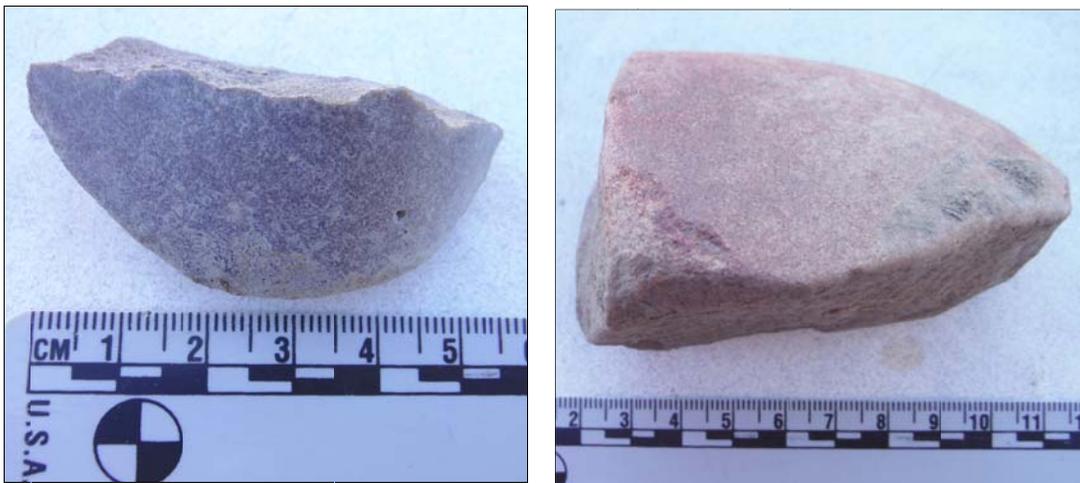
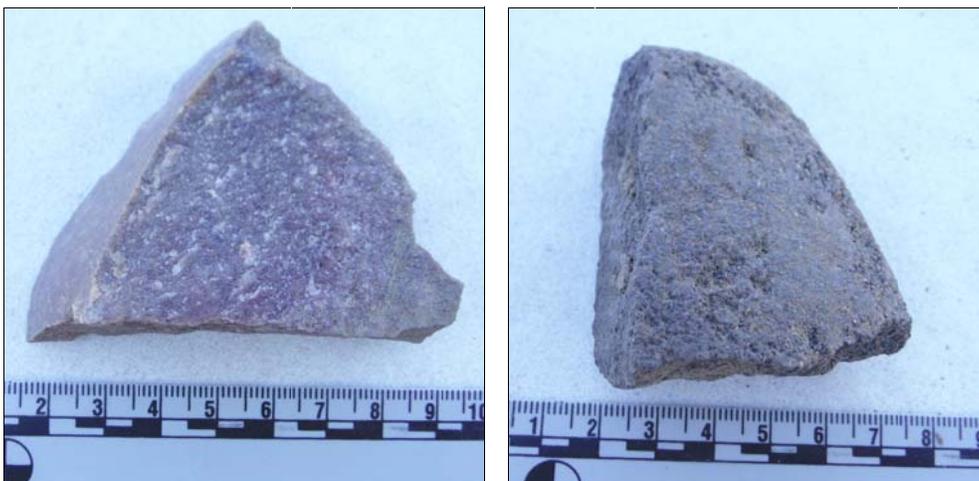
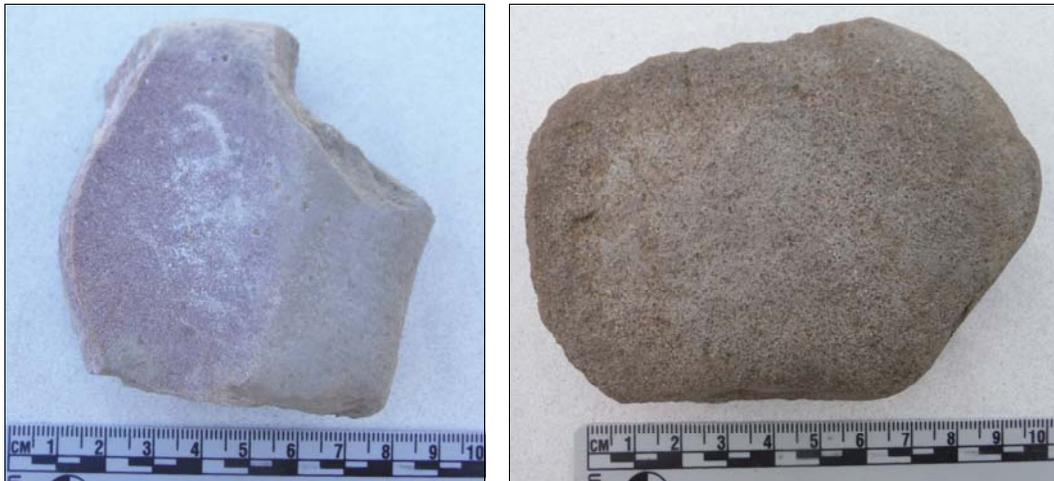
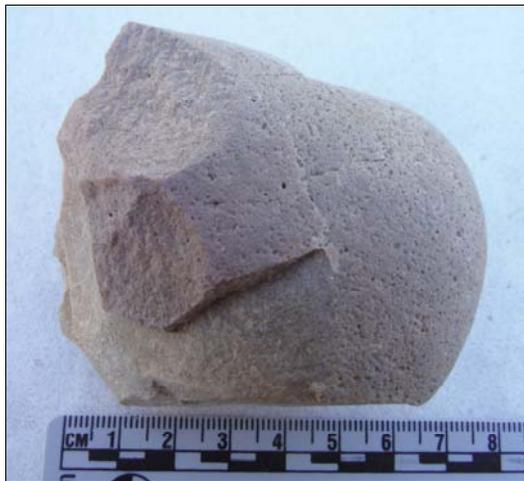
Of the 15 pieces of ground stone, three were mano fragments, three were metate fragments, and nine were undetermined ground stone fragments (Table 11.2). One of the three mano fragments was made from fine textured, red quartzite while the other two were made from a dense, coarse textured tan sandstone material. All three mano fragments exhibited grinding wear on only one surface. None of the three mano fragment's morphological category could be accurately determined due to the way in which each was fragmented. Two of the three metate fragments were made from a dense, fine grained tannish-red sandstone material, while the third fragment was made from a dense, medium grained gray quartzite material. One of the two sandstone metate fragments and the quartzite metate fragment exhibited grinding wear on two surfaces while the remaining fragment only had grinding wear on one surface. Much like the mano fragments on this site, none of the three metate fragments could be identified as to type (i.e. trough or slab) due to their extremely fragmented state. The nine remaining ground stone fragments, whose type could not be accurately identified due to the severity of their fracturing, were all made from quartzite material of varying color and texture. Two of the nine fragments exhibited grinding wear on two surfaces, while the remaining seven contained grinding wear on only one surface (Figures 11.1-11.9).

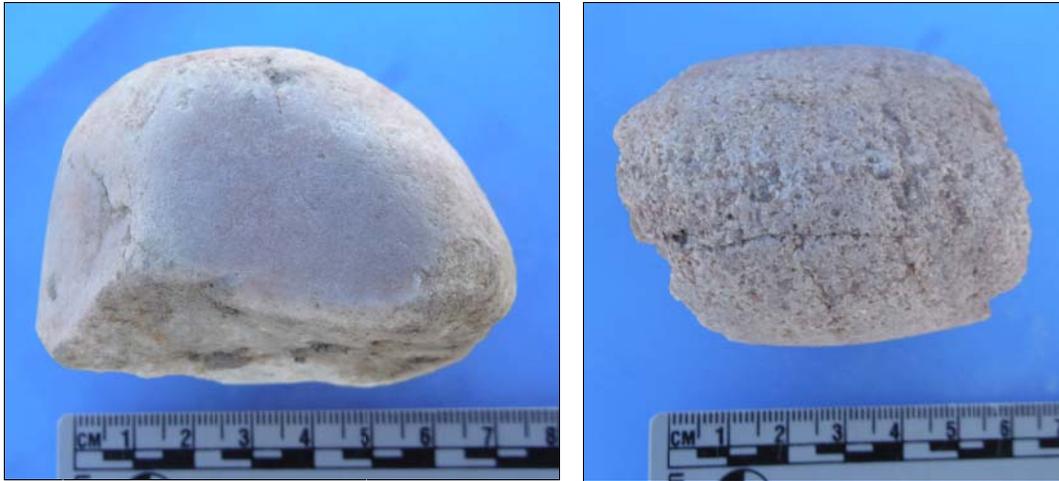
Figure 11.10. Quartzite mano fragments

Of the 12 pieces of ground stone two were single hand mano fragments, one was a metate fragment, and nine were undetermined ground stone fragments (Table 11.3, Figures 11.10-11.13). Both single hand mano fragments were made from fine grained, tan quartzite and exhibited grinding ware on only one surface. The only metate fragment identified was made

from a dense, fine grained tan sandstone material. This fragment exhibited grinding wear on two surfaces. The exact metate type (i.e. trough or slab) could not be determined due to the fragmented state in which it was in. The nine remaining ground stone fragments, whose type could not be accurately identified due to the severity of their fracturing, were all made from either sandstone or quartzite material (seven sandstone and two quartzite) of varying color and texture. All nine of the undetermined ground stone fragments exhibited grinding wear on only one surface.

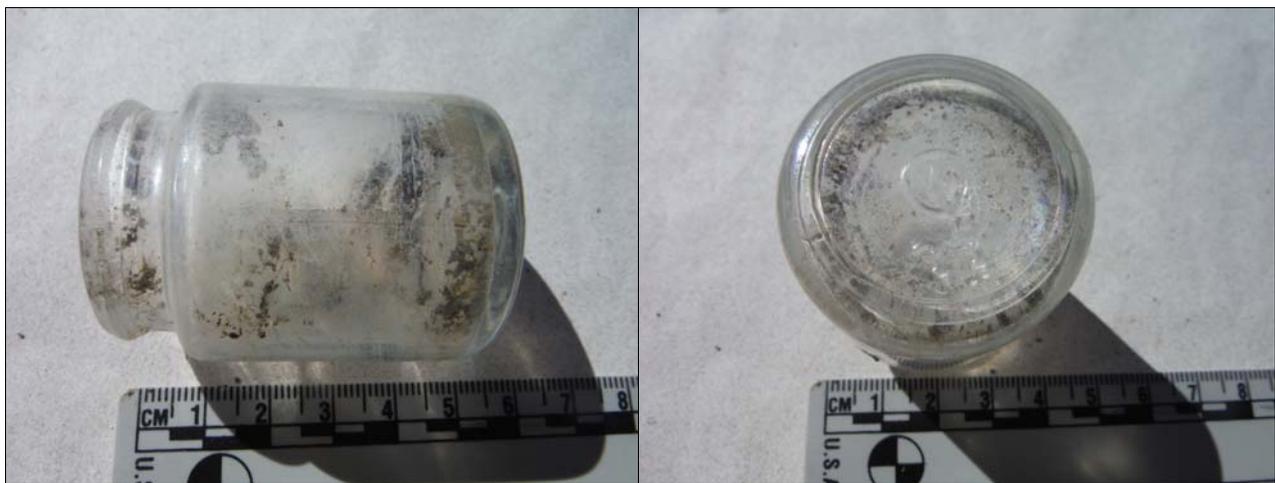
Figure 12.1. Clear glass medicinal(?) bottle from 42KA3077

The intensive surface inventory across site 42KA3077 within the NPLA resulted in the identification of a small clear glass medicinal(?) bottle with T.C. Wheaton, Co. trademark consisting of a “W” within a circle (Toulouse 1972; since 1946). No additional historic artifacts were encountered in the vicinity of this site.

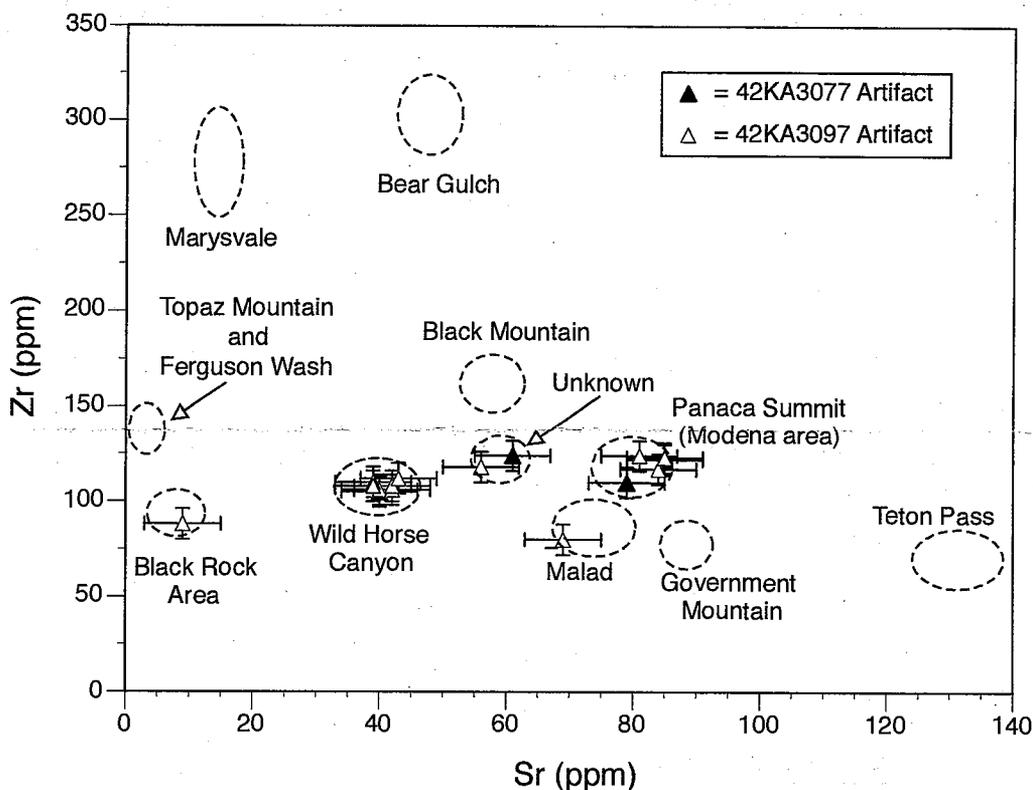
Dashed lines represent range of variation measured in archaeologically significant geologic obsidian source samples. Triangles plot values for specimens in Table 1. Error bars are two-sigma (95% confidence interval) composition estimates for each artifact. *Note:* values for artifact FS # 17 from 42KA3097 plot off the chart at this scale.

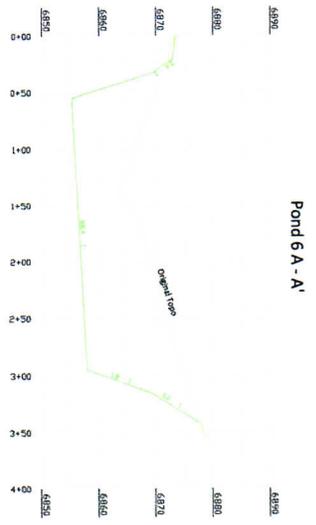
As Built Pond Storage Volumes			
Sediment Control Structure No. 6			
Water Elev (ft)	Area (Acres)	Average Area	Volume (Acre-Ft)
6855.00	0.024	-	-
6856.00	0.106	0.065	0.065
6857.00	0.258	0.182	0.182
6858.00	0.298	0.278	0.278
6859.00	0.330	0.314	0.314
6860.00	0.360	0.345	0.345
6861.00	0.391	0.376	0.376
6862.00	0.419	0.405	0.405
6863.00	0.449	0.434	0.434
6864.00	0.479	0.464	0.464
6865.00	0.510	0.495	0.495
6866.00	0.544	0.527	0.527
6867.00	0.586	0.565	0.565
6868.00	0.635	0.610	0.610
			1.439
			1.873
			2.338
			2.832
			3.359
			3.924
			4.534
