Inspection Report

Permit Number:	C0250005
Inspection Type:	PARTIAL
Inspection Date:	Wednesday, January 25, 2017
Start Date/Time:	1/25/2017 9:30:00 AM
End Date/Time:	1/25/2017 1:30:00 AM
Last Inspection:	Wednesday, December 07, 2016

Permittee: **ALTON COAL DEVELOPMENT LLC**
 Operator: **ALTON COAL DEVELOPMENT LLC**
 Site: **COAL HOLLOW**
 Address: **463 North 100 West, Suite 1, CEDAR CITY UT 84720**
 County: **KANE**
 Permit Type: **PERMANENT COAL PROGRAM**
 Permit Status: **ACTIVE**

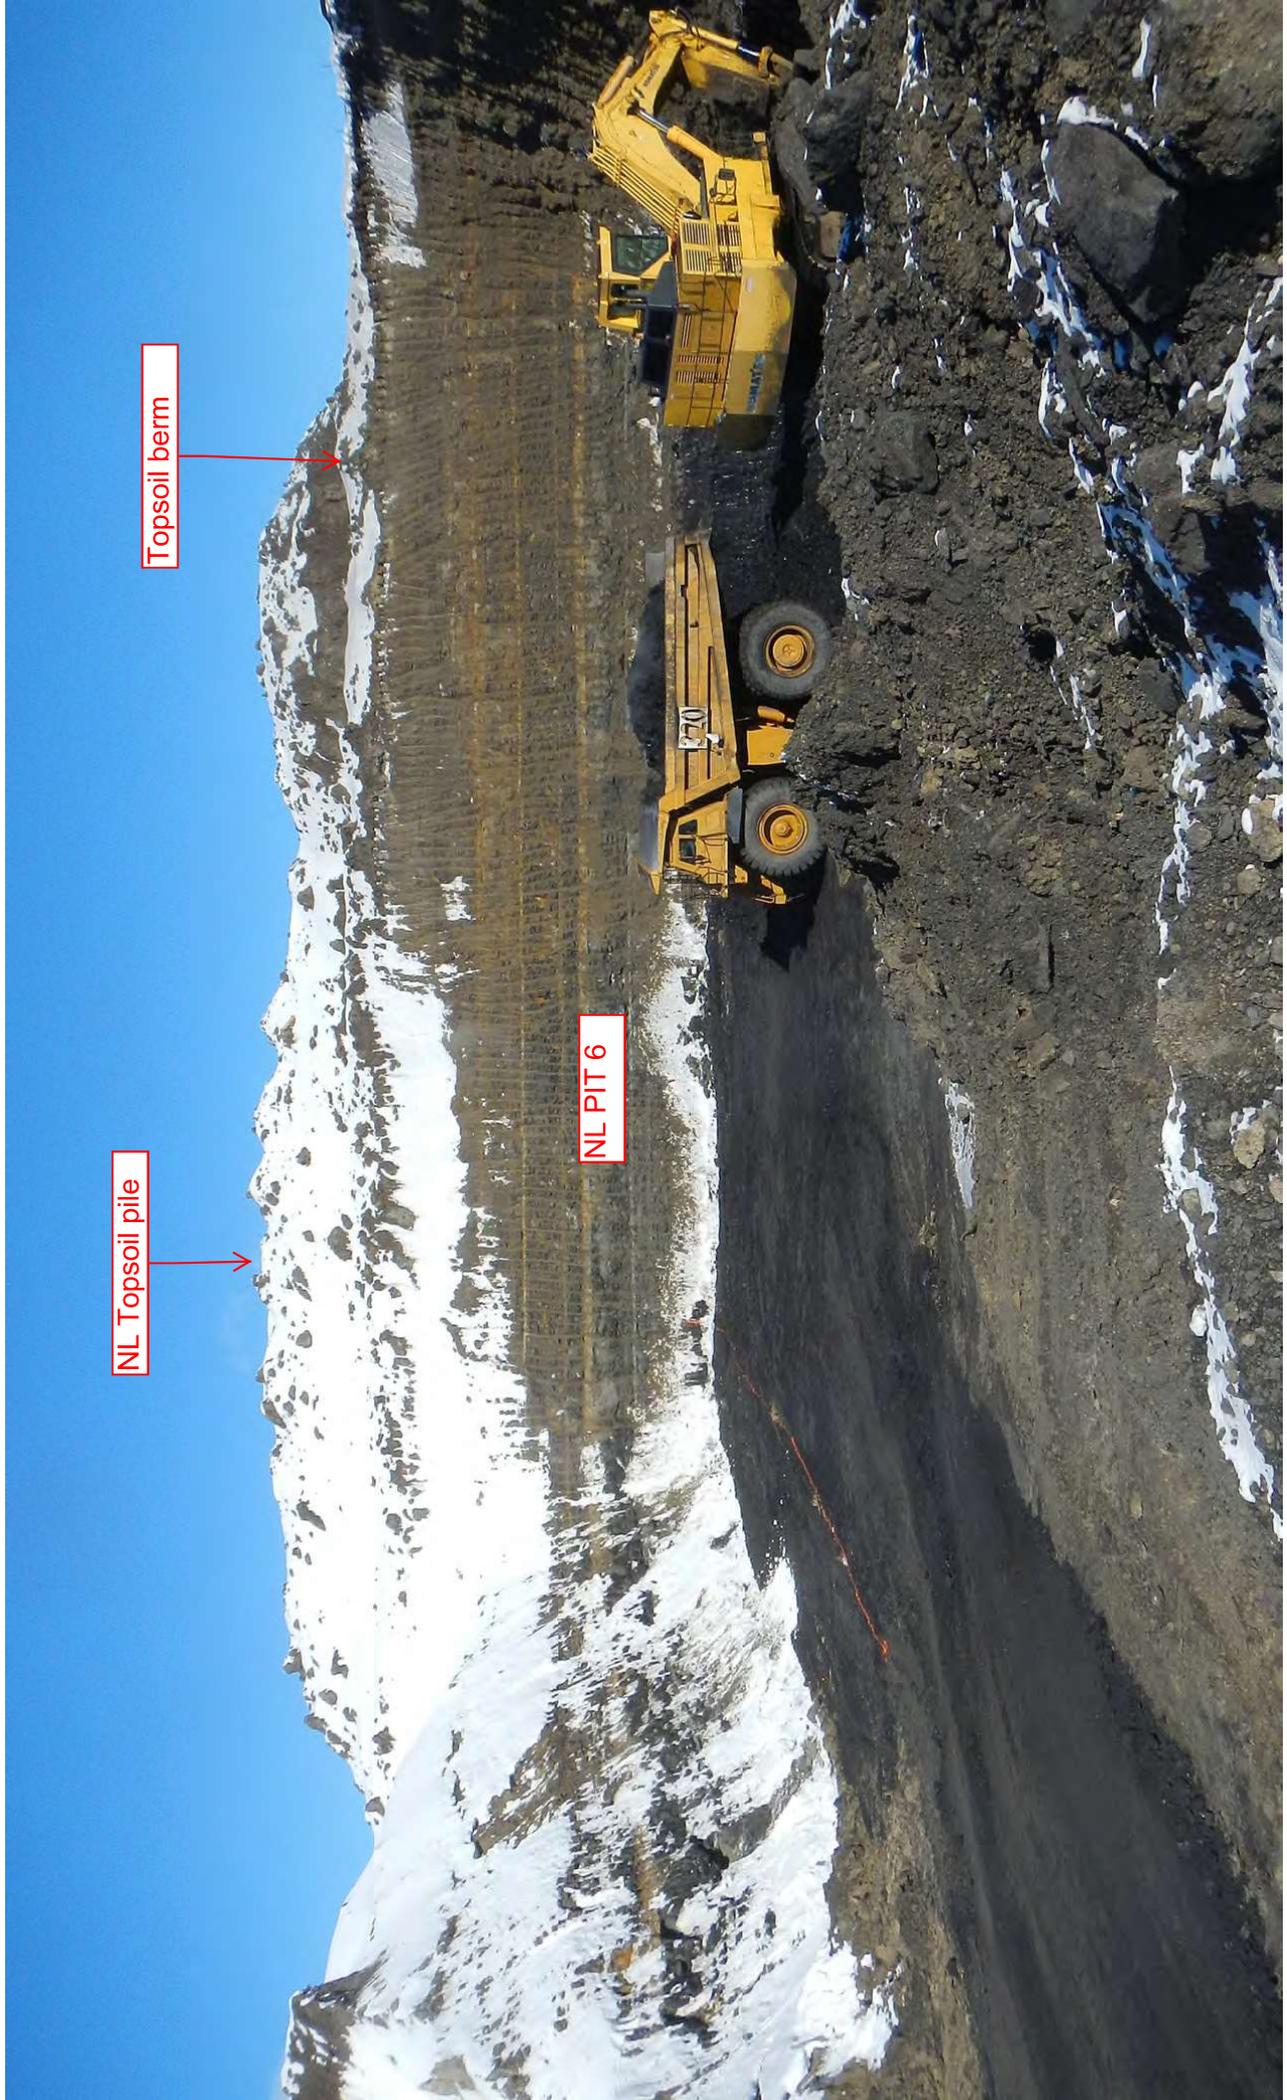
NL Topsoil pile

Topsoil berm

NL PIT 6

The North Lease topsoil pile is adjacent to the NL Pit 6 highwall. NOV 21191 was terminated because the pile was moved away from the previous highwall location and a berm was formed between the topsoil pile and the highwall. The location of the berm is shown on the attached 2017_01_PartialNL.pdf image. Its location can be compared with the December gps track along the edge of the topsoil pile also shown in the image.

In the last month the highwall has advanced, so the berm around the topsoil pile is now at the edge of the highwall. The berm must be maintained.

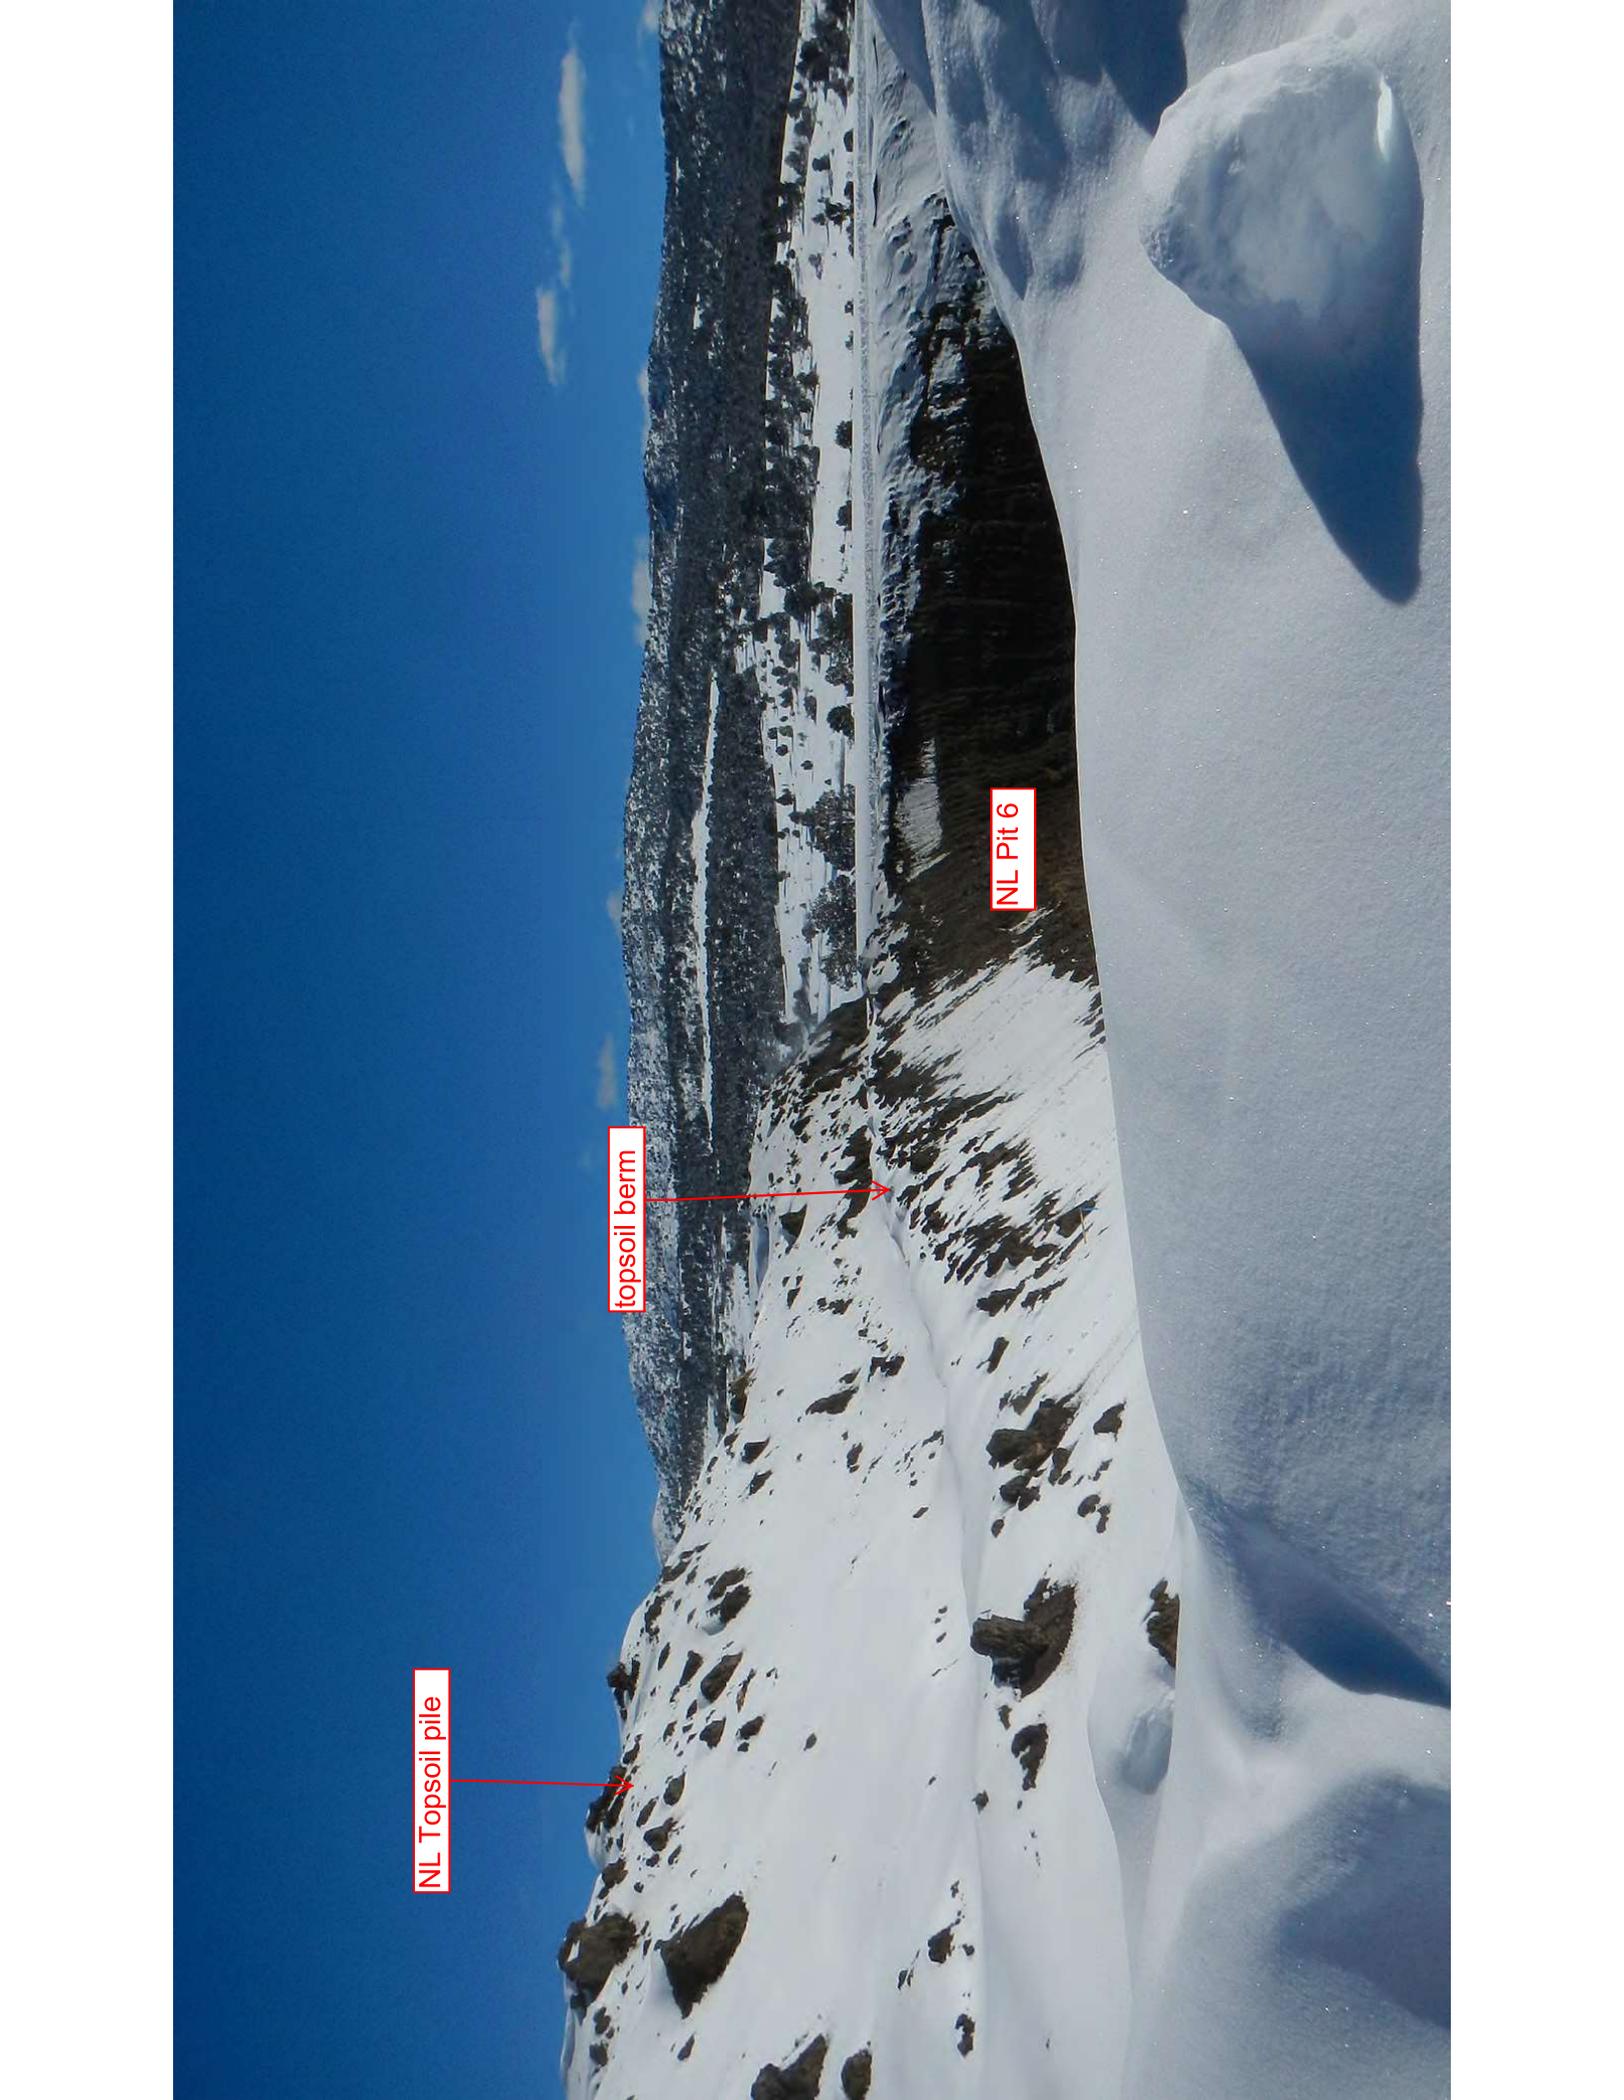
NL Topsoil pile

topsoil berm

NL Pit 6

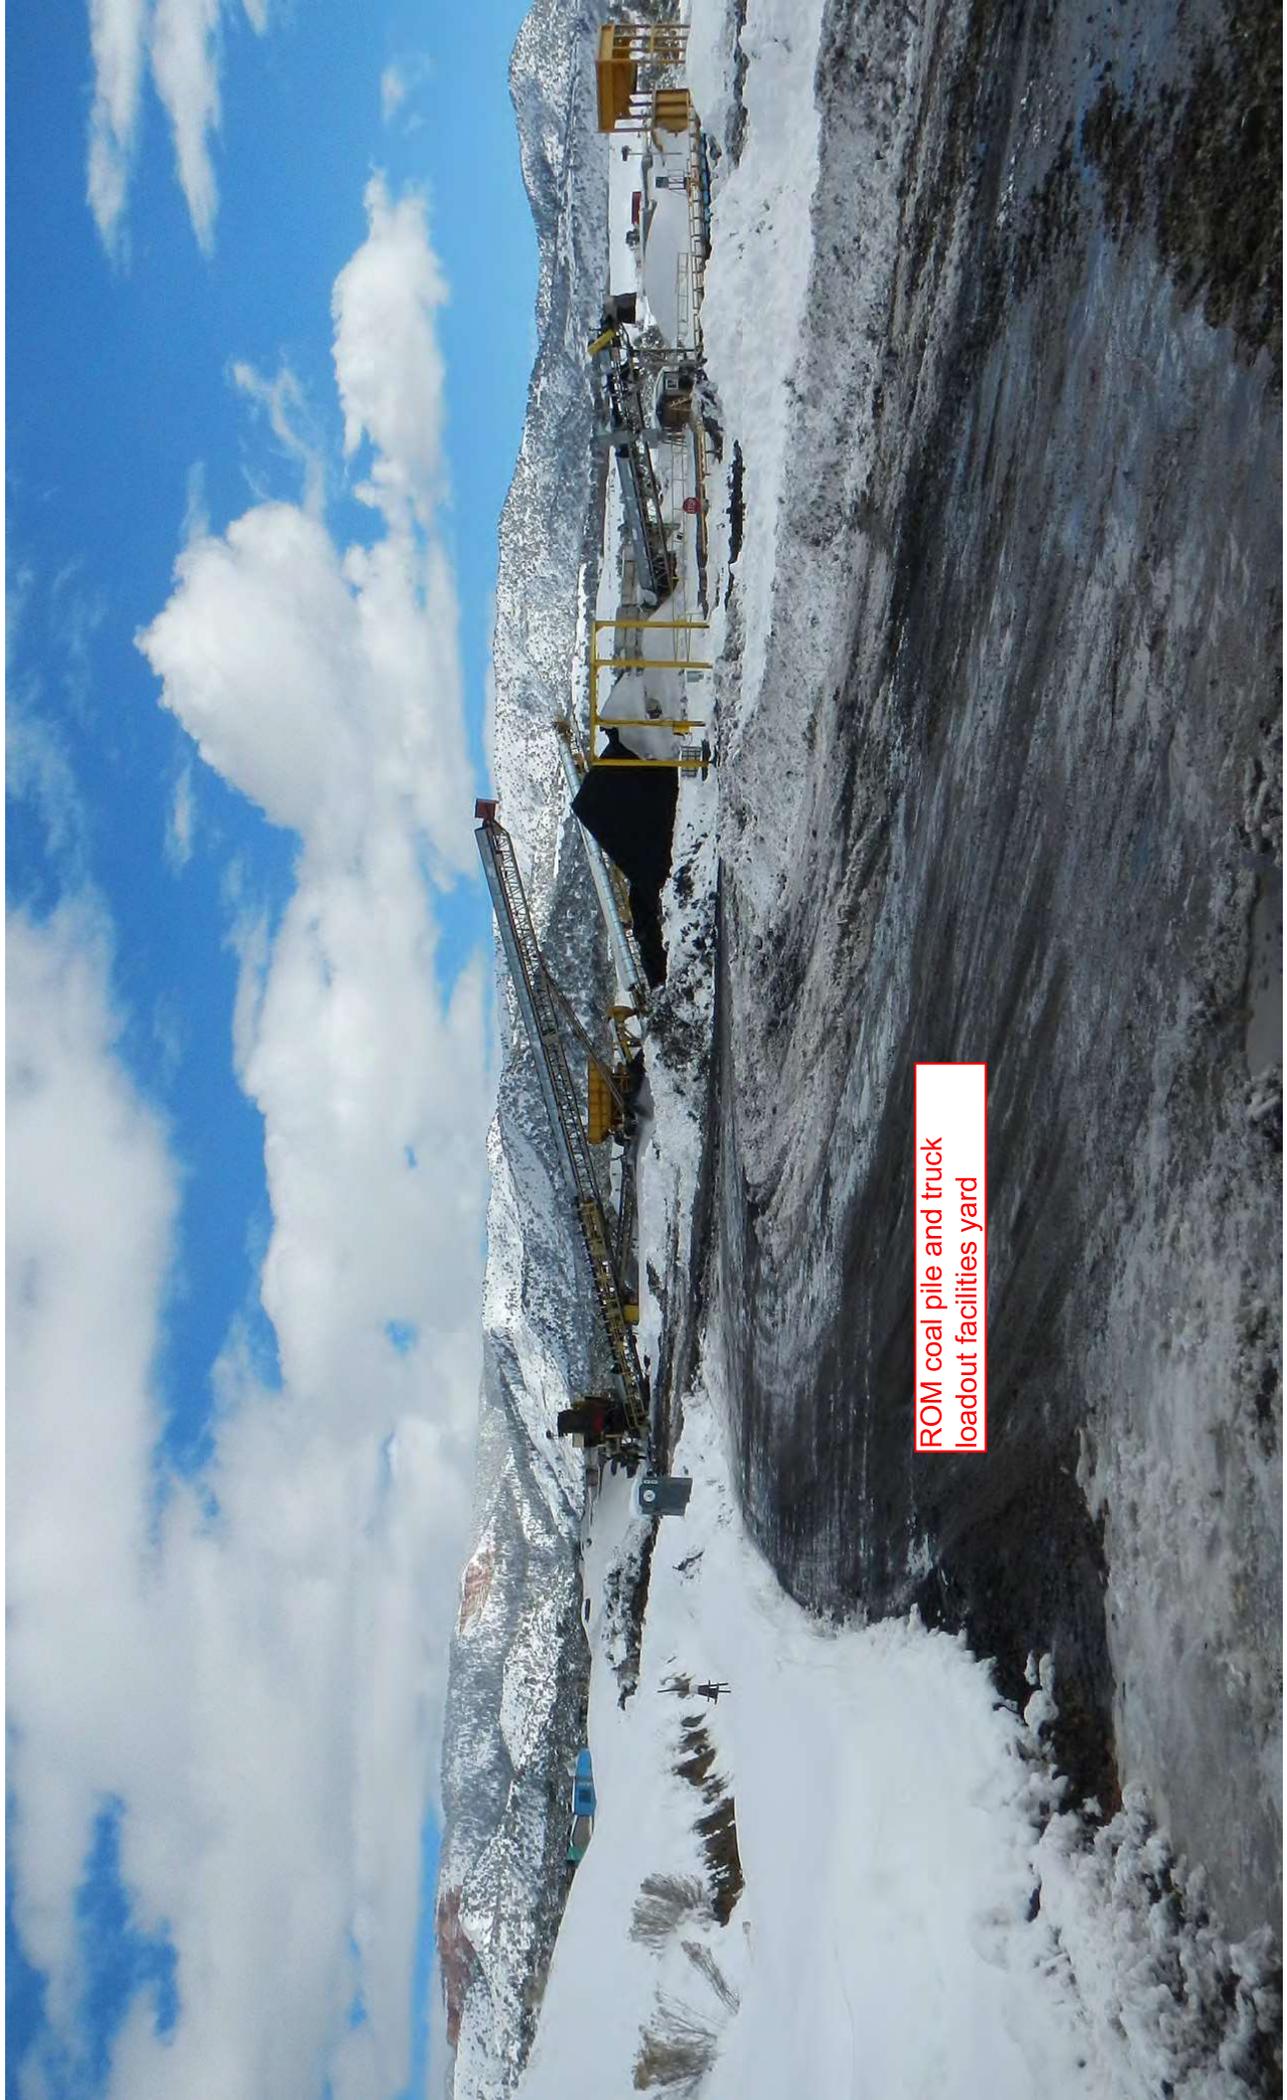
ROM coal pile and truck
loadout facilities yard

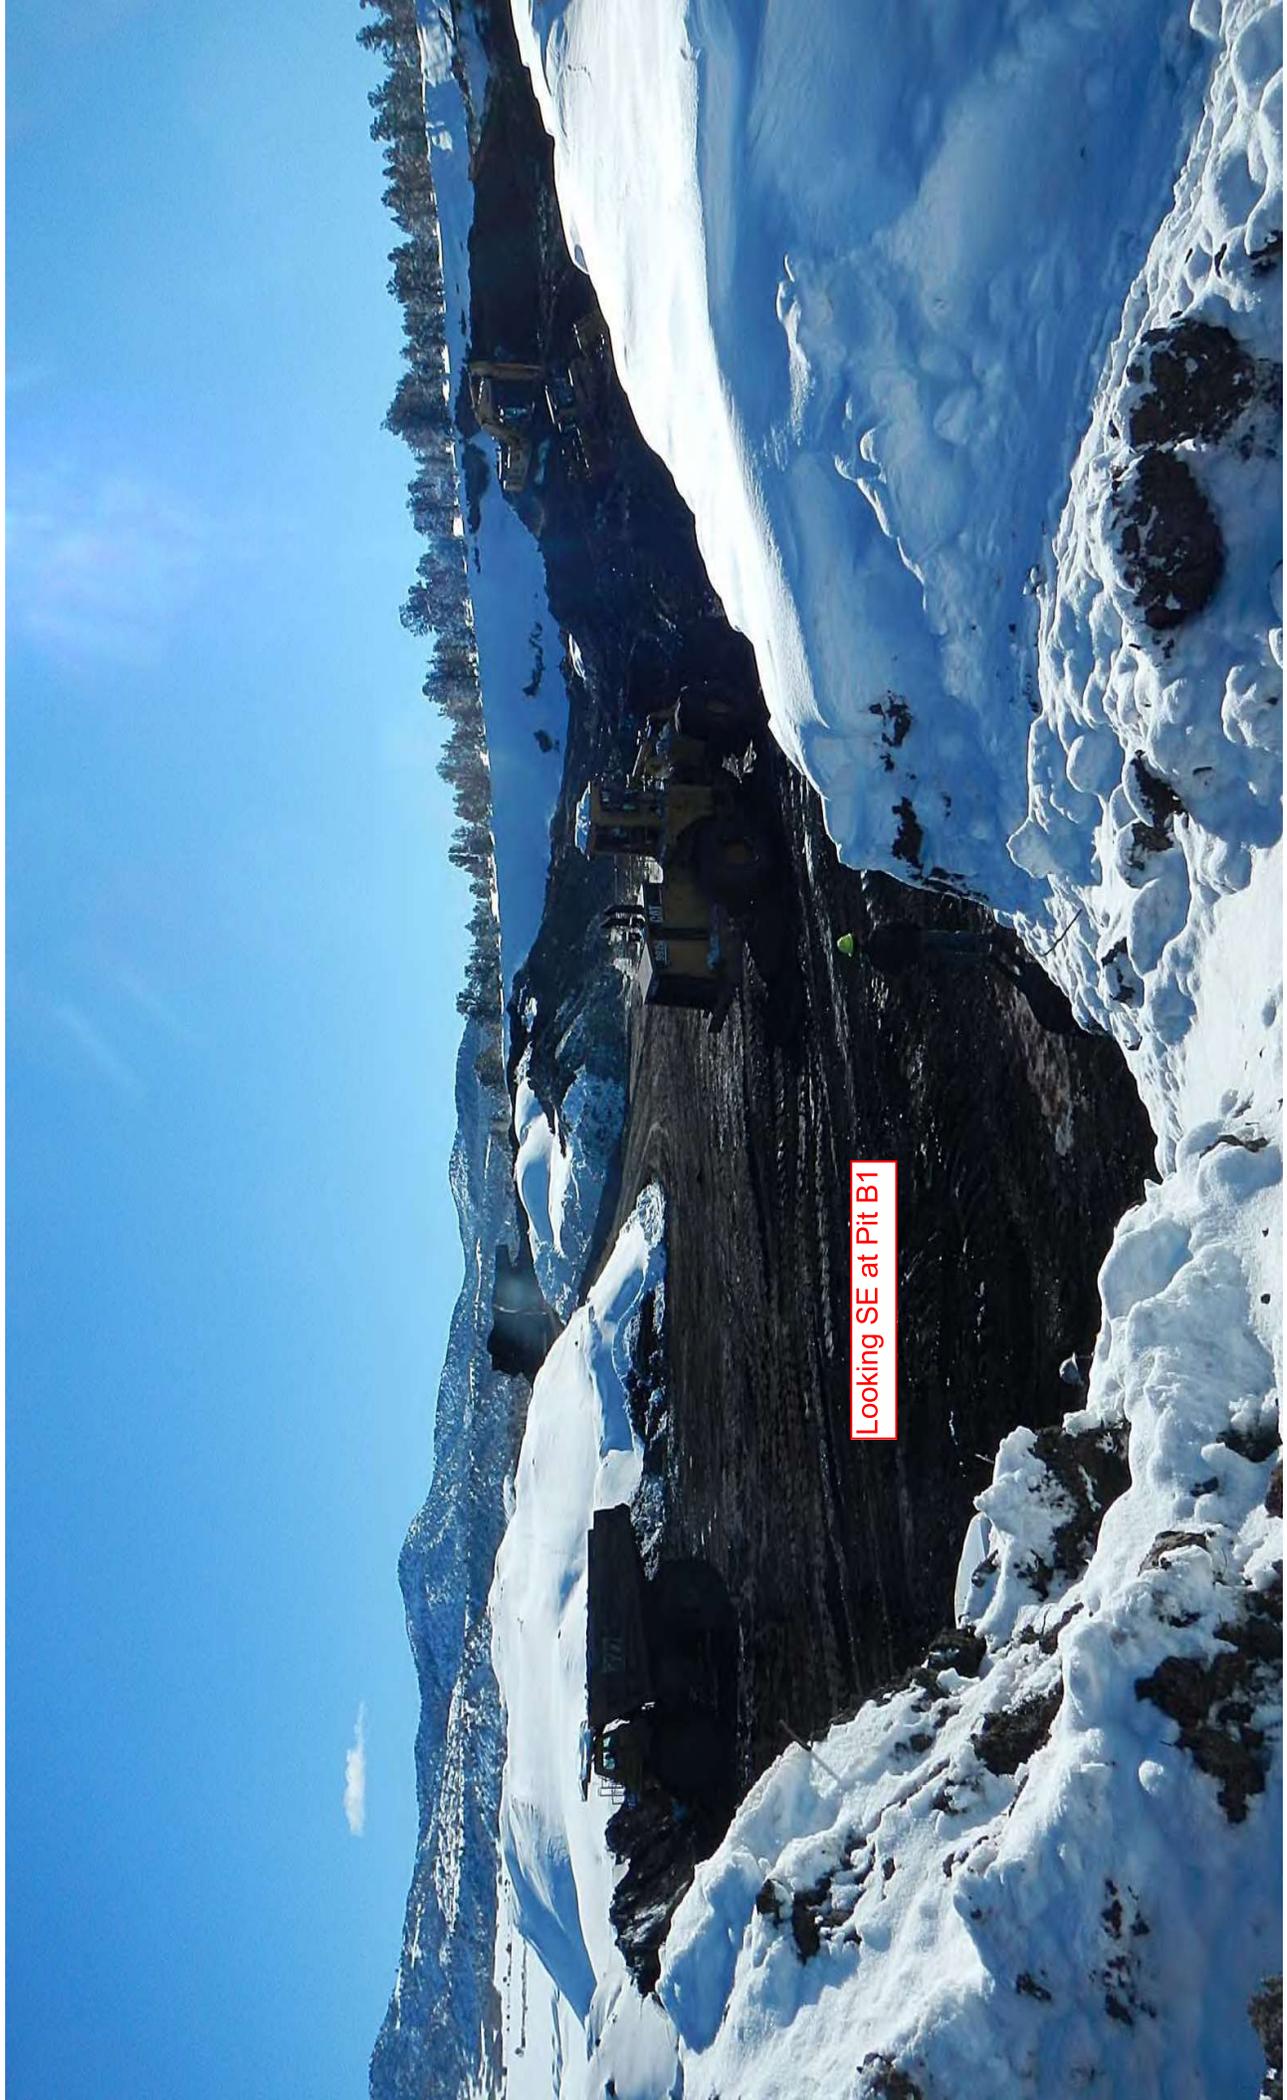
South Private Lease

Looking SE at Pit B1

At the South Lease: The extent of Pit B1 is marked by gps tracks shown on the attached 201_01_PartialSL.pdf image. Overburden is being hauled a short distance to the East to fill in the mined out section of Pit B1.

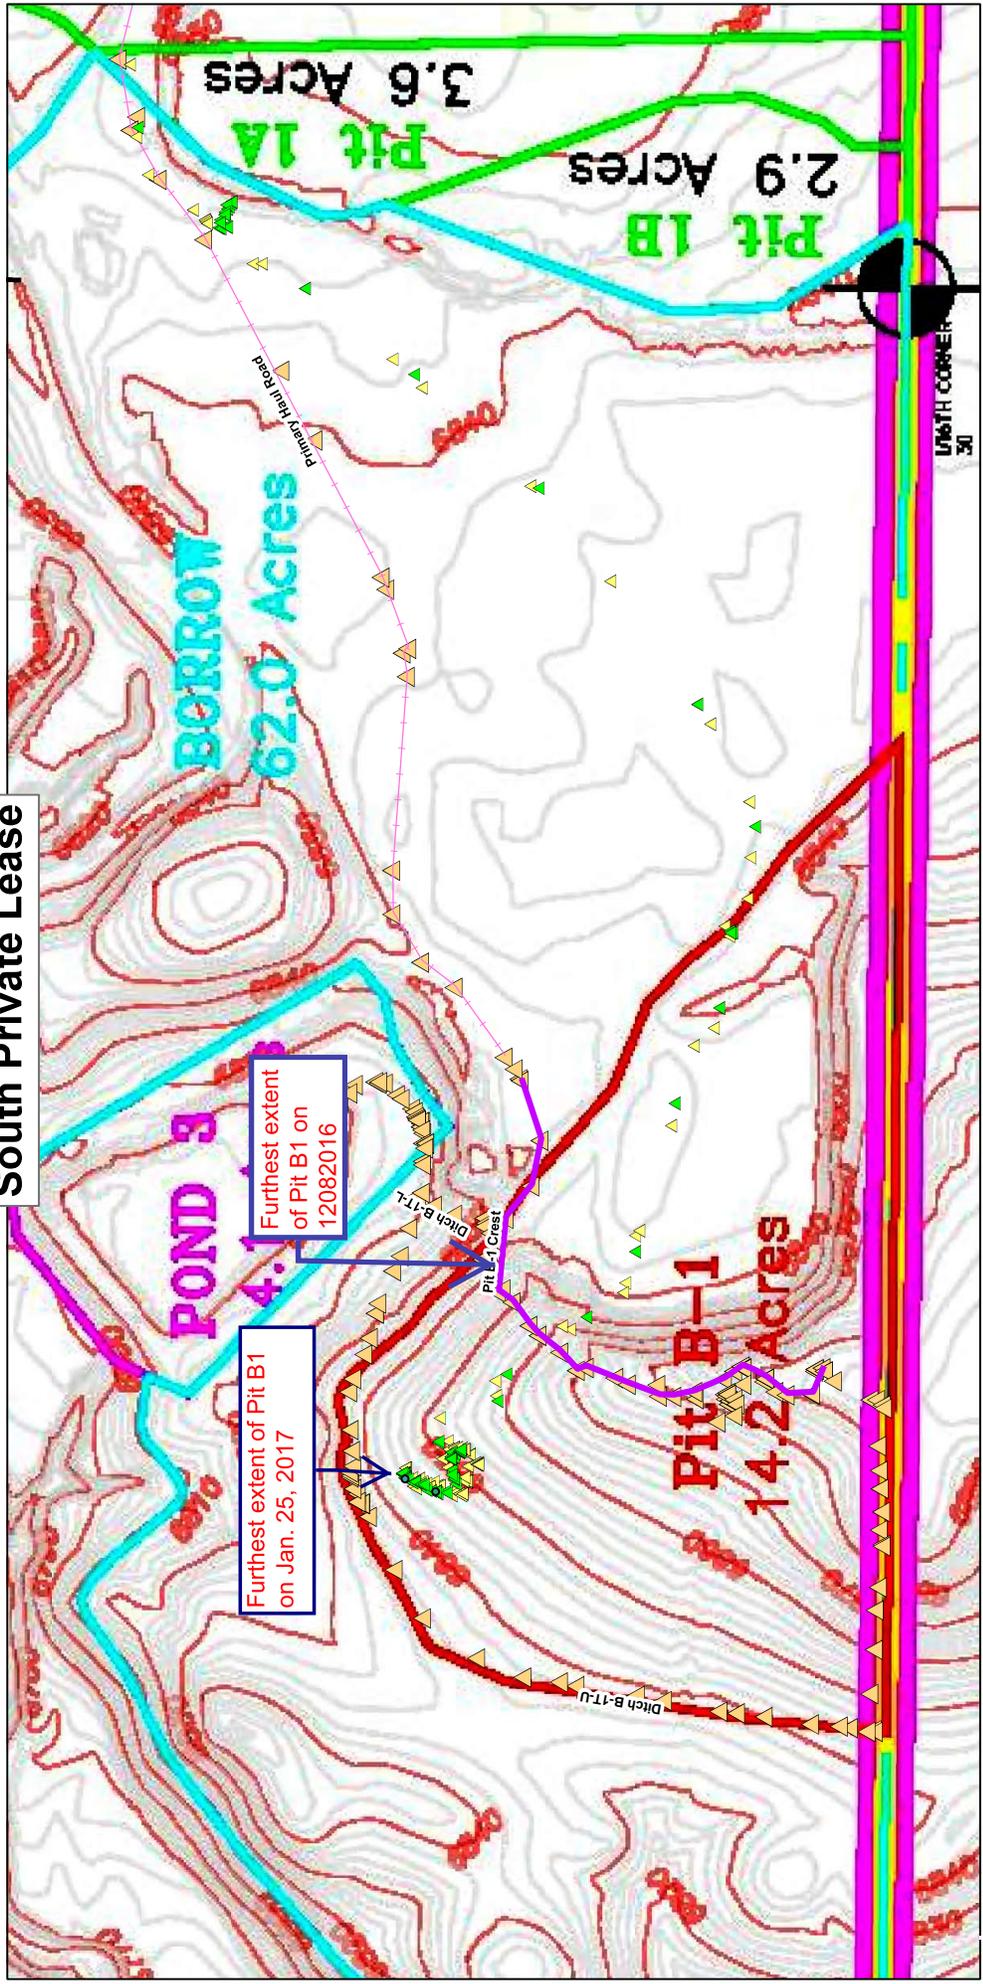
CLIENT	ALTON COAL DEVELOPMENT
PROJECT	COAL HOLLOW C/025/005
TITLE	JANUARY 25, 2017 PARTIAL INSPECTION
DATE	2017-01-28
PREPARED	CHERYL PARKER
DESIGN	CHERYL PARKER
REVIEW	PRISCILLA BURTON
APPROVED	###
MINE	Alton Coal Development
PROJECT	Coal Hollow
FIGURE	C025/005
	B

Furthest extent of Pit B1 on Jan. 25, 2017

Furthest extent of Pit B1 on 12/08/2016
