Subject: Phase I Bond Release Final Approval, Coal Hollow Mine, C/025/0005, Alton Coal Development, LLC, Task ID #5306

Phase I Bond Release on 21.288 acres
Alton Coal Development, LLC
Coal Hollow Mine
C/025/0005
Kane County, Utah

Inspection Report

InspectionID Report Number: 5711

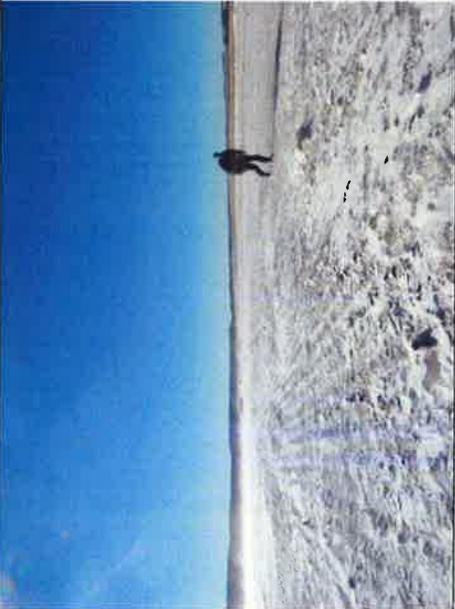
<p>PHOTO 1 Looking South across HWT 3B in BRP1_9 as Daron walks into the wind.</p>	<p>PHOTO 2 Looking N from the East boundary of HWT3B.</p>

The area BRP1-9 of HWT 2-B and HWT 3-B is adequately reclaimed. The reclaimed land surface elevation of BRP1-9 seamlessly transitions to the surrounding land surface elevation of the reclaimed HWT 2-A, Pit 20-b and Pit 21-A areas to the north and west. The reclaimed area also smoothly transitions to the unmined terrain to the east. Drainage across BRP1-9 matches the surrounding drainage patterns and runoff from the area is still routed to and treated by Pond 4 prior to leaving the permit area. Photos 1 through 6 show the reclaimed BRP1-9 area.

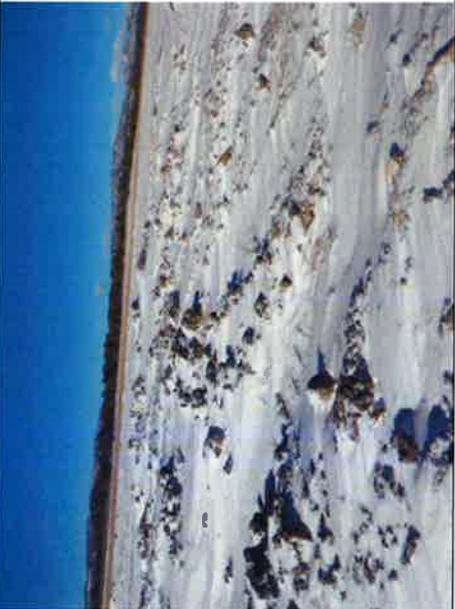
Topsoil was placed on HWT 2B and HWT 3B last July, but piles could not be redistributed over the area, because the soils were saturated. During the inspection, it was noted that there remains a small area in HWT 3B in which topsoil is not evenly redistributed due to super saturated soils. HWT 2B and HWT 3B were mulched with nutrimulch and straw. The mulch was incorporated with disc seeding. BRP1-9 was seeded two weeks ago (Nov. 16) along with HWT1A, HWT 1B, HWT 2A and Pit 9B. BRP1-10 was seeded last Saturday (November 24). Seed mixes are discussed below.

<p>PHOTO 3 Soft spot in HWT 3B where topsoil was not distributed.</p>	<p>PHOTO 4 Looking West across boundary between HWT 2B and 3B in BRP1_9.</p>

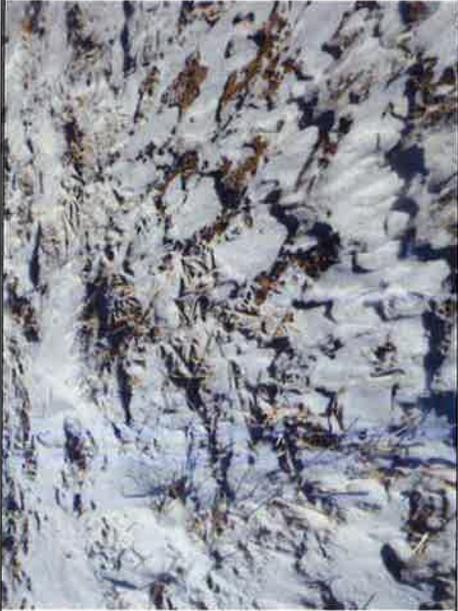
PHOTO 5 Straw mulch, nutrimulch and seed beneath the snow.

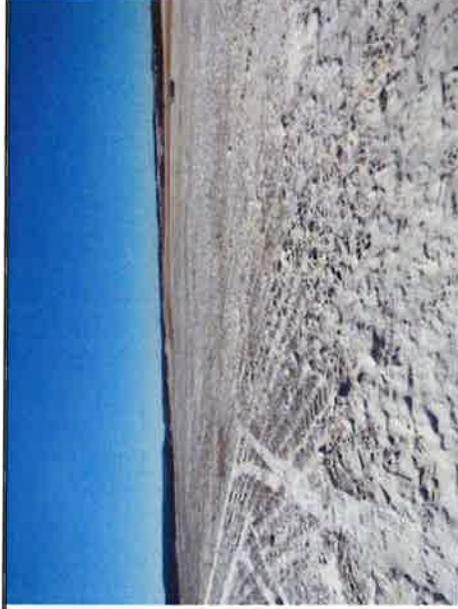
PHOTO 6 Looking SW at HWT 2B in BRP1_9

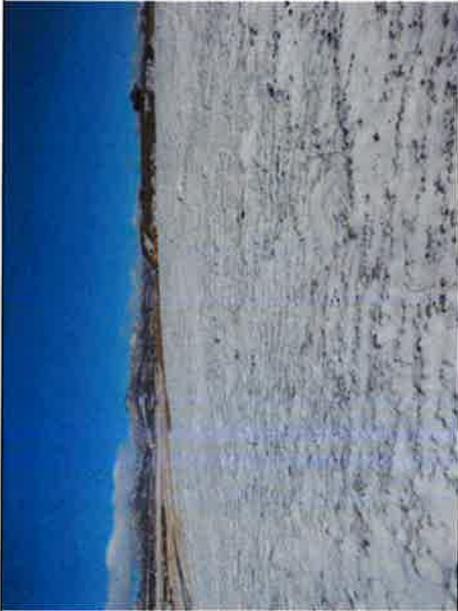
PHOTO 7

The BRP1-10 area of Pit 01, Pit 02, and Pit 03 is adequately reclaimed. Photo 7 in the inspection report shows the area matches the premining topography and drainage patterns. The majority of the reclaimed area flows to and is treated by Pond 5 while the southeastern corner of corner of Pit 03 reports to Pond 6.

Looking North across BRP1_10. Haul trucks are traveling along the eastern edge of reclaimed Pit 3 to unload spoil into Pit 4.

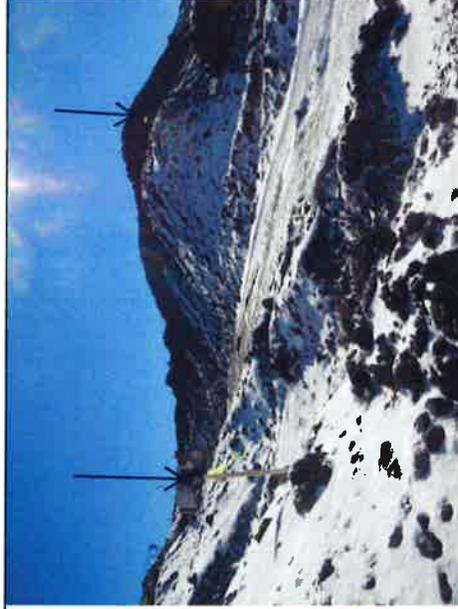
PHOTO 8

The East perimeter of BRP1-10 is about 15 feet above grade for a distance of 300 feet due to a haul truck breaking down in the area. Once the haul truck is repaired and moved, the fill will be moved. Mr. Christensen stated that this fill will be brought to grade in the next week. The Phase 1 bond release area is being used to run haul trucks. Mr. Nicholes stated that the access road will be ripped prior to topsoil placement. The survey of the perimeter of the BRP1-10 area should also be completed, since disturbed area (subsoil pile and a roadway) are adjacent. The bond release areas appeared to be stable and (except for the necessary grading noted previously) within the tolerance of approximate original contour.

Survey flags on fill piles denote eastern edge of BRP1_10.
