Inspection Report

Permittee: **ALTON COAL DEVELOPMENT LLC**
 Operator: **ALTON COAL DEVELOPMENT LLC**
 Site: **COAL HOLLOW**
 Address: **463 North 100 West, Suite 1, CEDAR CITY UT 84720**
 County: **KANE**
 Permit Type: **PERMANENT COAL PROGRAM**
 Permit Status: **ACTIVE**

Coal Hollow Inspection April 25, 2018

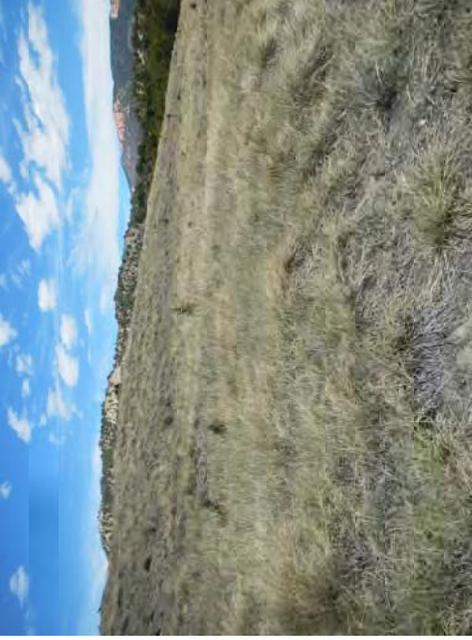
PHOTO 1 Topsoil pile 1

SL topsoil #1 = 2.74 acres, holds 25,289 CY is a well vegetated inactive pile; Topsoil #2 = 4.94 acres, holds 71,392 CY was last utilized in 2017 for reclamation, will remain inactive indefinitely; subsoil #1 = 2.83 acres, holds 73,070 CY is an inactive pile and will remain so indefinitely; subsoil #2 = 2.31 acres, holds 47,690 CY was actively used in 2017 but will remain inactive indefinitely.

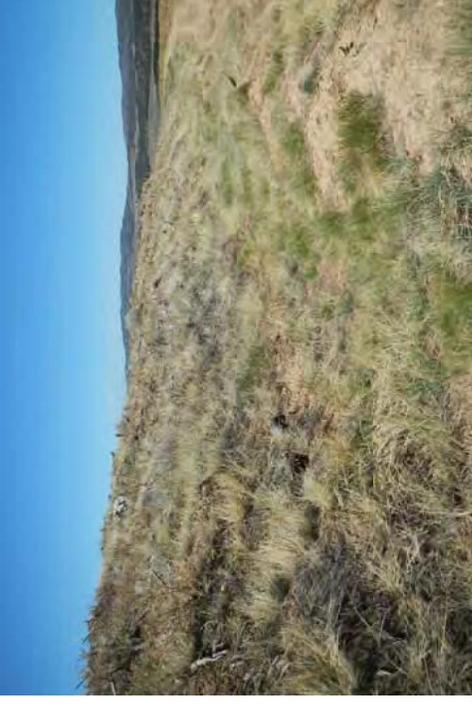
PHOTO 2 Topsoil pile 2

Topsoil pile #2 berms on the West side require re-shaping after additional soil was removed during the fourth quarter of 2017 for reclamation.

Recent work on the berms around South sides of topsoil #2 and subsoil #1 was done to ensure that the berms were high enough. In reality, the berms on the South side of the topsoil stockpile were so well vegetated that this work was unnecessary. The newly worked area will be susceptible to weed growth and should be watched closely.

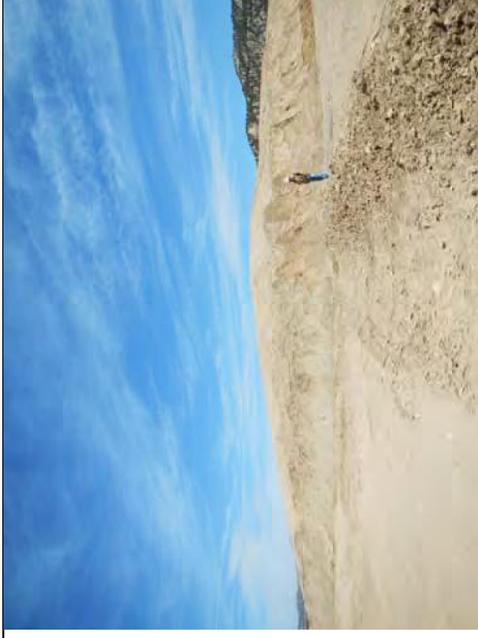
PHOTO 4 Subsoil pile 2

Field bindweed, *Convolvulus* spp., becoming established on the berms of SL subsoil pile #2. The field bindweed should be controlled as it is a Class 3 noxious weed. We discussed the use of chemicals vs. biological control (bindweed gall mite, *Aceria malherbae*).

Contemporaneous reclamation is completed at the South Lease. The remaining subsoil and topsoil stockpiles will be used for Pit 10 and the facilities and ponds. SL subsoil pile #2 was seeded in 2016. There is very little vegetation growing on the pile. The south half of the stockpile is approximately 7 feet thick with a flat topped surface. The north half of the pile is smooth and convex, about 30 feet high. This pile will be used to reclaim Pit 10 and the facilities yard. The portion of the pile which is not needed for Pit 10 will be relocated to the subsoil pile #1 location, if the federal leases are obtained. There are options for improving vegetation on this pile in the mean time:

1. Spread the pile out over the entire foot print to lessen and shorten the slopes sides and leave a roughened surface. Then reseed.
2. Move the pile to the subsoil pile #1 location and in doing create a pile with 3h:1v slopes and roughened surface. Then reseed.
- Or 3. Move all the pile except that volume required for reclamation of pit 10. Reshape the pile in place and the relocated pile and reseed both.
