# Inspection Report

Permit Number:	<b>C0250005</b>
Inspection Type:	COMPLETE
Inspection Date:	Tuesday, May 19, 2020
Start Date/Time:	5/19/2020 8:30:00 AM
End Date/Time:	5/19/2020 3:00:00 PM
Last Inspection:	Tuesday, March 3, 2020

Permittee: **ALTON COAL DEVELOPMENT LLC**  
 Operator: **ALTON COAL DEVELOPMENT LLC**  
 Site: **COAL HOLLOW**  
 Address: **463 North 100 West, Suite 1, CEDAR CITY UT 84720**  
 County: **KANE**  
 Permit Type: **PERMANENT COAL PROGRAM**  
 Permit Status: **ACTIVE**

**ATTACHMENT A – Coal Hollow**

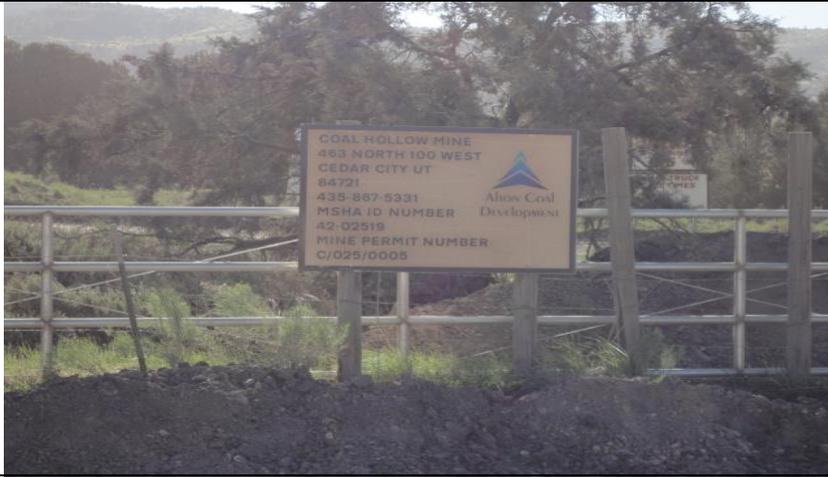
**PHOTO 1**  
Identification Sign

The identification sign was inspected and it meets the requirements of the R645 Coal Rules. See Photo

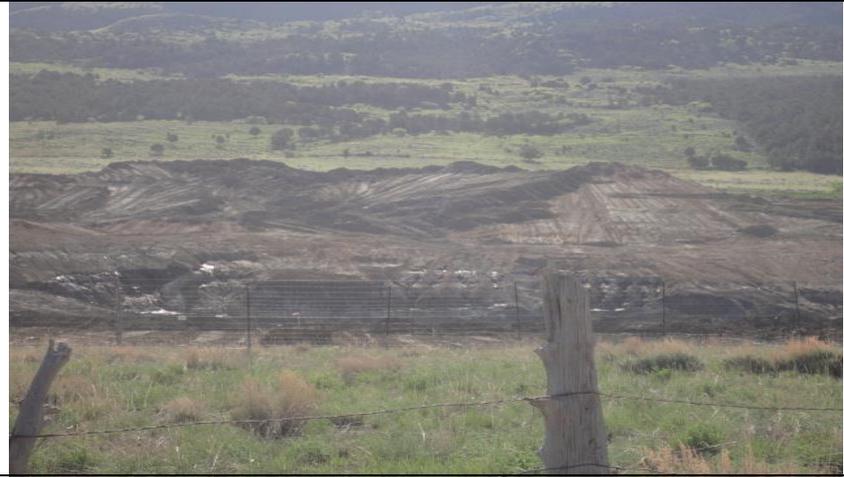
**PHOTO 2**  
North Lease

The permittee conducted a first quarter spoil pile inspections on Marcher, 2020. The report was P. E certified by Dan Guy. No hazardous conditions were reported. During my inspection I did not see any hazardous conditions. Spoil material was getting push into pits with two dozers on the North Lease.

The permittee was backfilling pits in the North Lease. Backfilling and grading should be finish by the end of the summer.

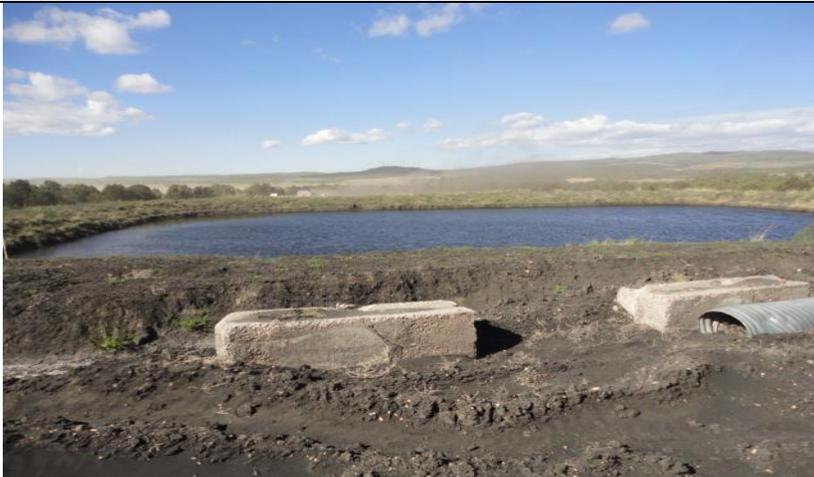
**PHOTO 3**  
Pond #1

I inspected the sediment ponds throughout the property. They contained some water but were not discharging. It is unlikely these structures will discharge in the near future. The embankments appear to be stable. Inlets and outlets would function as design. I did not see any hazardous conditions to these structures. The permittee conducted a first quarter sediment pond inspections on March 25, 2020. No hazardous conditions were reported. Water from pond #7 and #3 are used for watering roads.

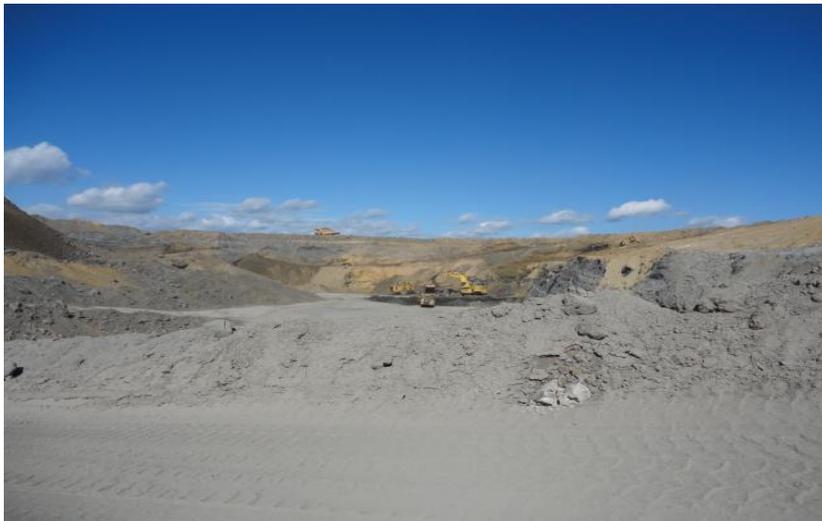
**PHOTO 7**  
South Lease – Pit F1

The permittee was mining westside of pit F1 in the South Lease. The North Lease had two dozers pushing spoil into the pits. The permittee plans to submit Phase 1 bond release for the Northside either in August or September of this year 2020.
