Re: Annual Report for Canyon Fuel Company LLC, SUFCO Coal Mine

**ANNUAL REPORT**

**CANYON FUEL COMPANY, LLC  
SUFCO MINE**

ANNUAL MINESITE SEDIMENTATION POND  
CERTIFICATION -- 1996

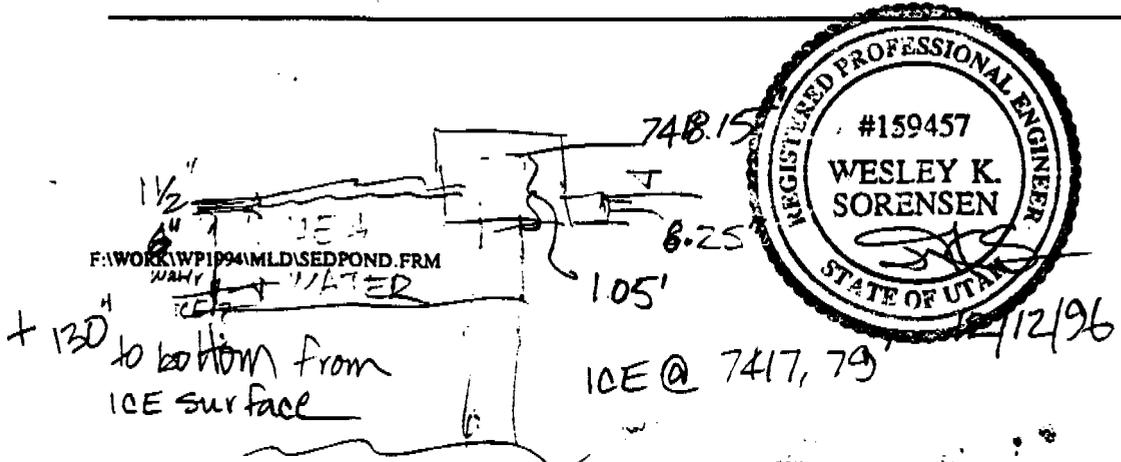
Minesite Sediment Pond ~~Quarterly~~ <sup>Annual</sup> Inspection Report

Minor erosion on slope above pond

Ice on surface Pond was water

Locked and closed. Dig A weir  
right over top surface

Sun shining. Thawing conditions. Bare slopes  
some snow in riprap.

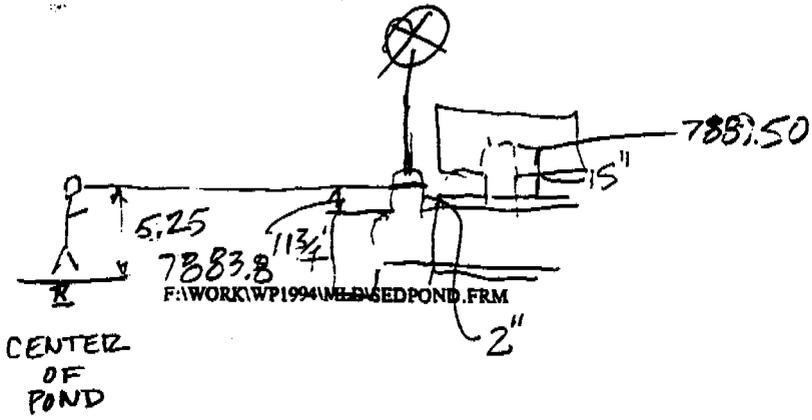
Rock Waste Sediment Pond <sup>Annual</sup> ~~Quarterly~~ Inspection Report

Pond has 3" snow in bottom  
1/2" ice & 1" water in south end about 1/2" ice in  
MIDDLE

B. Decant System  Yes  No  
closed & worked

8. Other Comments  
DECANT POND OKAY STRUCTURALLY SOUND  
NO EROSION  
EIK & DEER in area
