# 1999 ANNUAL REPORT

## CANYON FUEL COMPANY, LLC SUFCO MINE ACT/041/002

**1999 SUBSIDENCE REPORT**

## LINK TRAIL COLUMBINE

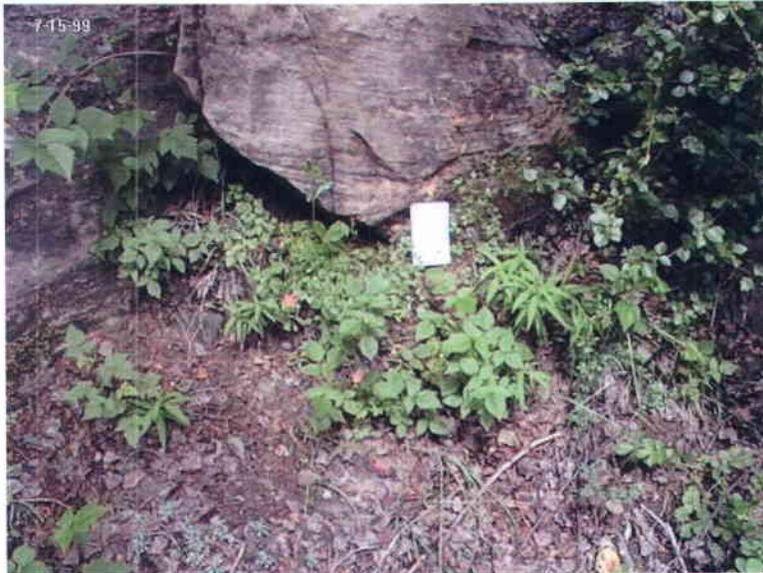
Link Trail Columbine Photo Point #3a

ledge above the small pool below the rock ledge. The plants seem to be growing in the cracks in the Castlegate formation where water would drain from within the formation to the surface. We then hiked down below the rock cliffs and found the Link Trail Columbine growing on both sides of the Canyon. The majority of the plants seemed to be growing in the cracks in the Castlegate formation as before but some of them were also growing at the base of the rock cliffs. A photo point was established in this area (see Photos 1a, 1b, and 1c). Two more photo points were established in this area. Photo point two was of the Columbine growing in rock cracks, (see photo 2), and the other photo point was of the Columbine growing at the base of the cliffs, (see photo 3a and 3b).
