From: "Davis, Mike" <MDavis@archcoal.com>
To: "Chris Hansen (E-mail)" <CHansen@archcoal.com>, "Craig Hilton (E-mail)" <CHilton@archcoal.com>, "Daron Haddock (E-mail)" <daronhaddock@utah.gov>, "Dave Darby (E-mail)" <davedarby@utah.gov>, "Erik Petersen (E-mail)" <petersen@relia.net>, "Jerriann Ernstsens (E-mail)" <jerriannernstsens@utah.gov>, "Ken May (E-mail)" <KMay@archcoal.com>, "Mark Bunnell (E-mail)" <MBunnell@archcoal.com>, "Pam Grubaugh-Littig (E-mail)" <Pamgrubaughlittig@utah.gov>, "Pete Hess (E-mail)" <petehess@utah.gov>, "Steve Fluke (E-mail)" <stevefluke@utah.gov>, "Susan White (E-mail)" <susanwhite@utah.gov>
Date: 11/25/03 10:08AM
Subject: East Fork Box Canyon Monitoring 11/17 & 19/03

Canyon Fuel Company, LLC SUFCO Mine	
EAST FORK OF BOX CANYON WEEKLY MONITORING	
DATE: NOV. 24, 2003	SCALE: 1" = 400'
397 SOUTH 800 WEST SALINA, UTAH 84654	
DRAWN BY: BDH	
FILENAME: H:\DWG\DOGM\EAST FORK BOX\3LPE WEEKLY MONITORING

**SUBSIDENCE CAVING PROFILE
ELUSIVE PEACOCK SHELTER**

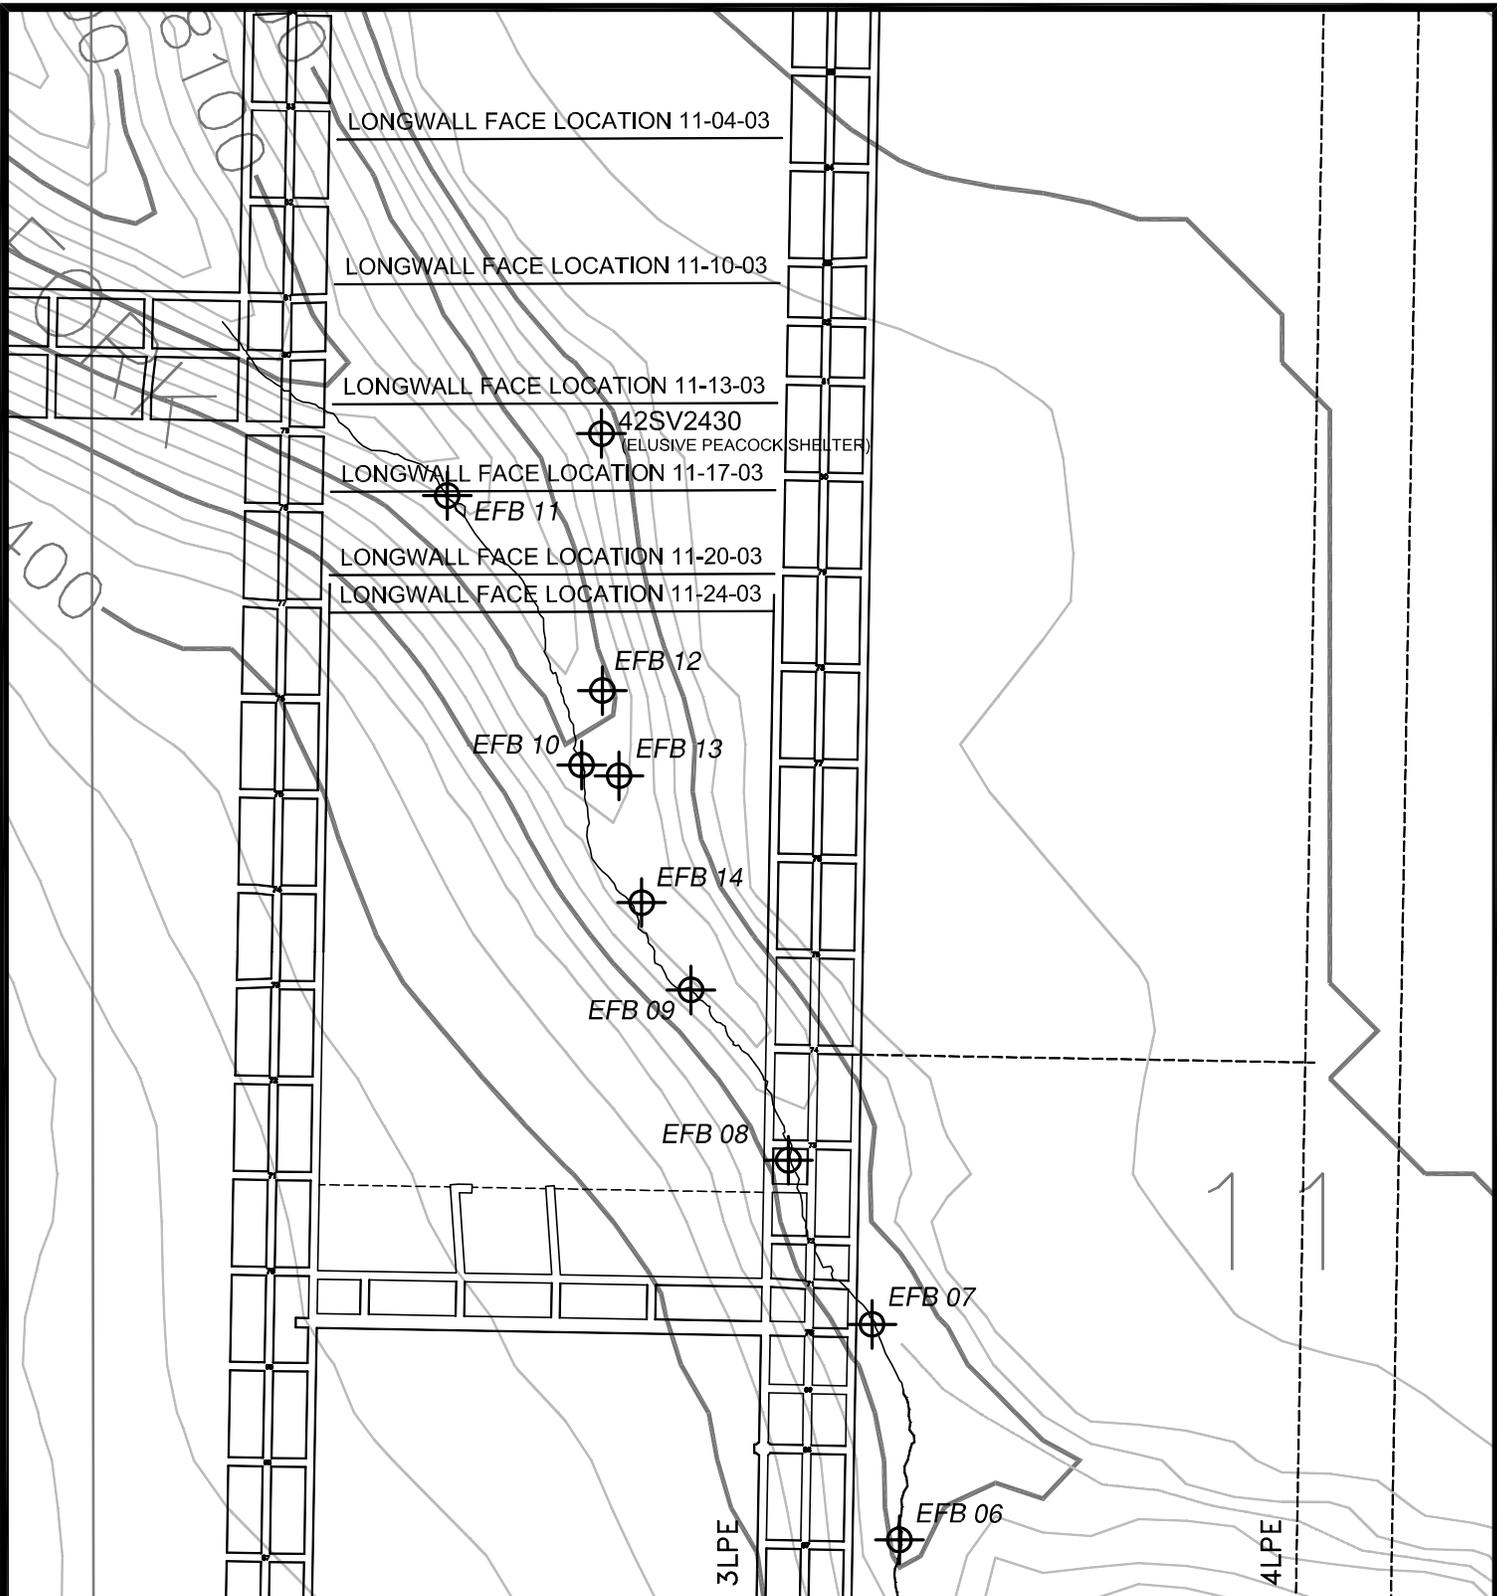
The East Fork of Box Canyon was monitored on 11/17/03 for both flow and subsidence cracks and on 11/19/03 for subsidence cracks. (See attached excel spread sheet, map of area, and pictures included in second email)

The area was covered with 3-4" of snow from the recent snow storms. All stream monitoring sites were covered with snow and ice.

During the 11/19/03 inspection the upper shelter roof had caved off onto the shelter floor and now rock covers the whole floor of the shelter. The floor of the shelter is still holding at this point. The lower overhang roof has also caved off more. Only one subsidence crack was found and it was located on the slope above the stream on the East side of the canyon. No cracks were found in the stream channel but a lot of it is covered with snow and ice. No new cracks were observed along the sandstone outcrop above the stream channel.

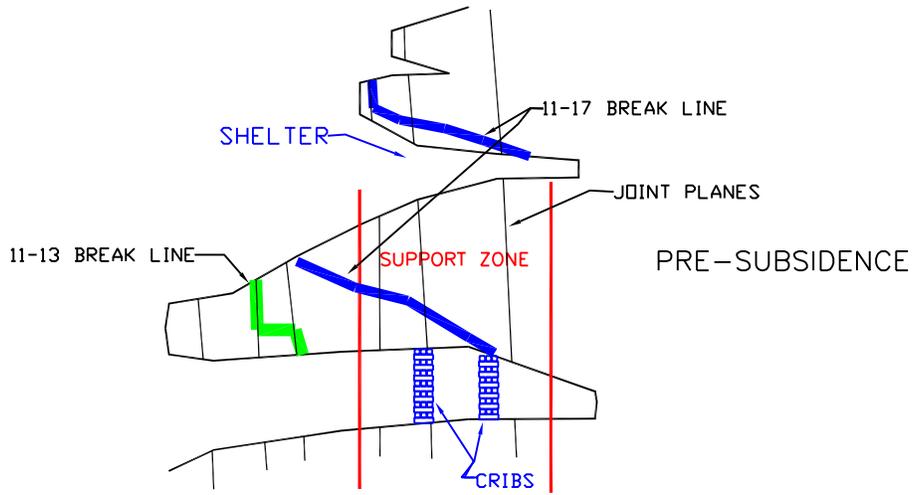
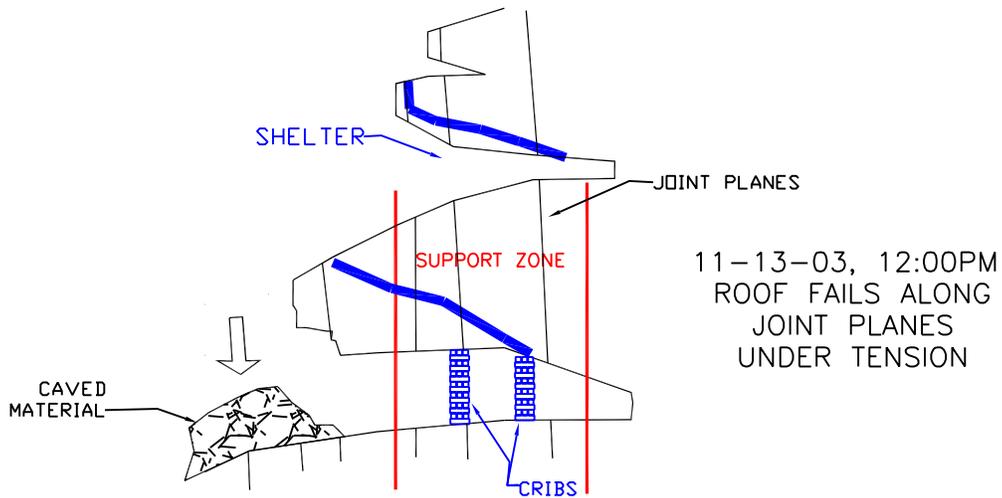
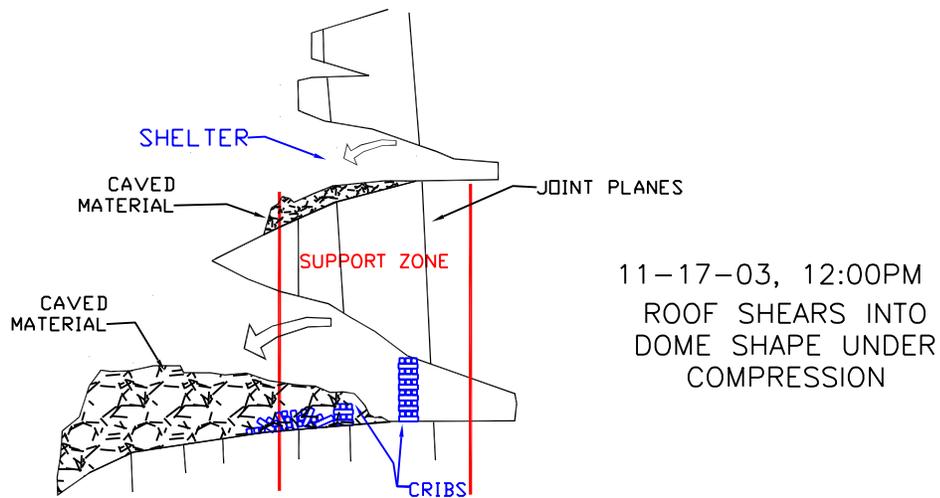
No subsidence cracks were observed in the stream channel on the 11/17/03 inspection. The roof of both shelters sheared into a dome shape under compression after the longwall passed under the shelter. (See Subsidence caving profile drawing dated 11-18-03)

SECTION B - B'
