2003 ANNUAL REPORT

CANYON FUEL COMPANY, LLC SUFCO MINE ACT/041/002

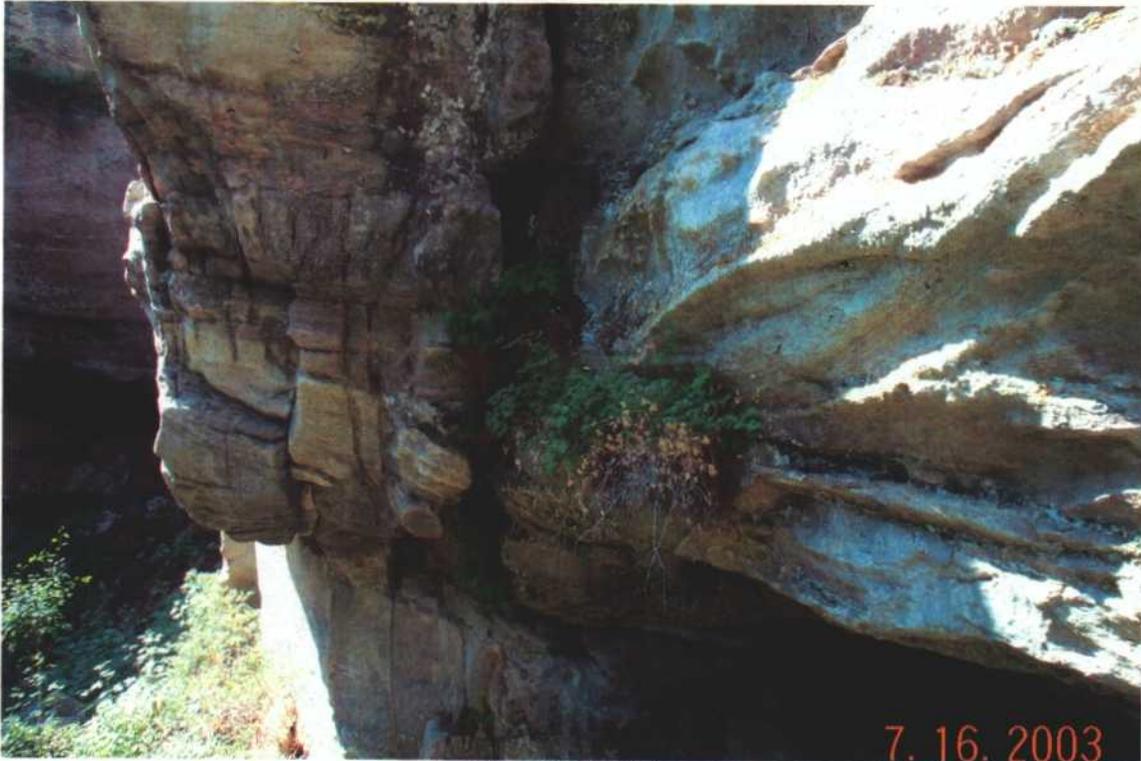
Photo Point 1A

At photo points 1,2, & 3 the growth of the Link Canyon Trail Columbine continues to be poor to fair. The plants that were growing where they would receive some shade and moisture from the fractures in the bedrock had a few inflorescence growths of 10-12 inches in length. The plants that received little or no shade had poor inflorescence, and none on some plants, with a total plant height of 4-7 inches.

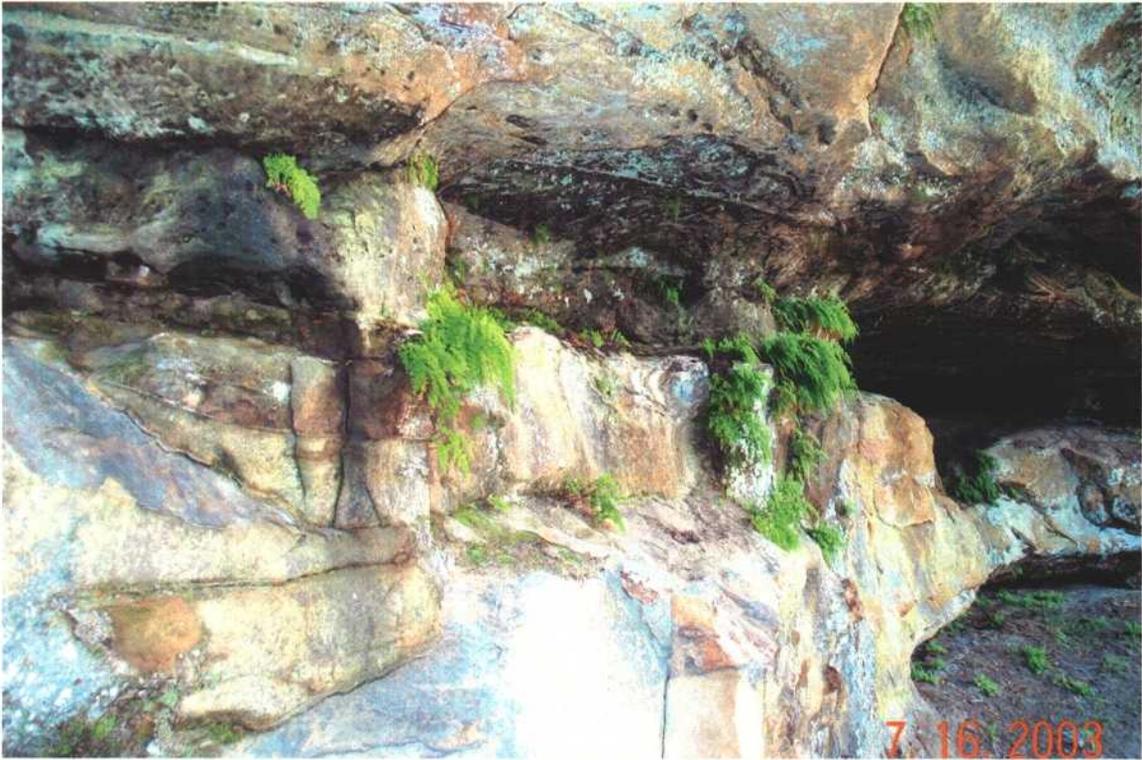
Photo Point 8

At photo points 8 & 9 ("Hanging Fern Garden) there was some fern growth 5-8 inches in length. The density of the fern is only poor and is very spotty. There is very little moss growth and it occurs mainly along fractures in the bedrock where there is a little moisture. In the locations where the cattle ate the moss last year there is no moss growing yet this year. These areas where the moss has been removed are now covered with lichens.

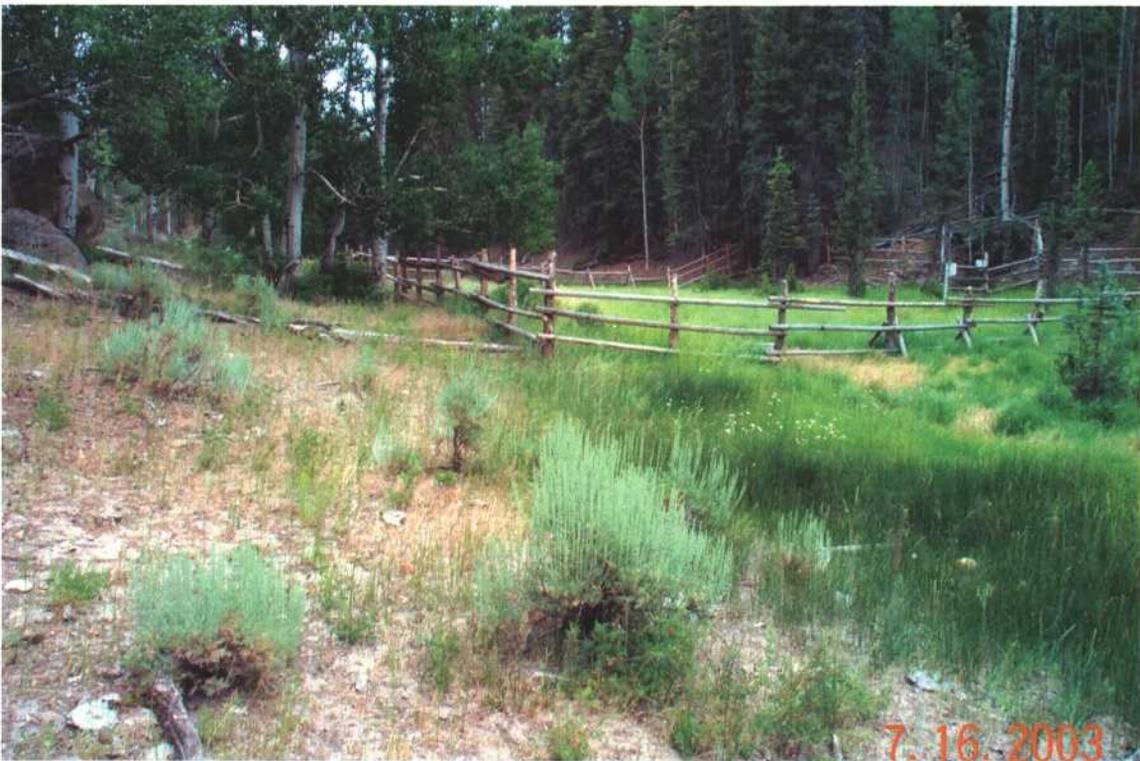
Photo Point 10

At photo point 10 the vigor in the wet meadow bottom is good and still has good density. However, the drier portions of meadow above the wet meadow have significantly deteriorated to the point where they can hardly still be considered as dry meadows. The vegetation in-between the sagebrush plants has changed from Bluegrasses and Carex to scattered Stipa and weedy annuals. The wet meadow growth is fair to good with Carex 8-10 inches high, Juncus 7-9 inches high, and Kentucky Bluegrass seed heads 15-18 inches high.

Continued drought conditions and last years heavy grazing has contributed to the decreased vegetative density in the drier portions of this area. Although the Link Canyon Trail Columbine vigor and density has decline no evidence has been identified to tie this change to under-mining of the coal reserves. It appears at this time that this decline is probably due to continued drought conditions and heavy grazing.

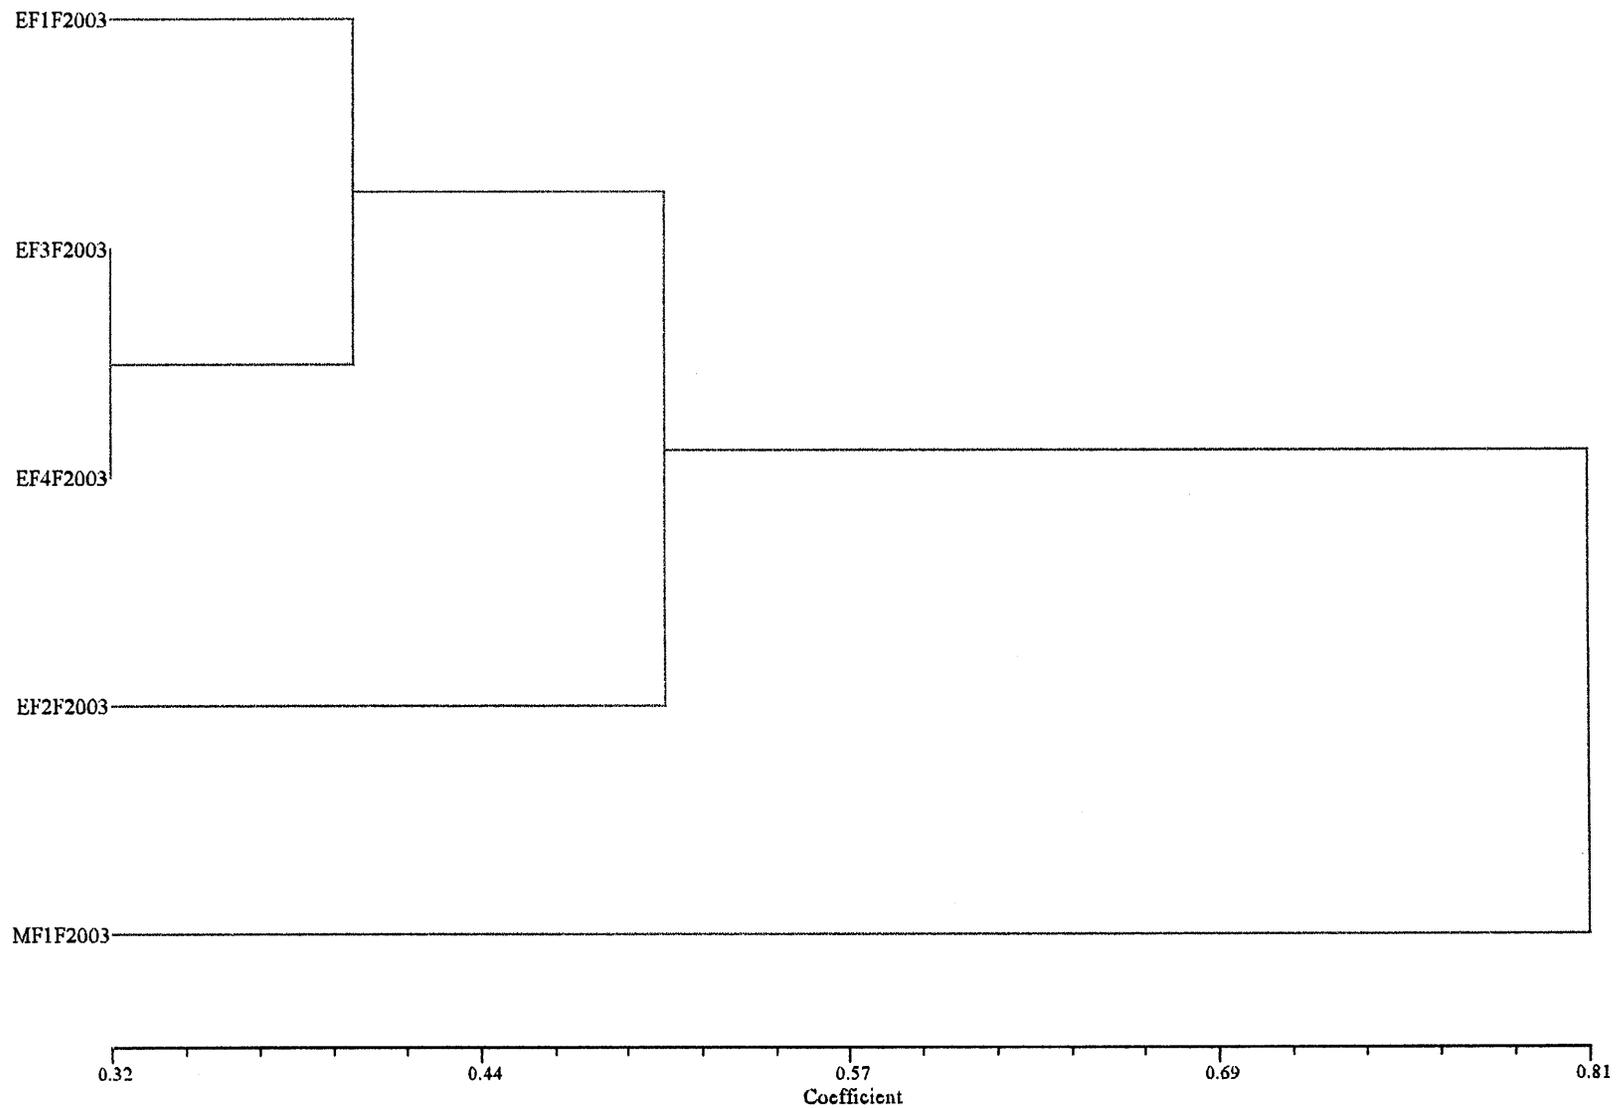
Figure 1. Cluster dendrogram for the Box Canyon samples.
