2004 ANNUAL REPORT

CANYON FUEL COMPANY, LLC SUFCO MINE ACT/041/002

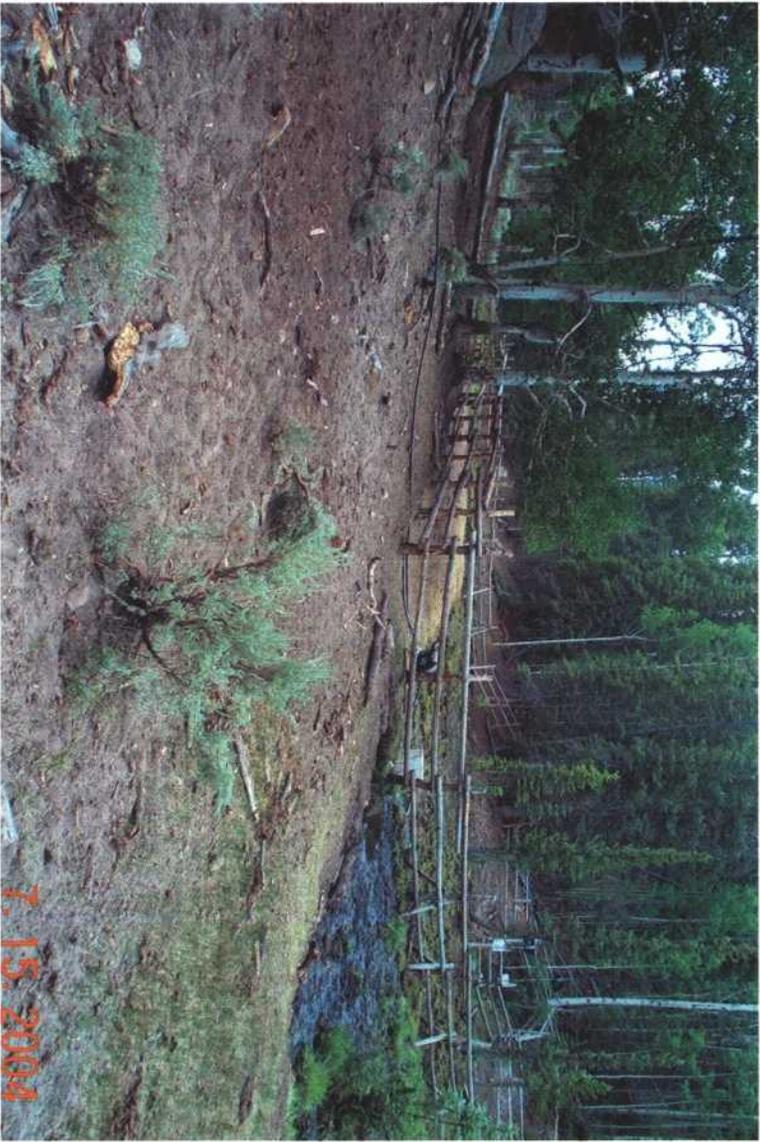
Photo Point 10

Photo point 10 is a riparian area in the East Fork of Box Canyon. The site has been grazed extremely heavy. This is probably due to the proximity to water coming from the flowing spring adjacent to this site. The riparian vegetation is grazed down to a stubble height on Carex of 0-1/2 inch. The only riparian with a higher stubble height is Juncus which has a stubble height of 4 inches. There are a few Rose species still existing which have also been heavily grazed. There were no dry meadow species that could be identified. Ocular survey shows that the area is 90% bare ground, 4% sagebrush, 1% Rose and 5% riparian species currently occupy the site. Additional photos were taken showing the extremely heavy grazing of the wet meadow adjacent to the photo point and of the heavy grazing inside the fenced enclosure.

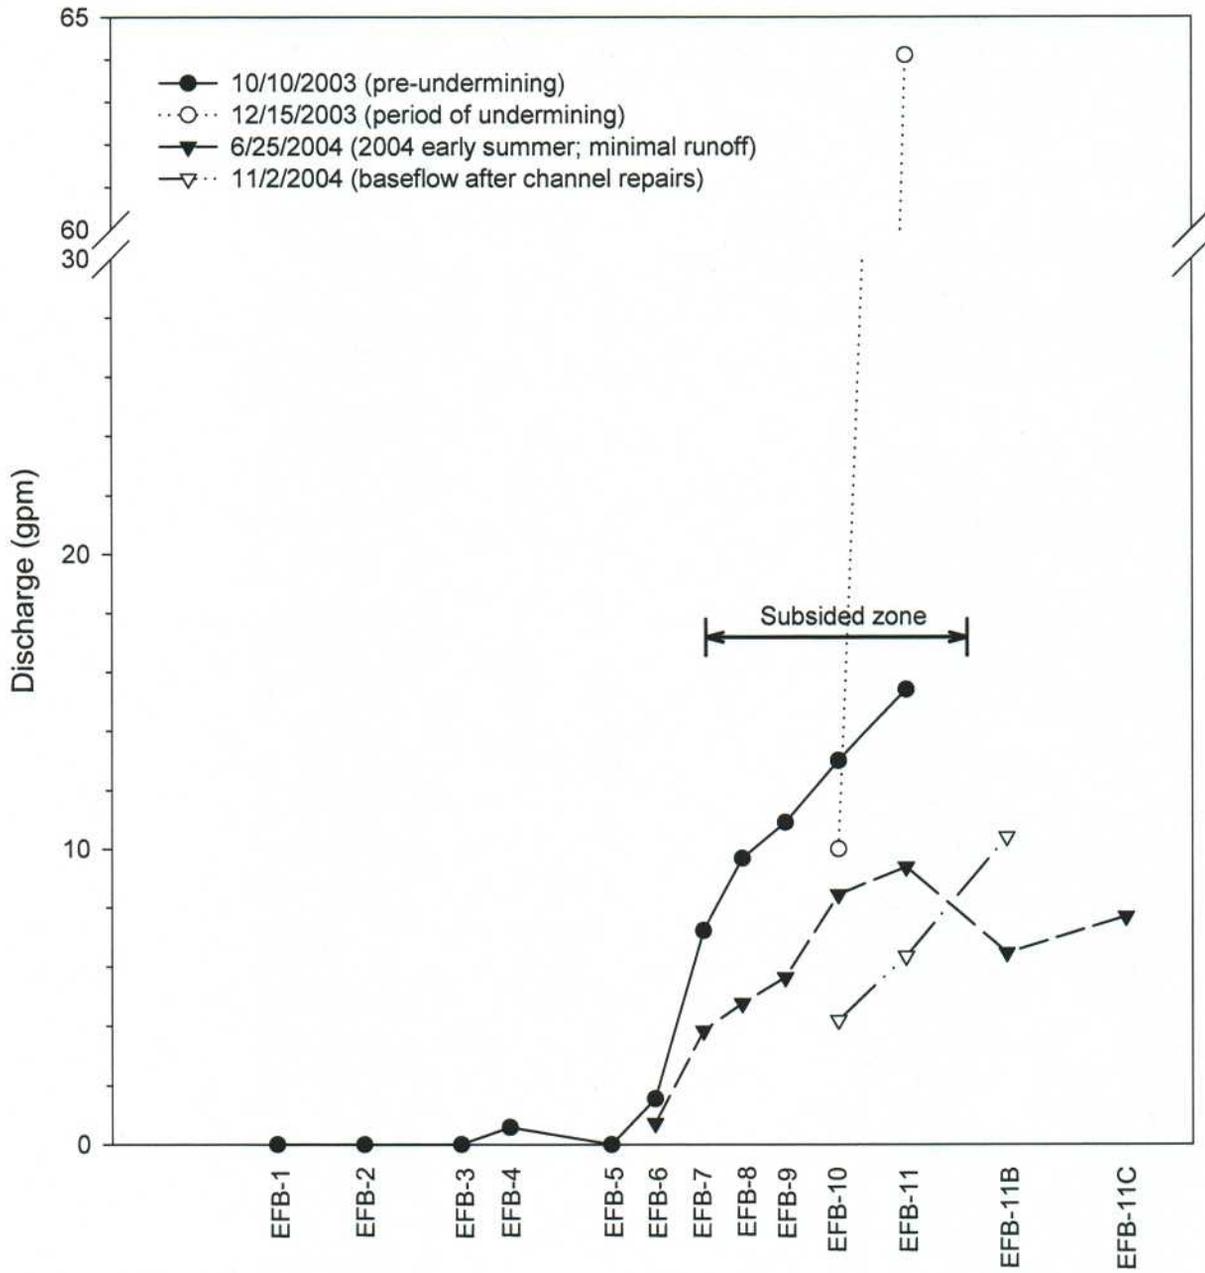
Figure 4 Plots of discharge from East Fork of Box Canyon Creek monitoring sites.

Note: Discharge data from EFB-11A not shown on graph.
