Re: 2006 Annual Report for Canyon Fuel Company LLC, SUFCO Mine
C/041/002, Sevier County, Utah

2006 ANNUAL REPORT

CANYON FUEL COMPANY, LLC SUFCO MINE ACT/041/002

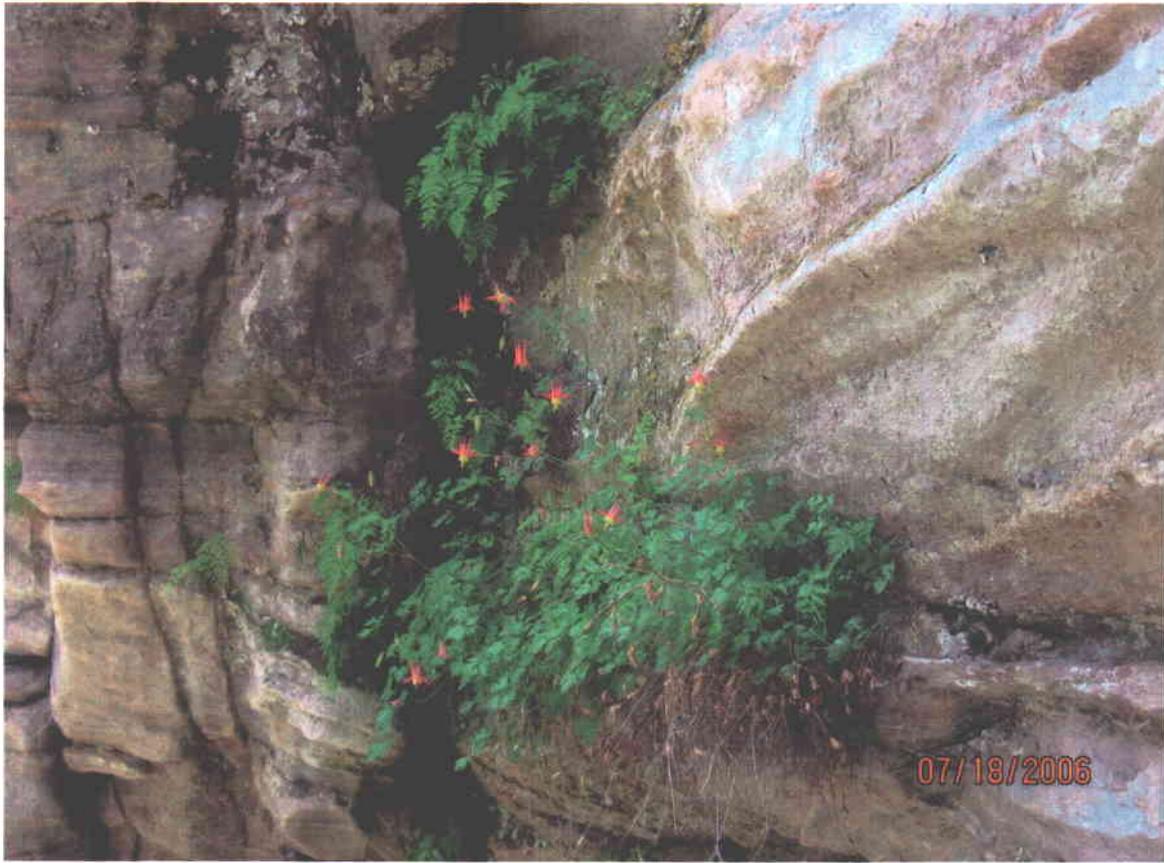
Photo Point 1a

At photographic point 1a there is still one columbine plant with several inflorescences stems ranging from 18 to 24 inches in length. This plant has good vigor and is growing out of a rock fracture and is probably getting moisture from the fracture.

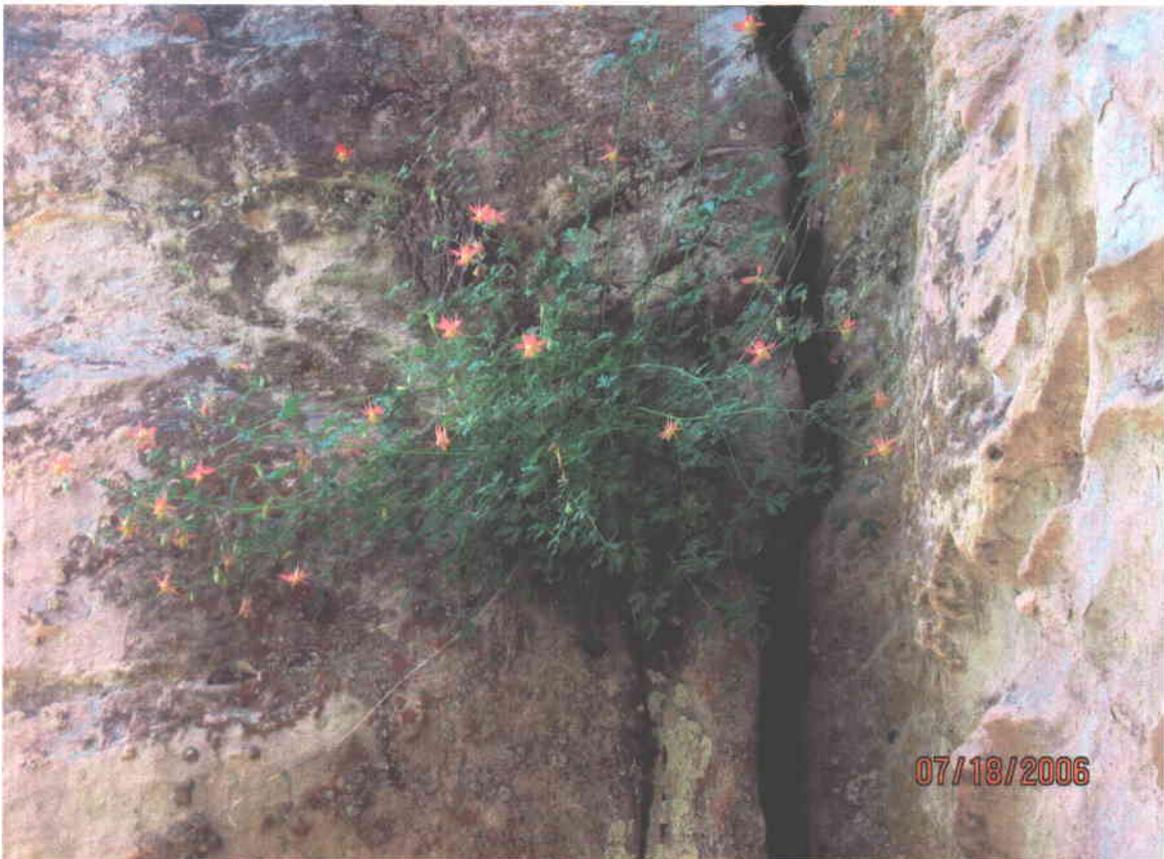
Photo Point 1b

At photographic point 1b there are two columbine plants in bloom. The inflorescence is 24+ inches in length. These plants have good vigor and are also growing out of a rock fracture and are probably getting moisture from this fracture.

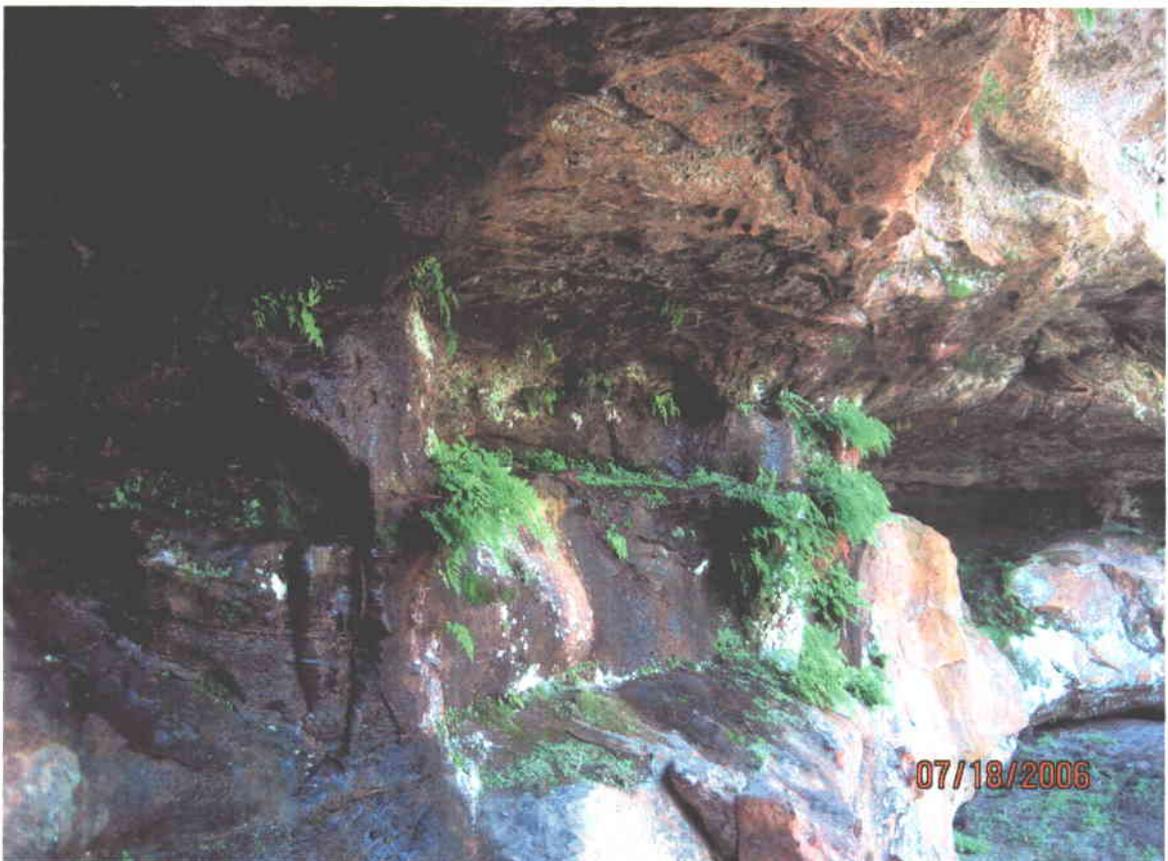
Photo Point 8

At photographic point 8 there is moisture coming from the fractures in the cliff face. The ferns appear to be increasing in density and have a vegetative growth of 5-10 inches in length. There appear to be many new small fern and lichen plants. There are no dead fern plants.

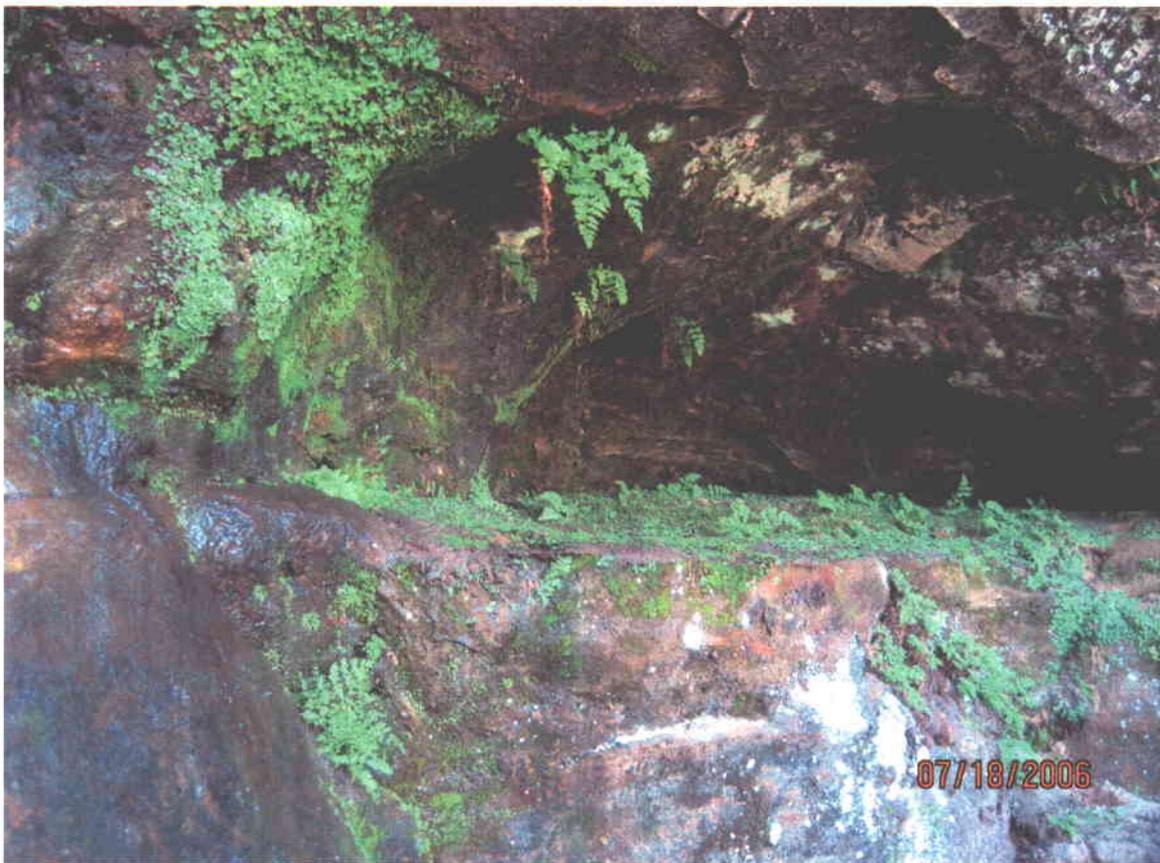
Photo Point 9a

At photographic point 9a there is moisture coming from the fractures in the cliff face. The ledge at this site is almost completely covered with lichens. The ferns have a good growth of 4 inches. There are no dead fern plants.

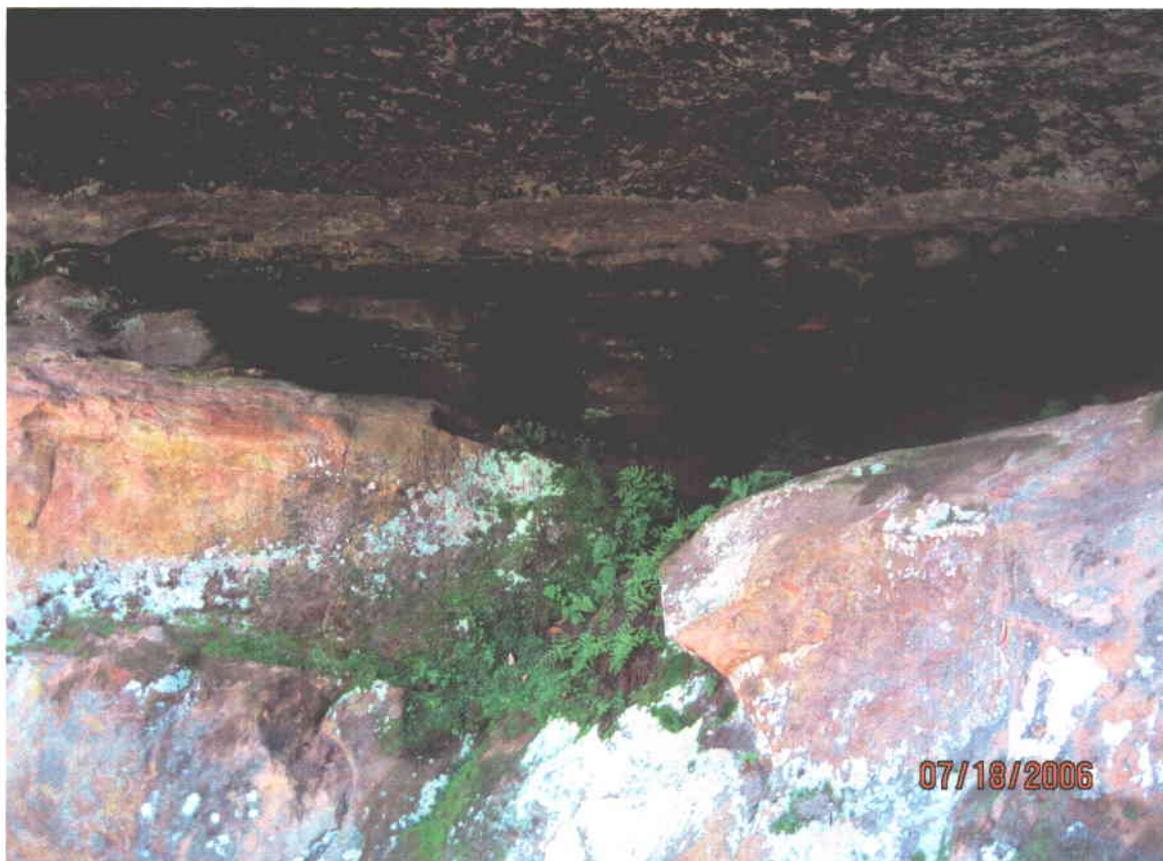
Photo Point 9b

At photographic point 9b there is moisture coming from the fractures in the cliff face. There is good lichen growth and an increase in density of the ferns. The ferns have a vegetative growth of 4-7 inches.

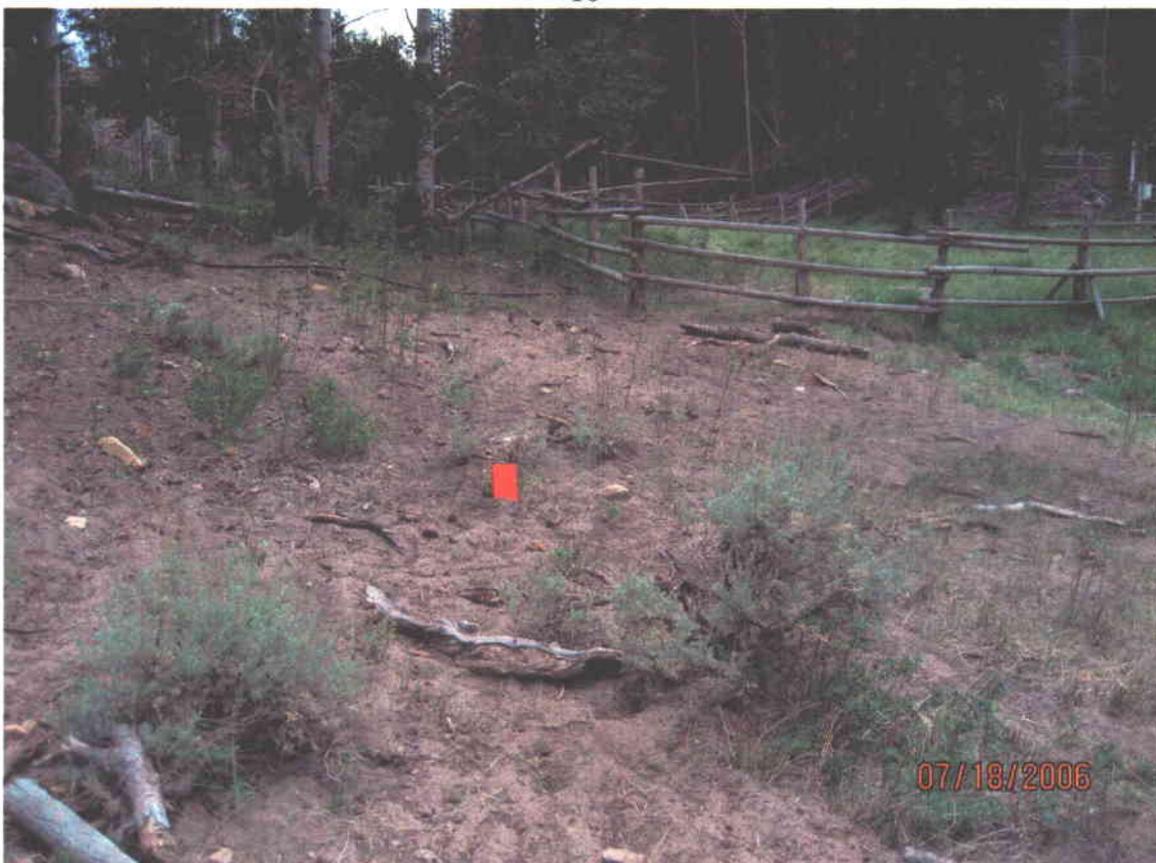
Photo Point 10

At photographic point 10 the site is originally a dry meadow site. It has been heavily grazed. All the new twig growth of the Aspen has been grazed off. Woods Rose has no flowers and all of the new growth grazed off. Sagebrush has not been grazed and has 4-5 inches of new growth. There are a few scattered *Juncus* plants that are 4-6 inches in height with no seed heads. All grass species have been grazed to ground level and show no regrowth. Ocular estimates show the site to have 50-60% bare ground. The adjacent moist riparian area has been heavily grazed but has good regrowth of the *Carex* plants, which have a 8-10 inches of regrowth. The soil in this area is dry and if the Spring 105 continues to not flow, it will have effects on this riparian area.

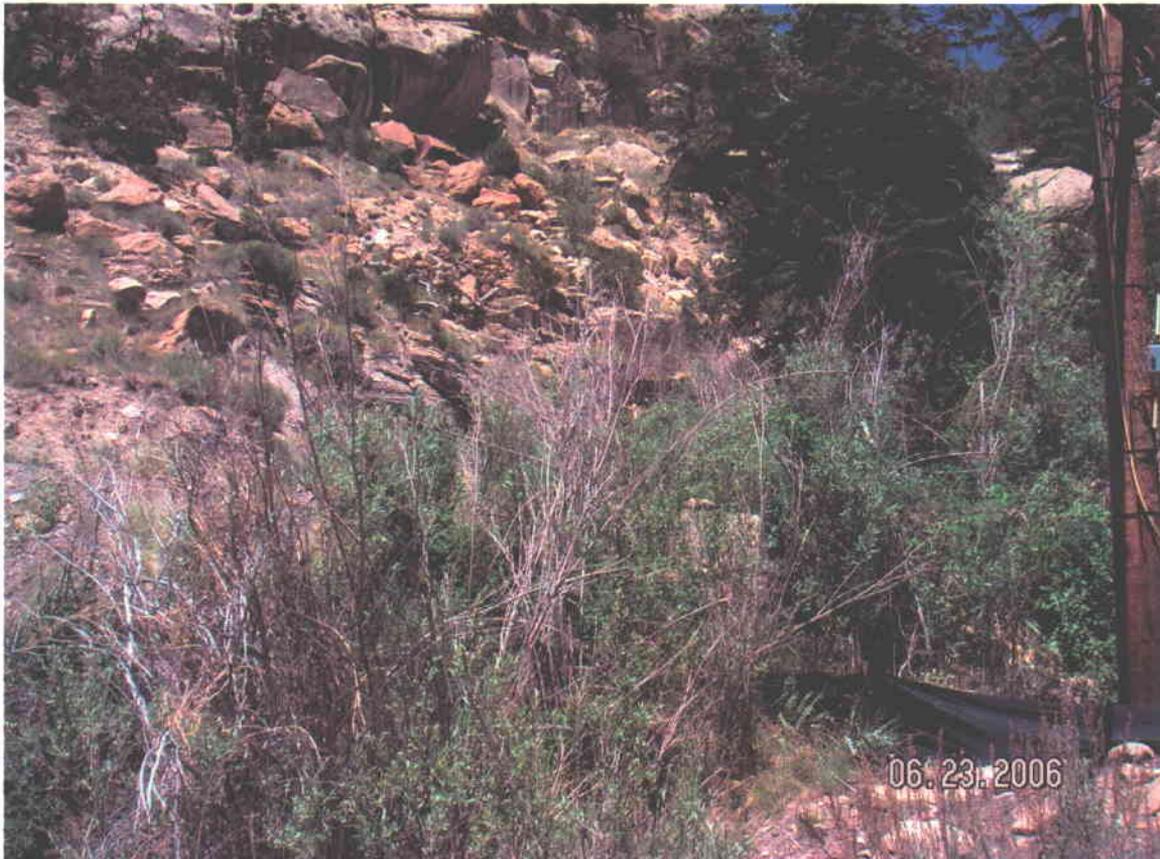
Link Canyon West Portal photo Point

There is no water discharge from this portal and no evidence that there has been any. The Willow (*salix spp.*) is in the late bloom stage. There are insect galls on many of the seed heads. The current new growth is 2-4 inches. There doesn't appear to be any new dead Willow plants. Wood Rose (*Rosa woodsii*) has bloomed and has set seed. It has 4-6 inches of new growth. Bluegrass (*Poa pratensis*) density is down considerable from last

year. The plants that are there only are in the 3-4 leaf stage and have very few seed heads. The density of wiregrass (*Juncus balticus*) is approximately half of that of last year. The height of the wiregrass is 10-12 inches with some seed heads. Clematis (*Clematis ligusticifolia*) has good growth and good vigor. The squawbush (*Rhus aromatica* var. *trilobata*) has bloomed and set seed and has 6-8 inches of new twig growth.

The overall growth and vigor at this portal area is not as good as last year. This is probably due to a combination of factors—1) The continued airflow from the mine discharge fan, 2) The difference in rainfall between the two years and 3) no moisture being discharged from the portals.

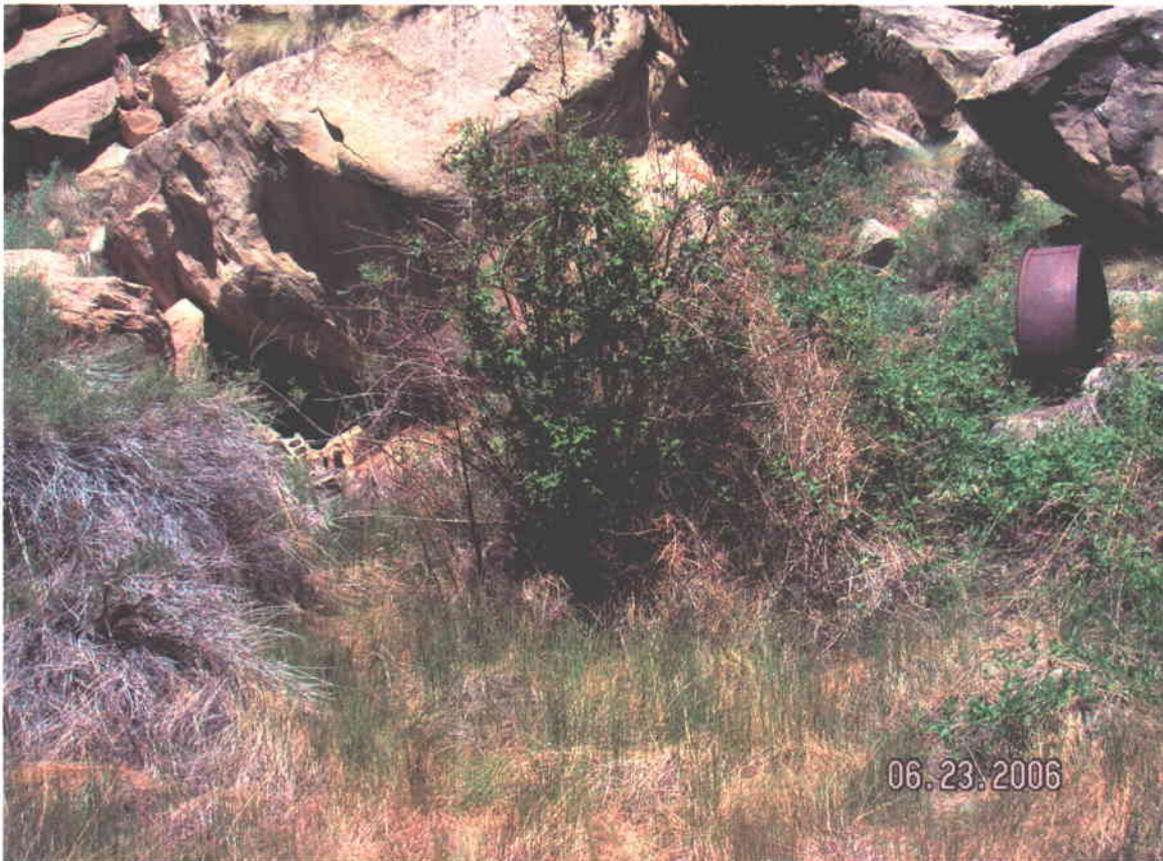
Link Canyon East Portal Photo Point

There has been no discharge from this portal and the area is dry. The density of the plants is significantly lower than last year. The Dogwood bush (*Cornus stolonifera*) has some additional die back from last year. It has bloomed and set seed. It has 1-2 inches of new twig growth. Land the vigor is considered fair. The Clematis growth is good with good vigor. The gooseberry plant has new growth of 4-6 inches. The density of the wiregrass is about 50% of last year with an average height of 1-12 inches with very few seed heads. The vigor of the wire grass would be considered poor. There are very few bluegrass

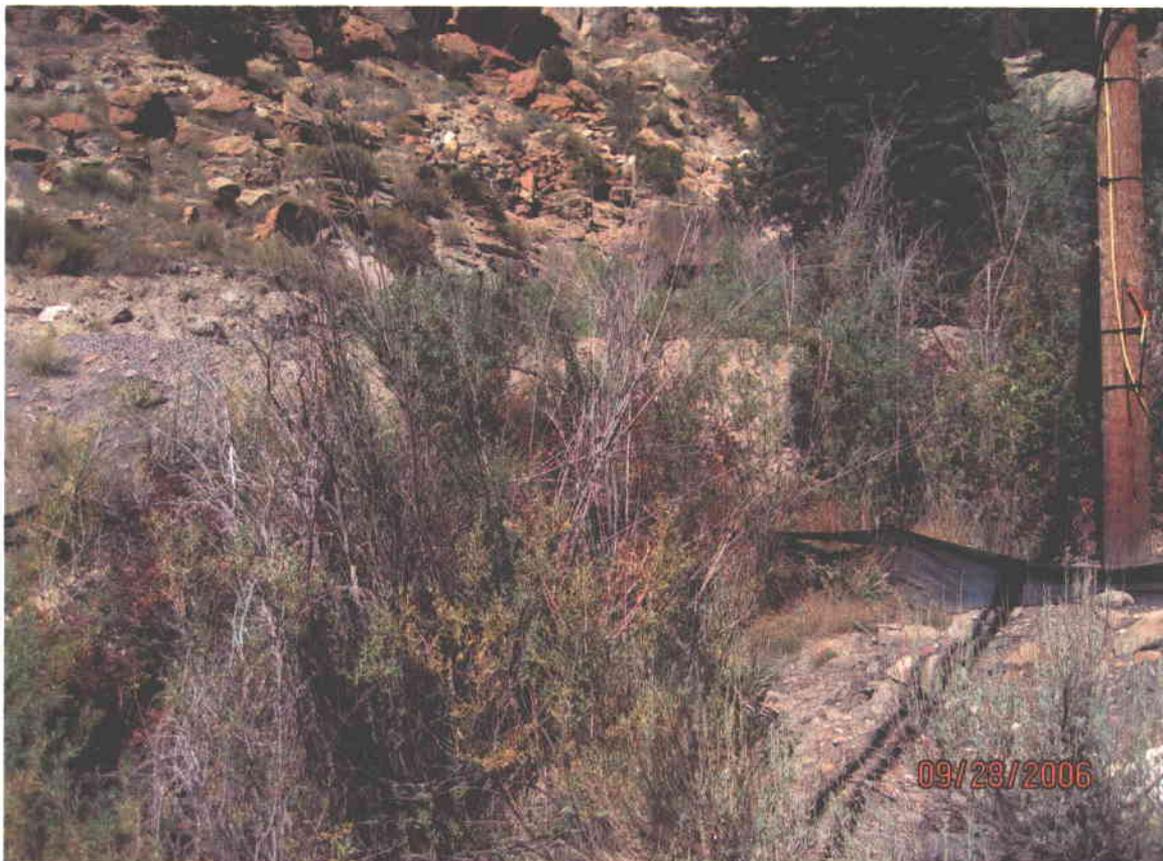
Link Canyon West Portal photo point

There is no water discharge from the West portal and there is no evidence that there has been any. The Willow (*Salix spp.*) has a current new growth

of 6-10 inches. There is no evidence of the insect galls that were present earlier this spring. It does appear that there is some additional new dead wood on some of the plants. Woods Rose (*Rosa woodsii.*) has some viable seed with a current growth of 4-6 inches. The amount viable seed is not as much as what you would expect to see. The Bluegrass (*Poa pratensis*) has poor density with 4-6 inches of leaf growth with very few seed heads. The density of wire grass (*Juncus balticus*) seems to be a little better than what it was in June, but still is only fair. The wiregrass has a current growth of 12-14 inches with very few seed heads. The Clematis (*Clematis ligusticifolia*) has good growth with fair seed production. The squawbush (*Rhus aromatica var. trilobata*) has good growth of 6-8 inches of current growth. There are no seeds left on the plant. The site continues to be very dry and the overall condition of this site appears to be in a downward trend.

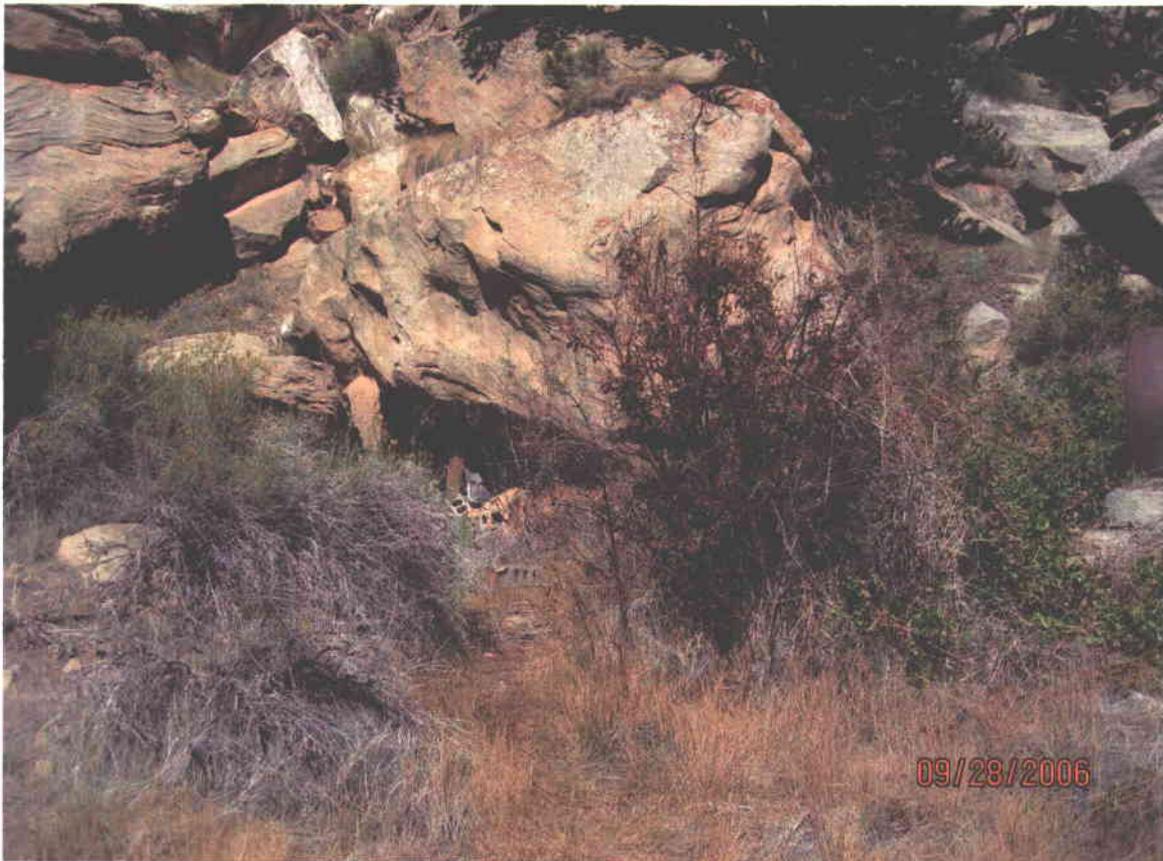
Link Canyon East Portal Photo Point

There is no water discharge from the East portal and the site continues to be very dry. The density of the vegetation continues to be only fair and appears to be declining. The Dogwood Bush (*Cornus stolonifera*) has some additional die back. There is no current terminal bud growth and all of the current growth of 3-4 inches is from lateral buds. There is no seed on the plant. The vigor of this plant is poor. The Clematis (*Clematis ligusticifolia*) has good growth but has very few seed heads. The Gooseberry (*Ribes spp.*) has a current years growth of 12-14 inches but there is no seed present on the plant. The wiregrass (*Juncus balticus*) has current growth of 14-16 inches with very few seed heads. The density is only fair. The Bluegrass (*Poa pratensis*) has a current growth of 4-6 inches with very few seed heads. The Willow (*Salix spp.*) has 7-10 of new growth. There is some additional dead wood on the willow plants. The Rabbitbrush (*Chrysothamnus nauseosus*) has 8-10 inches of new growth. There is some dead wood at the base of the plants. The Rabbitbrush plants are all in bloom. Overall this site appears to be in a downward trend.

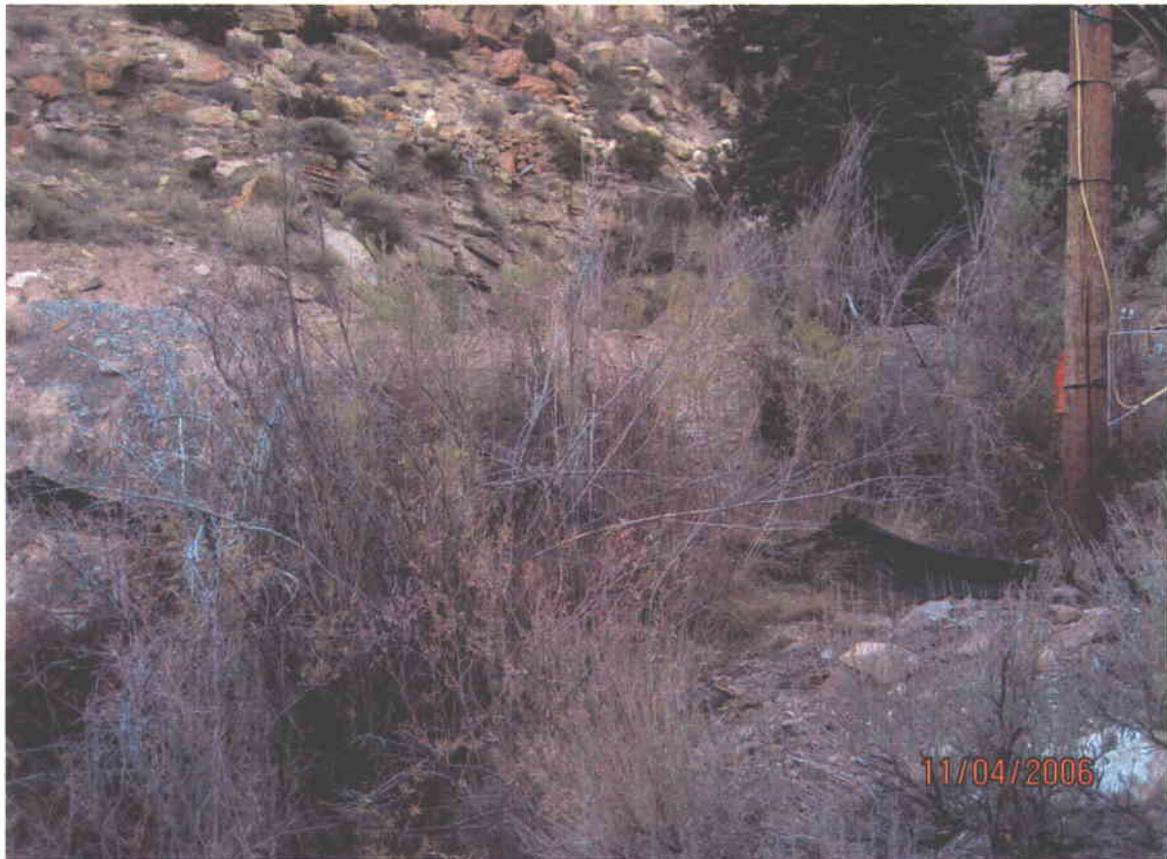
West Portal Area

The majority of the leaves have fallen although there are a few still persisting on some plants. No significant vegetative changes have taken place since the last pictures were taken in September 2006.

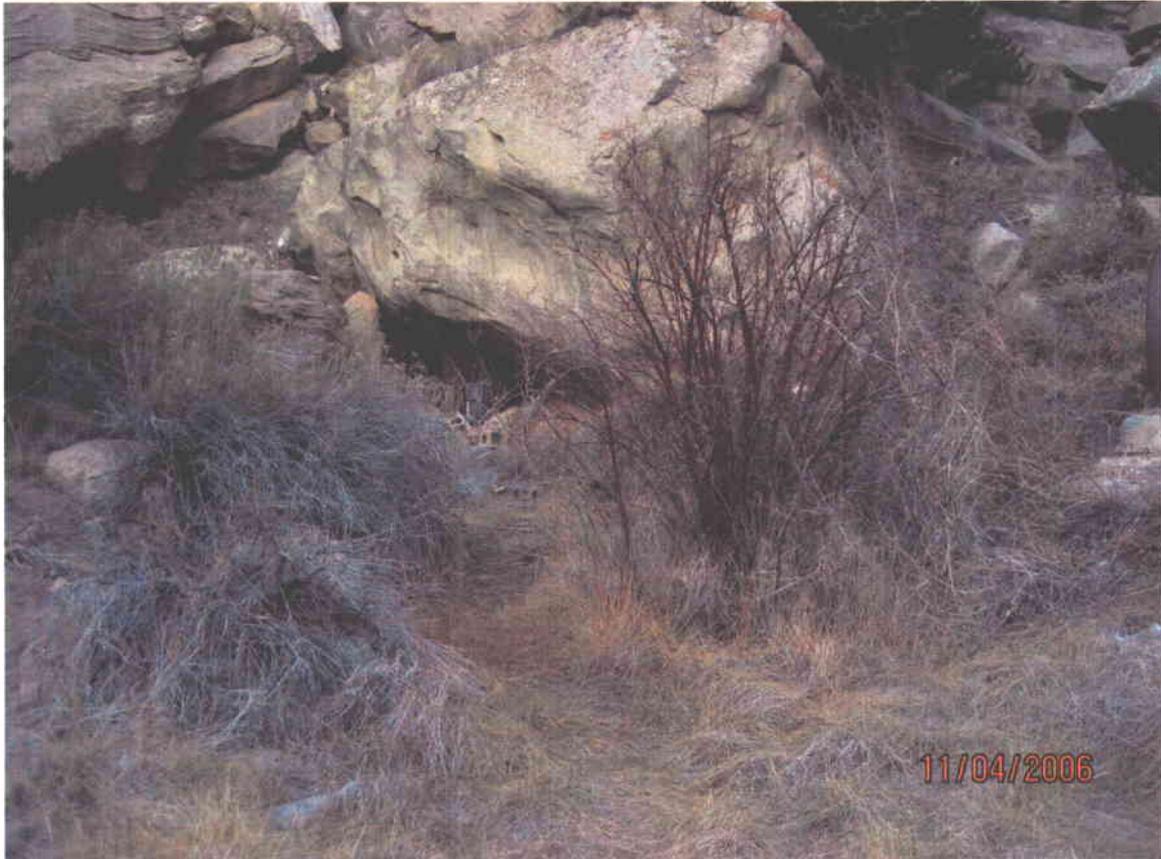
East Portal Area

Leaf fall is complete except for the Rabbitbrush and Sagebrush plants. There have been no significant vegetative changes since the last photographs were taken in September 2006.

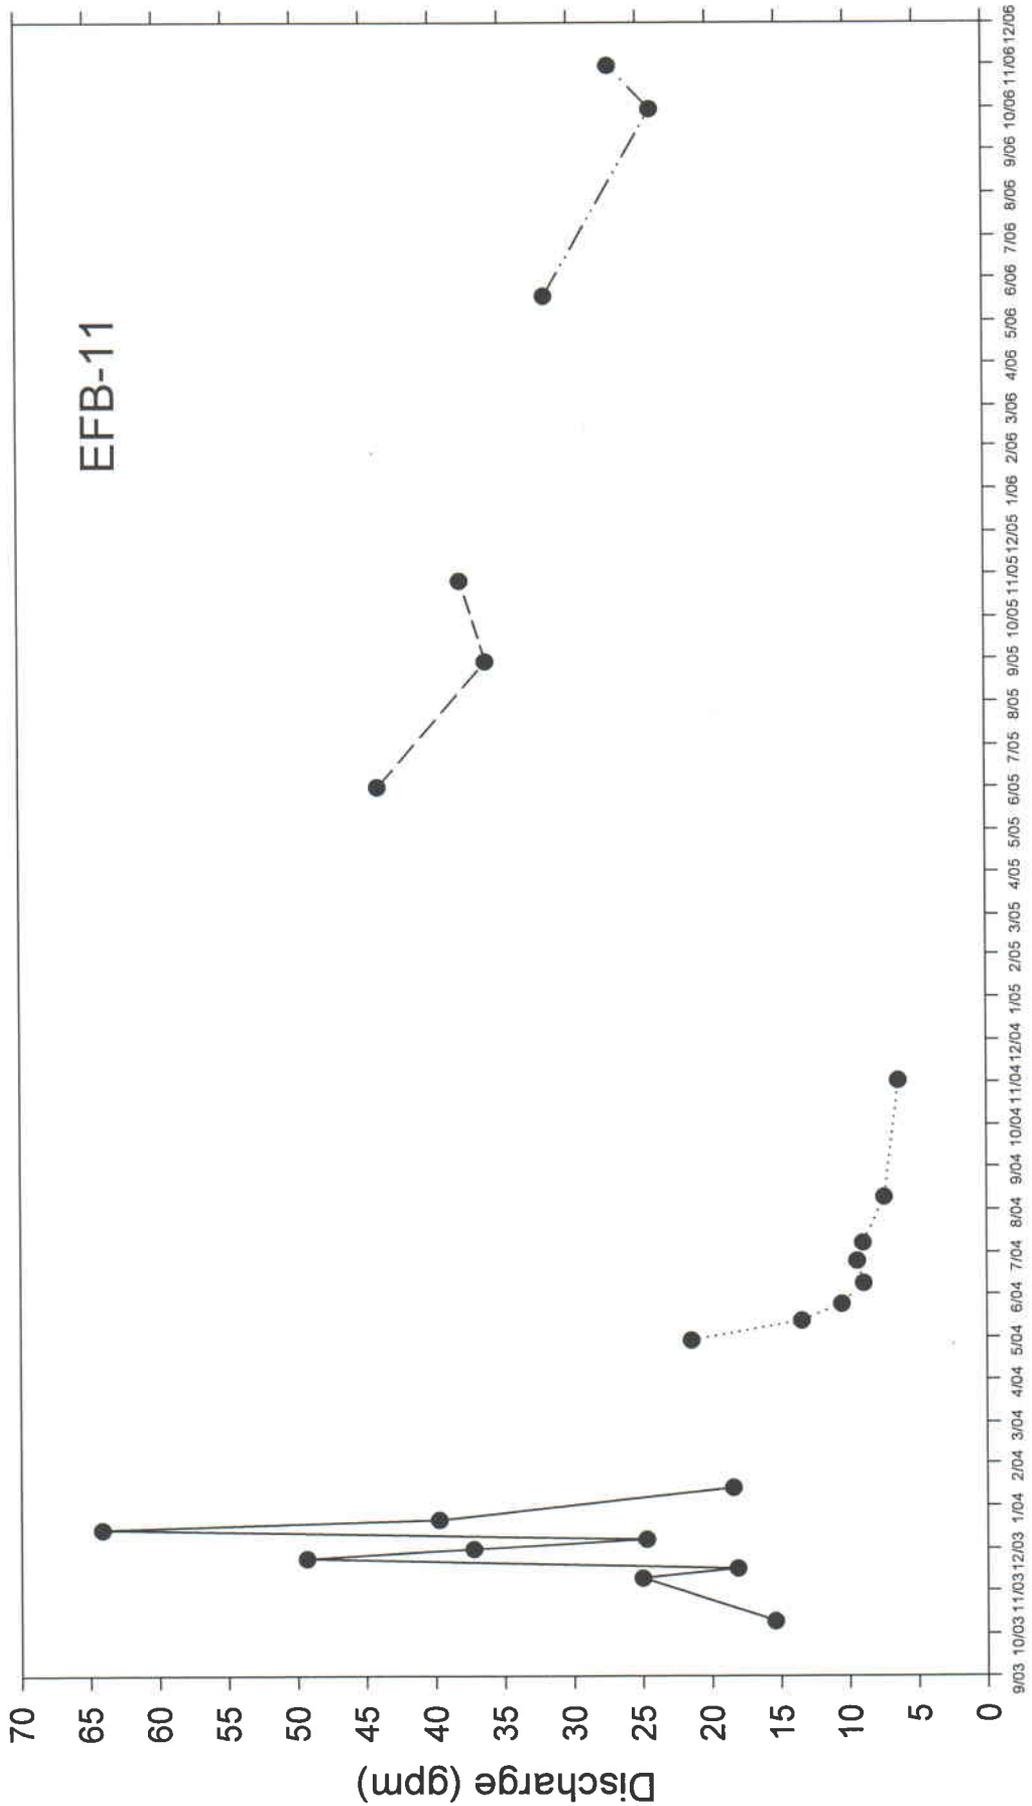
Figure 3 Discharge in the East Fork of Box Canyon Creek at monitoring station EFB-11.

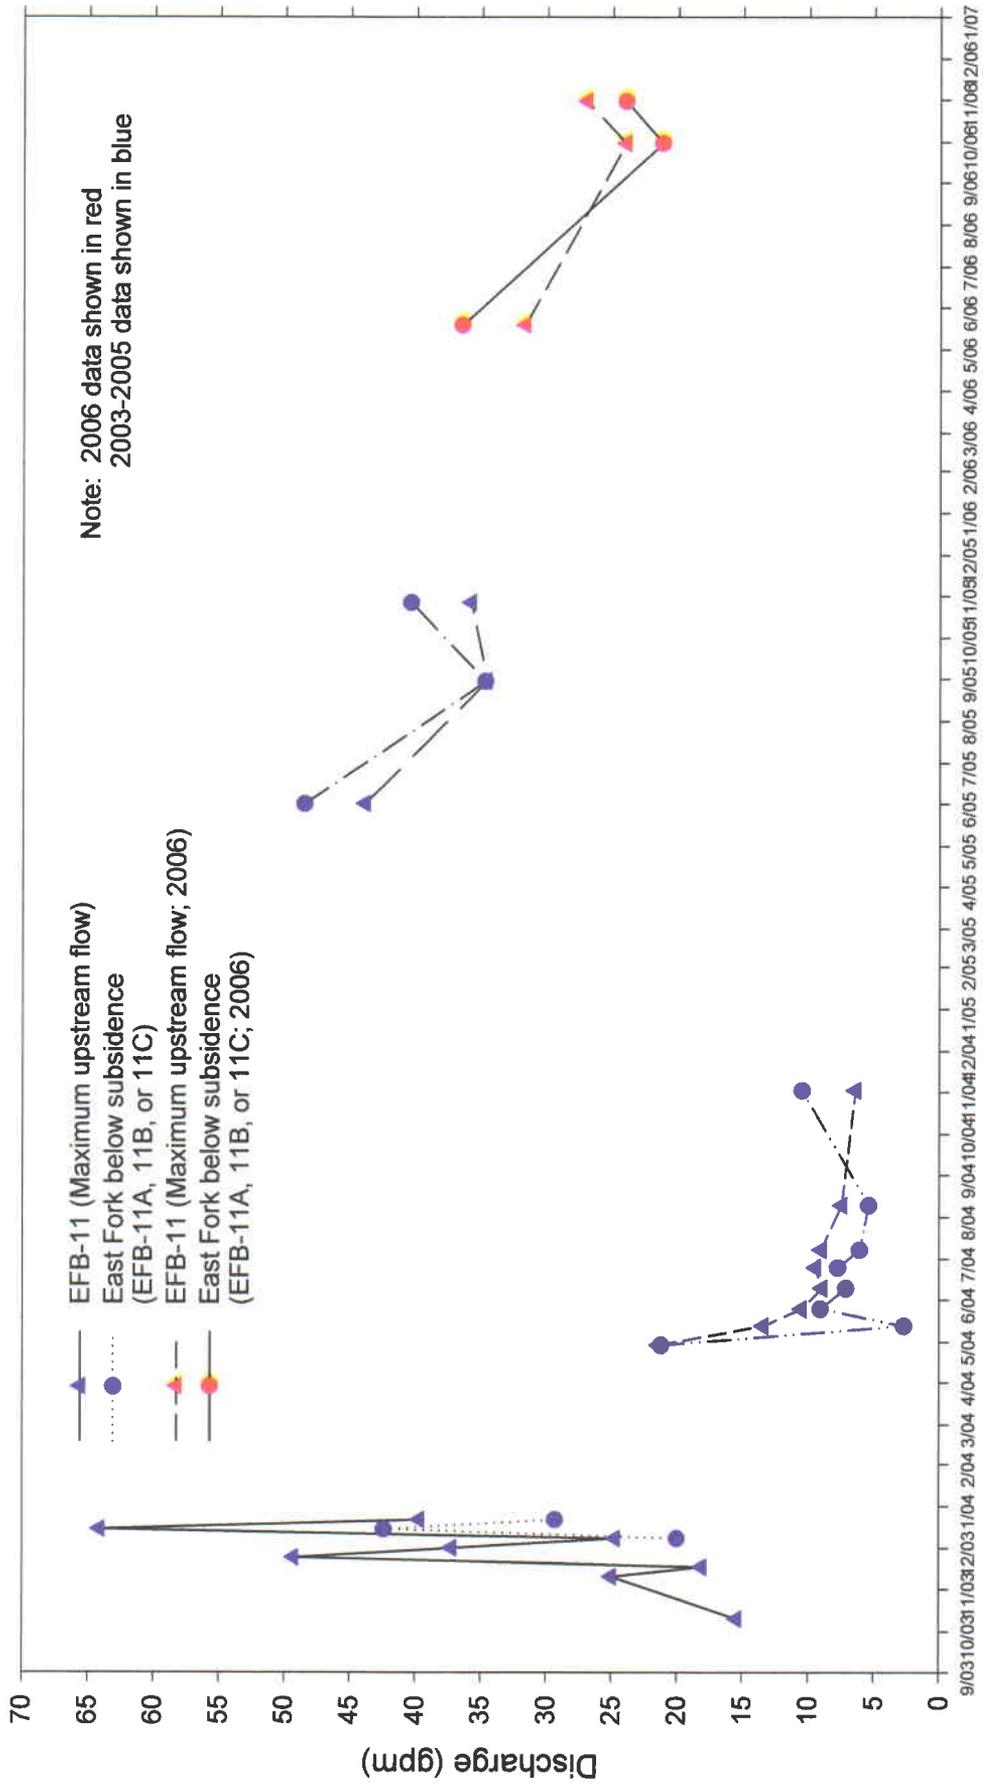
Figure 4 Comparison of maximum discharge in the East Fork of Box Canyon Creek

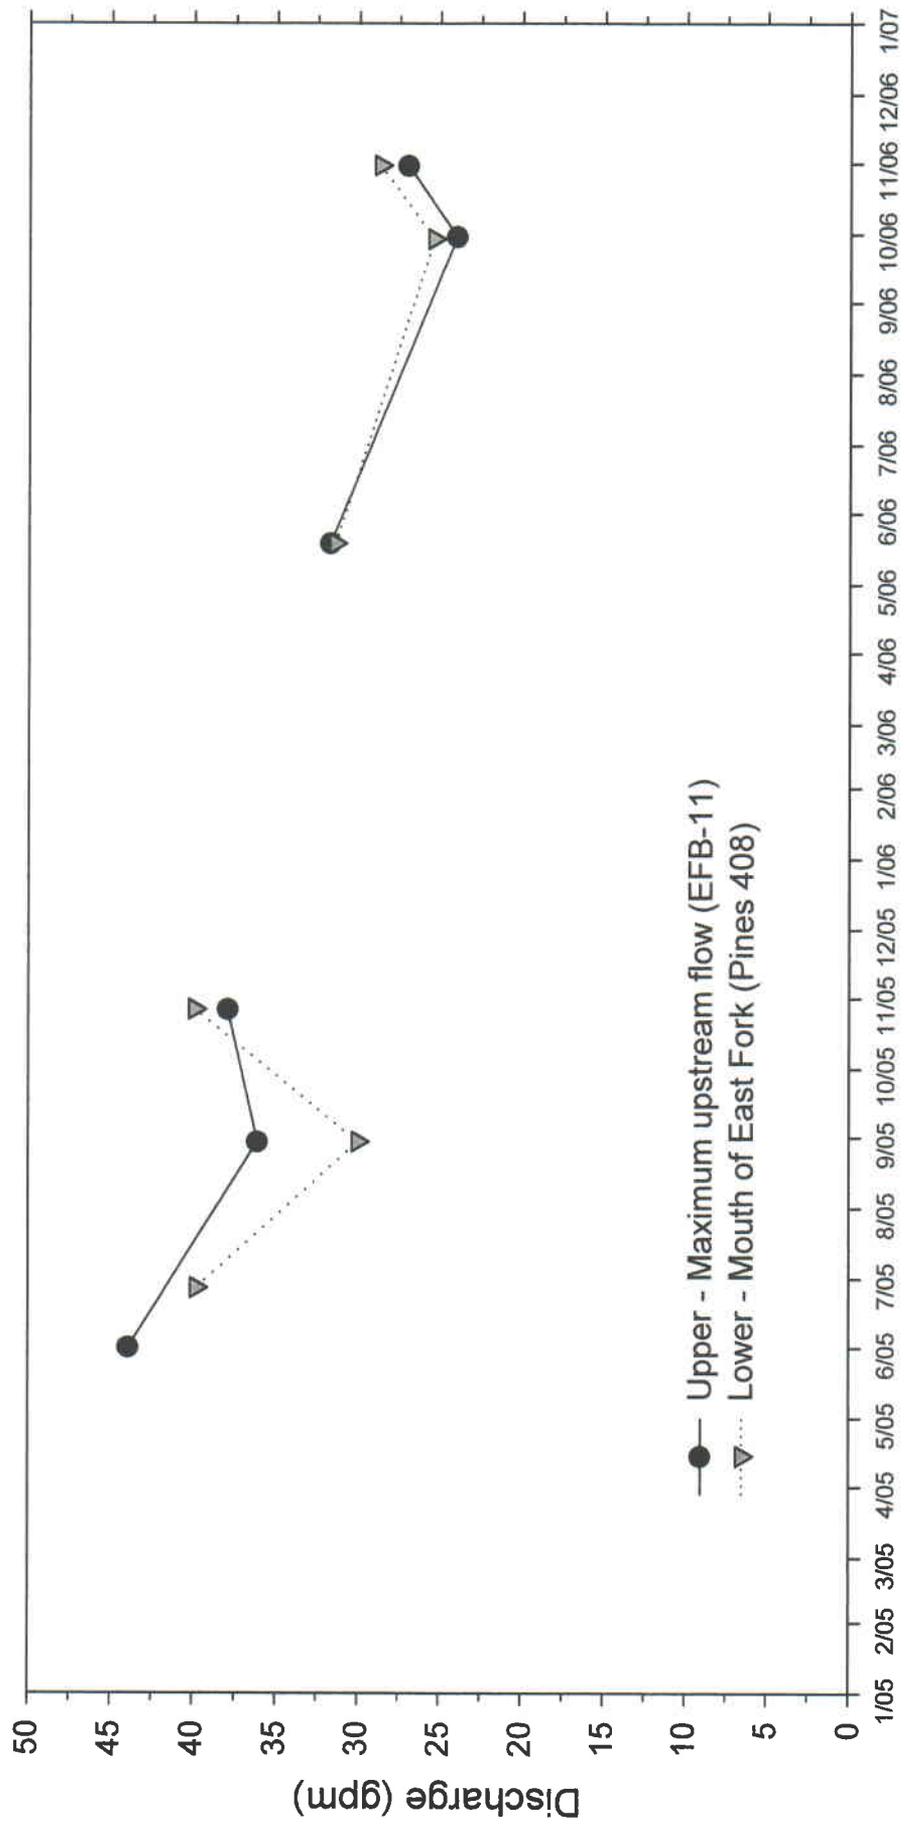
Figure 5 Comparison of maximum upstream flow in the East Fork of Box Canyon with discharge at the lower mouth.

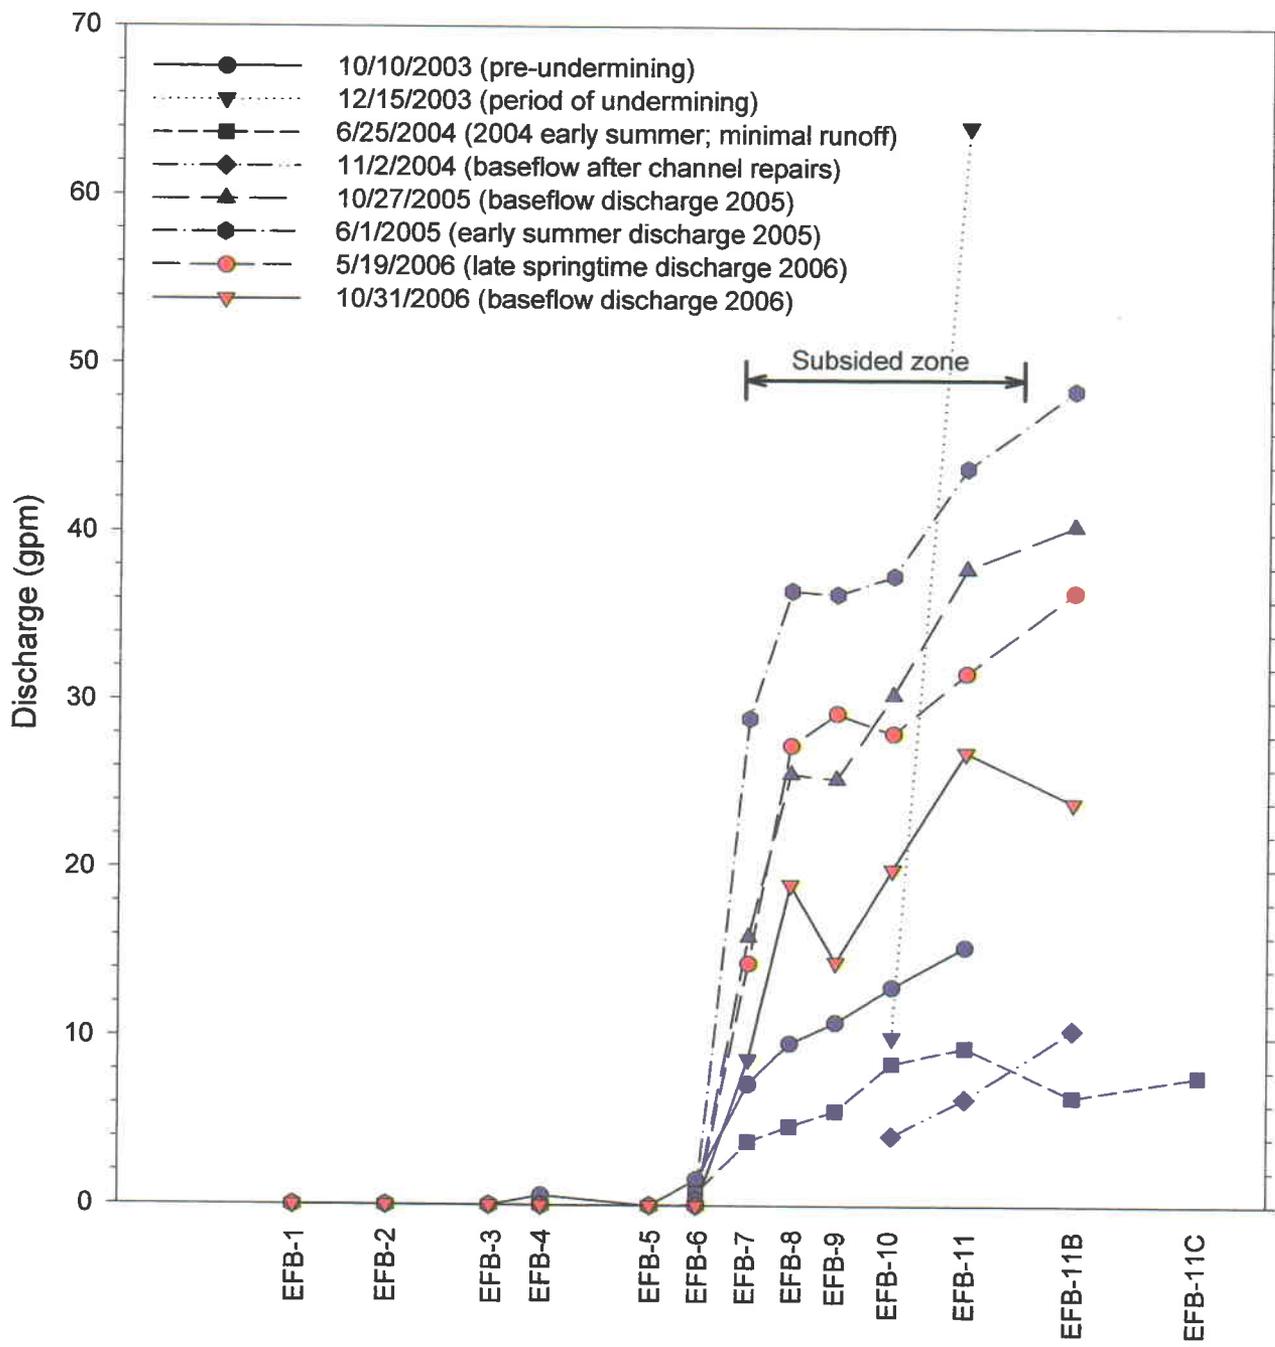
Note: 2005 data shown in red.
Discharge data from EFB-11A not shown on graph.

Figure 6 Plots of discharge from East Fork of Box Canyon Creek monitoring sites.

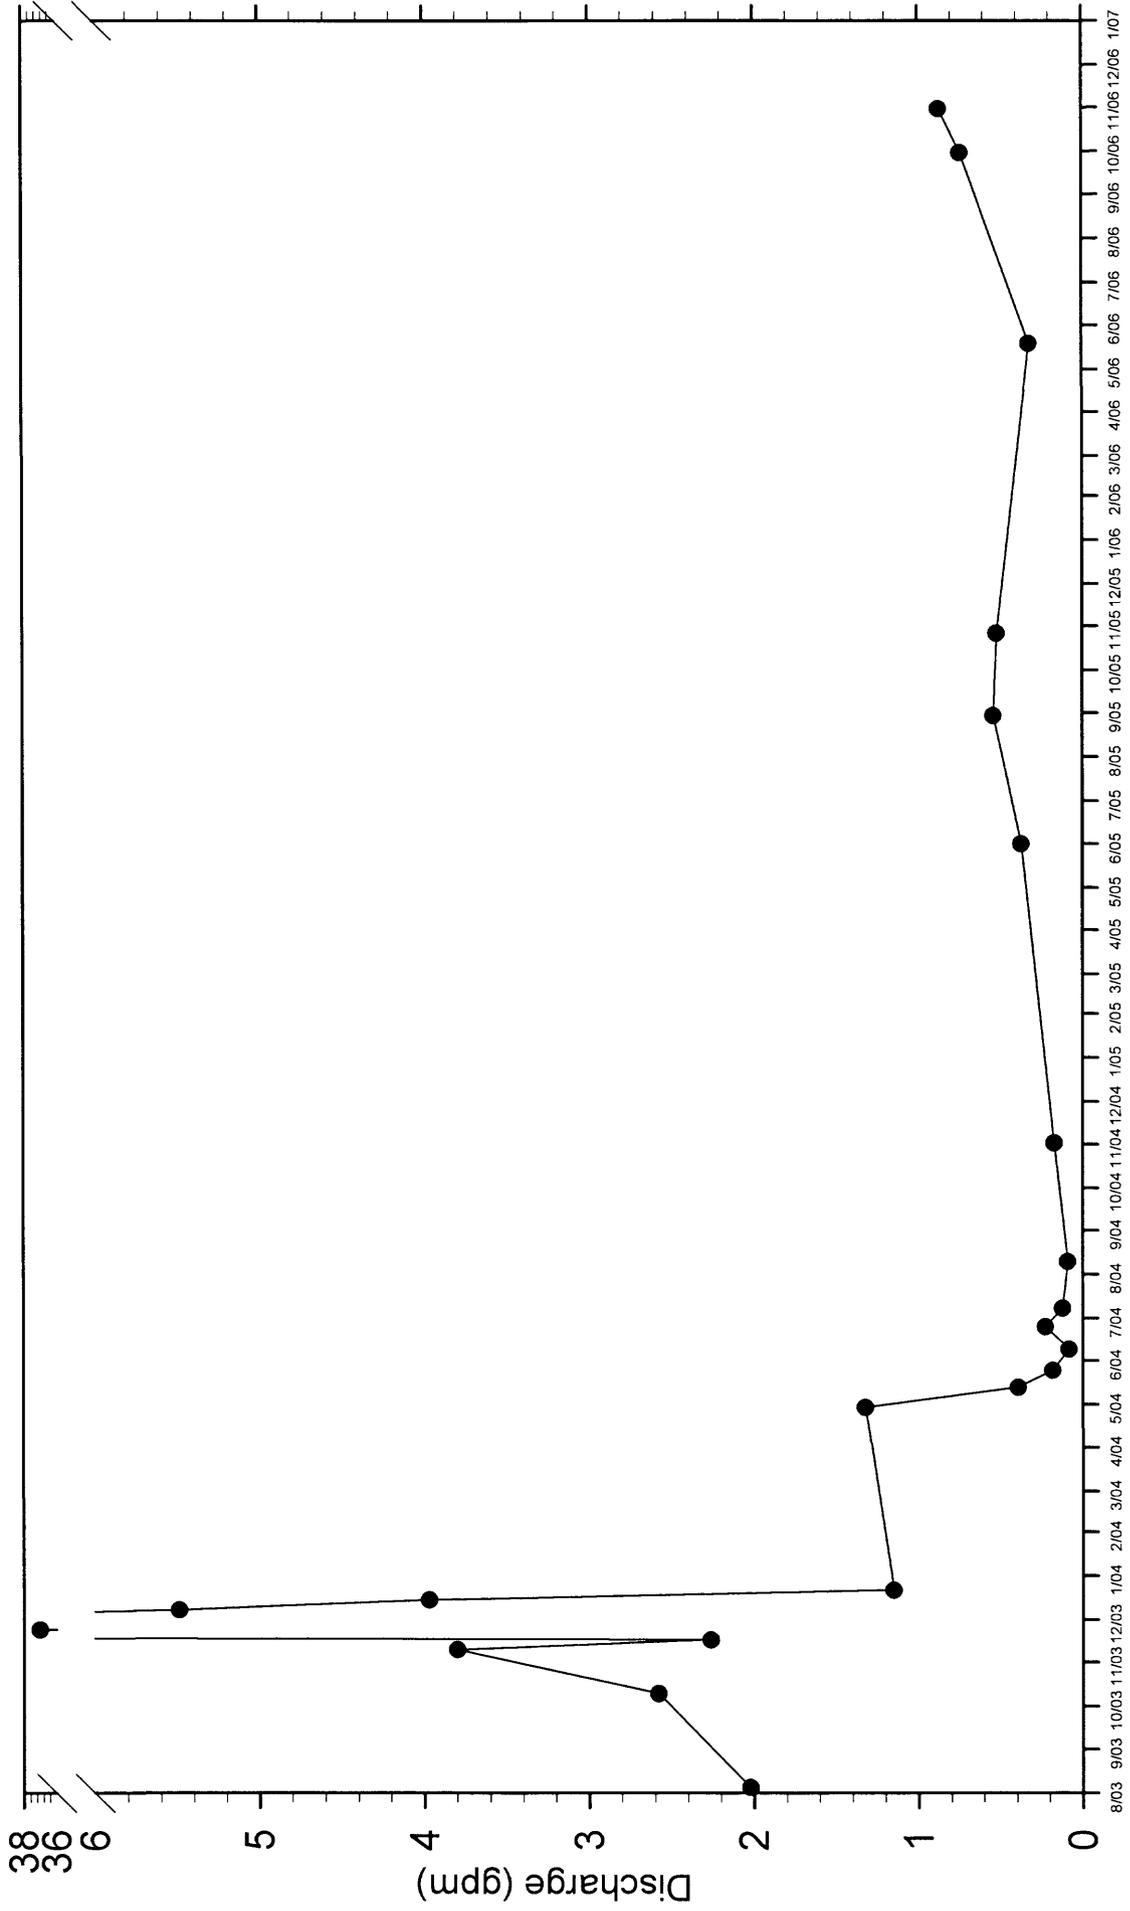
Figure 8 Discharge hydrograph for spring Pines 214.
