Re: 2006 Annual Report for Canyon Fuel Company LLC, SUFCO Mine
C/041/002, Sevier County, Utah

2006 ANNUAL REPORT

CANYON FUEL COMPANY, LLC SUFCO MINE ACT/041/002

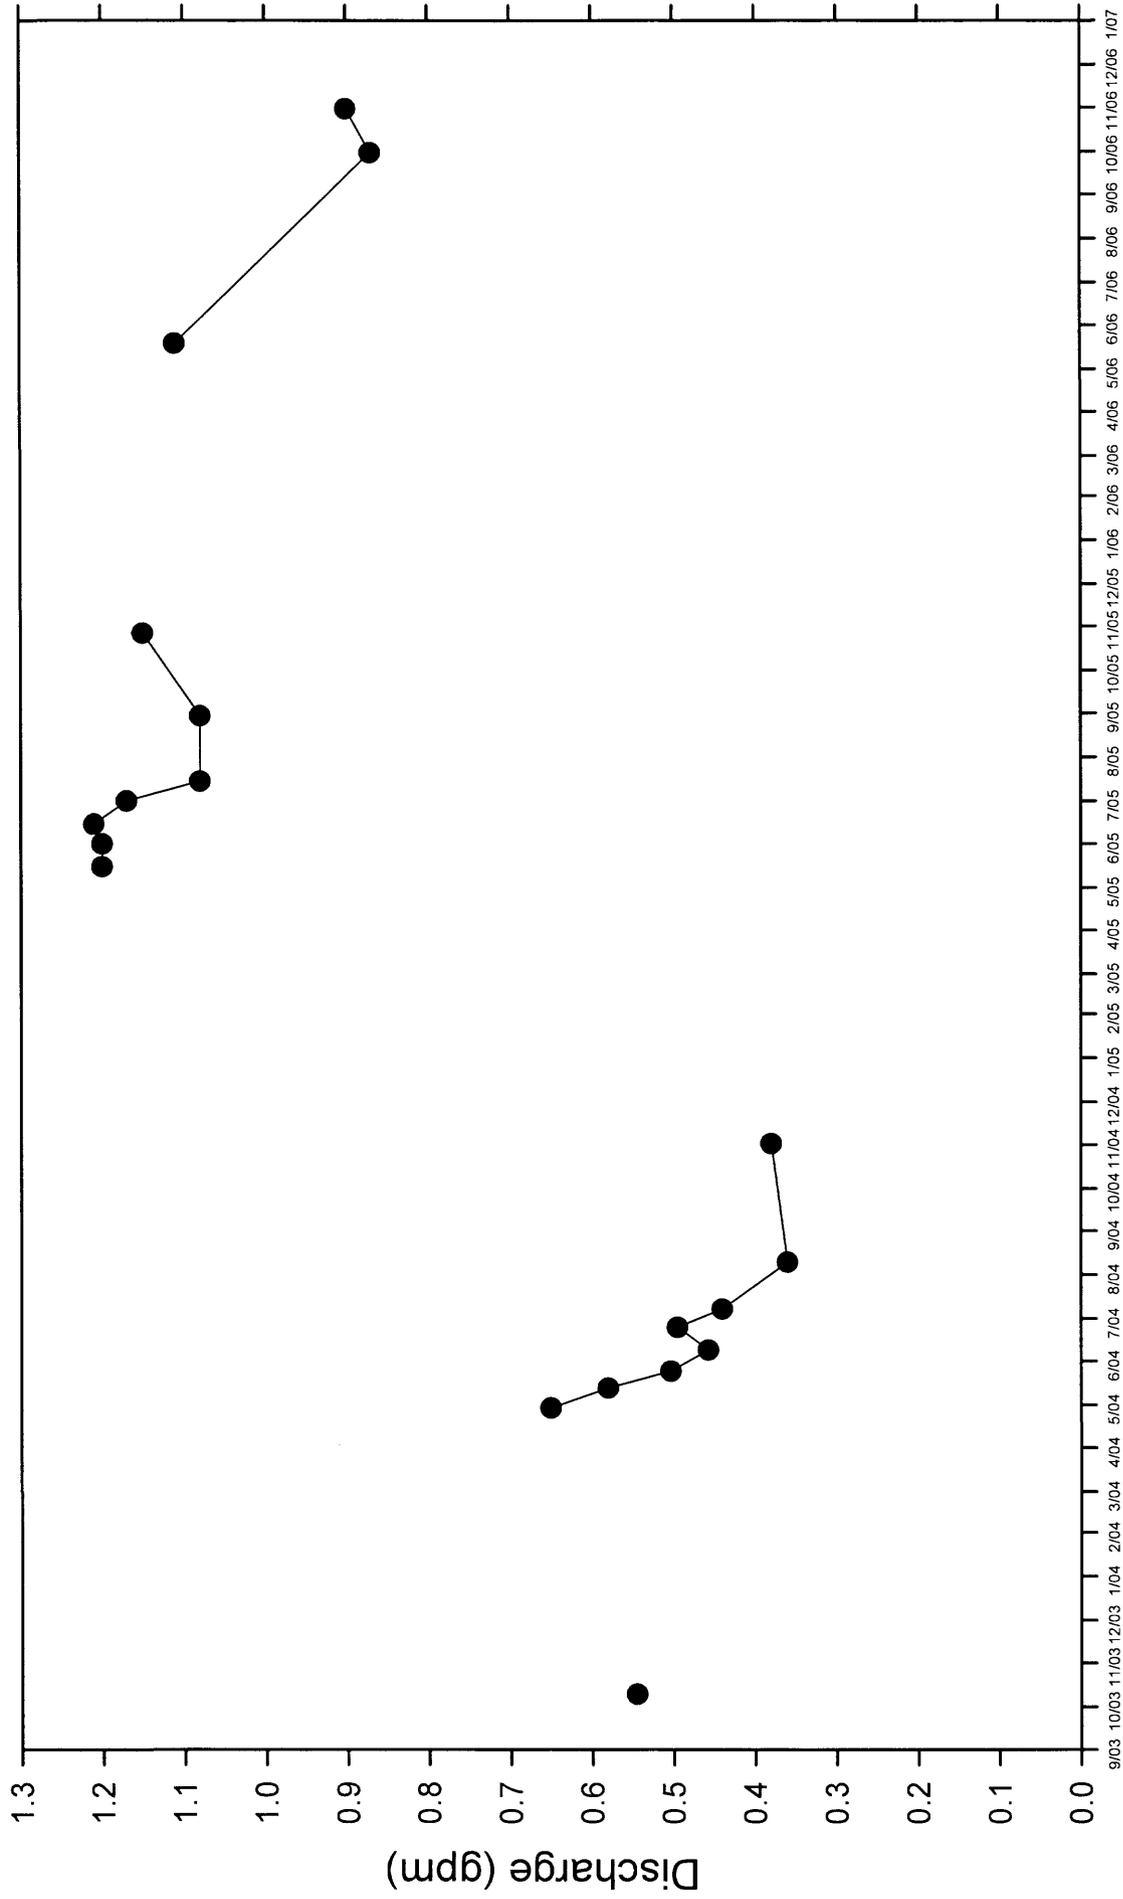
Figure 9 Discharge hydrograph for EFB-8 spring.
