LINK CANYON MINE PORTAL VEGETATION STUDY

Prepared by
Keith Zobell, Environmental Specialist
July 19, 2010

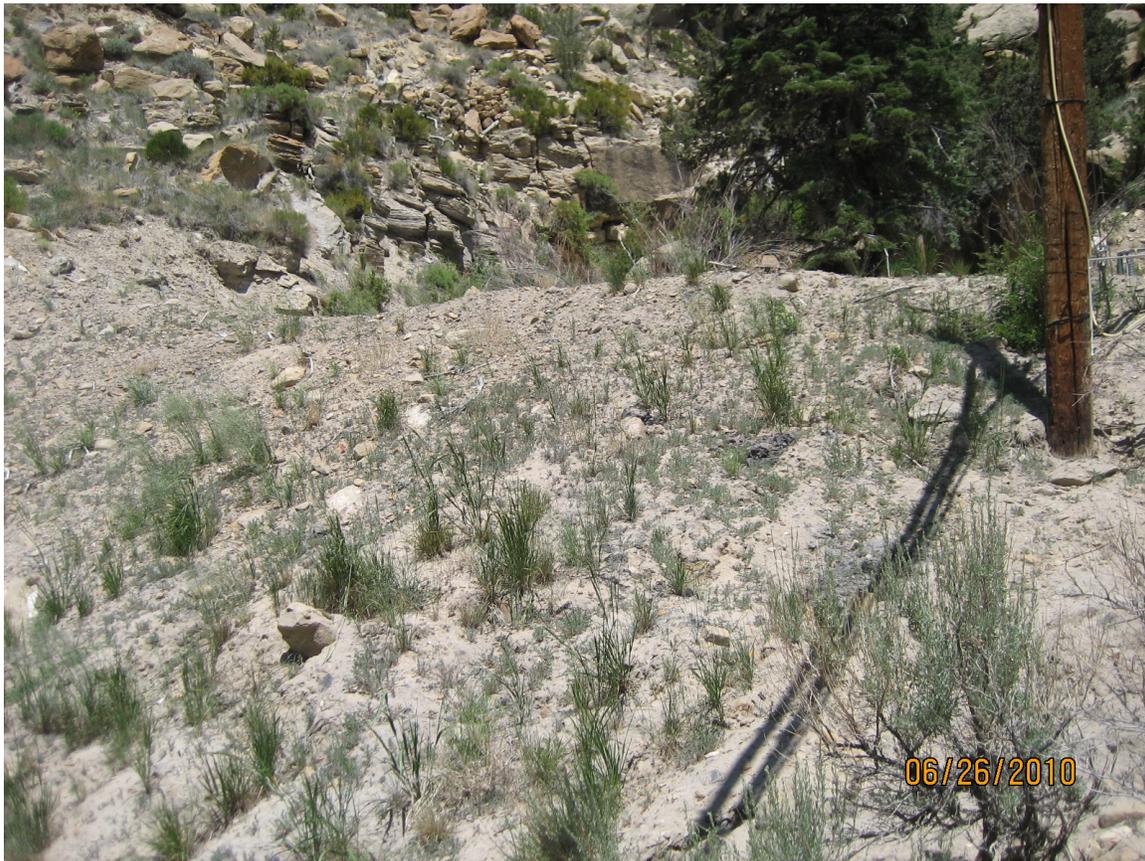
Link Canyon West Portal Photo Point

There is no water discharging from this portal and there is no evidence that there has been any this spring. There are numerous new plants now growing on the disturbed area. It is estimated that the site plant density is 30-35 percent plant cover.

The following plants were noted and measured on the site: (1) New Rabbitbrush plants (*Chrysothamnus spp.*) have a new average growth of 6 inches, (2) New sagebrush plants (*Artemisia tridentate*) have a new average growth of 7 inches, (3) New Crested

Wheatgrass plants (*Agropyron desertorum*) have some seed heads and new leaf growth of 6-8 inches, (4) New Great Basin Wildrye plants (*Elymus cinereus*) have some seed heads with new leaf growth of 24-30 inches, (5) New Slender Wheat grass plants (*Elymus trachycaulus*) have some seed heads with new leaf growth of 12-14 inches, (6) New Indian Rice grass plants (*Stipa hymenoides*) have multiple seed heads with new leaf growth of 12-14 inches, (7) Existing willow bush (*Salix spp.*) has some new shoots with new growth of 10-16 inches and has no insect galls, (8) Existing Squaw Bush (*Rhus aralmatica var. trilobata*) which has new growth of 3-4 inches,(9) Existing small Current Bush (*Ribes spp.*) has new growth of 3-4 inches, and (10) Halogeton (*Halogeton glomeratus*). Halogeton is an annual plant and is a noxious plant. There are numerous small plants on the site. These plants should be sprayed with a selective herbicide to control them. Caution should be taken to avoid spraying and getting over-spray onto other broad leaf plant such as the Willow, Sagebrush and Squaw bush. The selective herbicide will not kill the grass plants only the broad leafed plants.

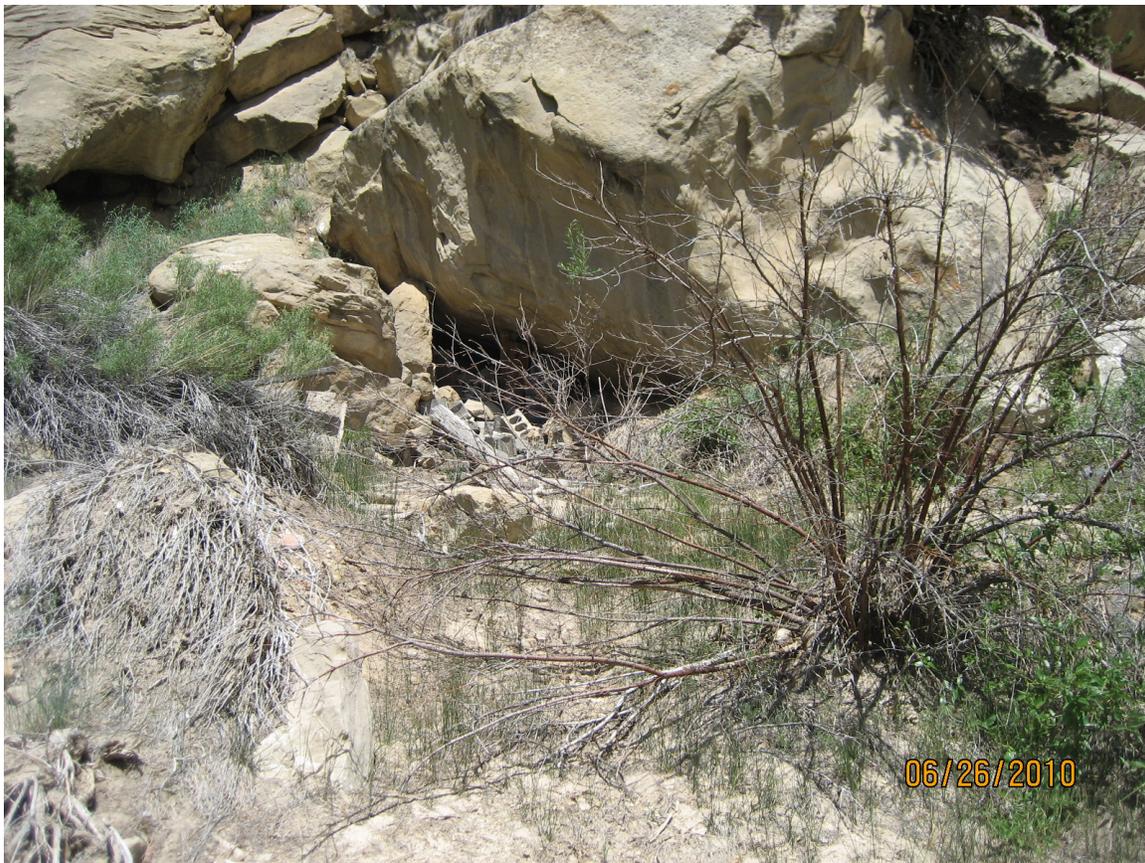
Link Canyon East Portal Photo Point

There is no water discharging from this portal and there is no evidence that there has been any this spring. There are a few scattered Bluegrass plants (*Poa pratensis*) which weren't evident last year. These Bluegrass plants have some seed heads which are 14 inches high and have 4-6 inches of new growth. There is some Cheatgrass (*Bromus tectorum*) plants invading the site and these plants have 12 in long seed heads. There is one Indian Ricegrass plant (*Stipa hymenoides*) that has invaded the site. This plant has numerous 14 inches seed heads. The Wiregrass (*Juncus spp.*) is increasing in density and has 12-14 inches of growth. There are some new Rabbitbrush plants (*Chrysothamnus nauseosus*) showing up on the site, and these plants have 5-6 inches of new growth. The Dogwood Bush (*Cornus stolonifera*) has a few shoots which are 3-4 inches in length. It appears that this Dogwood Bush is on its last legs. The Clematis Plants (*Clematis liquisticifolia*) has good growth. The existing Willow Bush (*Salix spp.*) has 10-12 inches of new growth. There are no insect galls on this plant.
