Monitoring Report South Fork of Quitchupah Creek

SUFCO MINE		
3 RIGHT 2 SOUTH - SOUTH FORK		
SCALE: N.T.S.	DATE: 7/1/2014	DRAWN BY: T.R.B.
ENGINEER:	CHECKED BY:	PROJ: ###
FILE NAME: E:\SUFCO\DRAWINGS\3R2S STREAM.dwg

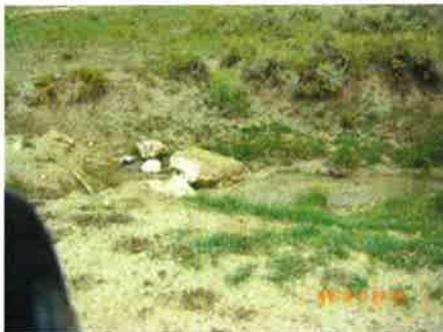
IMGP3991.JPG
1843K

During the past two weeks flow in the South Fork of Quitchupah Creek was estimated at between 130 and 150 gpm and the flow appeared similar the length of the channel. The springs were all observed to be flowing (IMG3871). Sediment is noticeably filling the channel in the upper reaches above and below the road culvert (IMG3991).

The channel was check for cracks during this period, several small cracks (5 - 6) were repaired with bentonite between the downstream end of the culvert and monitoring location 006D. Approximately 2.38 inches of rain fell at the mine site during the two week period. Both ponds being monitored were dry except on Aug 22nd, when one pond had about a foot of water in the bottom.

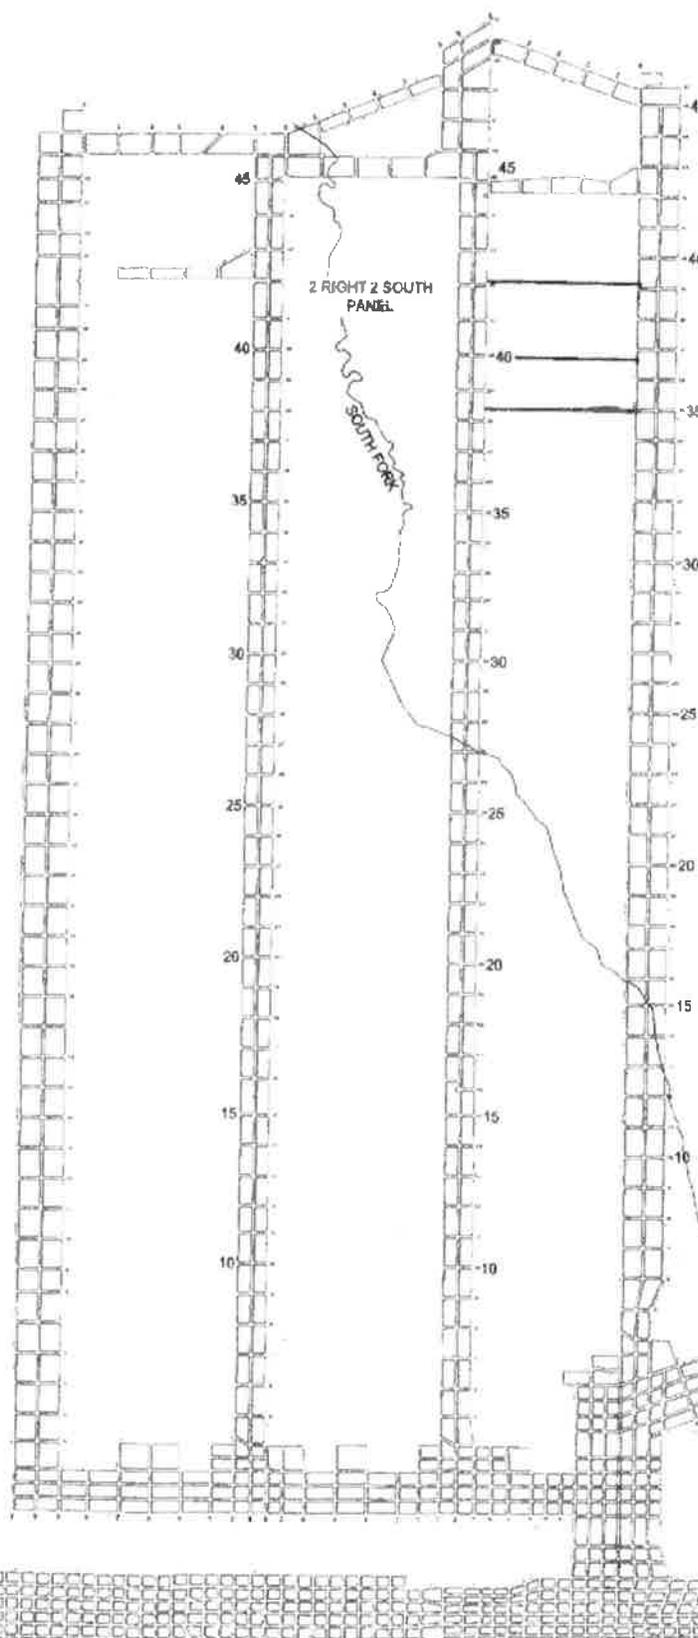
SHEET NO.
1

A drawing showing the location of mining is attached. Please let me know if you need any additional information. Thanks, Vicky

7/27/14

8/10/14

8/24/14
