Monitoring Report South Fork of Quitchupah Creek

The South Fork of Quitchupah Creek was observed on Sept.22, 24, 30 and October 3. The mine site recorded 1.6 inches of rain during the two week period . Following the rainstorms during this period the creek was inundated with sediment and the creek overflowed its banks (photos 4463, 4508). The temperatures dropped to freezing (4319) starting the week of the 22nd. On the 24th the ponds were dry and flow in the creek was estimated at 70 gpm, on the 30th flow was estimated at 90 gpm, on Oct. 3 all ponds had water in them. The use of the creek by cattle was heavy until Oct 3rd.

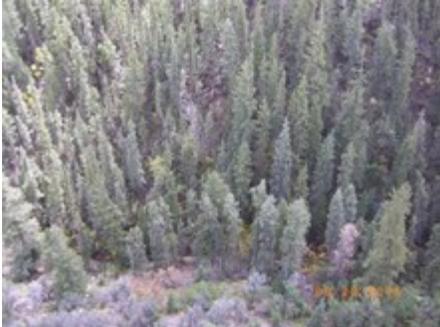
IMGP4305.JPG
1829K

No new subsidence cracks were located and the flow was observed to be similar from Spring 006 to Stream Monitoring Location 006D (4305) during the two week period. Monitoring location 006D was enveloped in a pond with three beaver dams in succession below it , see photos 4483 and 4487. The springs were checked and all were running (4323).
