Re: Revision to M&RP to Add Greens Hollow Lease Tract, Sufco Mine, Canyon Fuel Company, LLC, Permit Number C/041/0002

APPLICATION FOR COAL PERMIT PROCESSING

Title: Revisions to M&RP to Add Greens Hollow Lease Tract

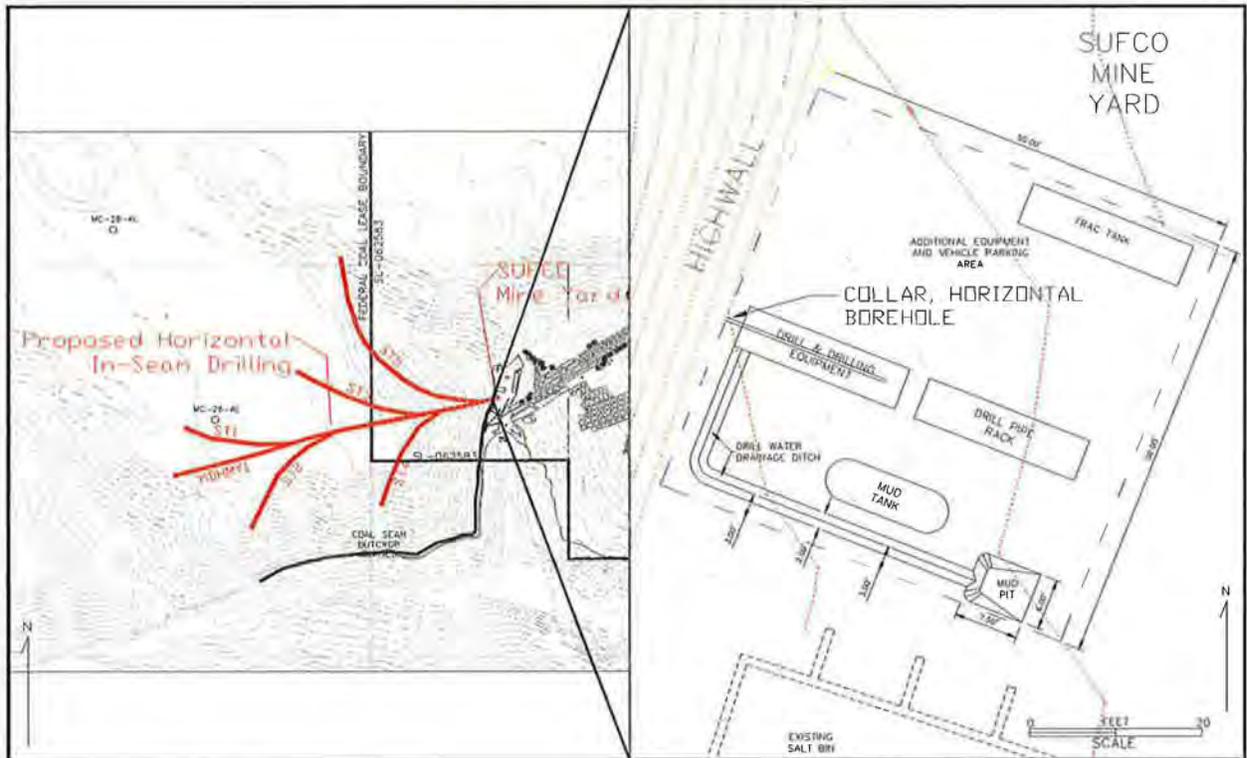
Figure 6-2. Location and approximate setup of directional horizontal drillsite within the permitted

Sufco minesite area.

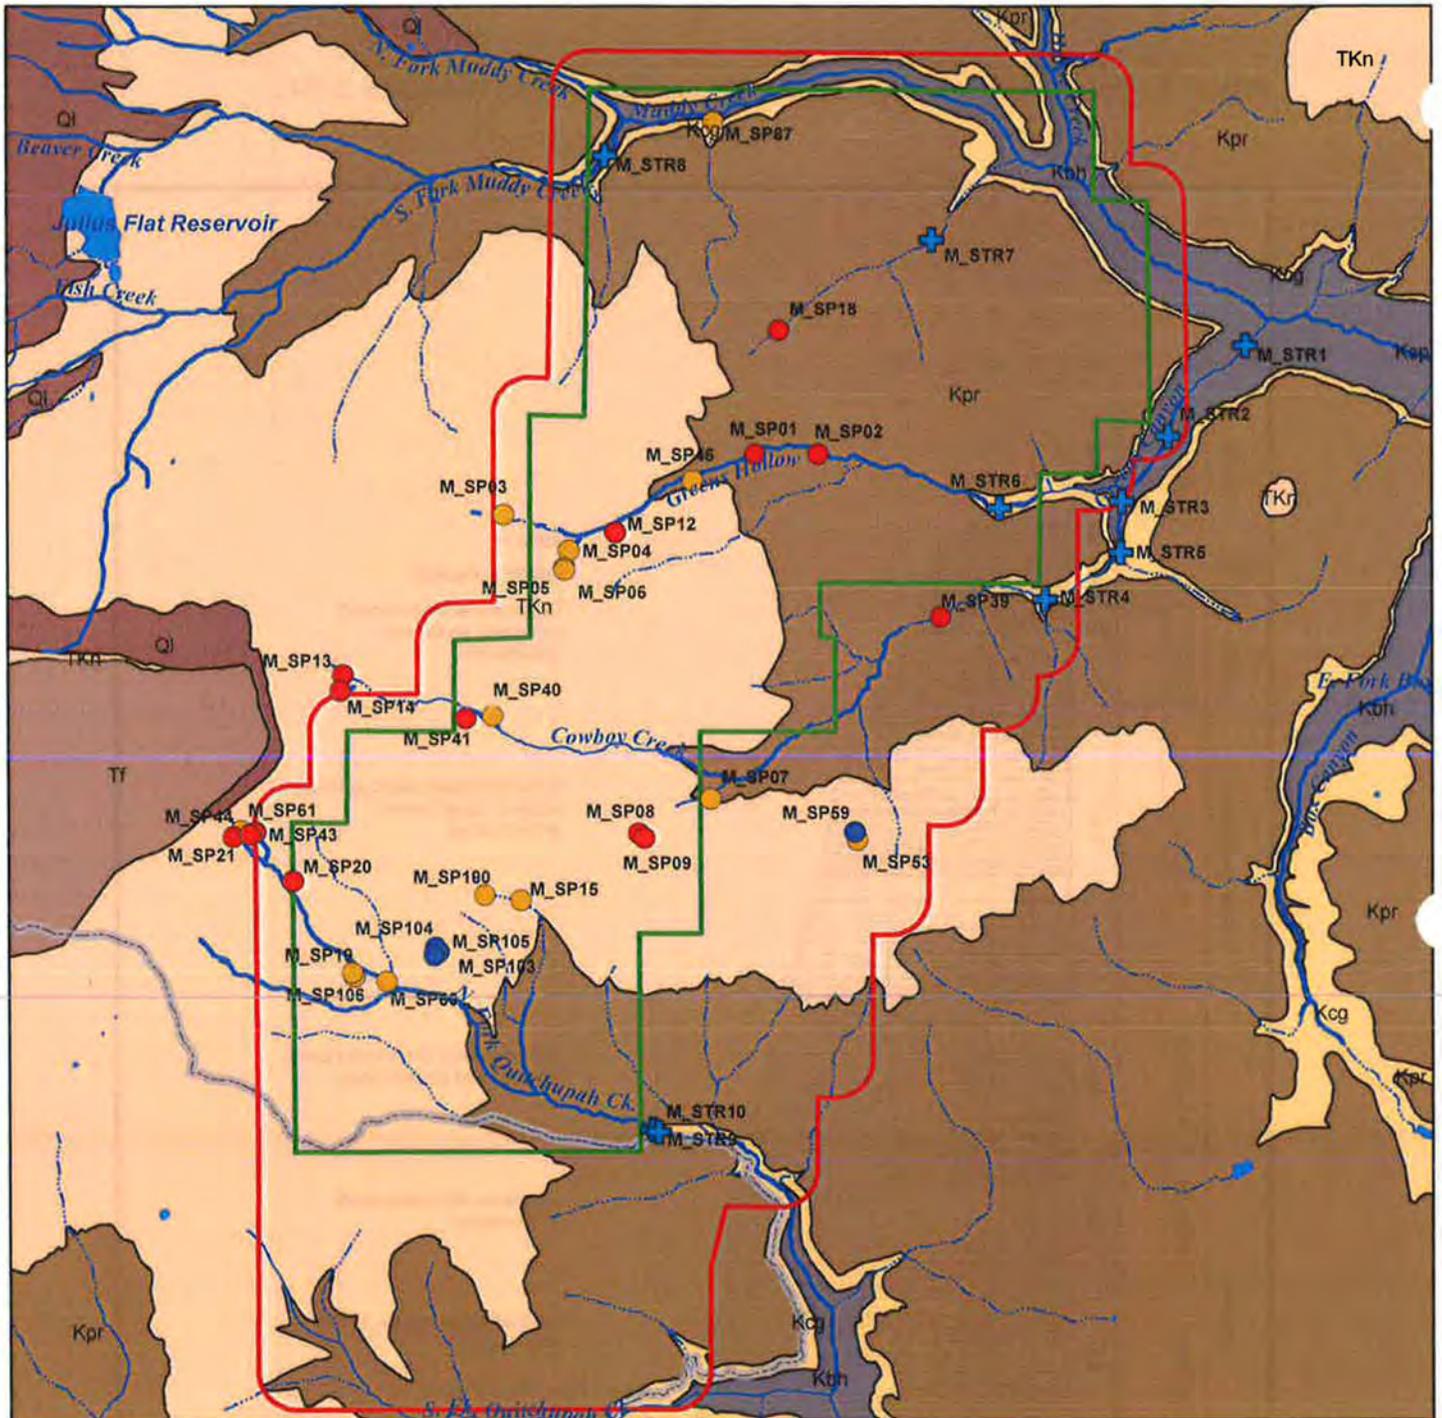
Figure 4. Greens Hollow water resources and geology.

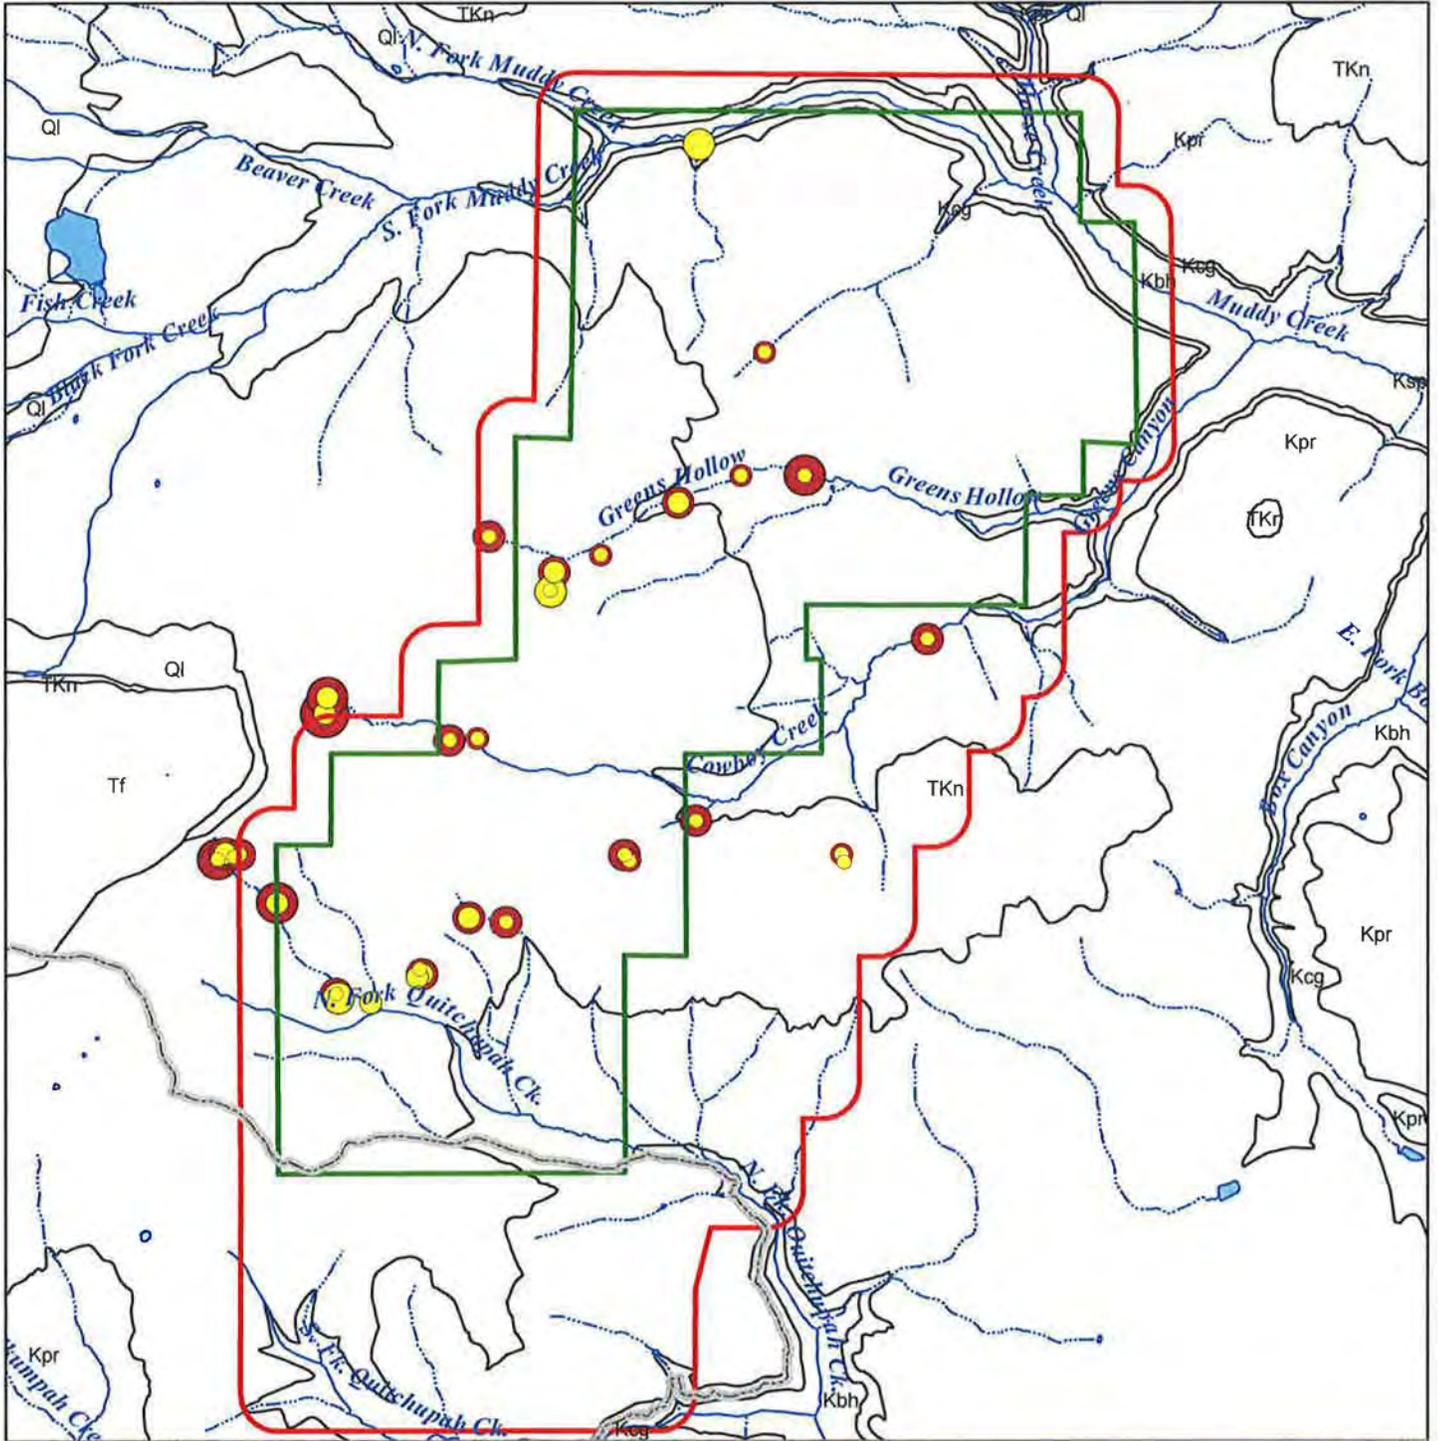
Figure 5. Flow Range for Measurable Springs

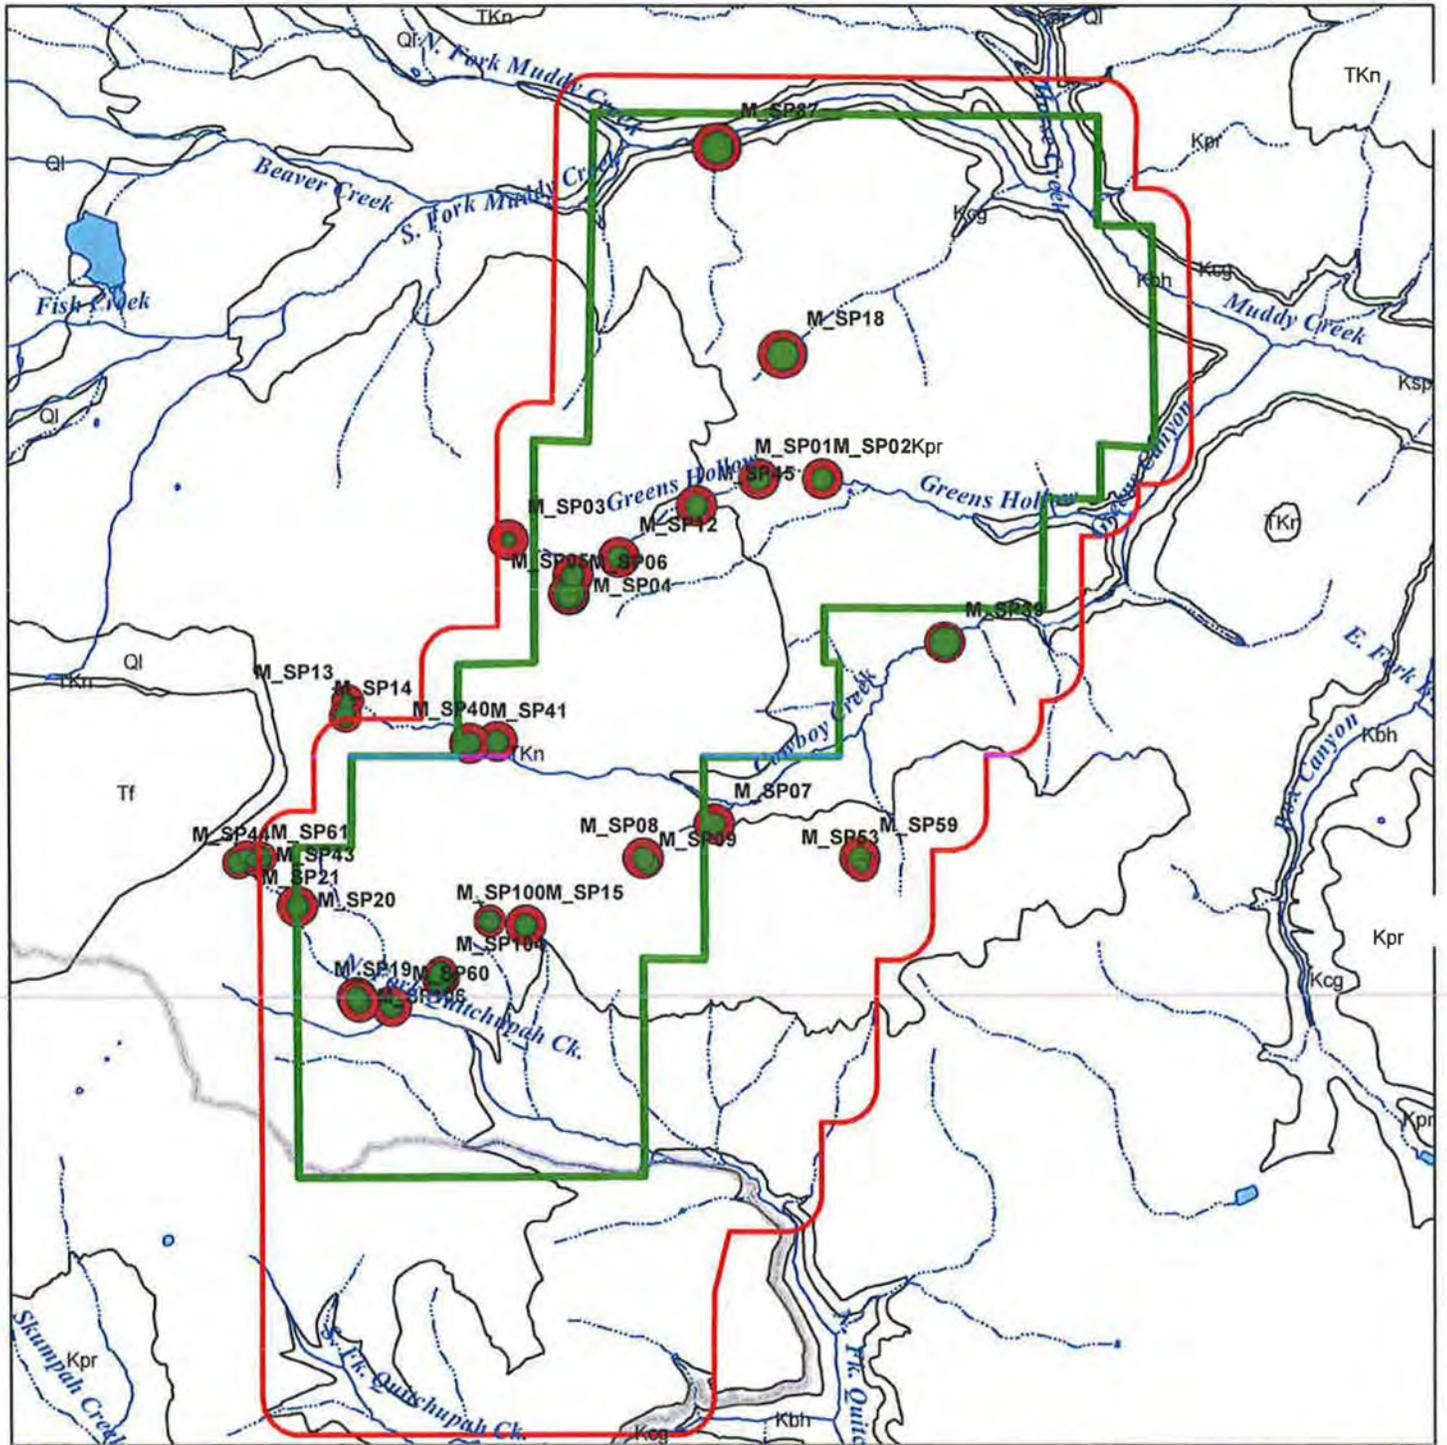
Figure 6. Specific Conductance Range for Measurable Springs

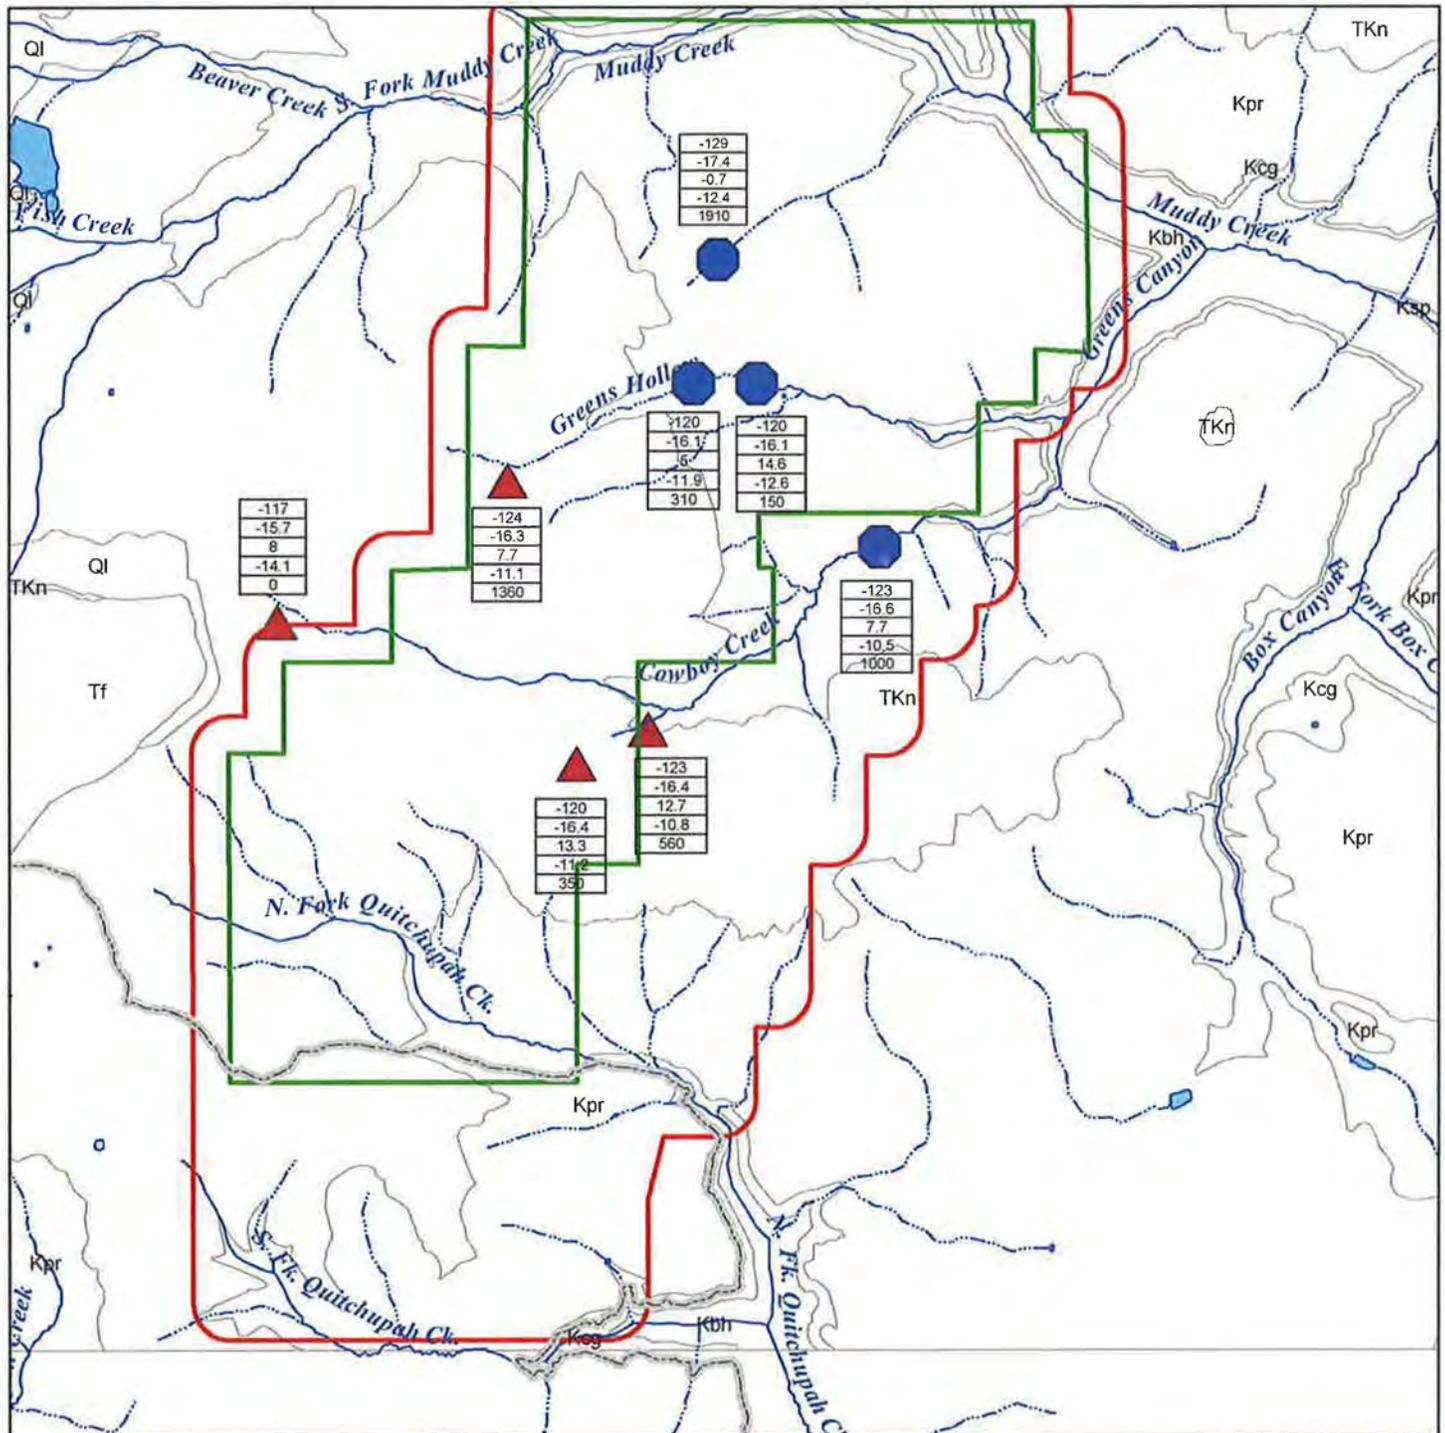
Figure 7. Spring Water Isotope Sampling

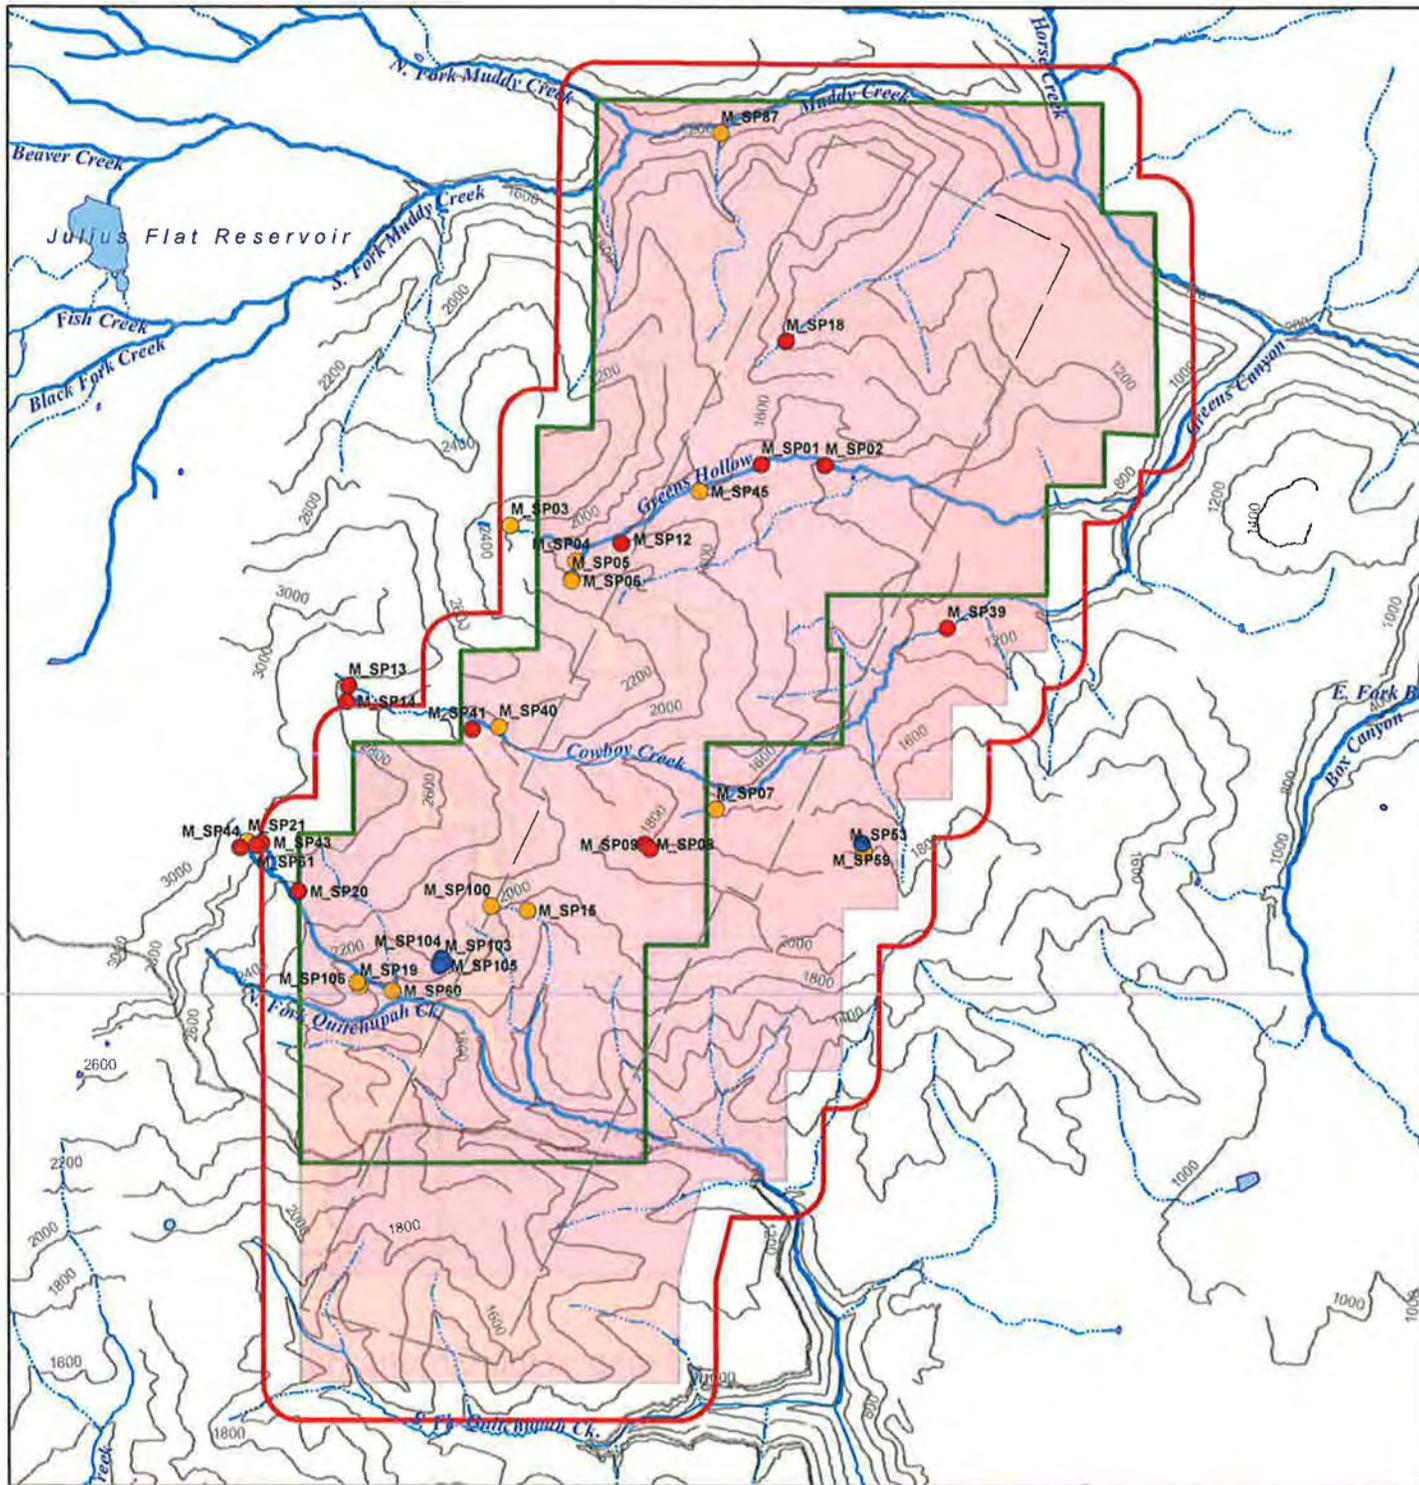
Figure 36. Alternative 2 - Spring Locations with Proposed Mine Area and Overburden Thickness

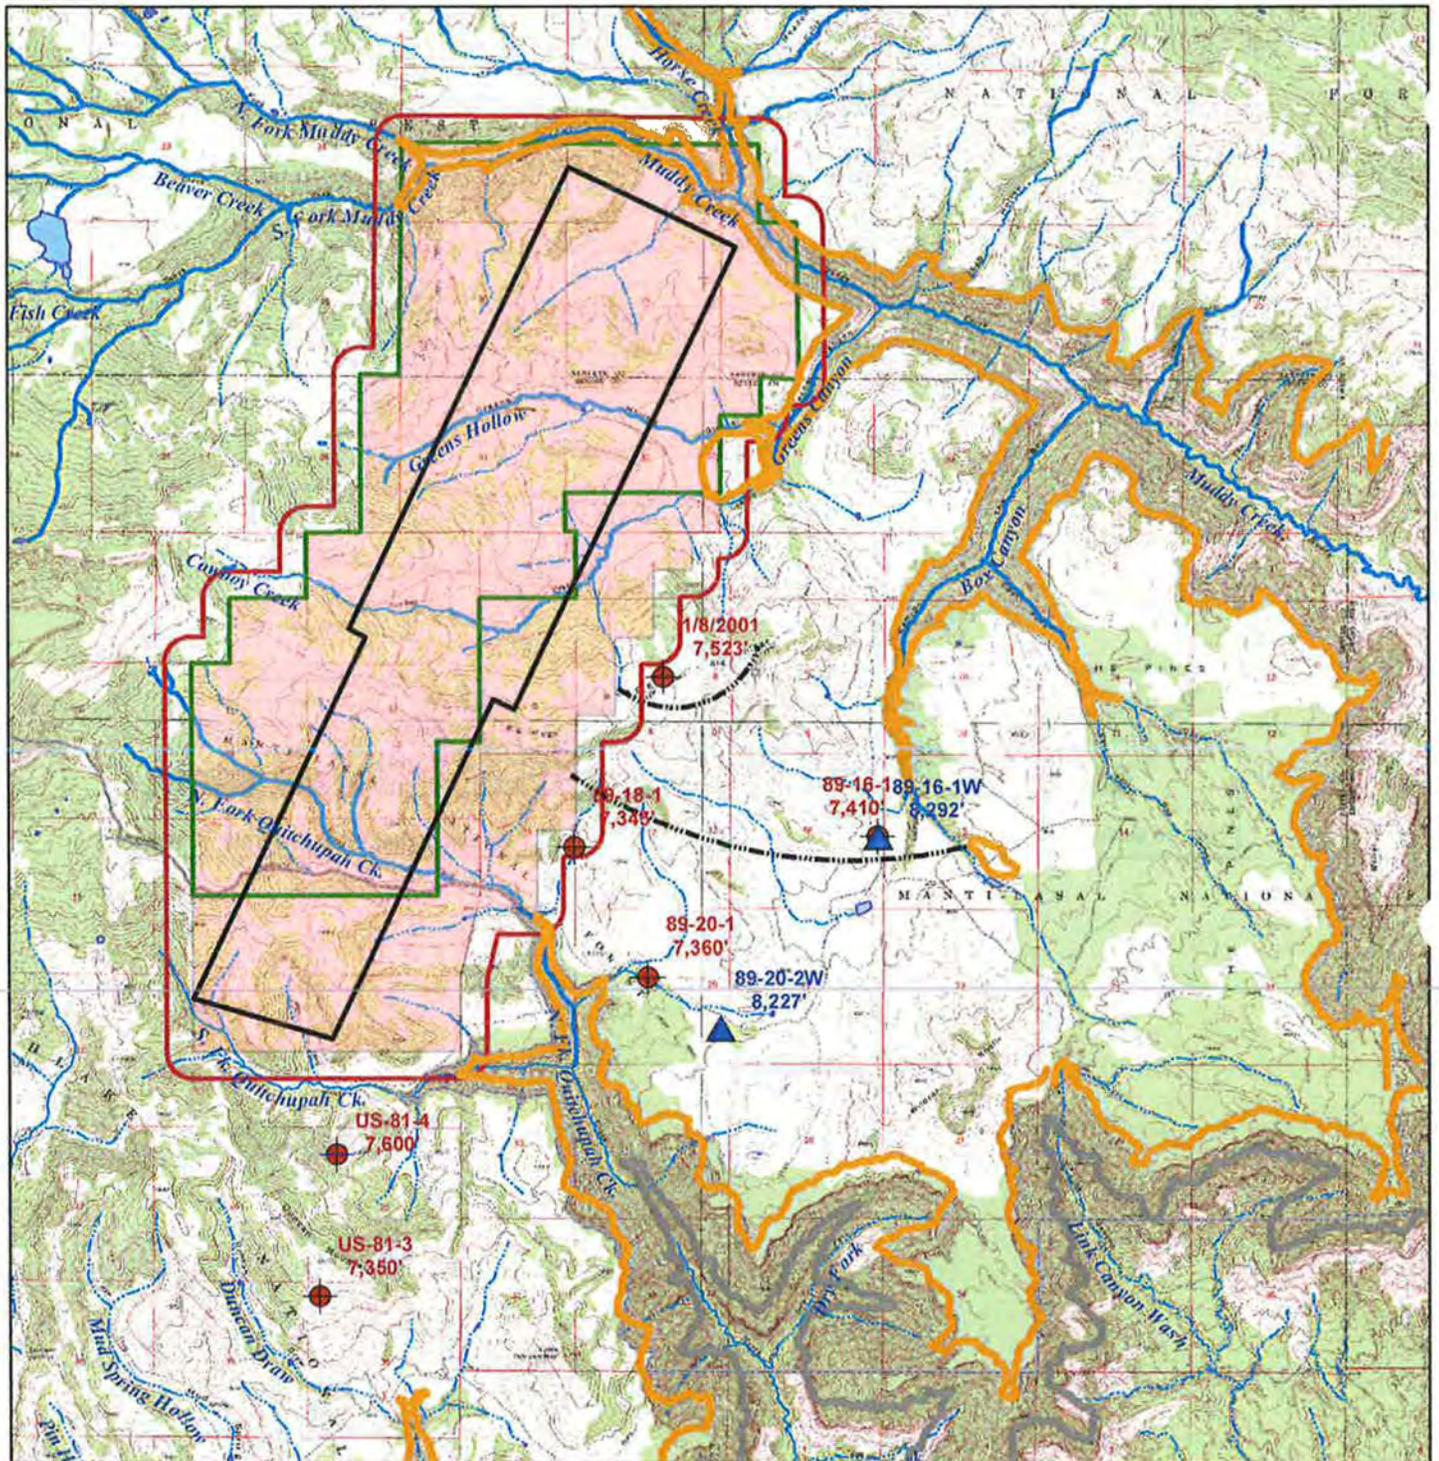
Figure 40. Water Level Elevation in Castlegate Sandstone and Blackhawk Formations.

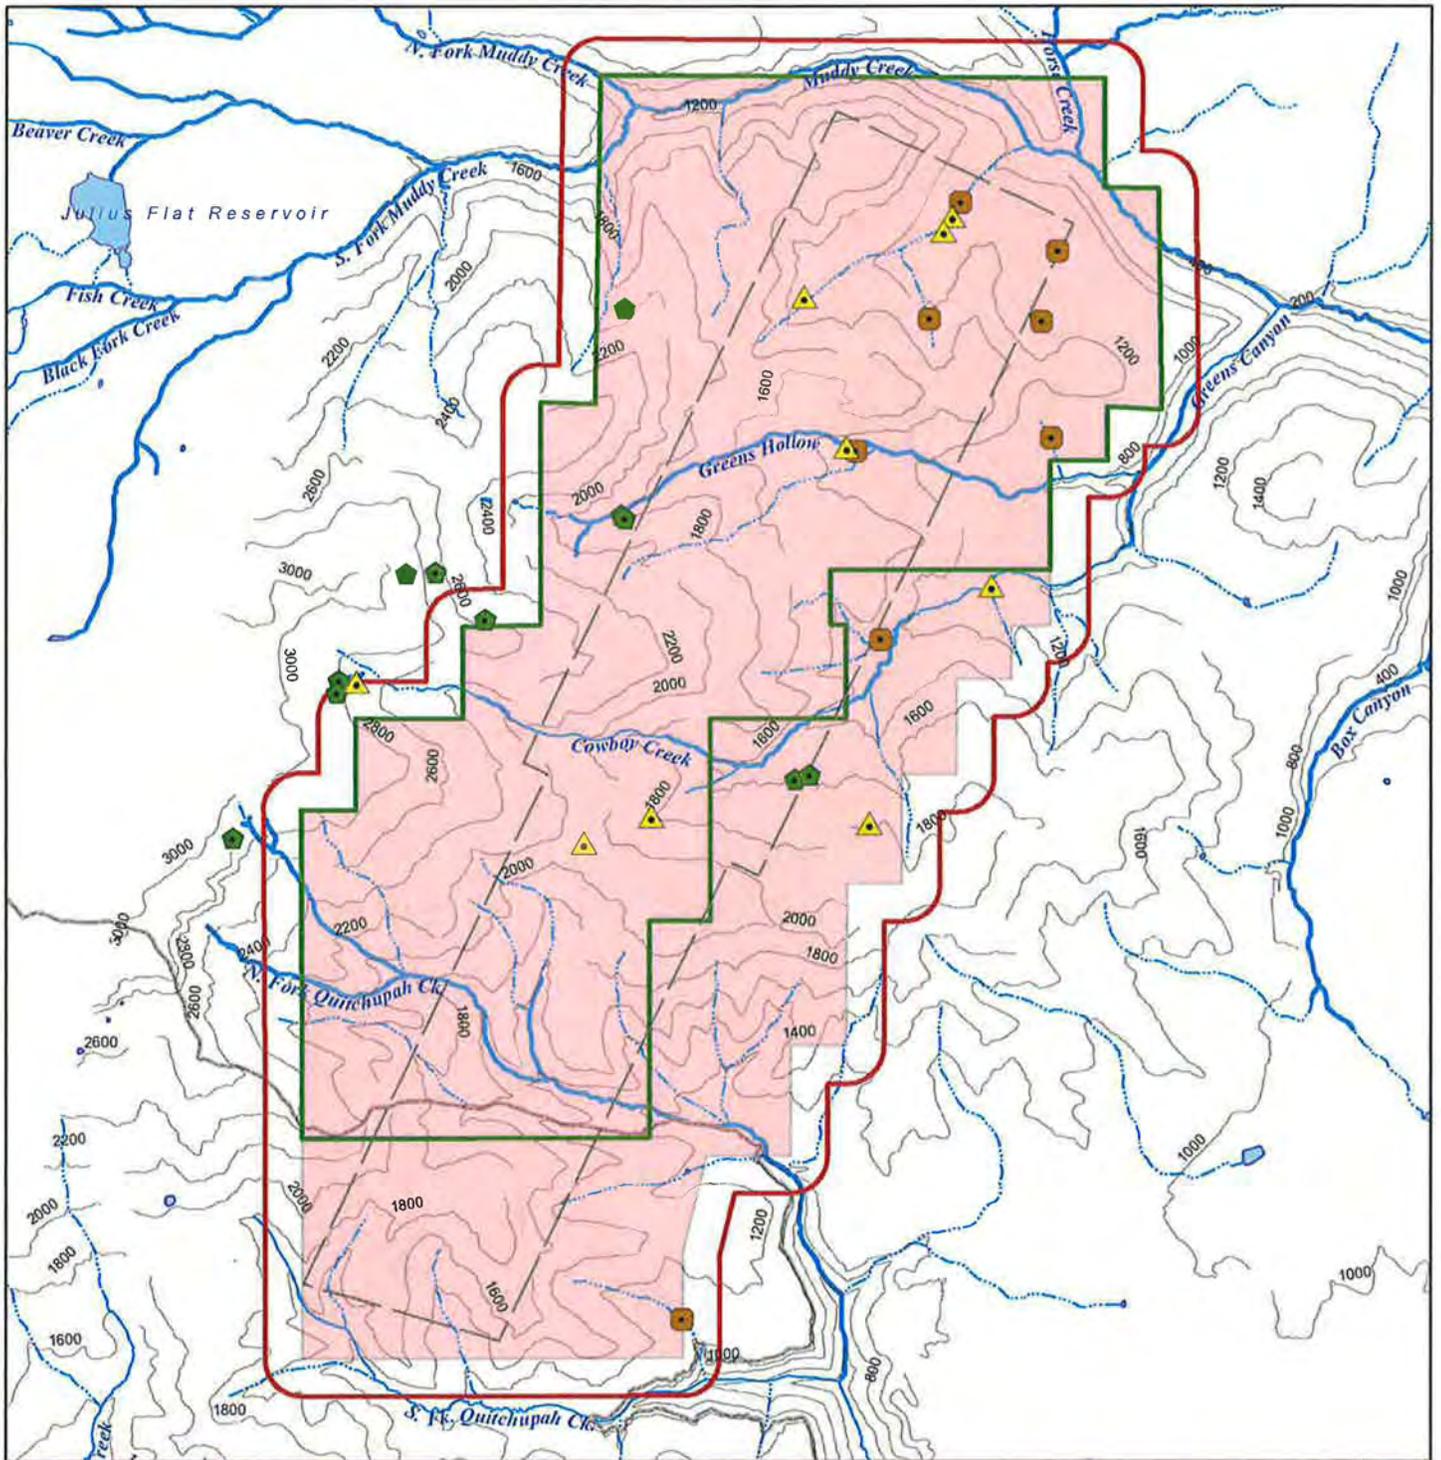
Figure 41. Alternative 2 - Surface Water Features with Mine Plan and Overburden Thickness

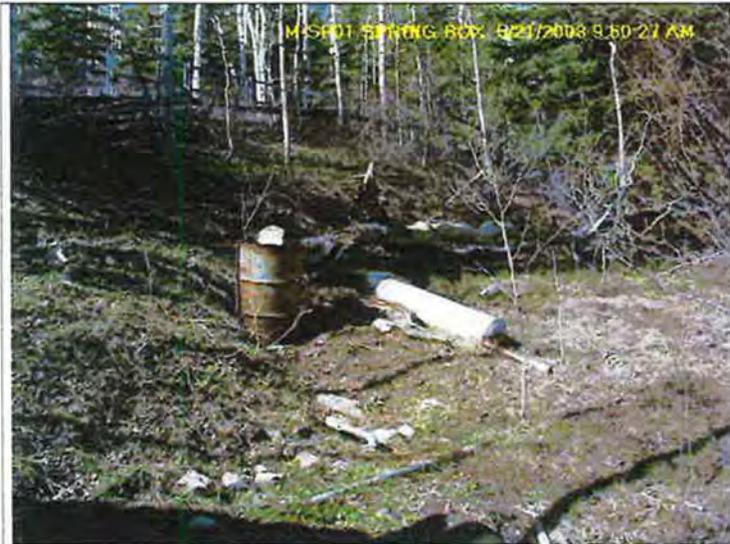
Tract	Muddy
Date of inventory	19 June 2001
Name	M_SP01, Rough Bros. Spring
GPS location	
Northing	4319979
Easting	465615
Comments	Developed spring at Rough Brothers cabin. Water is used as a culinary source of water and for irrigation purposes. Cabin and yard are fenced. Stainless steel spring box is located to the back of the cabin under an old barrel and discharges into a galvanized pipe leading to an underground storage tank and to a trough next to the cabin. Water quality samples were collected periodically for laboratory testing.

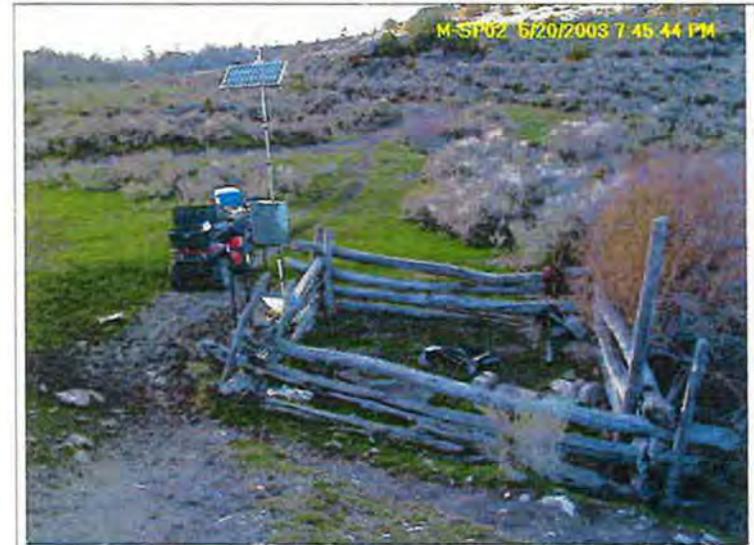
Tract	Muddy
Date of inventory	19 June 2001
Name	M_SP02
GPS location	
Northing	4319977
Easting	466086
Comments	Spring box is located next to Greens Hollow road crossing and instrumented by EWCD. Water quality samples were collected periodically for laboratory testing. Information obtained from ranchers indicates that this spring box is the water source for the trough located about 100 feet to the east on the south side of Greens Hollow. Water overflows the cattle trough at down slope end and continues to flow along the south side of Greens Hollow, eventually entering a pond.

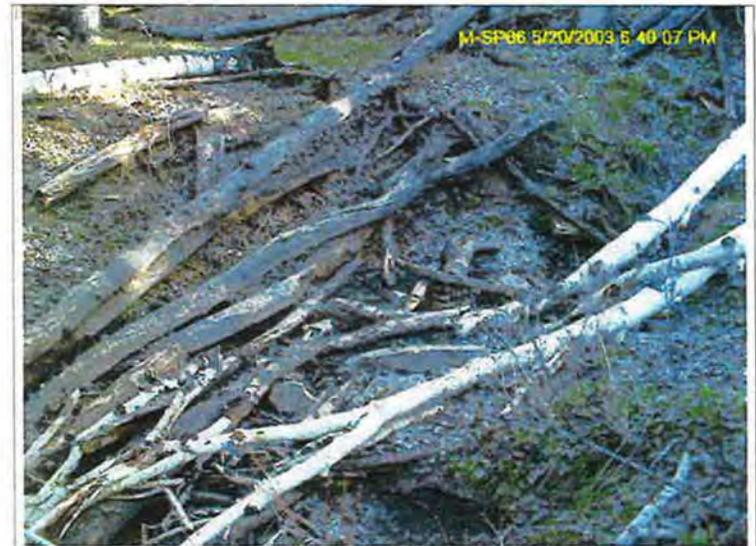
Tract	Muddy
Date of inventory	19 June 2001
Name	M_SP06
GPS location	
Northing	4319121
Easting	464215
Comments	Field water quality measurements were originally taken below the confluence of two spring/seeps (SP05 and SP06) located in the upper portion of a tributary flowing into Greens Hollow. SP06 is located at the base of an aspen-covered slope (small bench), has much greater discharge than SP05, and forms a small pond. The two springs were measured separately starting Sept 2002 because cattle heavily trampled the area of confluence.

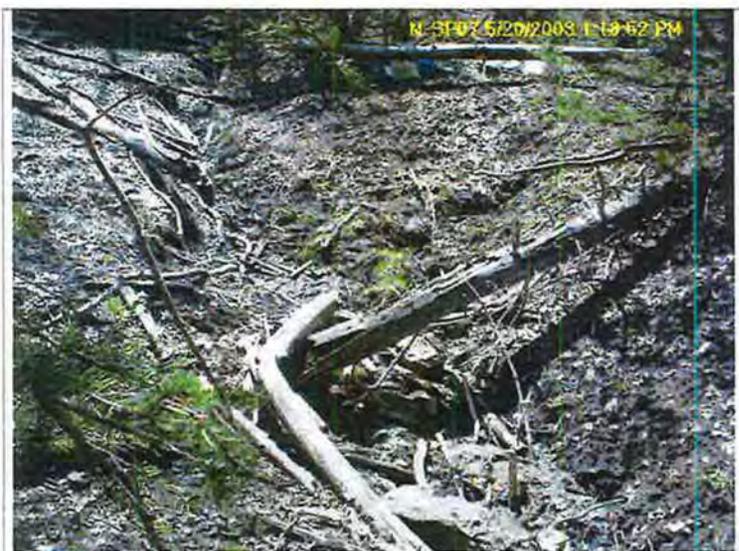
Tract	Muddy
Date of inventory	20 June 2001
Name	M SP07
GPS location	
Northing	4317433
Easting	465280
Comments	Water originates near the base of slump in an aspen/fir stand. Water flows from this source down to a moderately wide, flat-bottomed drainage (no channel) connected to Cowboy Creek. Water accumulates in floor of drainage, forms small wet pocket, but flow does not reach Cowboy Creek. Water quality samples were collected periodically for laboratory testing.

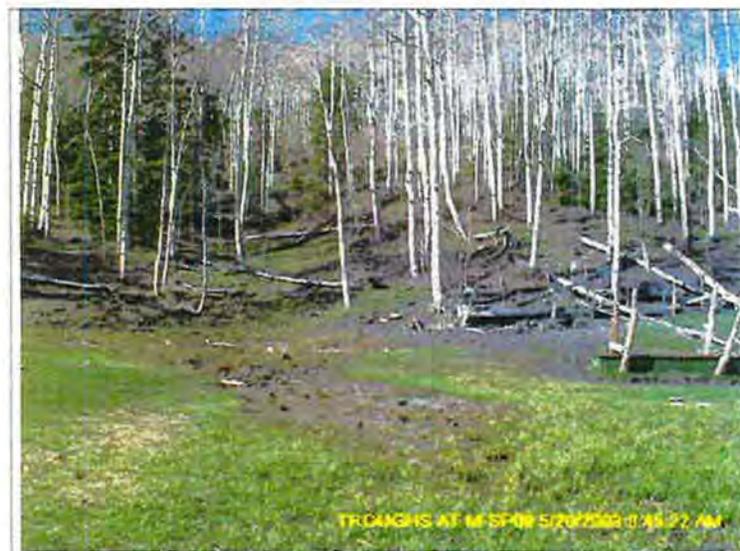
Tract	Muddy
Date of inventory	20 June 2001
Name	M SP08
GPS location	
Northing	4317178
Easting	464754
Comments	Developed spring that feeds into cattle trough. Water originates near base of hummock in aspen stand. Originally, most of the flow from spring did not enter pipe but flowed to the side of it. Spring was worked on in 2003. Old pipe was removed and replaced with a new pipe discharging into a different trough. No water in old channel anymore: apparently the new pipe captures all the flow. New trench below spring box with perforated pipe and gravel also captures water from seepy area below the spring. Water quality samples were collected periodically for laboratory testing.

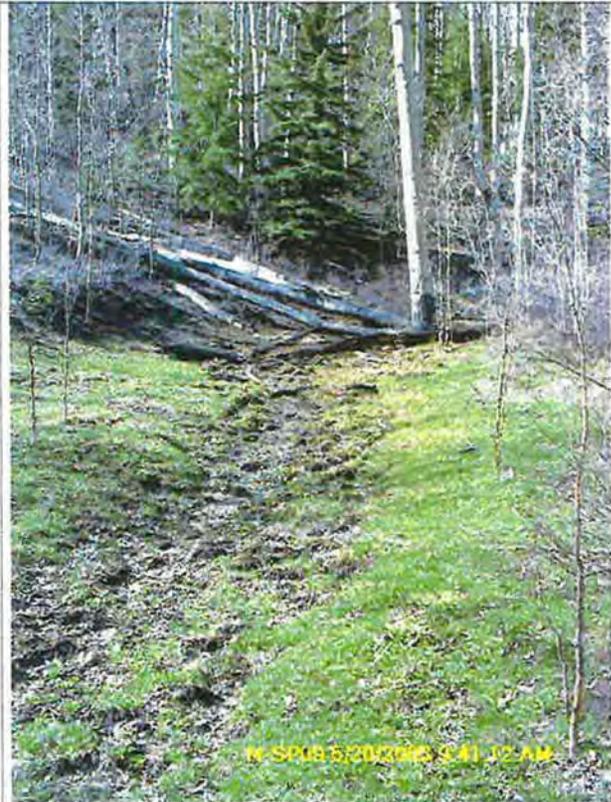
Tract	Muddy
Date of inventory	20 June 2001
Name	M SP09
GPS location	
Northing	4317141
Easting	464791
Comments	Small seep that enters top of meadow to east of SP08. Water discharges from base of slope in aspen stand, disperses into broad flow after entering meadow. Cattle trample area.

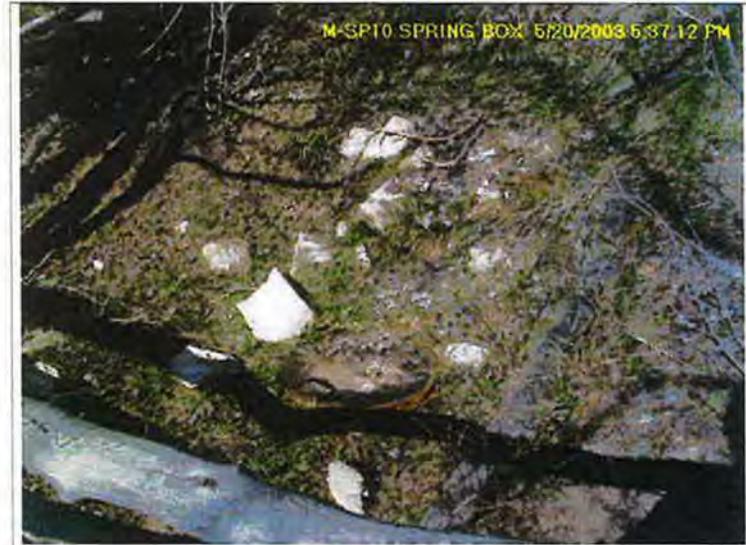
Tract	Muddy
Date of inventory	20 June 2001
Name	M SP10
GPS location	
Northing	4317562
Easting	467693
Comments	Developed spring with cattle trough (Lowery Springs?). Spring box is about 20 feet up slope of trough on east side of drainage leading down to Cowboy Creek. Water flows from trough across slope, eventually entering channel. Small pocket of sedge below trough (north). Not certain if sedge is supported by a seep or overflow from trough. No water in channel above this location. Instrumented spring, monitored by EWCD. Water quality samples were collected periodically for laboratory testing.

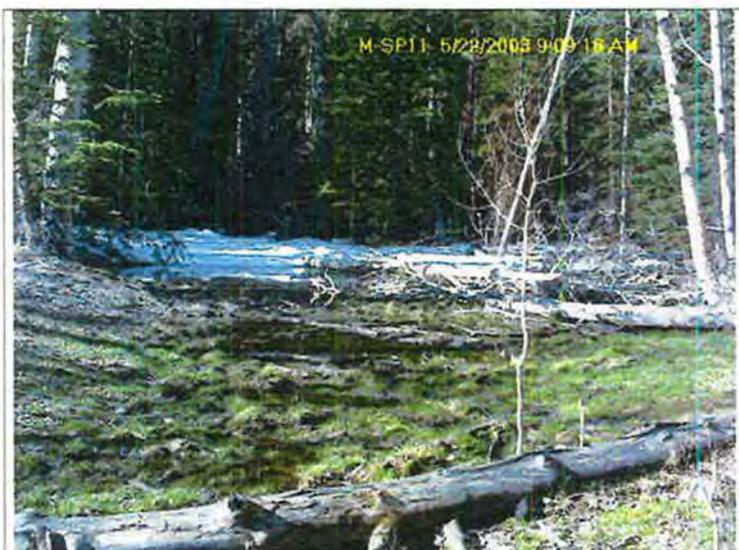
Tract	Muddy
Date of inventory	21 June 2001
Name	M SP11
GPS location	
Northing	4319958
Easting	462772
Comments	Spring/Pond located approximately 150' up slope of road. Pond appears to collect snowmelt runoff, may also receive some shallow ground water discharge. Field water quality measured in pond, flow measured at discharge side of culvert. Gradual slope in topography to north. A second pond is located about 50 feet west of SP11 and is likely hydrologically connected to it.

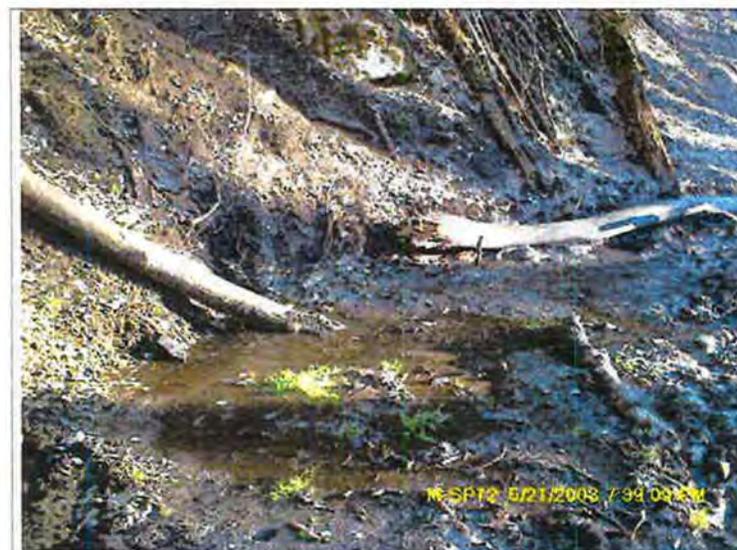
Tract	Muddy
Date of inventory	19 June 2001
Name	M SP12
GPS location	
Northing	4319397
Easting	464583
Comments	Water originates near toe of slope on small bench above Greens Hollow, discharges through silt bank along a 10 - 20 feet face into pond/wetland area. Flow eventually concentrates into a channel and flows into a second pond below, then into Greens Hollow.

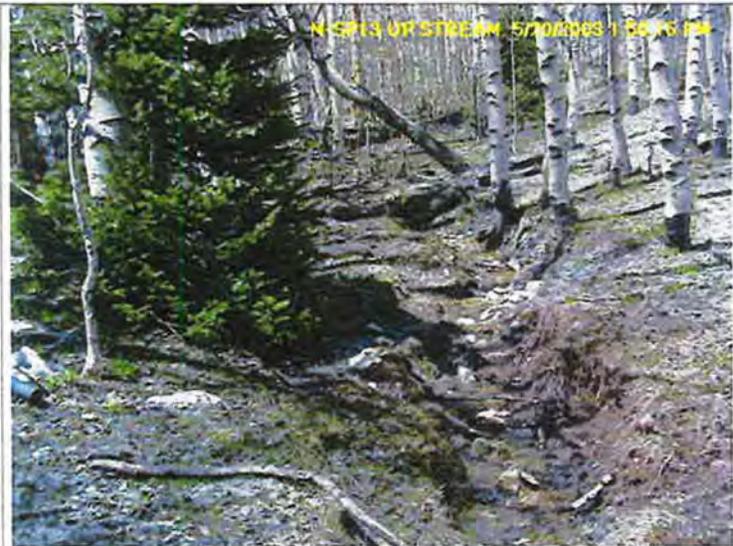
Tract	Muddy
Date of inventory	21 June 2001
Name	M_SP13
GPS location	
Northing	4318345
Easting	462562
Comments	Appears to be the uppermost source of water in Cowboy Creek. Moderately sloped, wide valley. Spring source is located in a slightly incised channel in an aspen stand, just below a point where the channel drops about 2 feet and becomes more incised. This site is usually dry in the fall.

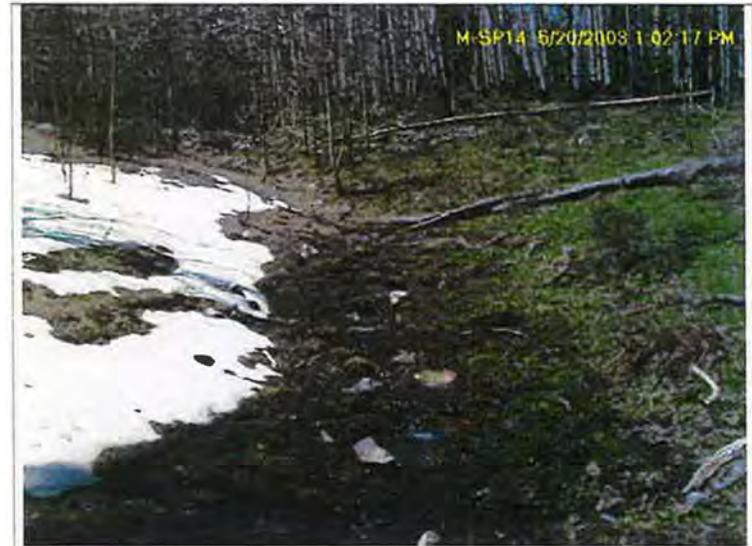
Tract	Muddy
Date of inventory	21 June 2001
Name	M_SP14
GPS location	
Northing	4318227
Easting	462545
Comments	Developed spring originating on gentle slope; spring box located about 50 feet downstream from source. Spring box does not capture all the flow from spring. Cattle trough located 250 feet down slope. Water from spring and overflow from trough enter drainage, eventually reach Cowboy Creek, about 1/4 mile downstream. Flow in Cowboy Creek approximately doubles below confluence. Water quality samples were collected periodically for laboratory testing.

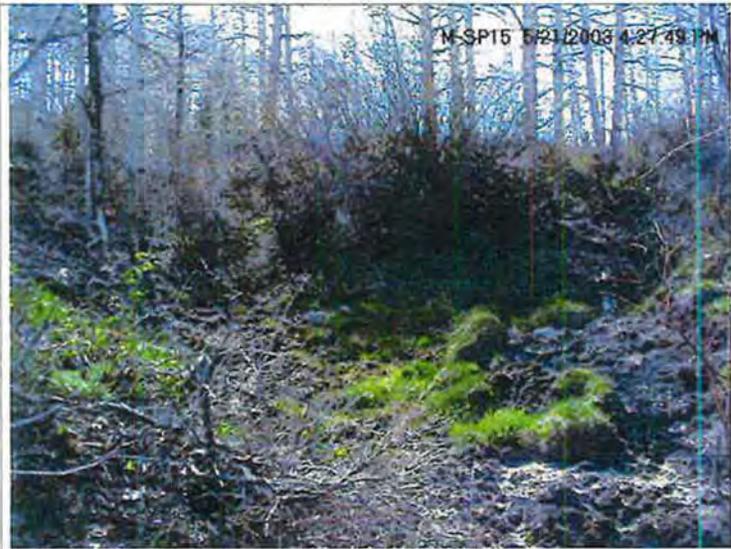
Tract	Muddy
Date of inventory	11 July 2001
Name	M SP15
GPS location	
Northing	4316685
Easting	463884
Comments	Fairly large seep or wallow on left side of channel near headwater of tributary to North Fork Quitcupah Creek. Good stand of willow and other shrubs around it. This spot is usually pretty well trampled by September. In 2001, flow of tributary below spring was measured instead of spring itself. The area drained by this tributary falls completely within the boundary of the project area. It was assumed that flow in stream was contributed primarily from spring flow, although recent rain activity may have been contributing surface/subsurface flows.

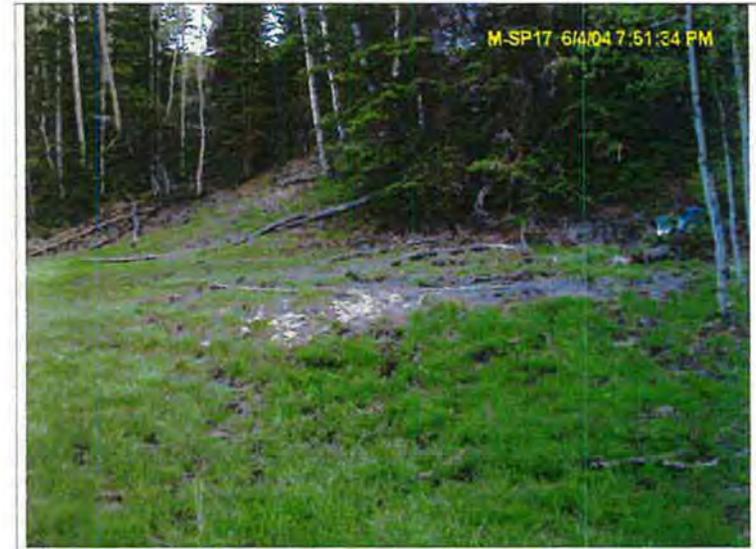
Tract	Muddy
Date of inventory	21 June 2001
Name	M SP17
GPS location	
Northing	4319385
Easting	461746
Comments	Water originates from seep face at toe of slope in small bowl (bench area) near base of 3 pines, about 50 feet from edge of bench. The water flows through a wet meadow on bench then converges into a steep rocky channel draining the bench area. It enters another wet meadow about 200' down.
