Re: Revision to M&RP to Add Greens Hollow Lease Tract, Sufco Mine, Canyon Fuel Company, LLC, Permit Number C/041/0002

APPLICATION FOR COAL PERMIT PROCESSING

Title: Revisions to M&RP to Add Greens Hollow Lease Tract

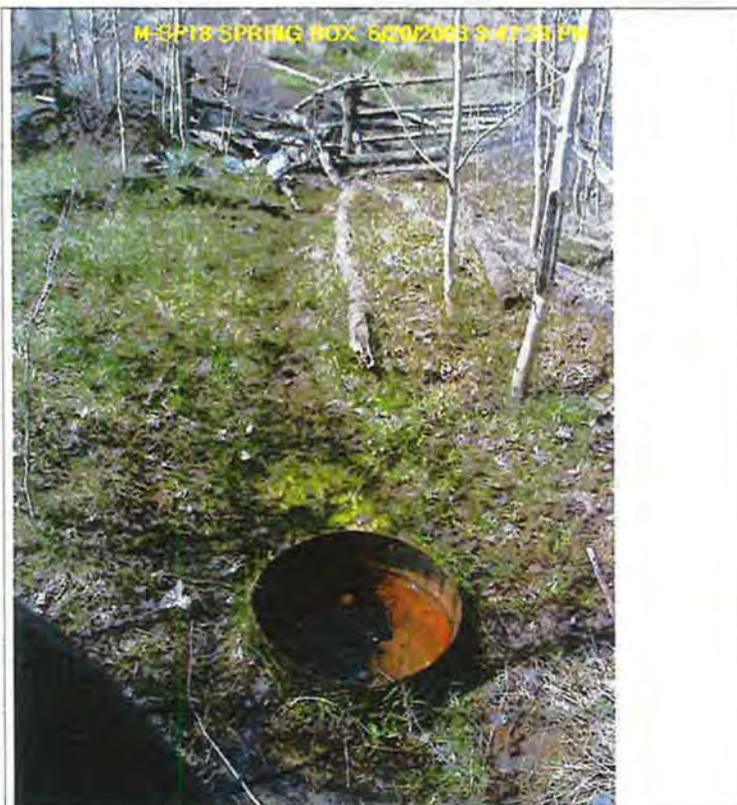
Tract	Muddy
Date of inventory	22 June 2001
Name	M_SP18
GPS location	
Northing	4320892
Easting	465794
Comments	Developed spring located at south end of wide, gently sloped valley above Muddy Creek. Field water quality was measured in spring box, which is heavily corroded. Line is broken below spring box, just below fence crossing, and no water reaches trough. Pipe appeared to be plugged or partially plugged on some visits, water appeared stagnant, and dead rodents were found in spring box. Water quality samples were collected periodically for laboratory testing.

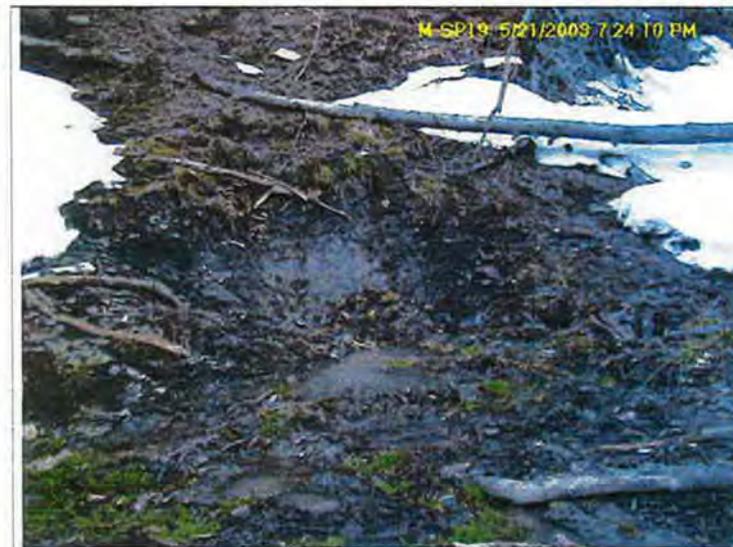
Tract	Muddy
Date of inventory	11 July 2001
Name	M_SP19
GPS location	
Northing	4316124
Easting	462644
Comments	Spring originates on a small bench, about 100 feet above an unnamed tributary of North Fork Quitcupah Creek. Two seeps located below have immeasurable flow. Field water quality parameters measured at spring source, flow measured below springs and seeps to obtain total flow from this location. Some evidence of slumping. Best way to locate it is to stay in main channel and look for the confluence with a smaller incised channel.

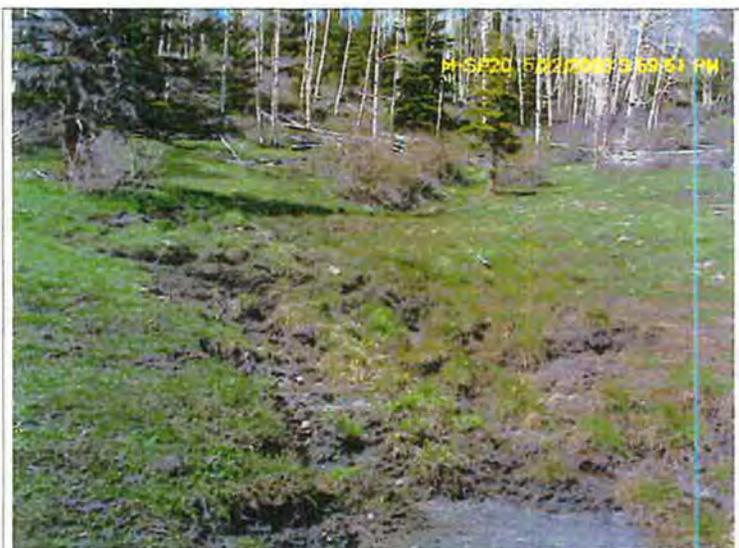
Tract	Muddy
Date of inventory	11 July 2001
Name	M_SP20
GPS location	
Northing	4316826
Easting	462191
Comments	Spring flows into large (1 acre) meadow that is drained by tributary to North Fork Quitchupah Creek. Spring found in aspen grove near toe of slope. This area is usually trampled by cattle in the fall. Collect field water quality measurements at the first point where steady surface flow is observed. Flow is measured at the downslope edge of meadow where channel drops off. Flow from this spring usually reaches the channel.

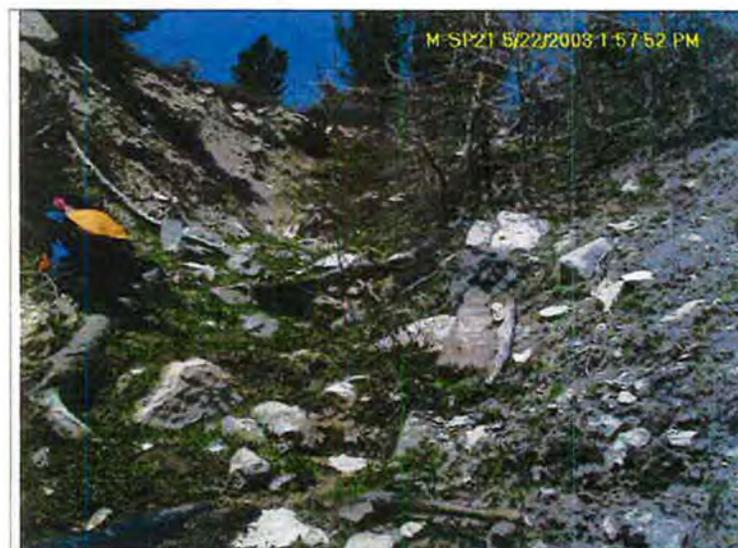
Tract	Muddy
Date of inventory	11 July 2001
Name	M_SP21
GPS location	
Northing	4317195
Easting	461814
Comments	First point in channel where flow surfaces; headwater of tributary to North Fork Quitchupah Creek. Look for flagging or tag on small bush or aspen tree at top of channel bank. This site is usually dry during the fall season. Best access is from the end of a spur road coming off the main ATV trail along Big Ridge. 5 minute hike from end of spur road.

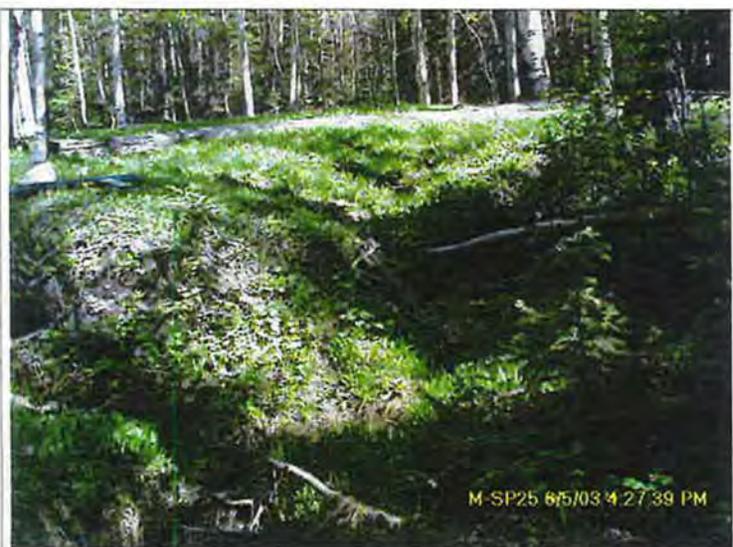
Tract	Muddy
Date of inventory	13 July 2001
Name	M_SP25
GPS location	
Northing	4319509
Easting	461537
Comments	Wet area located above road. Small network of seeps drained by a single channel. Many areas appear to have settled: wet areas are as much as 1 - 2 feet below the surrounding soil surface. Field water quality and flow taken immediately below the point of confluence. In May, need to subtract flow discharging from wetland above spring into the channel. This flow comes from snowmelt runoff and SP75 and is not present in the fall.

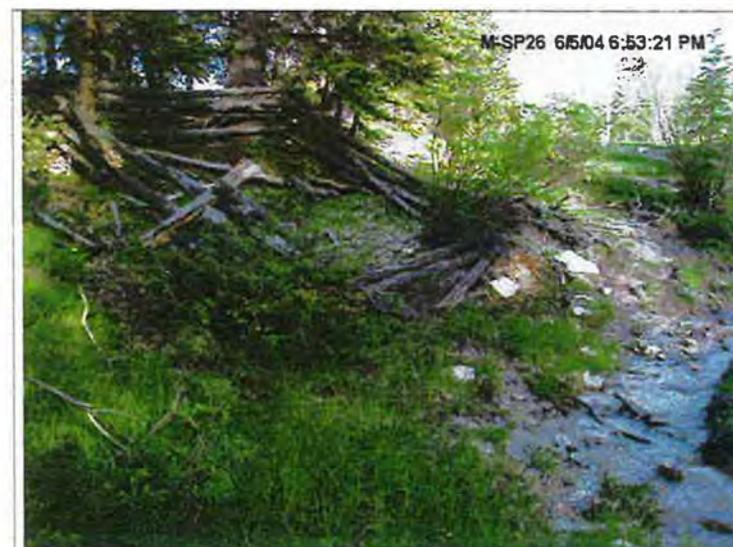
Tract	Muddy
Date of inventory	13 July 2001
Name	M_SP26
GPS location	
Northing	4319737
Easting	461132
Comments	Developed spring near White Mountain Cabin, surrounded by large seep face on stream bank upstream and downstream from spring. During springtime, measured flow in stream channel above and below spring and seeps in order to calculate entire contribution from spring and seeps. No flow in channel above spring and seeps in the fall.

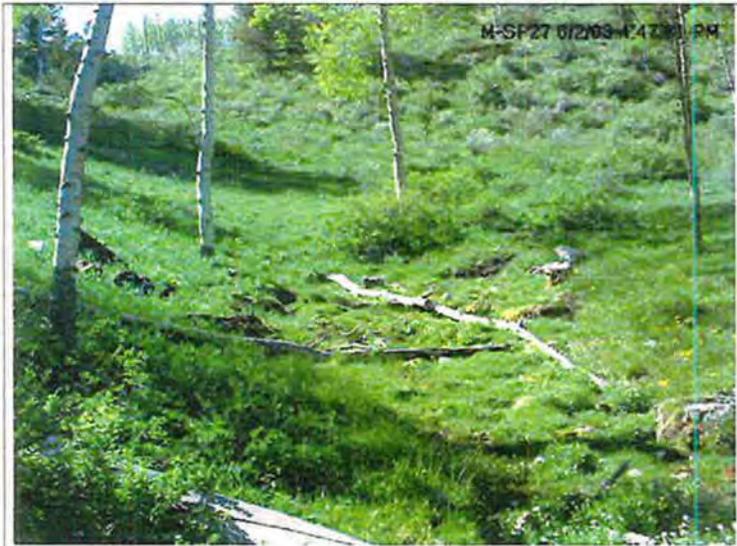
Tract	Muddy
Date of inventory	13 July 2001
Name	M_SP27
GPS location	
Northing	4320838
Easting	460549
Comments	Water originates in small open bowl, no stream channel evident above this point. Flow from this spring feeds a large beaver pond located 200 feet below. Water discharges from the beaver pond into Black Fork. Field water quality parameters were measured at source, flow was measured about 50 feet upstream from inlet to pond, using a collapsible flume.

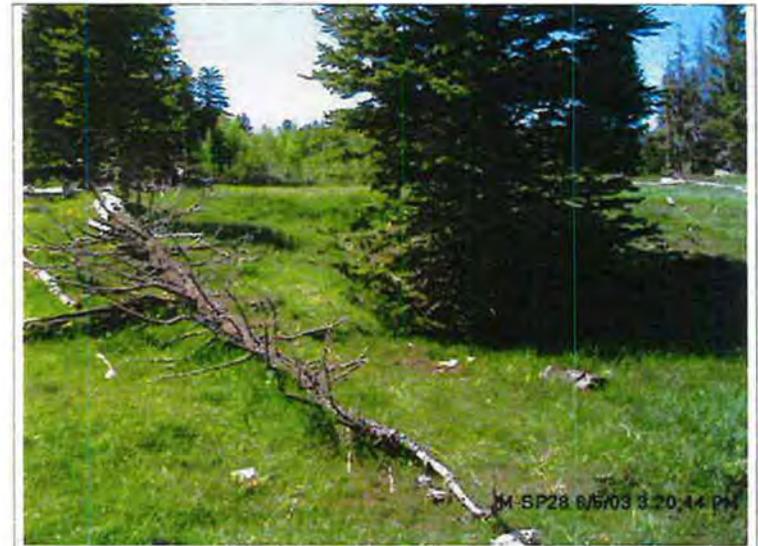
Tract	Muddy
Date of inventory	5 October 2001
Name	M_SP28
GPS location	
Northing	4321948
Easting	460757
Comments	SP28 and SP29 are located next to each other on either side of a medium-size spruce tree, on bench area immediately north of Julius Flat reservoir spillway and dam. These springs appear to be above the elevation of the reservoir bottom. During the spring, this area was hiked and appears to be covered by seep flow.

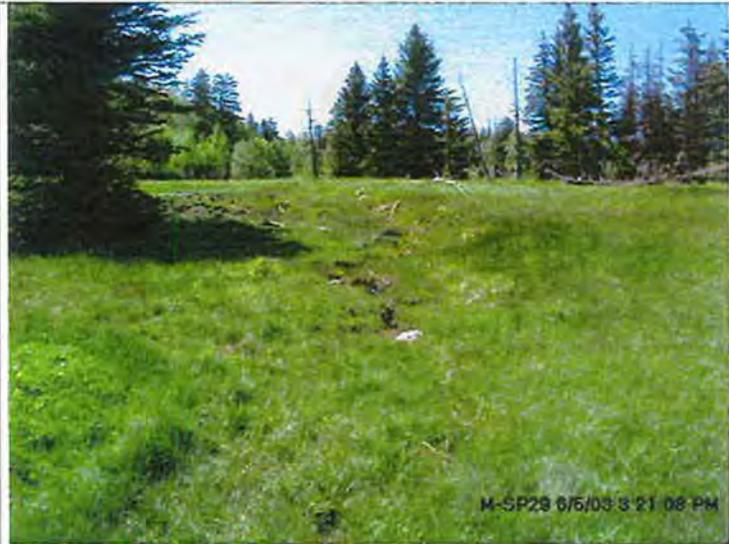
Tract	Muddy
Date of inventory	5 October 2001
Name	M_SP29
GPS location	
Northing	4321956
Easting	460755
Comments	SP28 and SP29 are located next to each other on either side of a medium-size spruce tree, on bench area immediately north of Julius Flat reservoir spillway and dam. These springs appear to be above the elevation of the reservoir bottom. During the spring, this area was hiked and appears to be covered by seep flow.

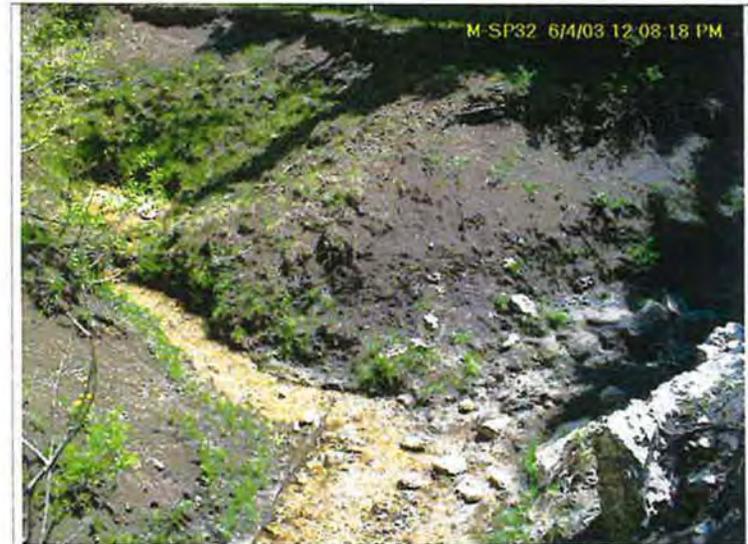
Tract	Muddy
Date of inventory	19 July 2001
Name	M_SP32
GPS location	
Northing	4323808
Easting	462159
Comments	Confluence of 2 small springs and a larger stream channel that drains a wet meadow above. The wet meadow appears to be a groundwater discharge point and likely collects surface runoff during the snowmelt season. Surface runoff from areas above the meadow was observed in the spring of 2003. Look for a flag and/or metal tag on a small aspen near the confluence of the small tributaries and the larger stream channel. This site is usually dry during the fall. Best access is to follow the cow path along the fence, spring is located about 200 feet below fenceline.

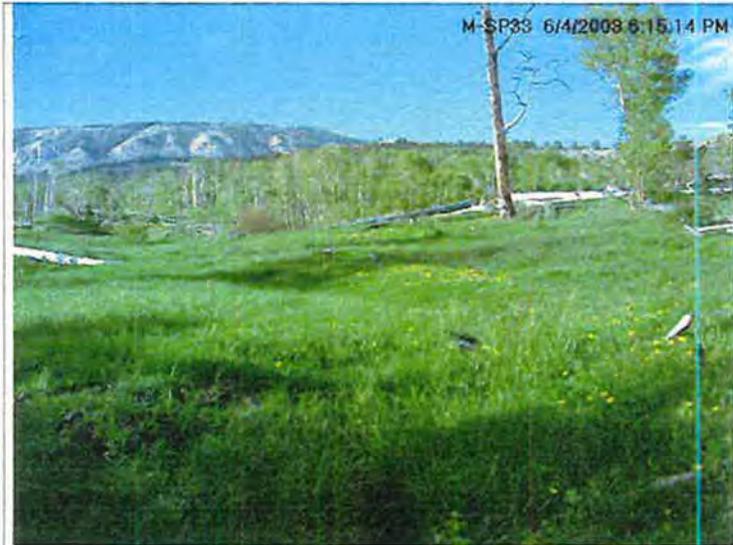
Tract	Muddy
Date of inventory	19 July 2001
Name	M_SP33
GPS location	
Northing	4324453
Easting	462370
Comments	Discharge from a pond, winds through a wetland area then drops into a stream channel and disappears. Stream channel eventually enters North Fork Muddy Creek. Field water quality and flow measured at a 4-foot drop into the stream channel, immediately below the small wetland located below the pond. This site is usually dry during the fall.

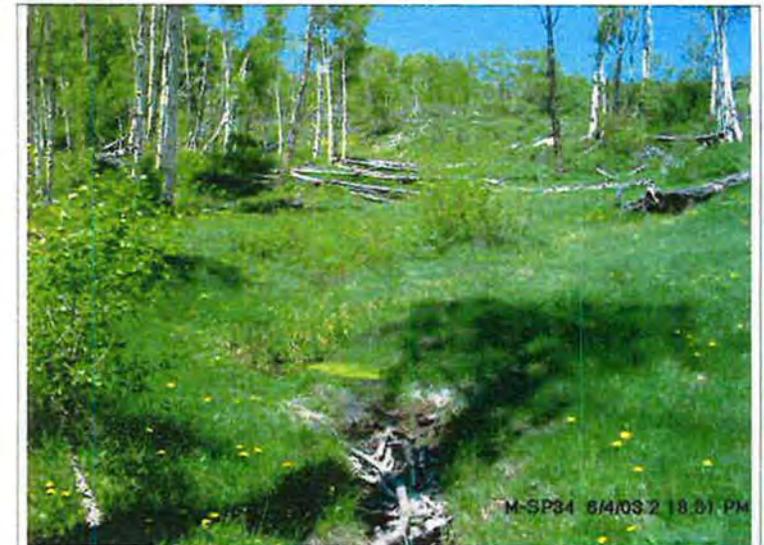
Tract	Muddy
Date of inventory	19 July 2001
Name	M_SP34
GPS location	
Northing	4324813
Easting	462246
Comments	Combined flows from several seeps and a few springs are concentrated in a stream channel that drops into a large pond. Field water quality parameters measured in this channel, below confluence of flows, about 100 feet above where it drops off to pond. Flow measured at point where channel drops off to pond. Look for flag on large aspen tree.

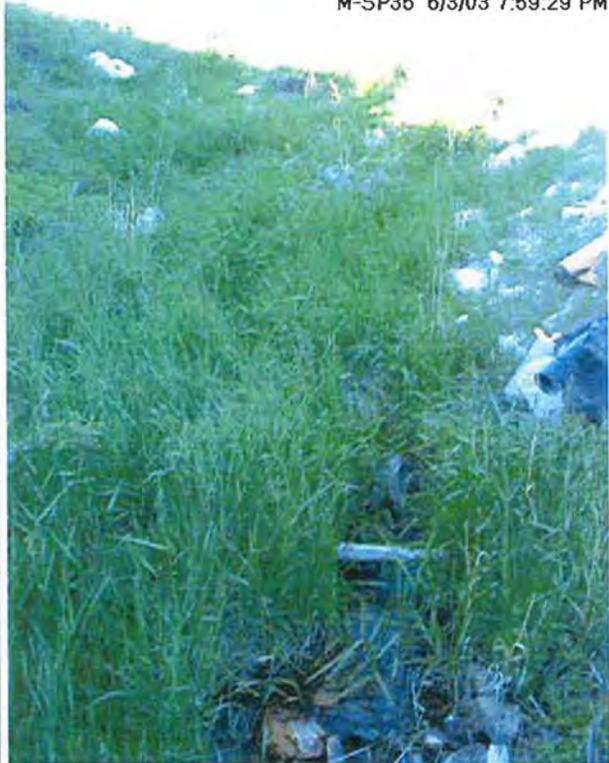
M-SP35 6/3/03 7:59:29 PM

Tract	Muddy
Date of inventory	19 July 2001
Name	M_SP35
GPS location	
Northing	4324550
Easting	461790
Comments	Discharge from a pond fed by a series of other ponds above it. During springtime, water breaches a berm/old beaver dam and flows through some areas covered with tall grass, eventually dropping down a steeper slope to another pond located on a small bench. Flow and WQ are usually measured where the slope begins to drop. This site is usually dry during the fall.

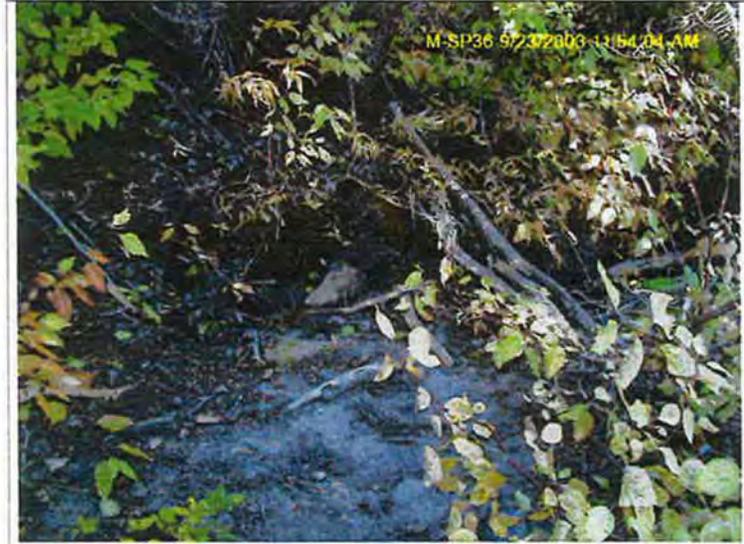
M-SP36 9/20/03 11:54:04 AM

Tract	Muddy
Date of inventory	20 July 2001
Name	M_SP36
GPS location	
Northing	4321859
Easting	463401
Comments	Water originates about mid-slope on a small bench (8 – 10 feet wide) in a stand of aspen/fir with thick brushy understory. Water flows down to a lower bench area where it enters a small channel, eventually reaching the South Fork Muddy Creek about 250 feet below.

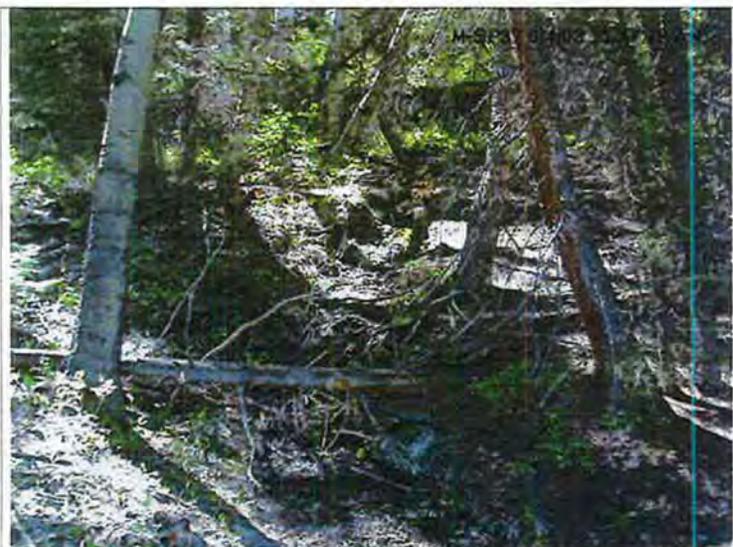
Tract	Muddy
Date of inventory	20 July 2001
Name	M_SP37
GPS location	
Northing	4321868
Easting	463357
Comments	This spring is located approximately 200 feet west of SP36, on a moderate slope above the South Fork Muddy Creek. Small amount of slumping noted above water source. Some white crust on soil surface surrounding this locator.

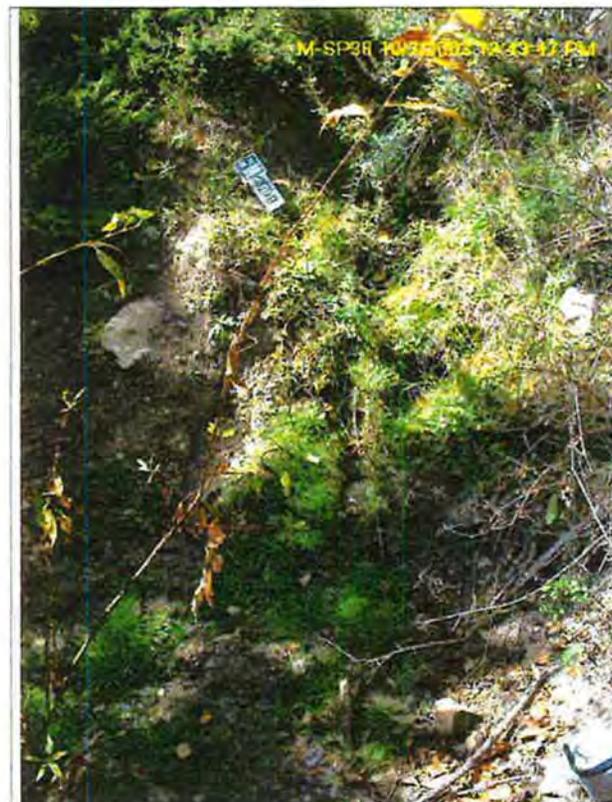
Tract	Muddy
Date of inventory	20 July 2001
Name	M_SP38
GPS location	
Northing	4321782
Easting	462767
Comments	Spring originates from base of large rock about 250 feet above South Fork Muddy Creek. Water flows downhill a short distance then splits into two streams. Flow measured at drop created by water flowing across small game trail. Spring is hard to see from above, surrounded by sedge/willow mix. Water quality samples were collected periodically for laboratory testing.

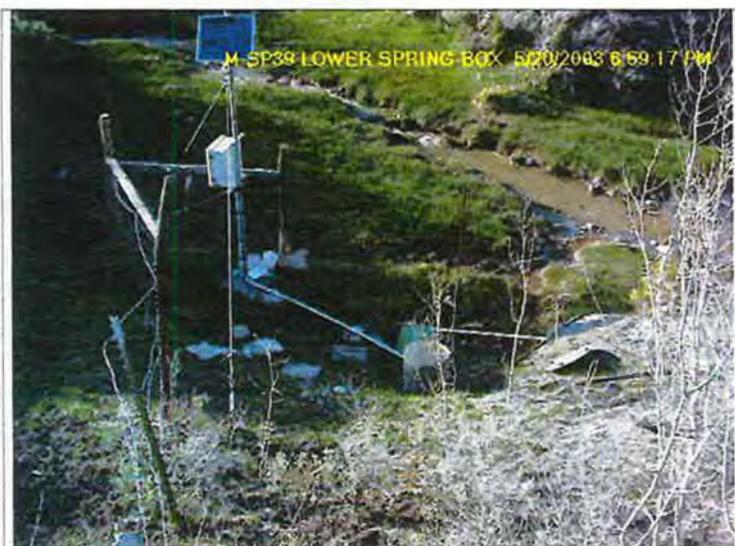
Tract	Muddy
Date of inventory	30 August 2001
Name	M SP39
GPS location	
Northing	4318775
Easting	466990
Comments	Developed spring located along Cowboy Creek. Includes three spring boxes: top spring box is disconnected and has no flow, only stagnant water; water from middle spring box flows into lower spring box, which discharges into Cowboy Creek. Instrumented spring, monitored by EWCD. Water quality samples were collected periodically for laboratory testing.

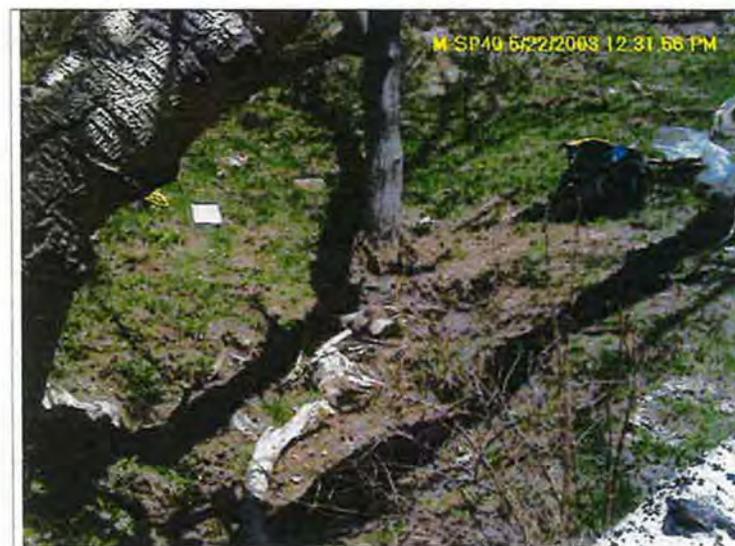
Tract	Muddy
Date of inventory	26 September 2001
Name	M SP40
GPS location	
Northing	4318041
Easting	463677
Comments	Spring originates at the base of a dead tree, on a small bench above Cowboy Creek, approximately 30 feet north of the Creek. Area is usually trampled by cattle.

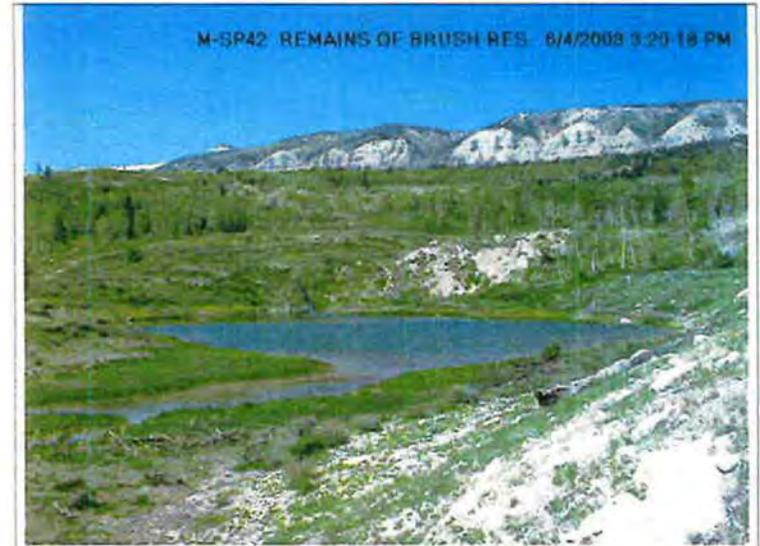
Tract	Muddy
Date of inventory	19 July 2001
Name	M_SP42
GPS location	
Northing	4324682
Easting	462141
Comments	This is the discharge point from what is left of Brush Reservoir. This pond is fed by several seep faces located on the north end. The dam is breached. There is usually a smaller pond/wetland below the larger pond. We measured water quality parameters and flow at the outlet point below the smaller pond on the far south end. Discharge from the smaller pond is concentrated in a small channel that allows flow measurements to be taken. Look for flag or metal tag at brush on cut bank, east side. This site is usually dry in the fall.

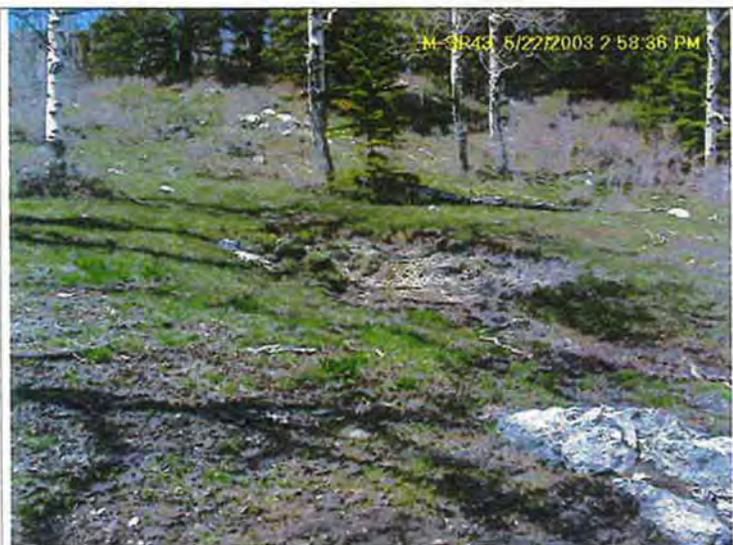
Tract	Muddy
Date of inventory	3 October 2001
Name	M SP43
GPS location	
Northing	4317186
Easting	461919
Comments	This spring originates at the edge of a large clearing at upslope end of a bench above a tributary to the North Fork Quitcupah Creek. No recent slumping observed in the area. The clearing is heavily trampled. Flow is usually measured about 25 feet below the source. Flow usually dries up about 250 feet below source, does not make it to the stream channel.

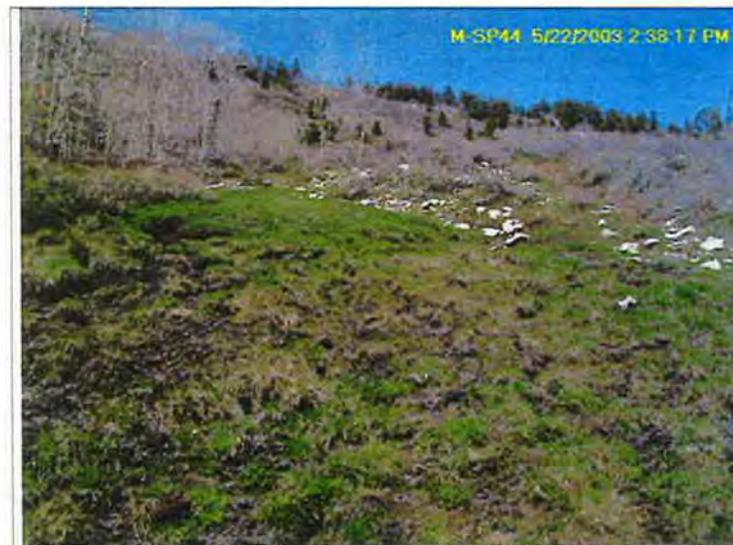
Tract	Muddy
Date of inventory	3 October 2001
Name	M SP44
GPS location	
Northing	4317150
Easting	461759
Comments	Water originates near a willow/shrub stand, near the source of an unnamed tributary to the North Fork Quitcupah Creek (M_SP21). Water bubbles up in sand/silt pocket. Area is heavily trampled and flow is usually hard to measure near source. Flow eventually confines into measurable form about 50' below source. May enter tributary at more than one location during springtime. Look for flag and metal tag on willows.

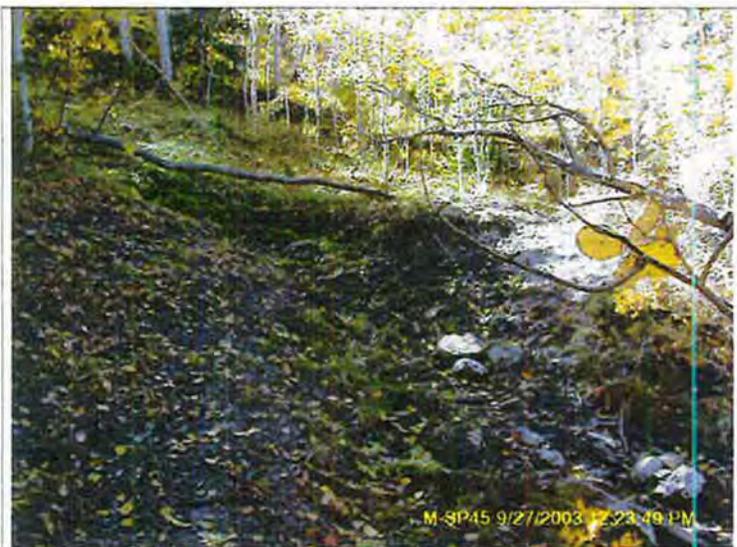
M-SP45 9/27/2003 12:23:19 PM

Tract	Muddy
Date of inventory	4 October 2001
Name	M SP45
GPS location	
Northing	4319780
Easting	465156
Comments	Source is on a narrow bench, approximately 10 – 15 feet wide, above Greens Hollow. Water is discharged from the toe of a small band of rock/shrub. Area immediately around source is fairly undisturbed, area below is heavily trampled.

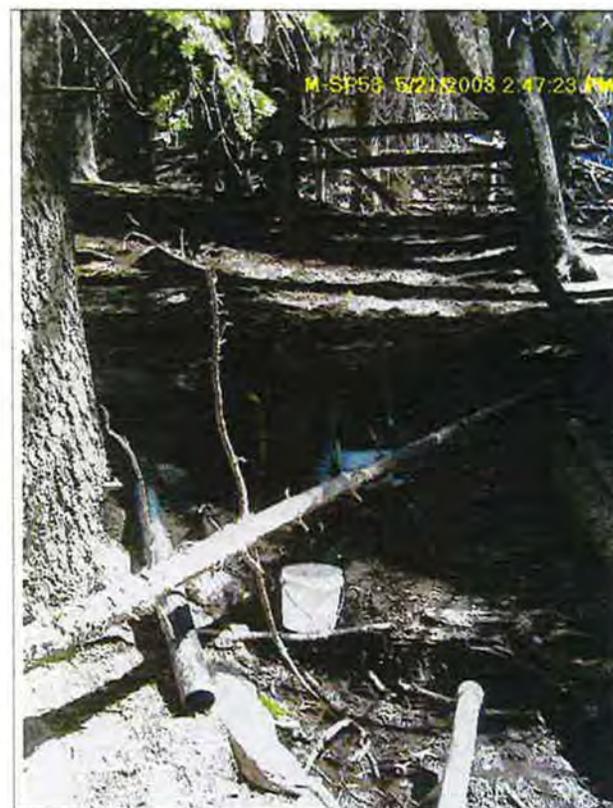
Tract	Muddy
Date of inventory	24 October 2001
Name	M_SP53
GPS location	
Northing	4317126
Easting	466373
Comments	This is a developed spring that was connected to a cattle trough (now broken, smashed by fallen tree). Flow is measured from a pipe that appears to run back 10 feet upslope to a pole fence enclosure. Could not find spring box inside enclosure. Surface water disappears about 15 feet below discharge from pipe. Best access is to drop down from ATV trail along Big Ridge. Hike down west side of dry drainage, cut over to the west to spring. Look for old cow path leading to spring.

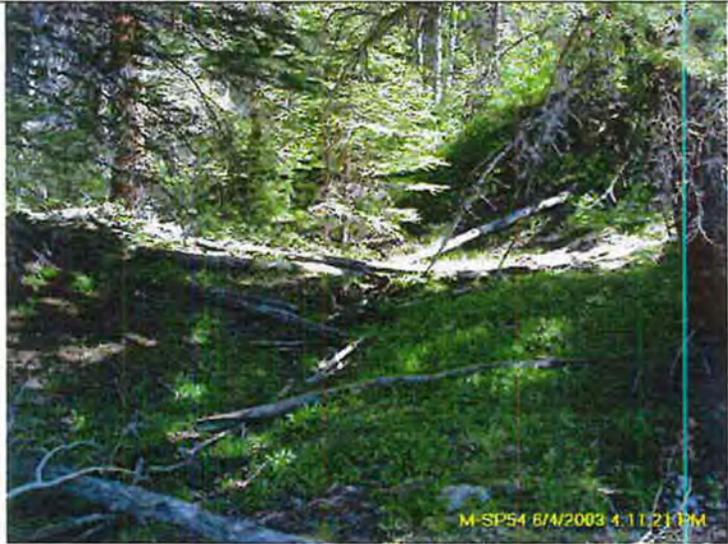
Tract	Muddy
Date of inventory	25 October 2001
Name	M_SP54
GPS location	
Northing	4321205
Easting	4623320
Comments	Spring originates at the base of a large rock near edge of bench. Water meanders along edge of small meadow before dropping into South Fork Muddy Creek.

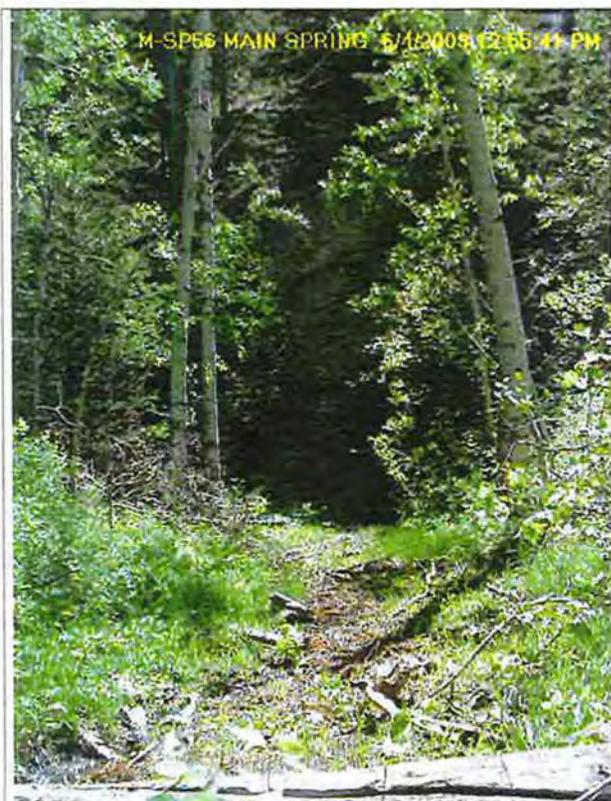
Tract	Muddy
Date of inventory	25 October 2001
Name	M_SP55
GPS location	
Northing	4321330
Easting	462585
Comments	Spring originates at base of slope under a dead tree, in a deadfall area. Water flows down into a wet meadow, then into South Fork Muddy Creek.

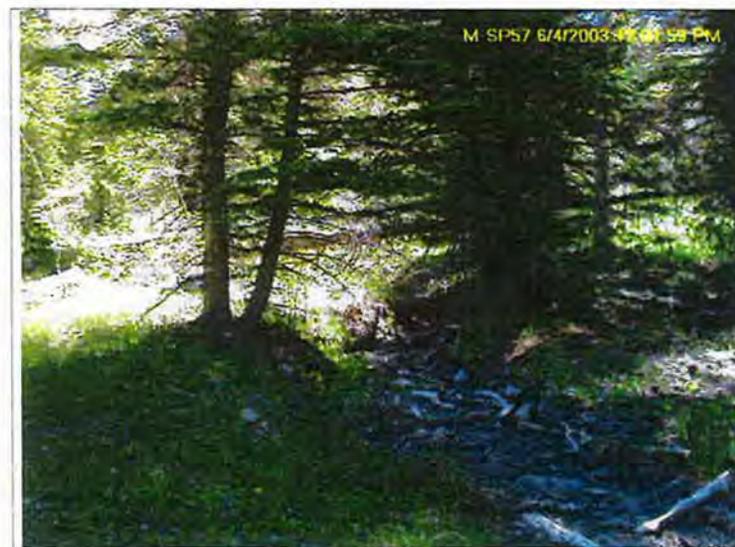
Tract	Muddy
Date of inventory	25 October 2001
Name	M_SP57
GPS location	
Northing	4321845
Easting	463278
Comments	Water source is located approximately 100 feet from the base of a gentle slope. Some evidence of recent slumping above. White crust observed on soil near source. Water moves downslope into a small channel, and then into South Fork Muddy Creek. There is typically no water above this point in the stream channel. Best way to find this site is to follow water up the stream channel to the point where water is seeping down the channel bank. Climb out of channel and follow to source.

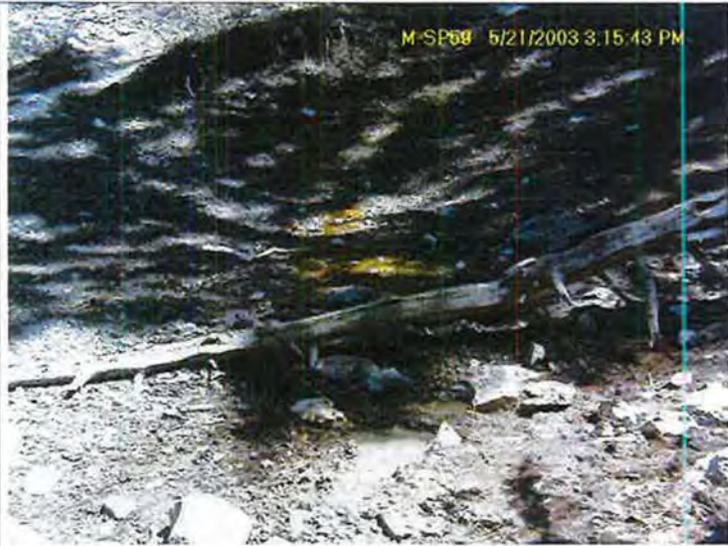
Tract	Muddy
Date of inventory	24 October 2001
Name	M_SP59
GPS location	
Northing	4317186
Easting	466357
Comments	Water originates in small bowl (100 square feet), barren and surrounded by pines. Water is somewhat dispersed from source, concentrates about 10 – 20 feet below. Area is usually trampled in the fall. Water flows over edge of bench towards a stream channel located about 150 feet down slope. Water usually disappears about 50 feet or so below the source and does not reach the stream channel. Best access is to drop down from M_SP53.

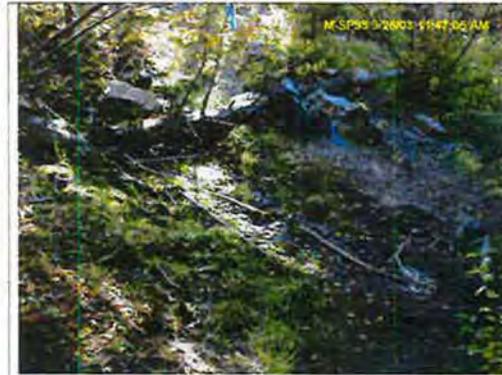
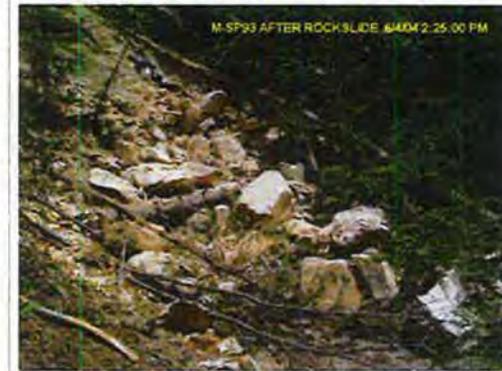
Tract	Muddy
Date of inventory	26 June 2002
Name	M_SP91 (Pines 202)
GPS location	
Northing	4317250
Easting	469623
Comments	Appears to be Pines #202. Originates on very steep, unstable slope, about 100 feet above Box Canyon creek. Seepy area to the south of spring has no measurable flow.

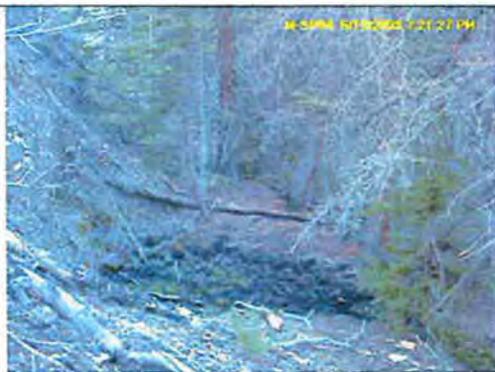
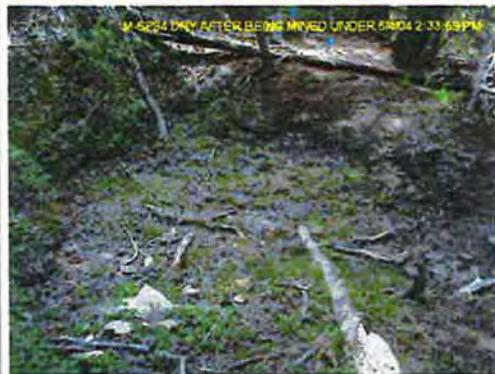
Tract	Muddy
Date of inventory	25 June 2002
Name	M_SP93 (Pines 216)
GPS location	
Northing	4317428
Easting	471356
Comments	This spring originates on the northeast side of the East Fork Box Canyon, on a narrow bench below a cliff, and crosses a well-used wildlife/cattle path. This spring appears to be Pines #216 and is marked with a stake labeled "EFB52(N)". The spring/seep 20 feet to the east was flowing very slowly at the time of the first visit, not measurable. On subsequent visits, it was measured as SP98. After SUFCO mined under the East Fork Box Canyon in the winter of 2003-2004, both springs stopped flowing and were covered by a rockslide.

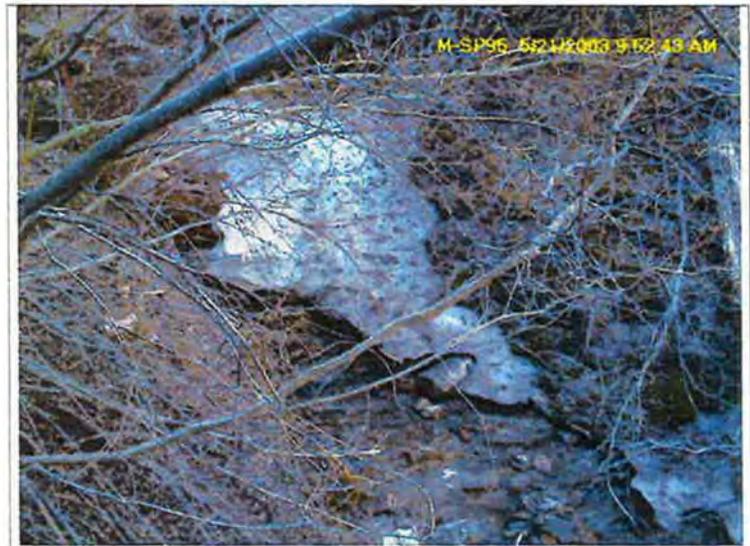
Tract	Muddy
Date of inventory	25 June 2002
Name	M. SP94 (Pines 217)
GPS location	
Northing	4317389
Easting	471375
Comments	This spring originates on the northeast side of the East Fork Box Canyon, on a narrow bench below a rock face, and crosses a well-used wildlife/cattle path. This spring appear to be Pines #217 and is marked with a stake labeled "EFB53(N)". There is another spring/seep about 50 feet to the south that was not flowing at the time of the first visit. On subsequent visits, that second spring was measured as SP99. After SUFCO mined under the East Fork Box Canyon in the winter of 2003-2004, both springs stopped flowing (unlike SP93 and SP98, they were untouched by rockslides).

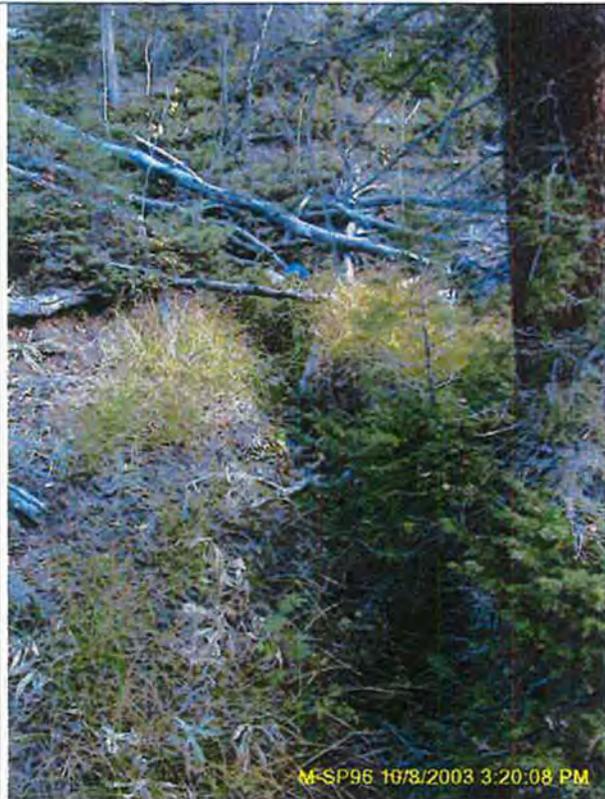
Tract	Muddy
Date of inventory	26 June 2002
Name	M_SP96 (Pines 211A)
GPS location	
Northing	4317260
Easting	469657
Comments	This spring is located in a stand of aspen/fir mix above the main stem of Box Canyon. A metal tag at source is labeled Pines 211A. A tag found at creek nearby has 212 and 203 written on it.

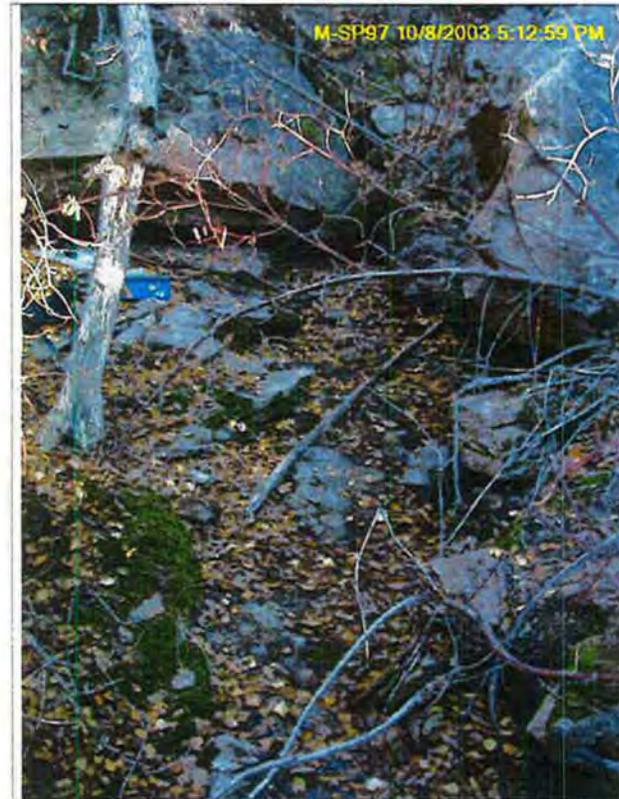
Tract	Muddy
Date of inventory	28 September 2002
Name	M_SP97 (Pines 207)
GPS location	
Northing	4317699
Easting	469937
Comments	Water appears from under a big boulder in the stream channel. Metal tag near source is labeled Pines 207. This spring is difficult and somewhat dangerous to get to, due to extremely steep slopes and cliffs surrounding it. Water is dripping from a big overhang just upstream of the spring but no measurable flow there. Water flows on surface for about 70 feet below spring then disappears. It reappears with additional flow from other seeps/springs at SP95.

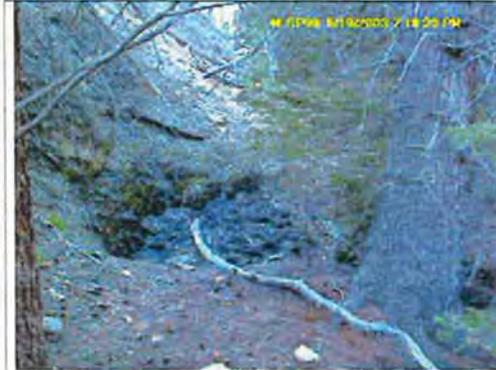
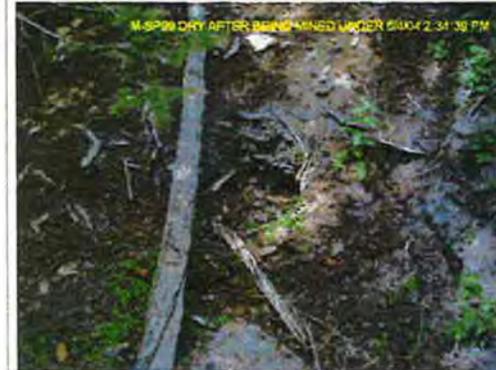
Tract	Muddy
Date of inventory	27 September 2002
Name	M SP98 (Pines 216A)
GPS location	
Northing	4317434
Easting	471365
Comments	This spring originates on the northeast side of the East Fork Box Canyon, on a narrow bench below a cliff, and crosses a well-used wildlife/cattle path. This spring appears to be Pines #216A and is marked with a stake labeled "EFB52(S)". It is located just east of SP93. After SUFCO mined under the East Fork Box Canyon in the winter of 2003-2004, both springs stopped flowing and were covered by a rockslide.

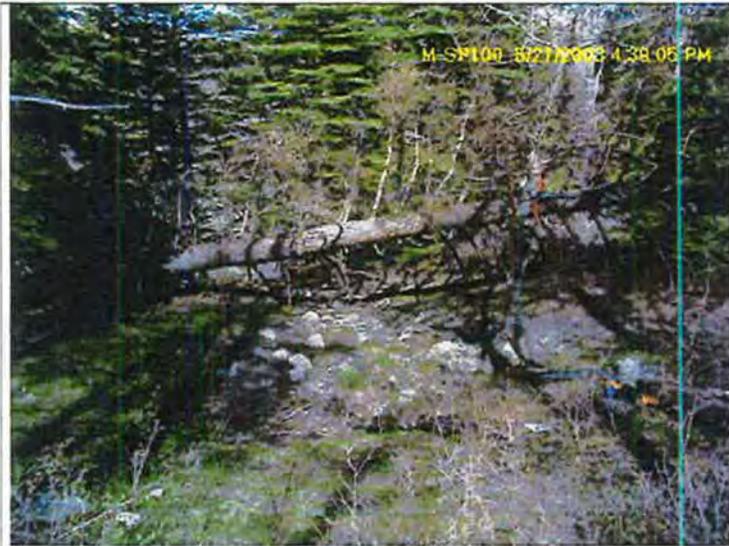
Tract	Muddy
Date of inventory	27 September 2002
Name	M SP99 (Pines 217A)
GPS location	
Northing	4317375
Easting	471376
Comments	This spring originates on the northeast side of the East Fork Box Canyon, on a narrow bench below a rock face, and crosses a well-used wildlife/cattle path. Water disappears underground near edge of bench and reappears on slope just below bench. This spring appear to be Pines #217A and is marked with a stake labeled "EFB53(S)". It is located about 50 feet south of SP94. After SUFCO mined under the East Fork Box Canyon in the winter of 2003-2004, both springs stopped flowing (unlike SP93 and SP98, they were untouched by rockslides).

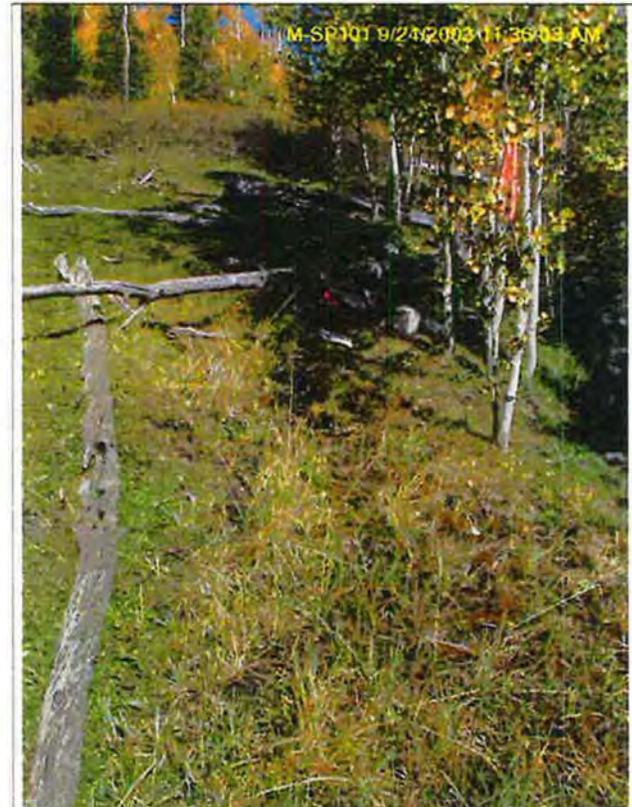
Tract	Muddy
Date of inventory	27 September 2002
Name	M SP100
GPS location	
Northing	4316719
Easting	463616
Comments	This spring is located 75 feet above the stream channel of an unnamed tributary to Quitchupah Creek, upstream of SP15. A seep face is located 10 feet upstream of this spring. No flow in channel above this point.

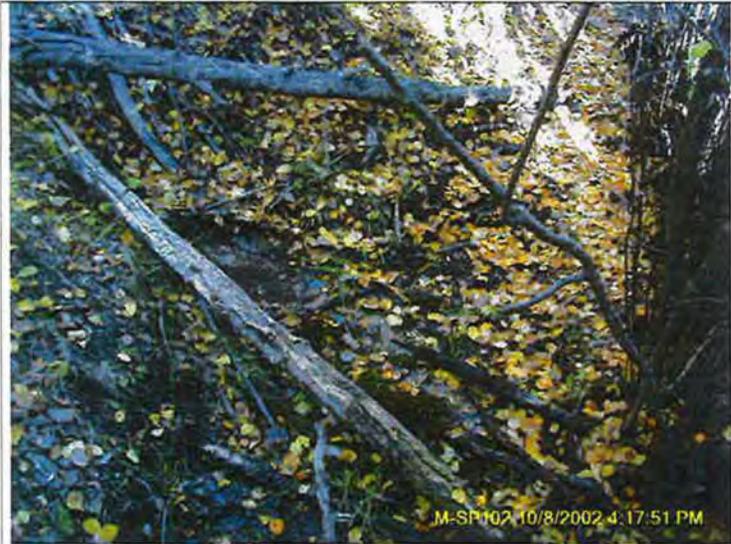
Tract	Muddy
Date of inventory	28 September 2002
Name	M SP101
GPS location	
Northing	4322527
Easting	461364
Comments	This spring is located on a gentle slope above an unnamed tributary to Beaver Creek, about 150 feet east of SP64 and 75 feet east of SP110. Flow from a seep directly to the west of this spring joins flow from SP101 before discharging into the creek.

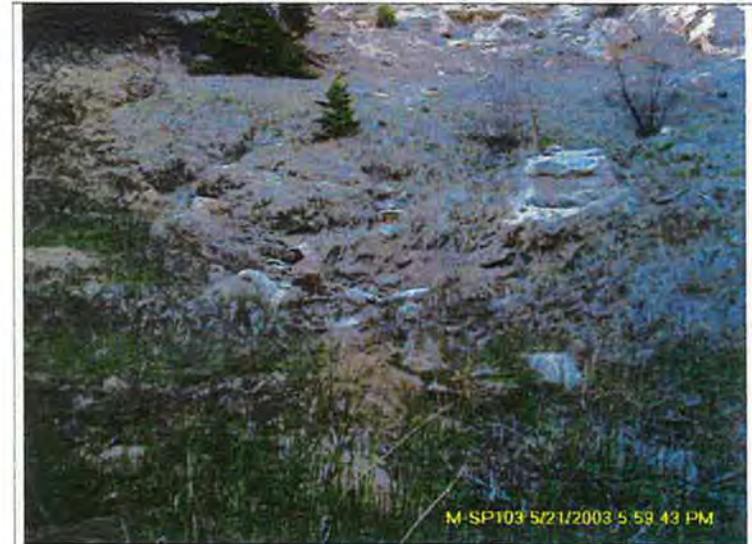
Tract	Muddy
Date of inventory	21 May 2003
Name	M_SP103
GPS location	
Northing	4316302
Easting	463271
Comments	Found this new spring on the way to M_SP60 is a small slide area. Flow originates at base of cliff. Not certain how far down the water travels; it does not appear to reach the river below. Located just east of SP104

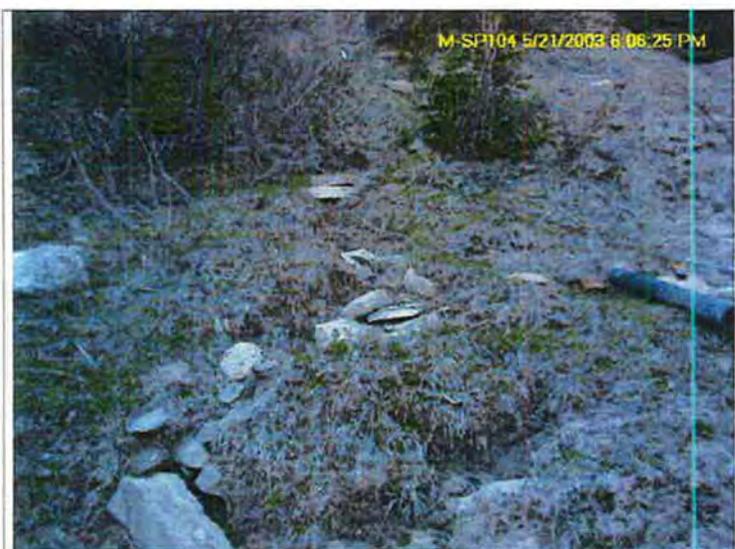
Tract	Muddy
Date of inventory	21 May 2003
Name	M_SP104
GPS location	
Northing	4316335
Easting	463250
Comments	This spring is located just west of M_SP103. Flow disappears 30 feet below source. Water picks up a lot of silt, making it very turbid.

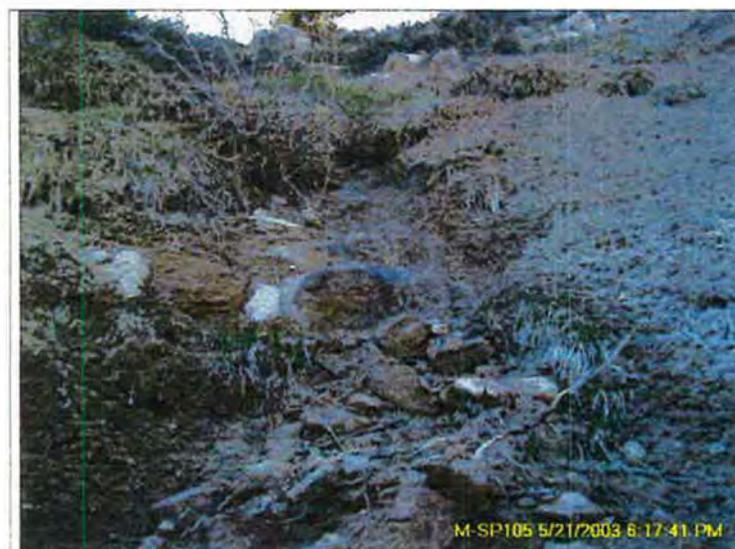
Tract	Muddy
Date of inventory	21 May 2003
Name	M_SP105
GPS location	
Northing	4316280
Easting	463233
Comments	This spring was found about 150 feet southwest of SP104.

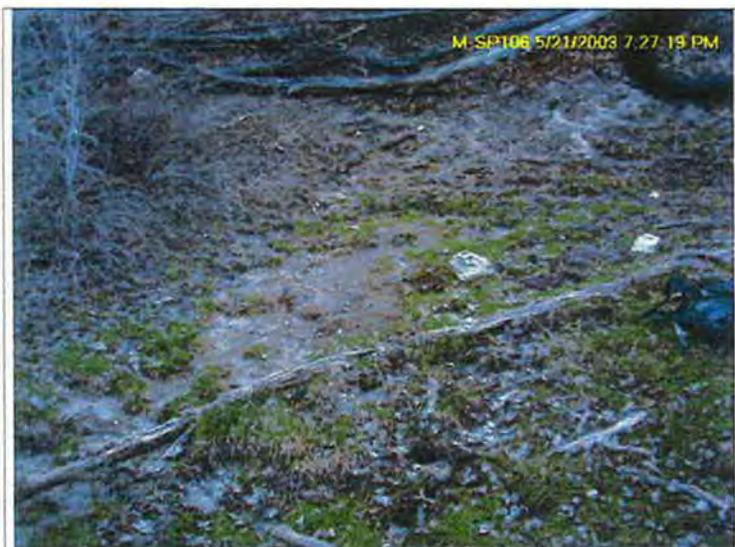
Tract	Muddy
Date of inventory	21 May 2003
Name	M_SP106
GPS location	
Northing	4316155
Easting	462626
Comments	Spring is located about 100 feet west of M_SP19, above an unnamed tributary of the North Fork Quitcupah Creek.

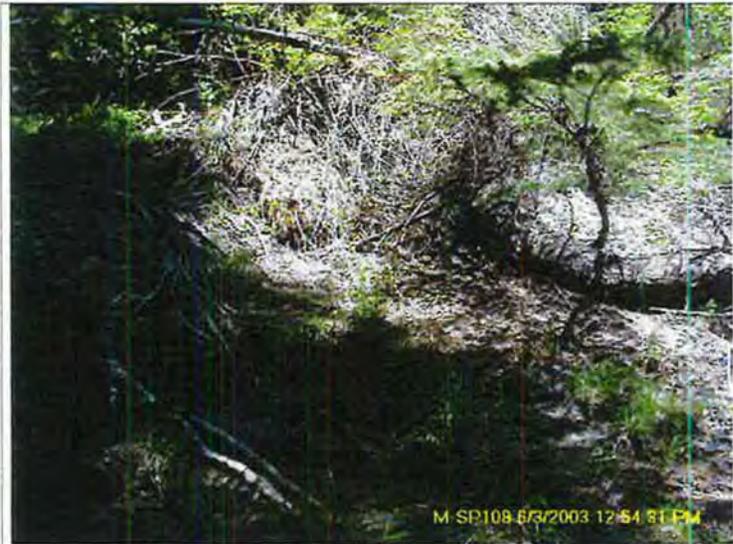
Tract	Muddy
Date of inventory	24 May 2002
Name	M_SP107
GPS location	
Northing	4323024
Easting	463091
Comments	Spring is located above and feeds an extensive pond/wetland complex located on several benches to the north of the North Fork Muddy Creek. Very light cattle/wildlife use. Very nice. Thick grass and moss. Pond is about 75 x 100 feet and has fish (Pond E). Water goes from pond down into creek. (Note: somehow this spring and SP_70 were assigned the same ID and were mixed up when the data was entered after this first visit. As a result, this spring was not visited in the fall of 2002 because we didn't realize it existed.)
