Re: Revision to M&RP to Add Greens Hollow Lease Tract, Sufco Mine, Canyon Fuel Company, LLC, Permit Number C/041/0002

APPLICATION FOR COAL PERMIT PROCESSING

Title: Revisions to M&RP to Add Greens Hollow Lease Tract

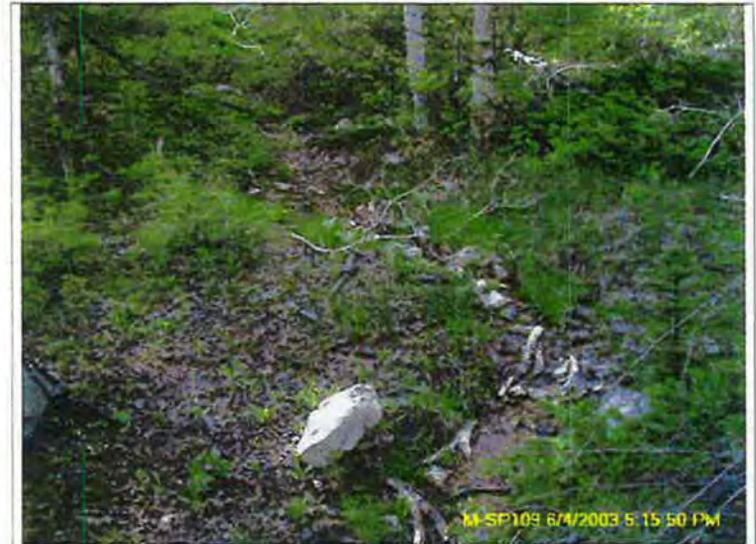
Tract	Muddy
Date of inventory	4 June 2003
Name	M_SP109
GPS location	
Northing	4321387
Easting	462075
Comments	This spring was found while walking between SP49 and SP48. Spring is on the hillside just above a small wetland, on the north side of the North Fork Muddy Creek. There are a few large fir trees in the area. Water comes out of the ground, stays above ground for only a few feet, then disappears for about 5 ft, then flows above ground again.

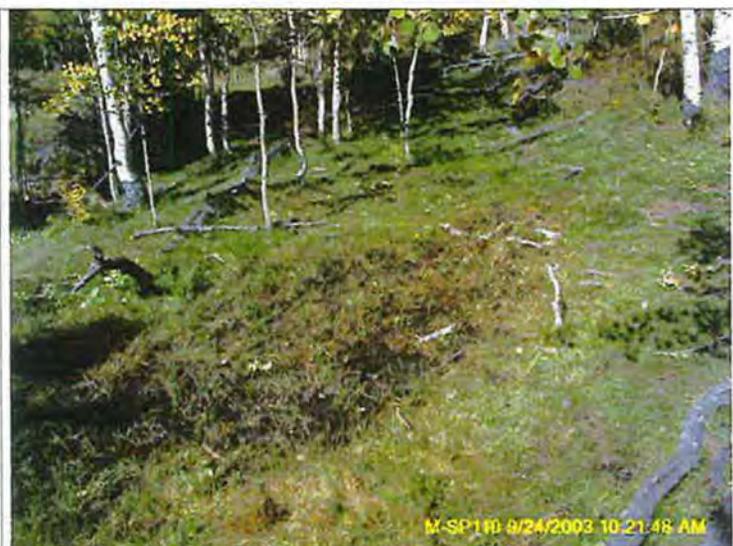
Tract	Muddy
Date of inventory	25 September 2003
Name	M-SP110
GPS location	
Northing	4322520
Easting	461347
Comments	Small spring located approximately midway between SP64 and SP101, on a gentle slope above an unnamed tributary to Beaver Creek.

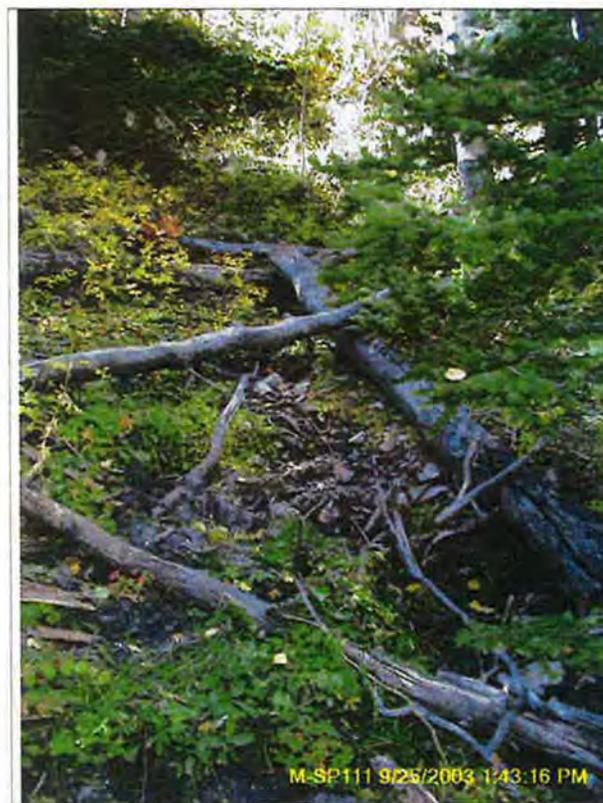
Tract	Muddy
Date of inventory	7 October 2002
Name	M-SP111
GPS location	
Northing	4320391
Easting	461597
Comments	This spring was originally mistaken for SP76, which was not flowing at the time, but later proved to be a new spring. It is located on a fairly steep, forested north-facing slope with some deadfall, 300 - 400 feet to the east of the actual SP76. Elk and elk sign were observed near this spring.

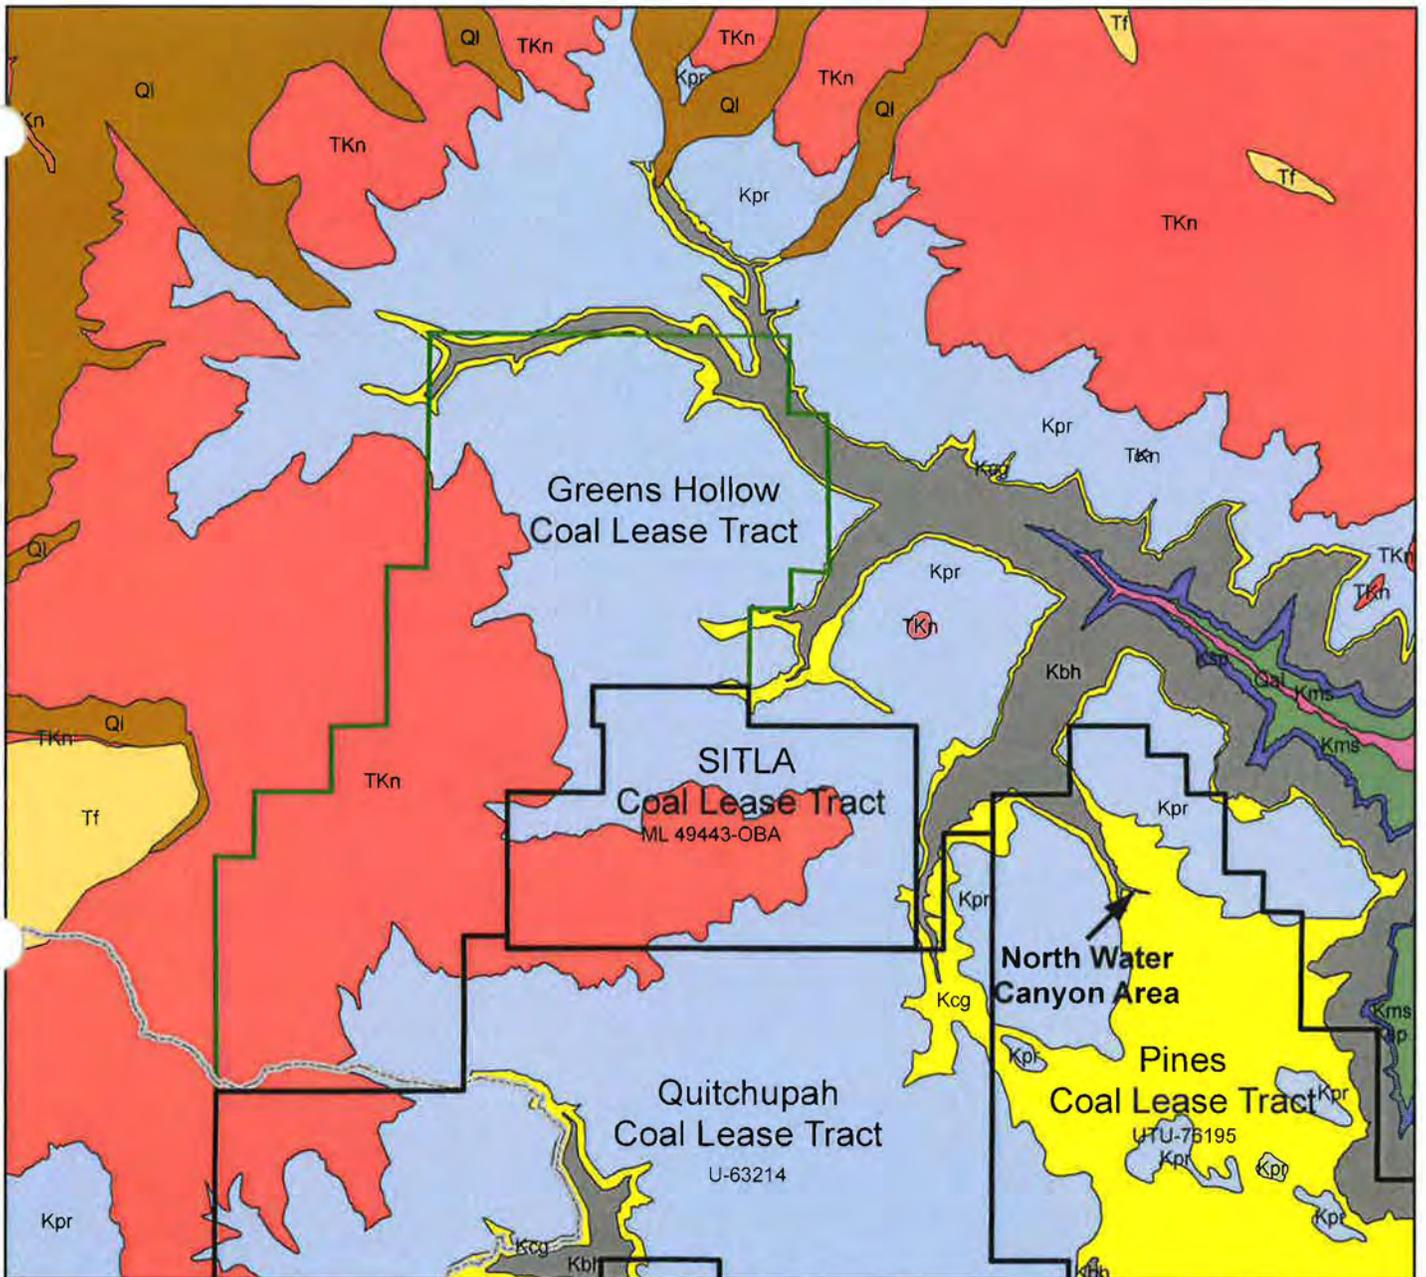
Figure 4.1. Bedrock geologic map of the Greens Hollow tract and adjoining leases.

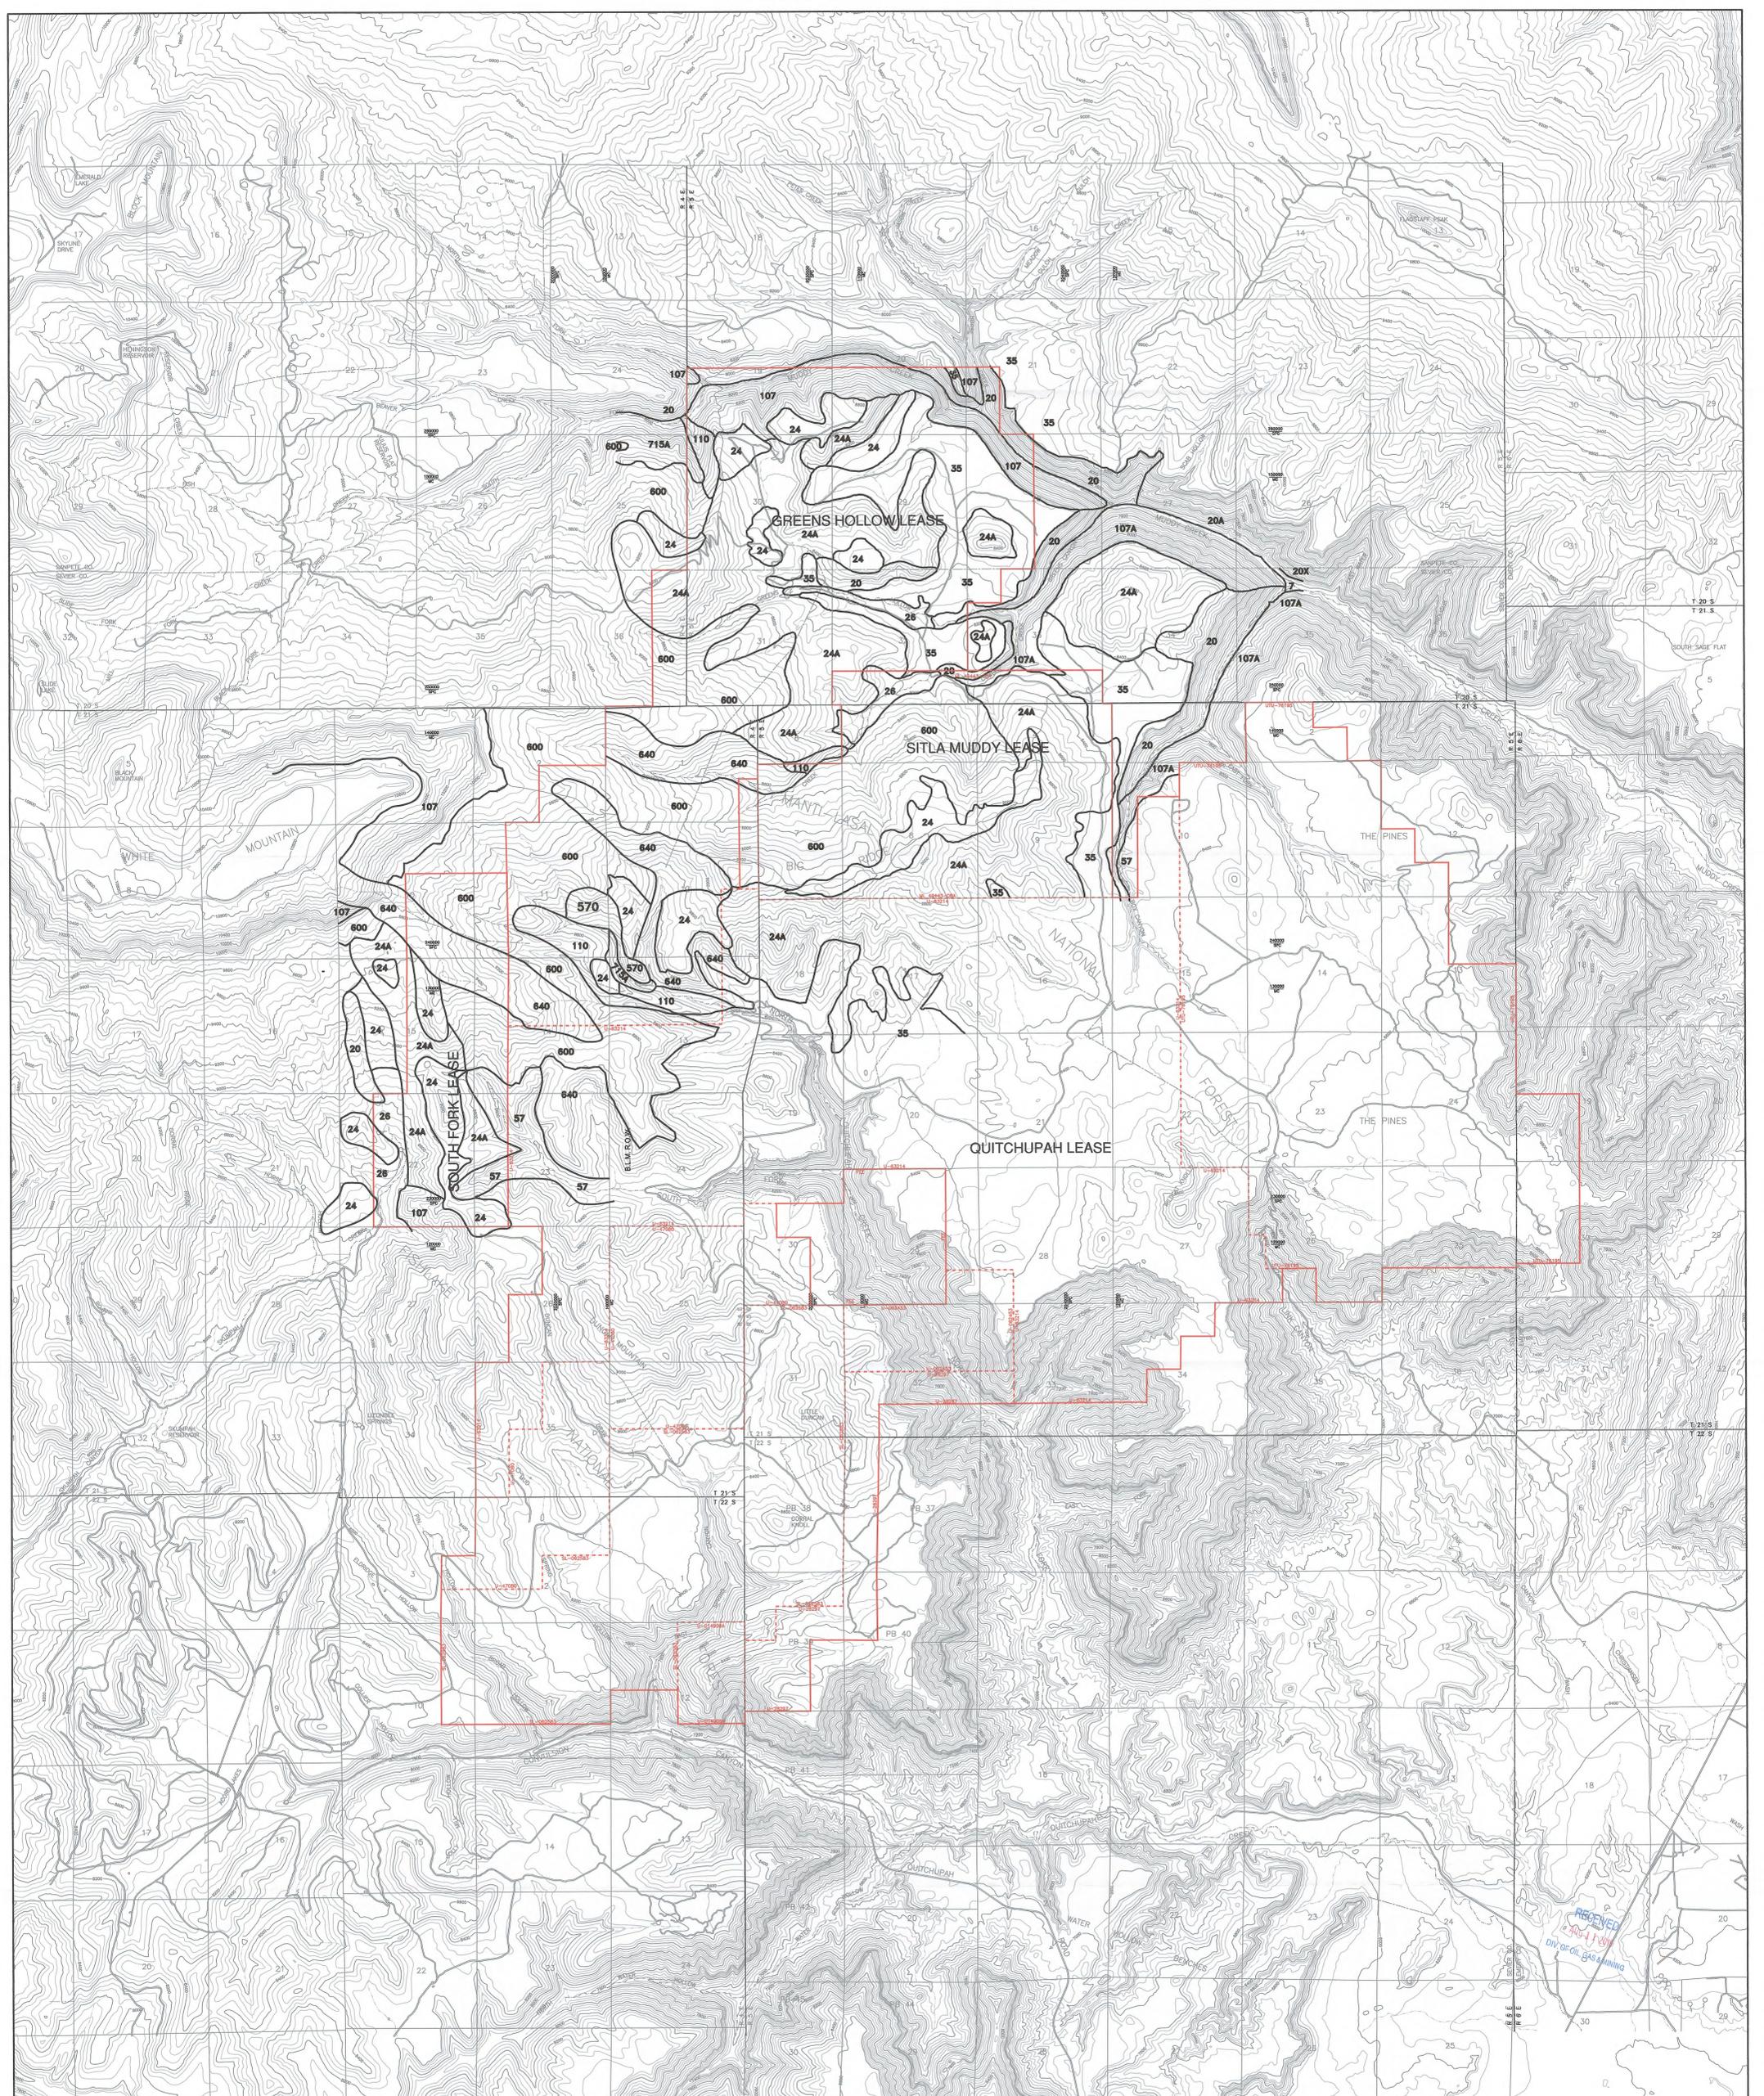
SOIL TYPES

- 7 SHUPERT-WINETTI FAMILIES
- 20 STROCH-PATHHEAD-WIGGLER FAMILIES
- 20A ANDOK-STROCH-WIGGLER FAMILIES
- 20X ANDOK-WELRING FAMILIES
- 24 RABBITEX-REPP FAMILIES
- 24A WHETROCK-DETRA FAMILIES
- 26 MANA-RABBITEX FAMILIES
- 35 DETRA FAMILY
- 57 FALCON FAMILY
- 107 BUNDO-SCOUT-JUNTA FAMILIES
- 107A CIRCLEVILLE-SCOUT-PANGUITCH FAMILIES
- 110 CASTINO-ELWOOD FAMILIES
- 600 FARM-CLAYBURN-CASTINO FAMILIES
- 640 KILDOR FAMILY
- 715A CROYDON-MORTENSON FAMILIES
- 570 LUCKY STAR-PRITCHETT FAMILIES

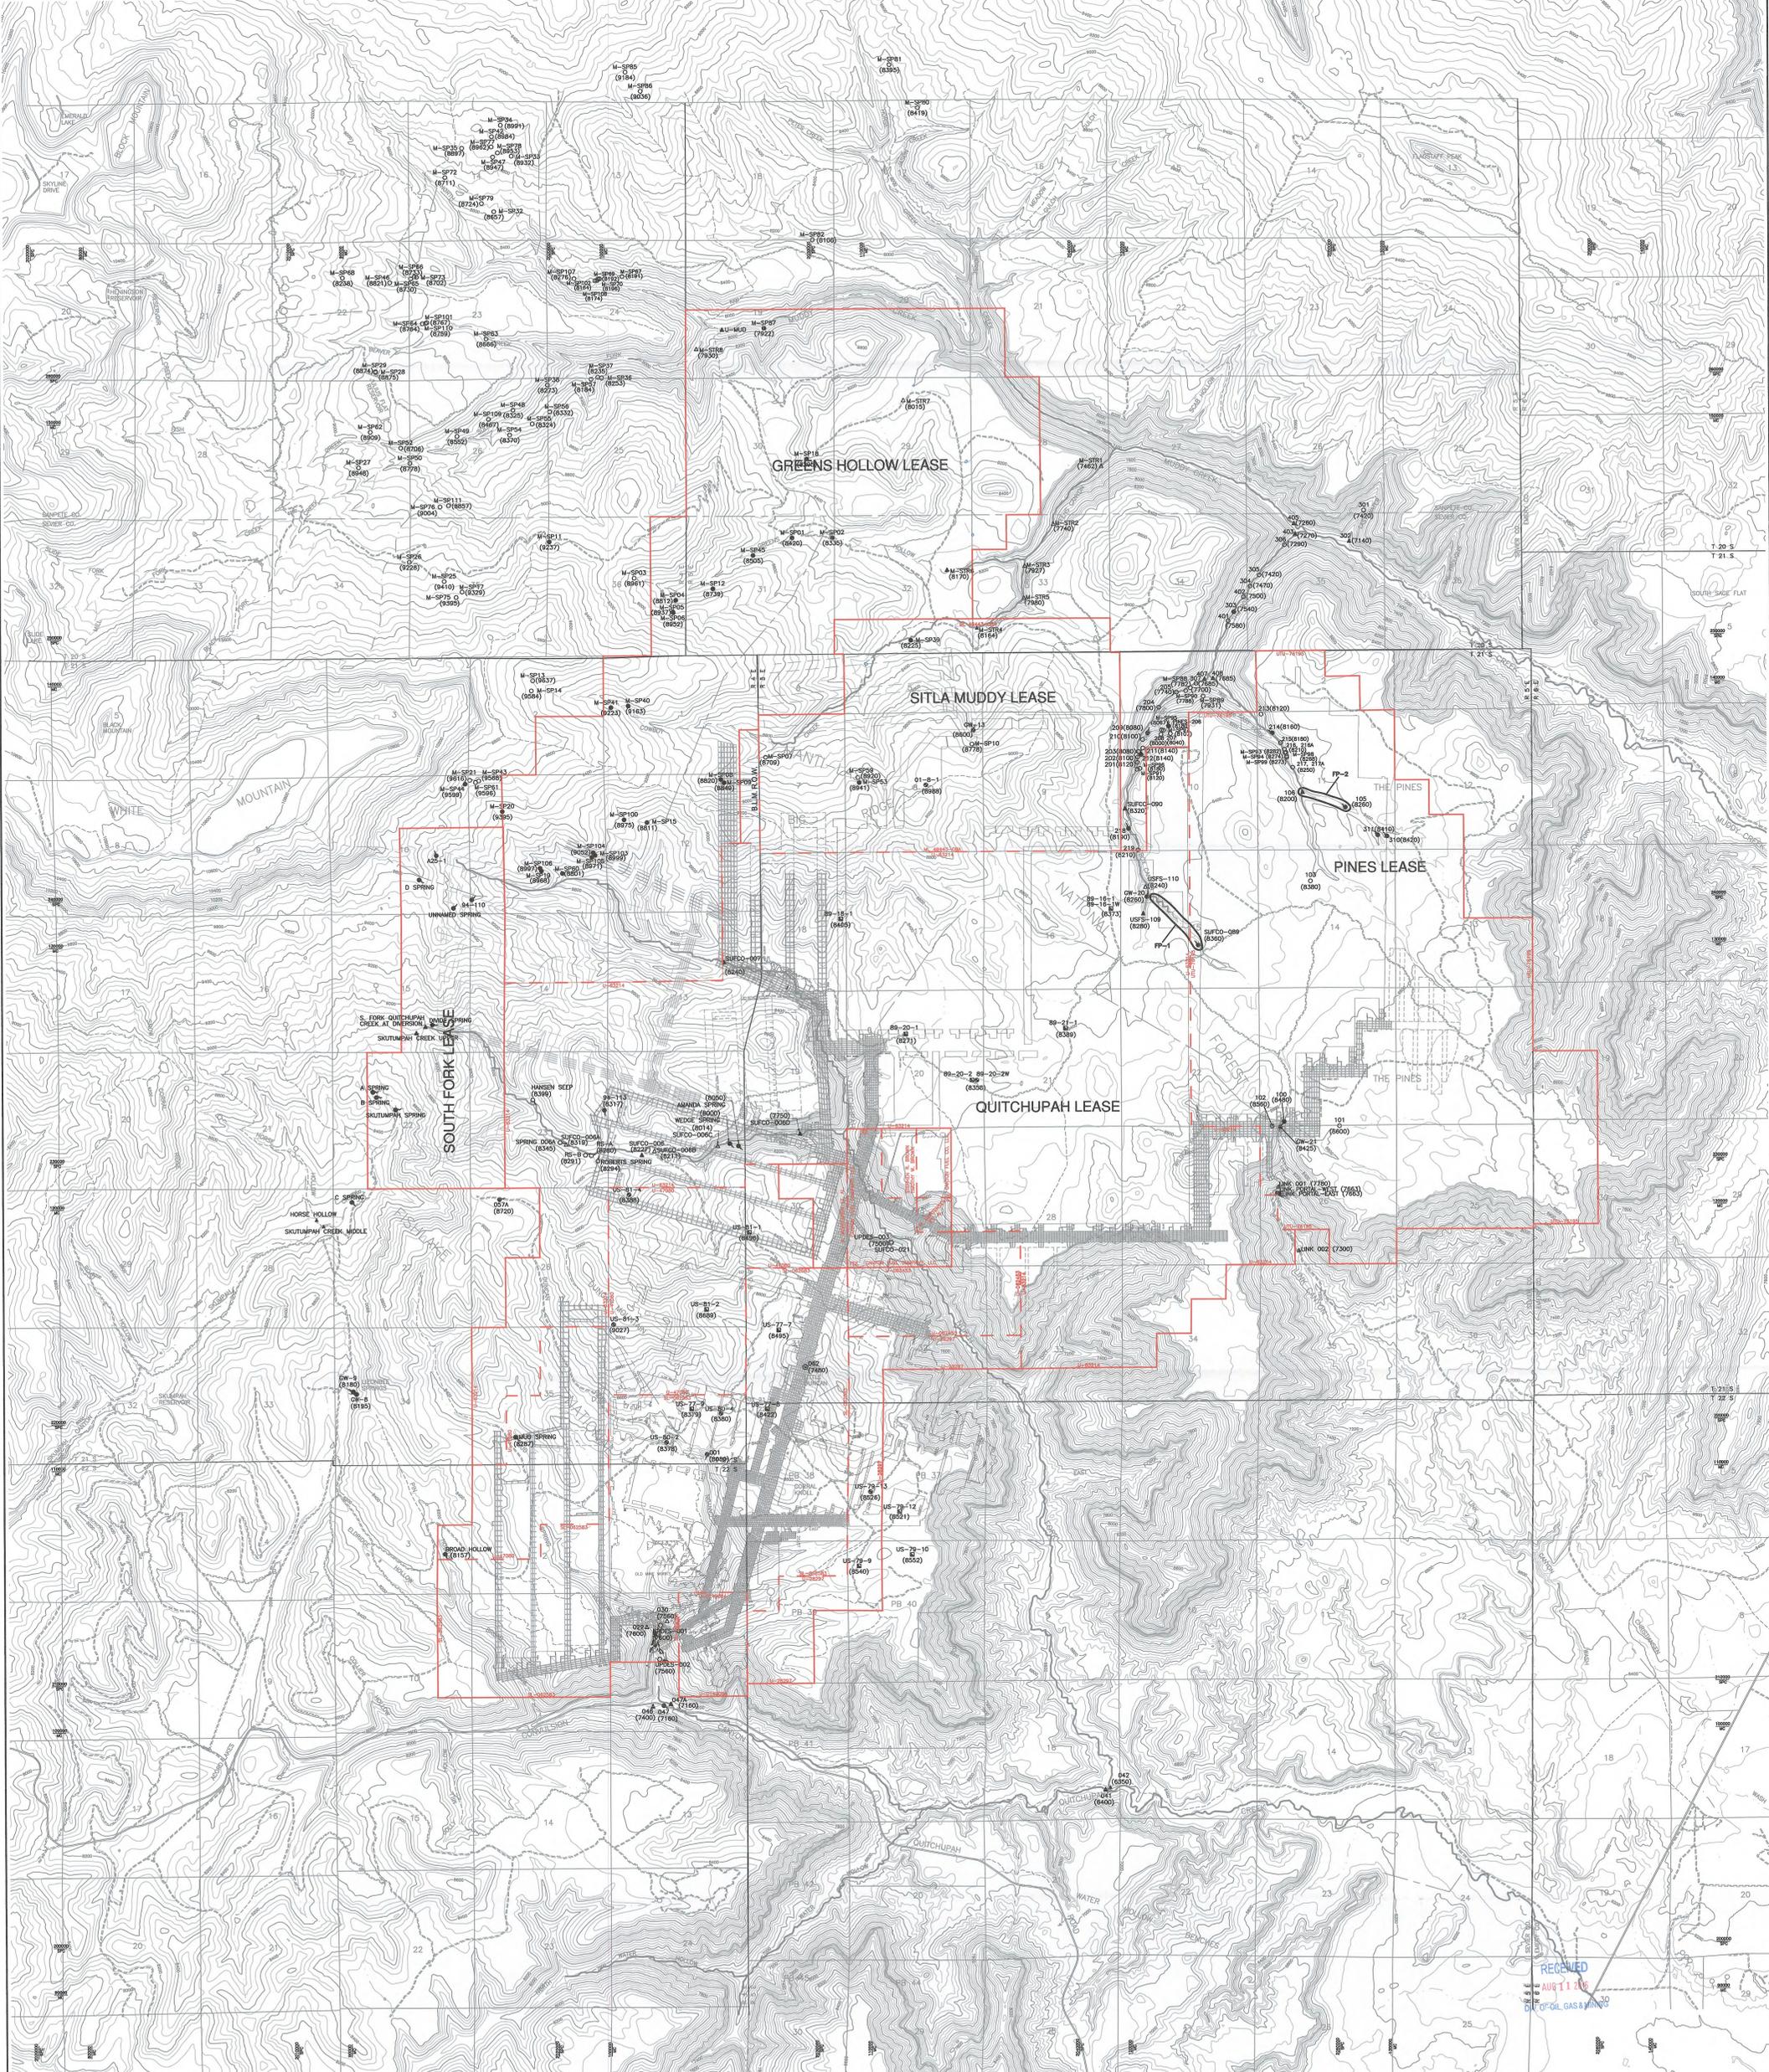
SCALE: 1" = 1,500'
DATE: 7/26/2018
DRAWN BY: J.C.C.
ENGINEER: VM
CHECKED BY: VM
SHEET NO.: 7-2

SURFACE AND GROUNDWATER RIGHTS-QUITCHUPAH TRACT
