**Minerals Regulatory Program
Inspection Report**

Mine Name: TMM ASPHALT RIDGE	Inspection Date: May 18, 2021 12:23 PM
Permit Number: M0470089	Lead Inspector: April Abate
Mine Status: Active	Secondary Inspector(s):
Operator: PETROTEQ ENERGY	Prior Inspection: December 10, 2020
Attendee(s): Gabriel Miranda, Valkor, John Potter, TomCo.	Permit Fees: Paid 01/27/21
Weather: Sunny	Bond Amount: \$385,672
Reviewed By: Paul Baker	Bond Escalation: 5/30/2019
Inspection Purpose: Follow Up from Enforcement	
Conclusions and Recommendations: Oil sand stockpiles from an off-site source were observed on the permit area. Sand end-product stockpile also was observed. These stockpiles will need to be accounted for in the updated NOI and included in the bond calculations.

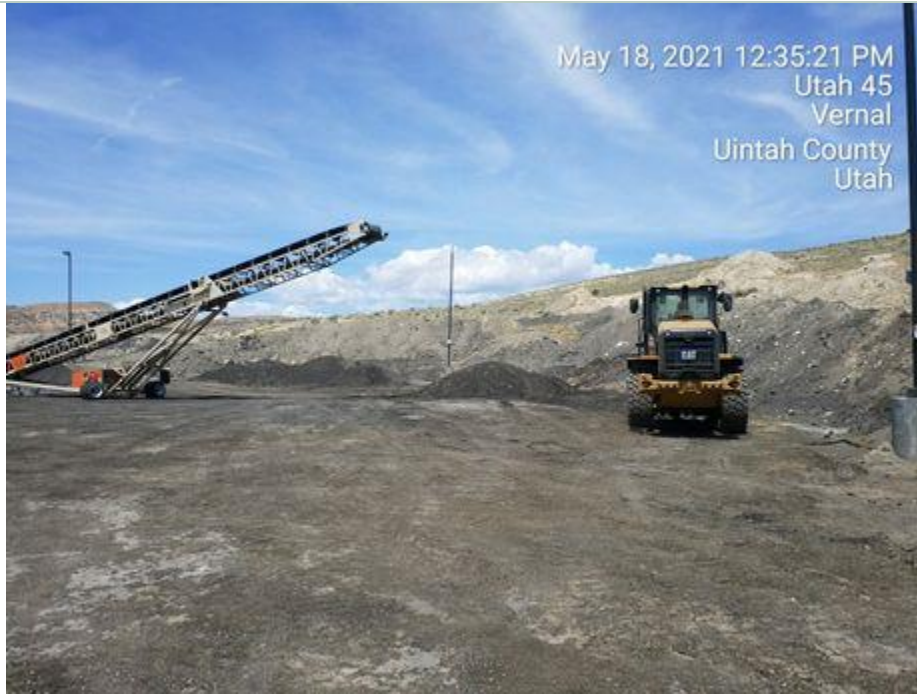
Latitude: 40.3373, Longitude: -109.48656
Small amount of ore was staged in front of the crusher.

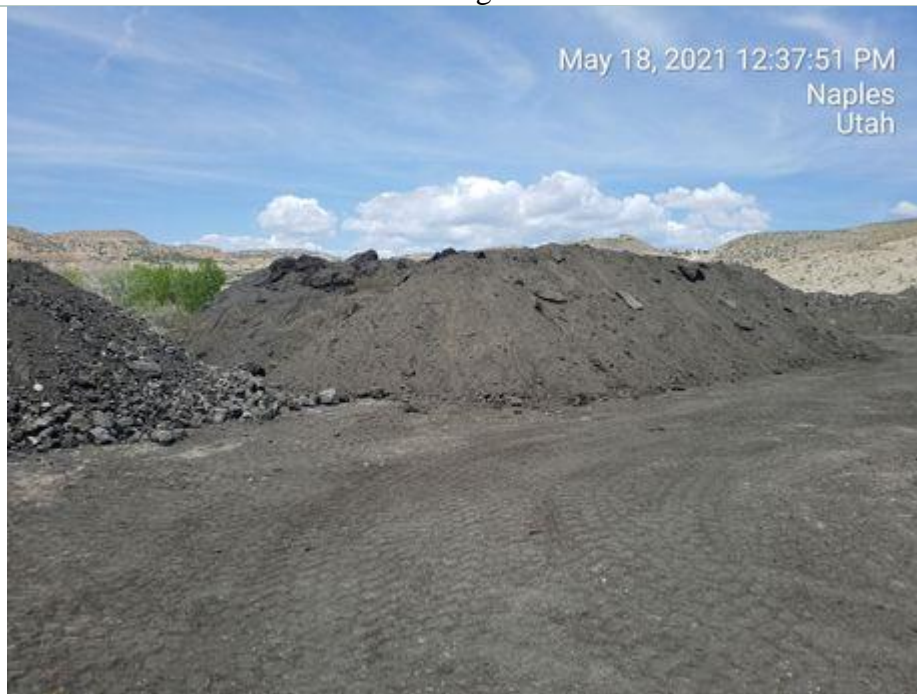
Latitude: 40.33713, Longitude: -109.48884
A separate staging area west of the plant is where trucked in ore was located.

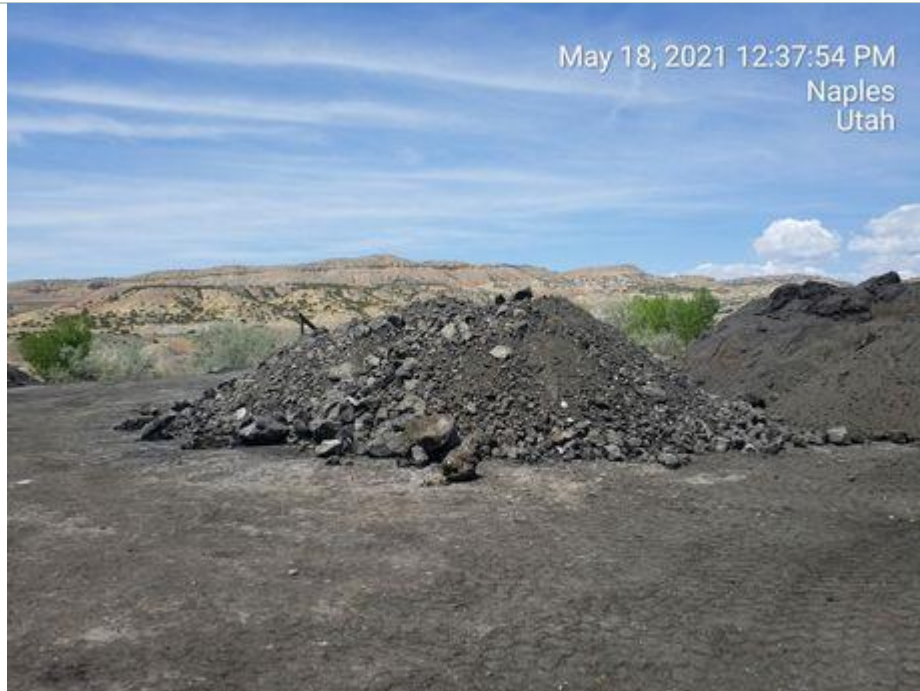
Latitude: 40.33715, Longitude: -109.48883

This same area had a combination of stockpiles from the on- site mine and trucked in ore.

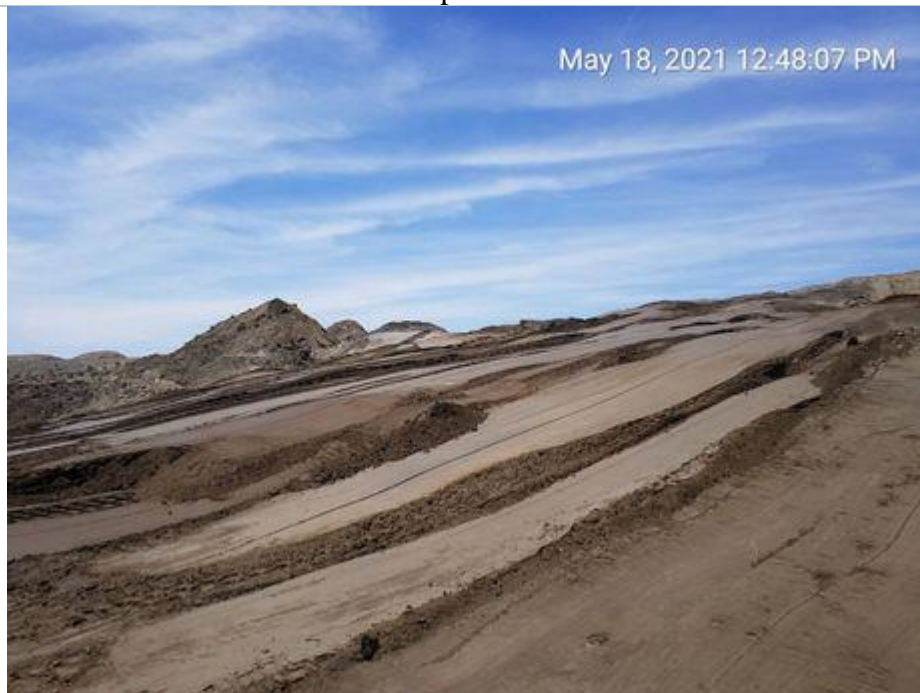
Latitude: 40.1996, Longitude: -109.65909

4. Deleterious Material	<input checked="" type="checkbox"/> Evaluated & Commented <input checked="" type="checkbox"/> Enforcement
The plant has produced a small amount of sand that is stockpiled on the west side of the permit area. This sand represents the end-product of the process. According to the operator, the sand contains just 2% hydrocarbons. This sand is combination of oil sands from both the pit here and from a different pit further north. Additional data is needed to determine if this material is

deleterious. This information will be used in determining how this material is handled during reclamation.	
5. Roads (maintenance, surfacing, dust control, safety)	<input type="checkbox"/> Evaluated & Commented <input type="checkbox"/> Enforcement

Sand end-product stockpile. The sand had a very strong hydrocarbon odor.
